Report on the investigation of  
the grounding of the ro-ro freight ferry  
***Arrow***  
in the approach channel of Aberdeen Harbour  
on 25 June 2020

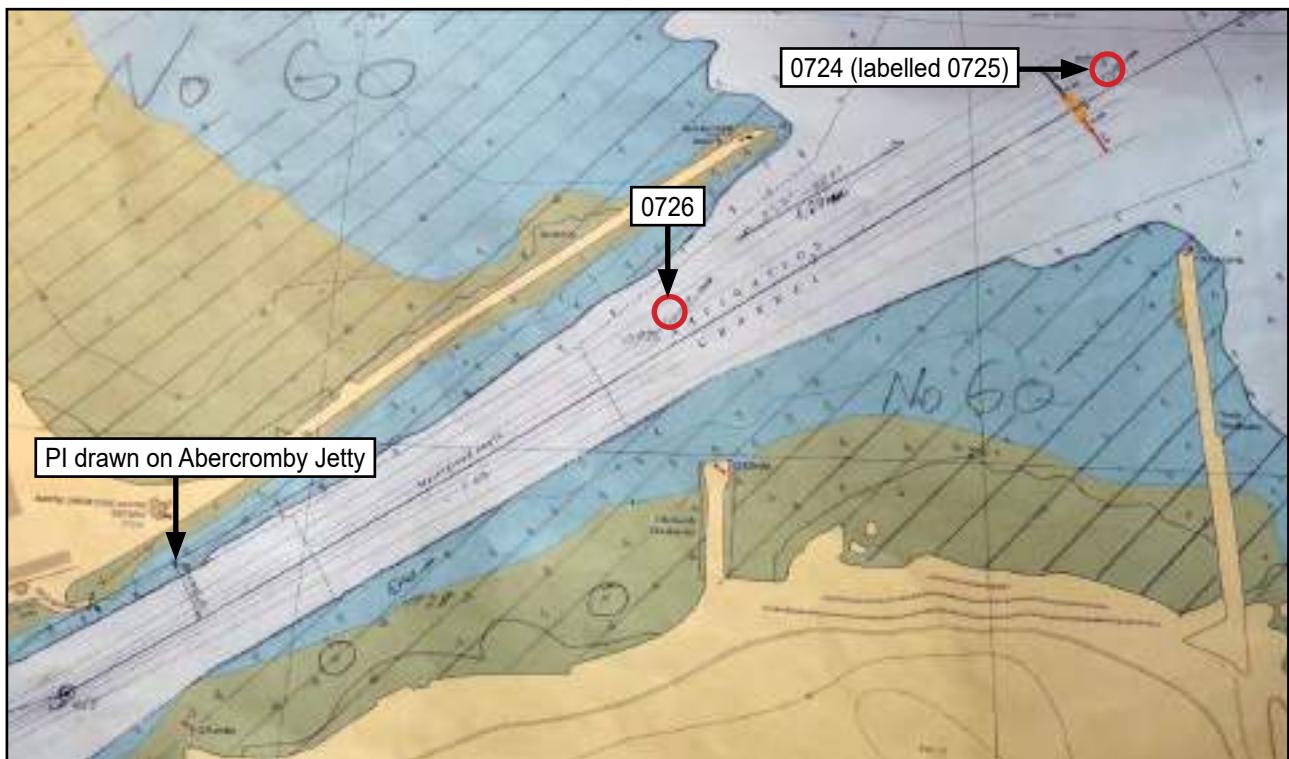
At 0724, Arrow's 3/O plotted a Global Positioning System (GPS) position on the chart which was marked as 0725. The position indicated that the ship was north of the planned track (**Figure 10**). A further fix was plotted at 0726, showing the vessel just to the north of the centreline. This position was not recorded in the log, and it is not clear if this was reported to the master and the PEC holder.

**Figure 10:** Extract from Chart 146 showing fixes at 0724 and 0726, both to the north of the centreline

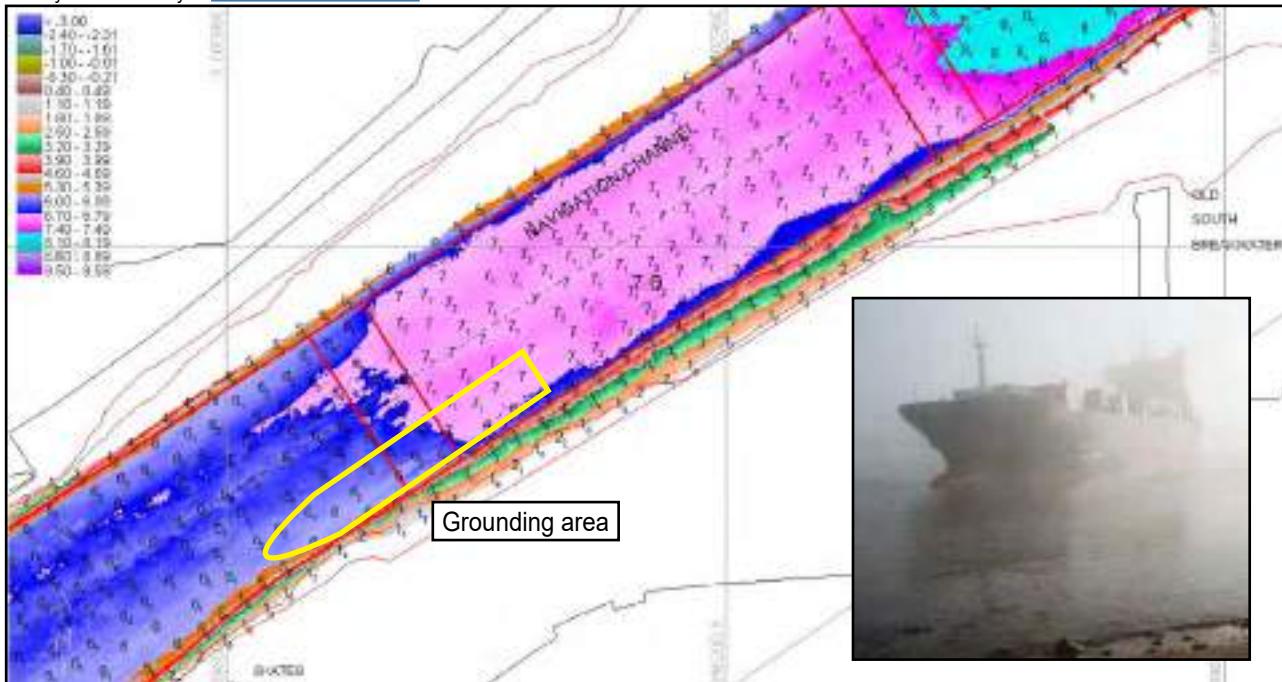
Arrow's PEC holder applied about 10° of port rudder to bring the ship back towards the planned track. In response to prompting from the master, the PEC holder applied more helm until there was 30° of port rudder applied. The effect of the helm altered the vessel's heading to 215°, 22° off the 237° base track. Arrow rapidly crossed the narrow channel, and after 15 seconds, the PEC holder realised the new danger and applied maximum starboard rudder (35°) to turn the bows away from the channel edge. By now, Arrow's bow was very close to the steep southern edge of the channel and while the bows turned to starboard, the alteration was too late. Arrow left the channel and grounded at 6.5kts, raking along its port bow and port side before coming to a stop on the southern edge of the Navigation Channel (**Figure 11**) at 0727:10.

**Figure 11:** Aberdeen Harbour survey chart of Navigation Channel and *Arrow* aground

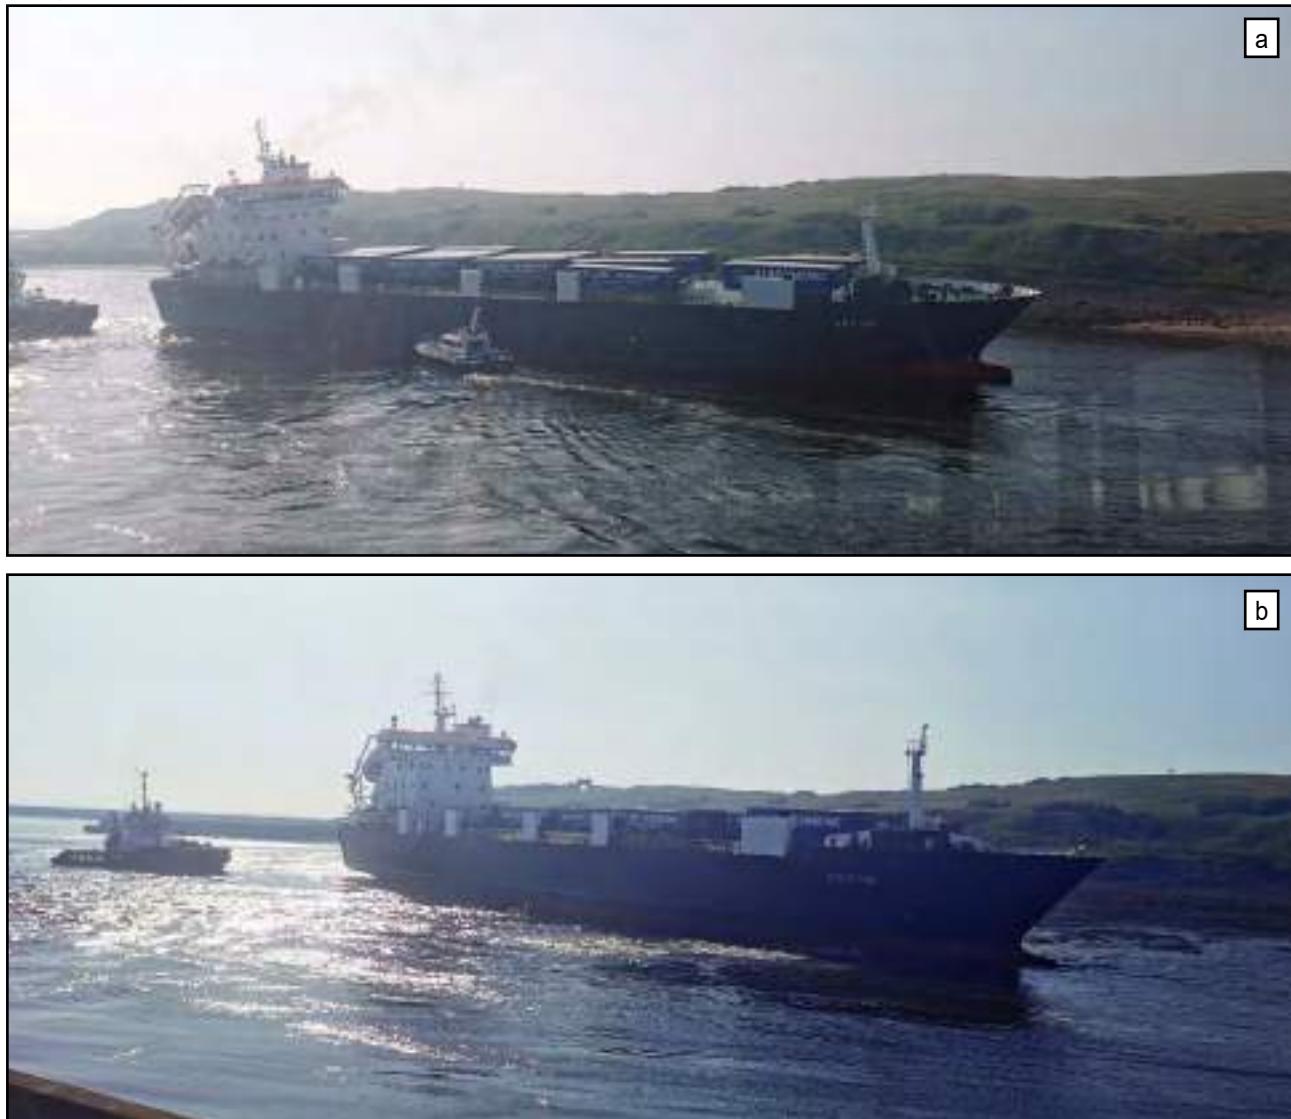
ferry off the bank. Power from the tug and thrust from the engines and bow thruster were gradually increased until at 0811 *Arrow* slowly moved off the bank and into the Navigation Channel (**Figure 12b**).

**Figure 12:** *Arrow* just before re-floating (a) and after re-floating (b)

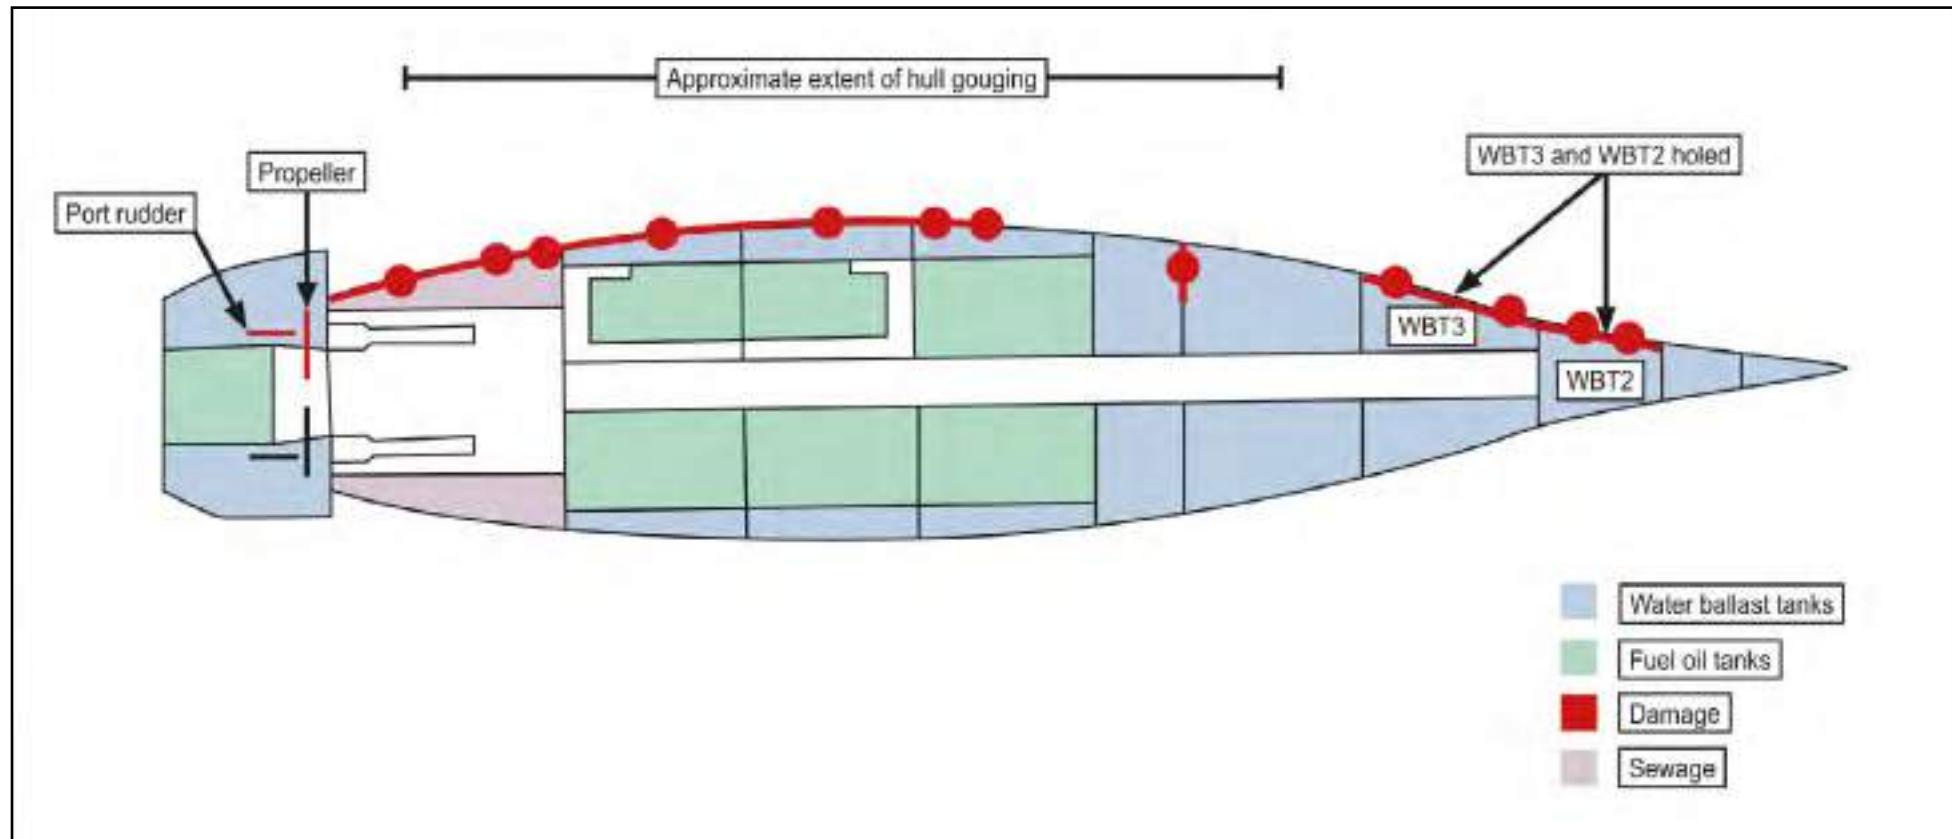
Once docked, a full assessment of damage revealed holing to Water Ballast Tanks (WBT) 2 and 3 requiring new shell plating (**Figures 13 and 14**), together with further shell repairs to cracks in several other areas on the port side. The port bilge keel was deformed in several places and there was significant scrape and dent damage to extensive areas of the port hull, which needed re-preserving, and in some areas, welding and flush grinding (**Figure 15**). All four port propeller blades showed signs of damage and the port rudder and rudder stock required repairs. *Arrow* was out of service for four weeks.

Figure 13: Arrow's bottom tank arrangement showing areas of damage

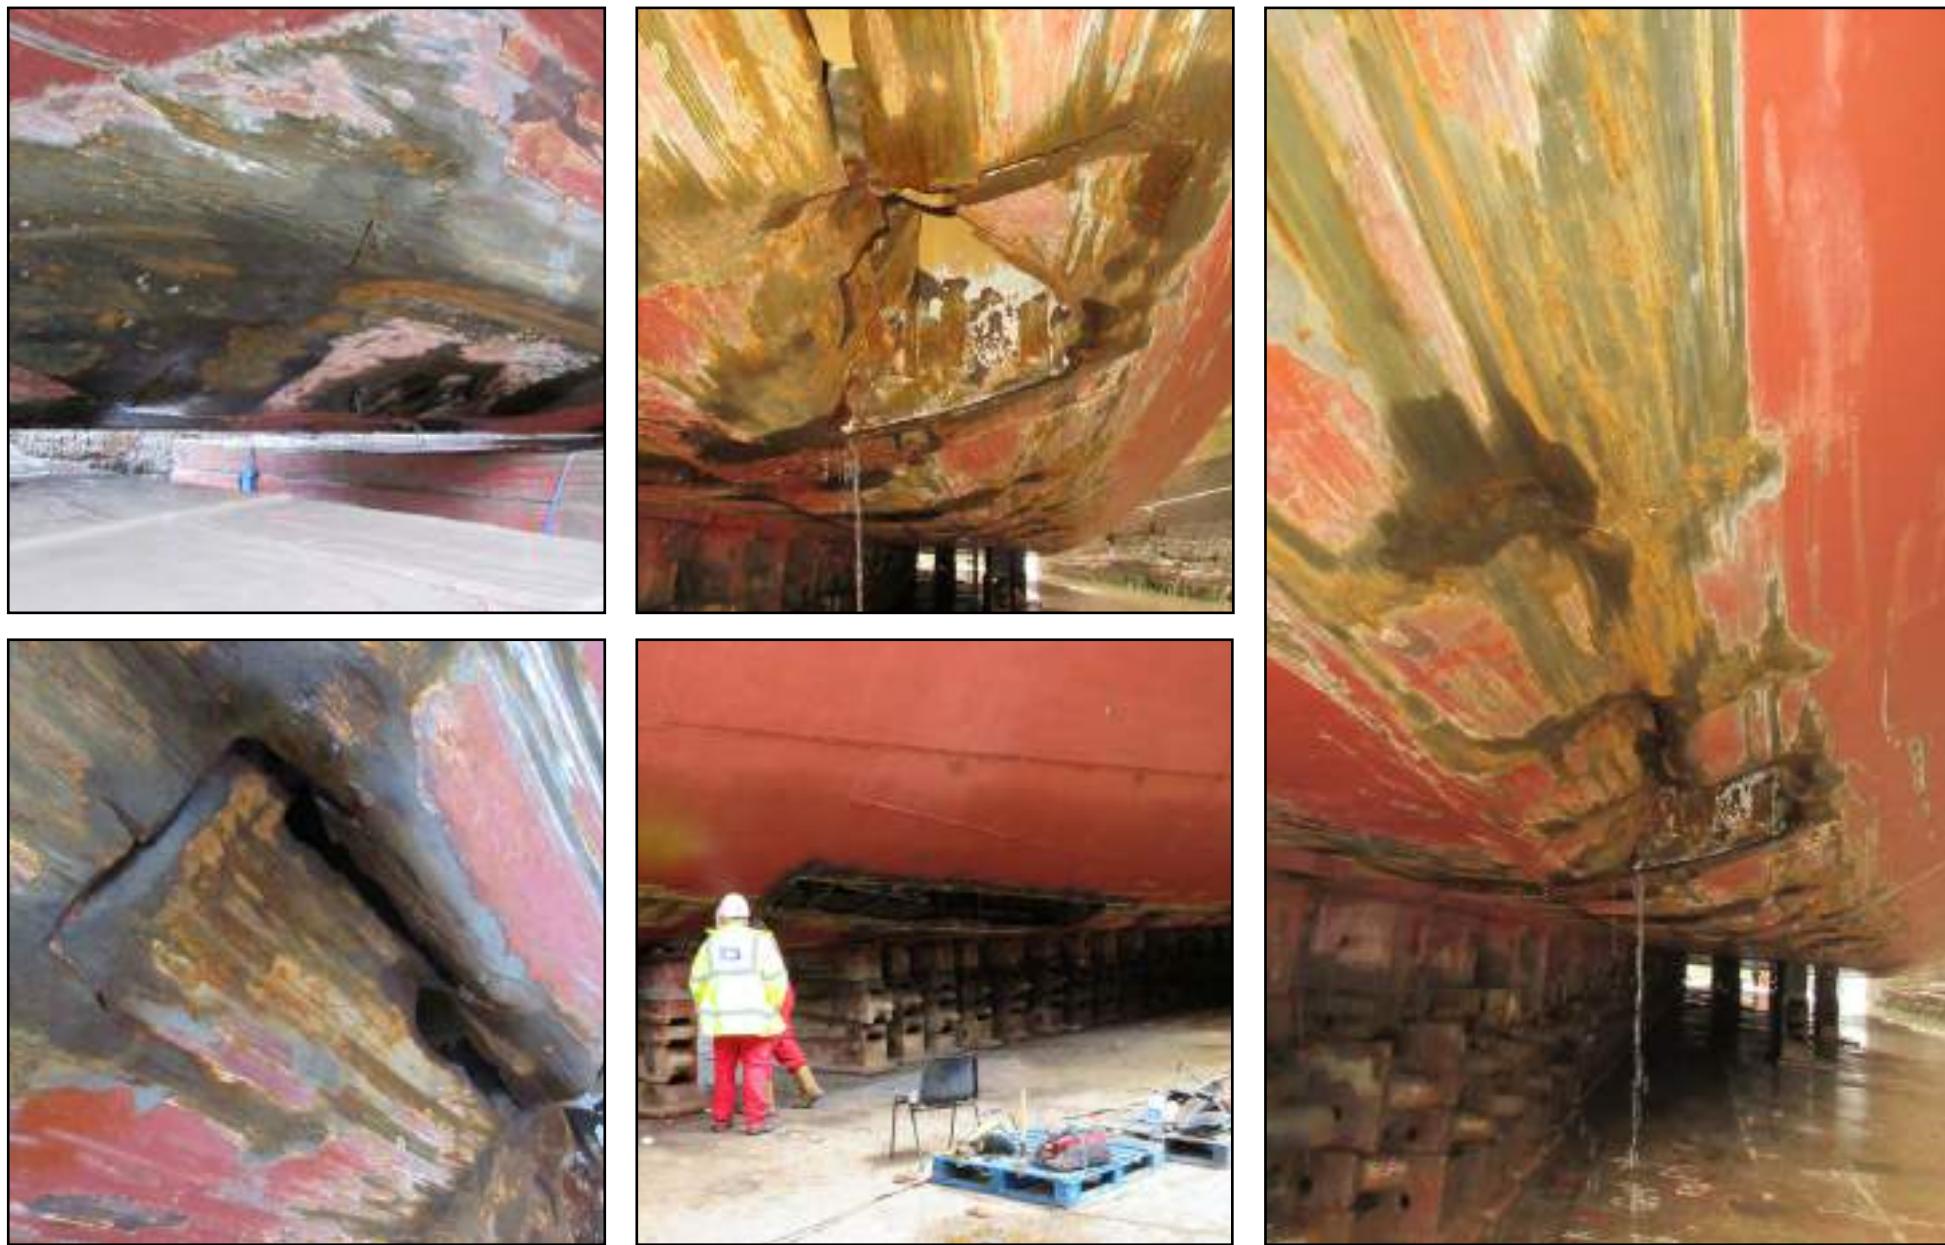
**Figure 14:** Damage to Arrow's water ballast tanks

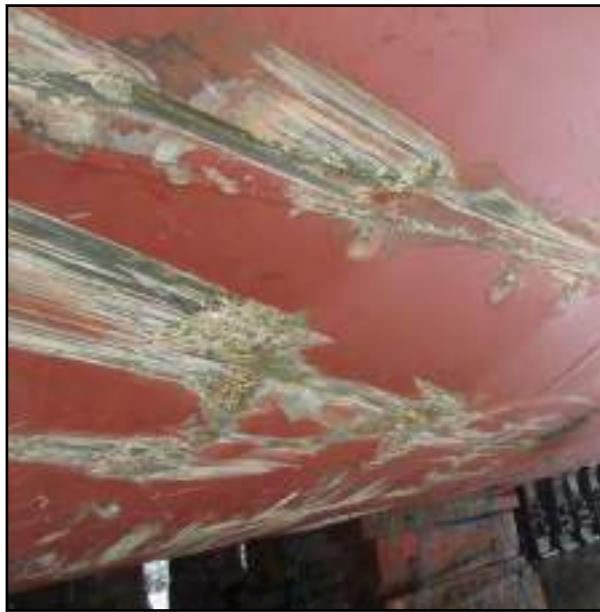
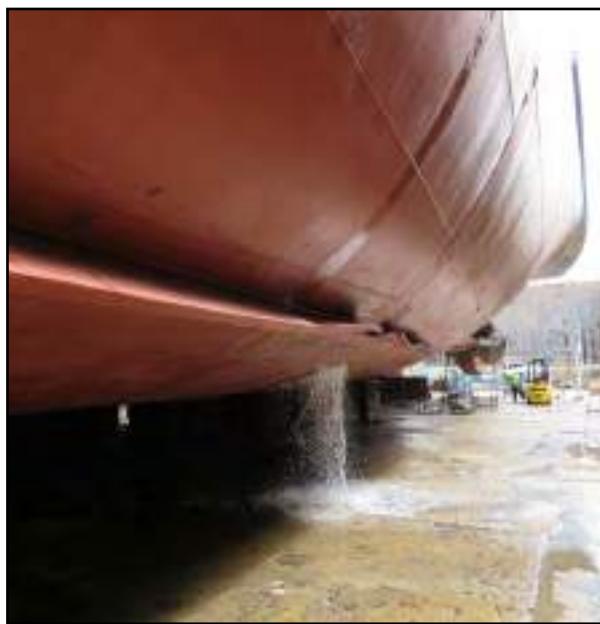
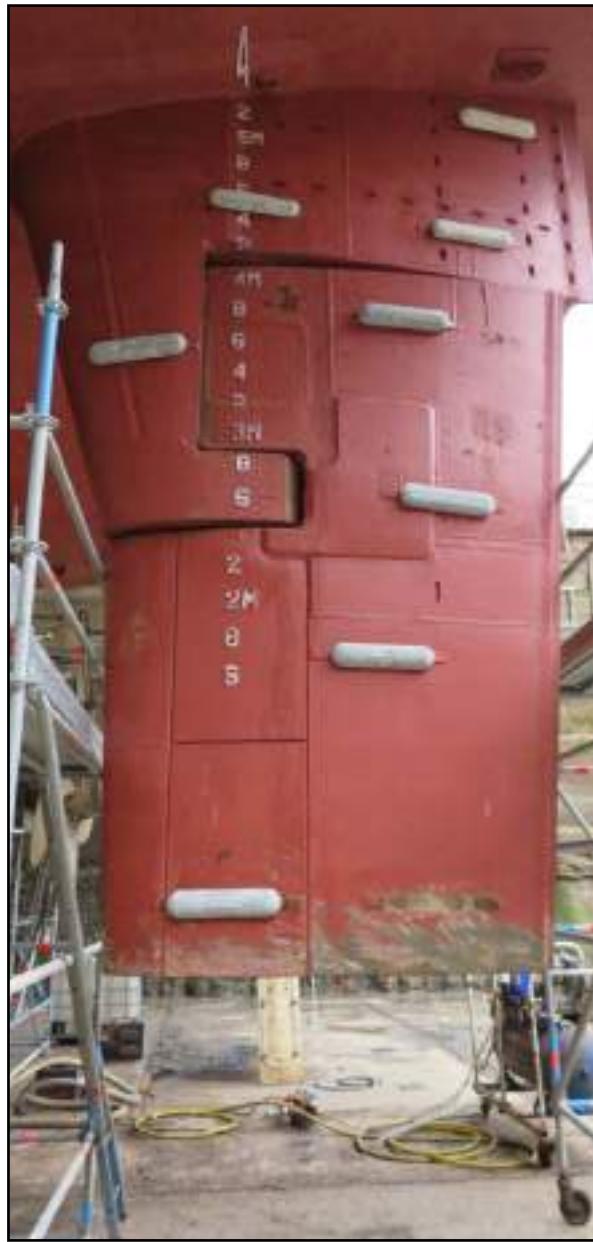
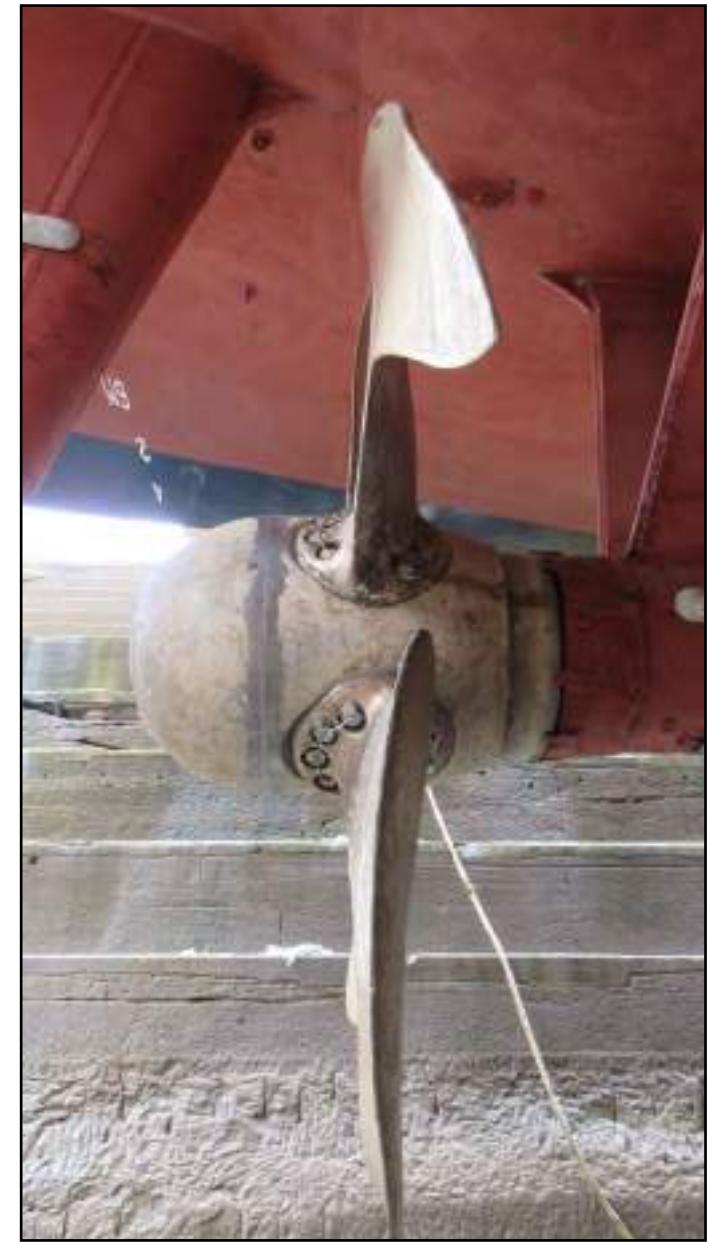
**Figure 15:** Damage to Arrow's hull, bilge keel, port rudder and propeller

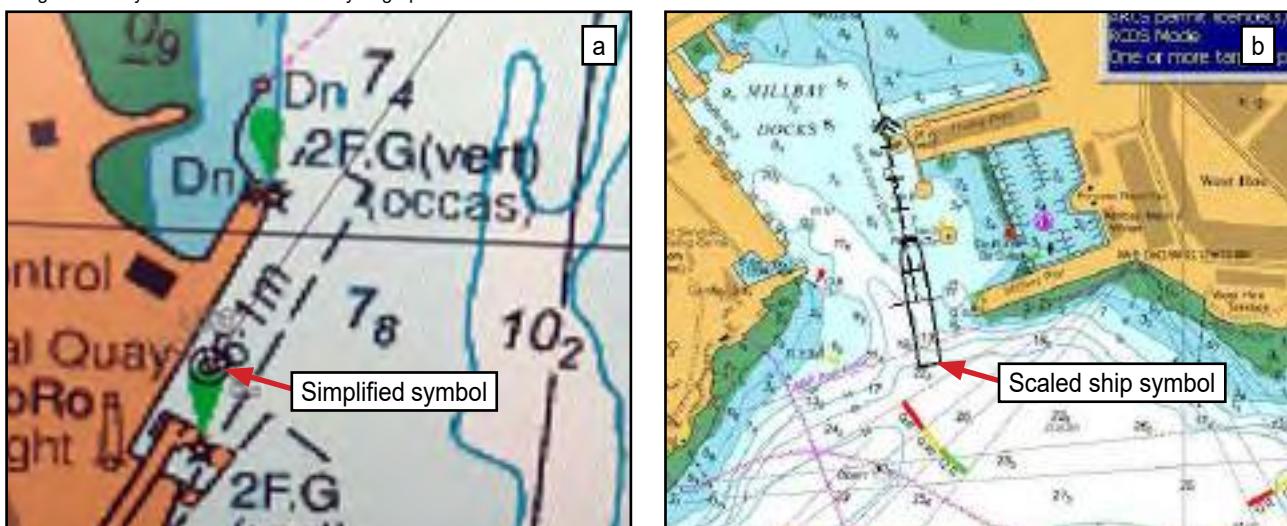
On 25 June, no additional information had been loaded into *Arrow*'s ECS and the system was displaying a simplified symbol (**Figure 16a**) to indicate the ship's position. Some versions of the Navmaster ECS were capable of displaying a ship outline (**Figure 16b**), provided it was enabled with the correct ship dimensions and antenna position. The shape scaled with the scale of the chart and the system reverted to a simplified symbol at smaller scales. The version of Navmaster ECS installed in *Arrow* did not have this capability. This had been identified by the crew, and enquiries with the manufacturer had been made early in 2020 to try to enable it but had not been successful.

Figure 16: Navmaster ECS software with simplified symbol (a) and scaled ship (b)

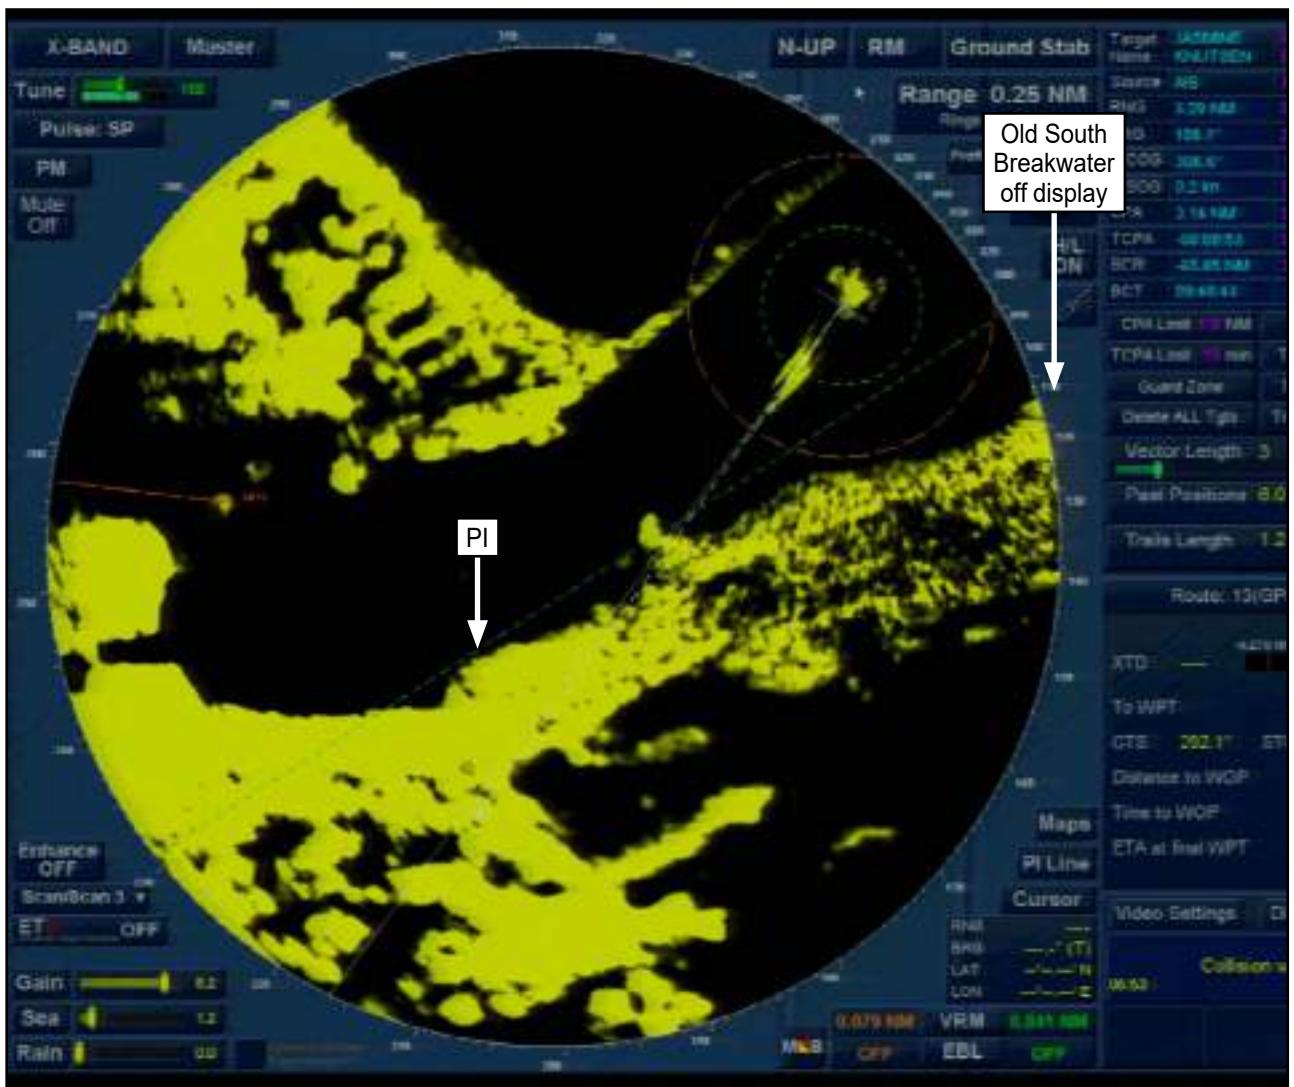
**Figure 21:** Arrow's X-Band radar display just before the vessel grounded

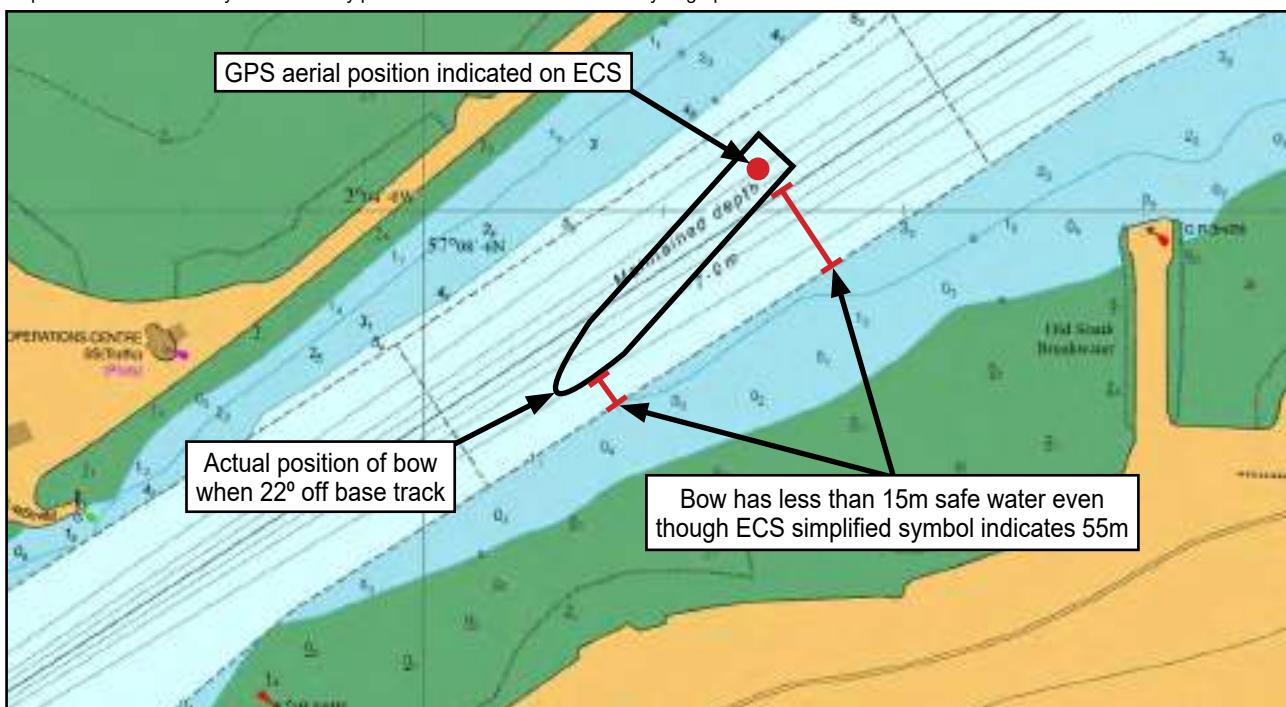
The ECS was not able to display a representative scaled ship shape, only displaying the position of the antenna. On board Arrow, the antenna was approximately 100m from the bow, and in such a narrow channel, this can render the display less helpful (**Figure 23**). To be useful in such confined pilotage situations, ECDIS and ECS should be configured to show the shape of the ship, with the correct antenna offsets input into the system. For operations close to navigational dangers, and particularly in restricted visibility, this feature can be valuable as it provides the mariner with a better representation of the position of the whole ship in relation to hazards.

**Figure 23:** Diagram showing relative position of GPS and radar aerials compared to the bow of Arrow when 22° off base track in Aberdeen Navigation Channel
