SAFETY INVESTIGATION REPORT

REPORT NO.: 02/2022

MV FABIO DUO' **Serious injury to a crew member, during crane operations in the port Santa Margherita Ligure, Italy 11 January 2021**

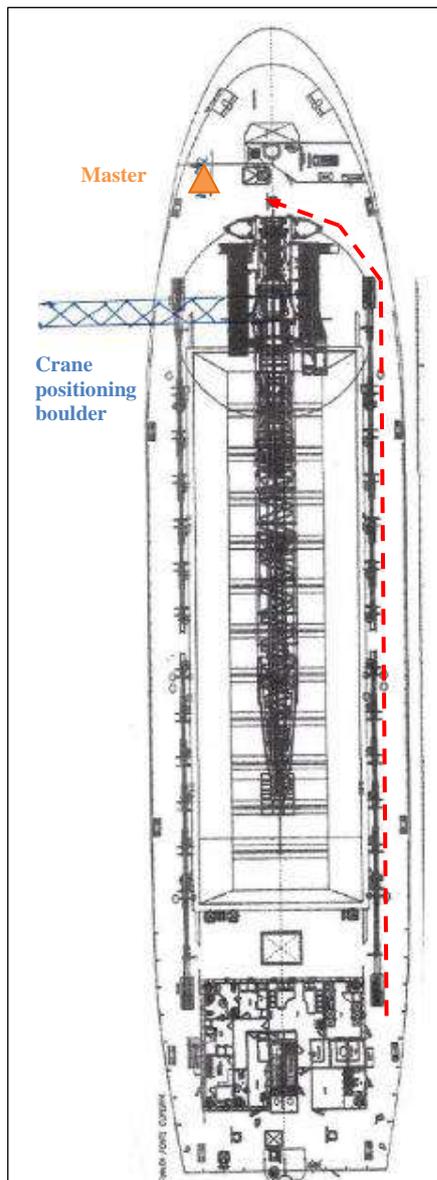
The master took the access way on starboard side of the cargo hold to reach the forecastle (Figure 2), since the port side access way had been cordoned off. During this time, the crane operator, who was placing one boulder in position at the breakwater, noticed the master in proximity of the paint locker (Figure 2).

Figure 2: The route taken by the master to access the forecastle is indicated in red. The master's position when the crane operator saw him before the accident is marked in a triangle

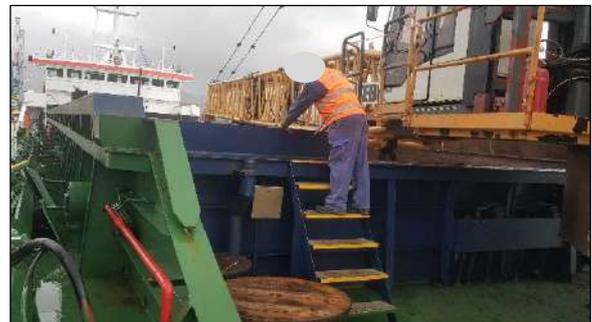
After checking on the maintenance, the master made his way to the accommodation block but decided to check the status of the boulders in the cargo hold. The master climbed the starboard stairs to the cargo hold and looked inside the cargo hold (Figure 3).

At this time, the crane operator had the crane's boom in line with the cargo hold and was picking up one of the boulders from the hold. Within a matter of seconds, the crane turned in a clockwise direction, towards the breakwater, entrapping the master between the body of the crane and the cargo hold coaming.

Figure 3: A simulation of the master on the stairs

At the time of the accident, the master had just climbed the stairs leading to the cargo hold to check its status. The crane operator, having picked up one boulder from the cargo hold, turned the crane towards the breakwater. While doing so, the sudden movements of the crane caught the master off guard and trapped him in between the body of the crane and the cargo hold coaming.

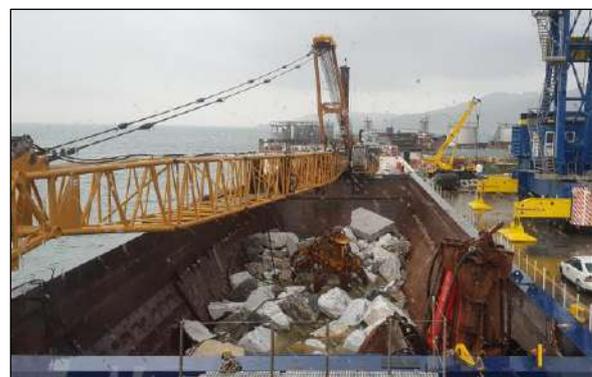
At this time, while the crane operator was placing one of the boulders in position, he heard a scream and turned the crane back towards the cargo hold. He immediately noticed the master lying on deck from the crane's side mirror. He alerted the bridge and switched off the crane. The cargo operation was suspended at 1514 (Figure 4).

Figure 4: The status of the cargo hold, as viewed from the bridge, after the cargo operation was suspended

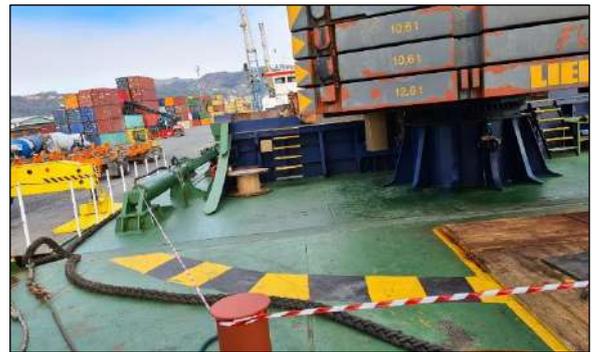
As indicated elsewhere, the free access to the main deck was restricted. In fact, due to the ongoing operations, access to the forecastle from the port side of the cargo hold had been cordoned off by means of a chain (*i.e.*, a physical barrier system). However, access to the forecastle (from the accommodation block) was possible from the starboard side of the cargo hold. Black and yellow markings were painted in a semi-circle on the deck around the crane, extending from port to starboard (Figure 5). The paint marked the hazardous area for the crane operations.

Figure 5: Black/yellow markings on the deck (starboard side only)

Paint markings are classified as a symbolic barrier system and therefore require one's interpretation to be effective (as opposed to a physical barrier system). After the accident, the master could not recall these markings on deck and his impression was that the deck was easily accessible.

The safety investigation concluded that the (symbolic) barriers in place at the time of the accident did not serve their intent and purpose.

- 02/2022_R1** Install physical barriers systems to all deck accesses and around the crane prior to the commencement of crane operations.
- 02/2022_R2** Ensure that joining officers do not find themselves in a situation where they are expected to assume responsibility without getting a detailed handover and prior knowledge of critical aspects of the ship's operations.
- 02/2022_R3** Assess the risks related to access to the crane's cabin from starboard side, taking into consideration the open cargo hold.
- 02/2022_R4** Ensure that crew employed on board, with special reference to officers, can communicate in English, and that all crew members can communicate in the determined working language.

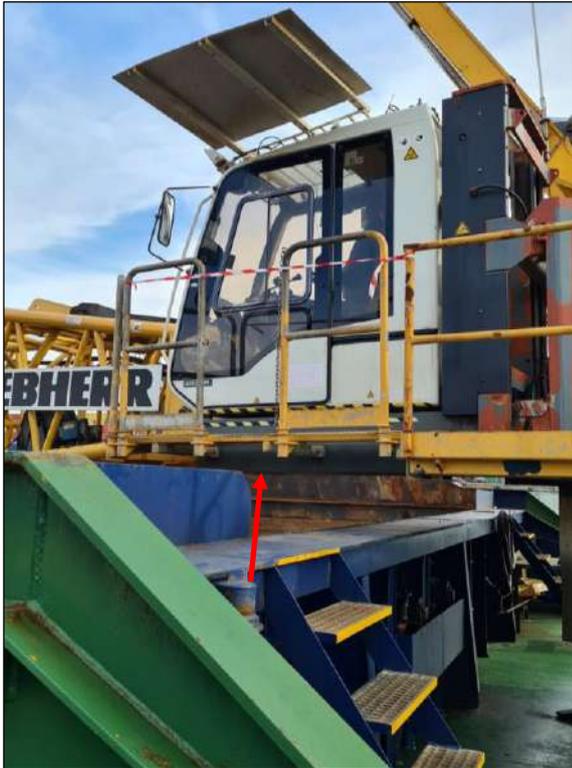
It was possible for the crane driver to step inside the crane cabin either from port or starboard side. However, if access was made from the starboard side through the stairs on the deck (Figure 5), it necessitated the crane

driver to step onto the coaming, leap into the cabin, and in so doing, exposing himself to the hazard of a fall from a height⁷ (Figure 6).

Figure 6: Access to the crane from starboard side
