SAFETY INVESTIGATION REPORT

REPORT NO.: 05/2022

March 2022

MT SEASCOUT **Explosion leading to equipment** **and structural damages** **in position 21° 07.1' N 059° 31.9' E** **18 March 2021**

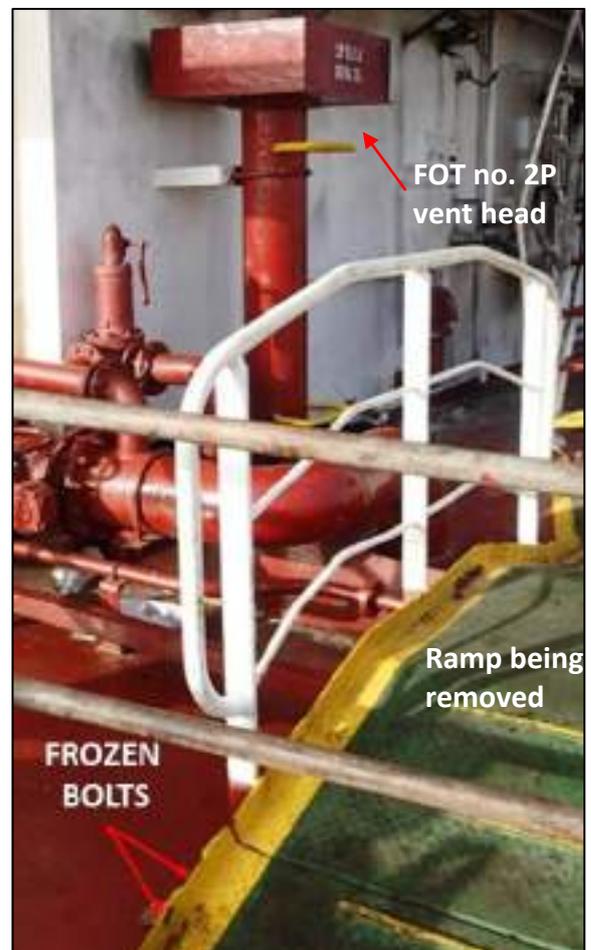
Figure 3: The location of occurrence

However, by the time the pumpman and the AB arrived at the technician's position, they observed smoke coming out of the vent of FOT no. 2P (Figure 3). The pumpman directed everyone to move away and clear the area. At around 1833, while the pumpman, AB and the technician were running towards the midship store to get fire-fighting equipment, the pumpman and AB saw a flash and flames from the air vent, followed by a loud explosion.

1. Sparks emitted from the angle grinder reached the vent head of FOT no. 2P and an explosion occurred.
2. The VLSFO in FOT 2 P was heated up to 48°C, to maintain pumpability of the fuel during the vessel's stay in the dry dock, which resulted in an increase in the generated volume of flammable gas.
3. The safety investigation considered that spark(s) and high temperature particles either passed through the mesh of the flame arrestor, or landed inside the save-all of the tank head, leading to the explosion.

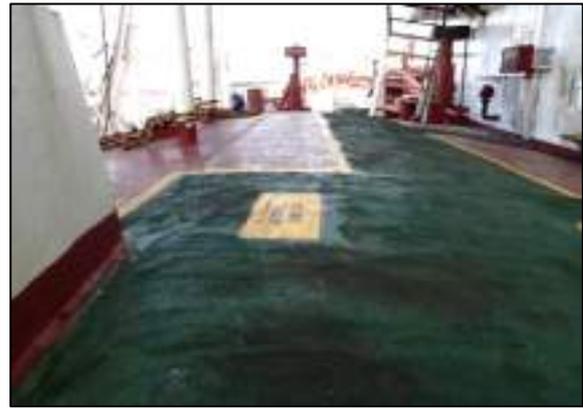
- deck deformation between frames 28 and 46 (Figure 4);
- buckling of the side shell and internals between frames 28 and 46, in way of the main deck to the second deck;
- buckling of the forward bulkhead inside FOT no. 2P;
- buckling of the aft bulkhead inside FOT no. 2P;
- misalignment of the port side lifeboat davit;
- damage to the foundation of no. 1 liferaft; and
- damage to the stairs leading to the lifeboat platform.

Figure 4: Bulging of the open deck, directly above FOT no. 2P

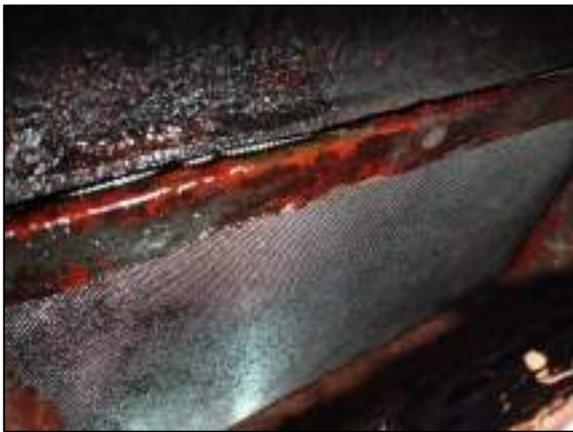
The safety investigation considered that spark(s) and high temperature particles⁷ either passed through the mesh of the flame arrestor, or landed inside the save-all of the tank head, leading to the explosion. Oily / waxy residues on the flame arrestor (Figure 5), found after the accident may have contributed to the flame propagation at the tank's vent head and into the tank.

Figure 5: The flame arrestor of the vent head of FOT no. 2P after the occurrence, indicating oily / waxy residues

4. Oily / waxy residues on the flame arrester (Figure 5), found after the accident may have contributed to the flame propagation at the tank's vent head and into the tank.

- The planned maintenance schedule was updated to include bimonthly inspections of the vent heads, for the removal of any accumulated oily and waxy residues.

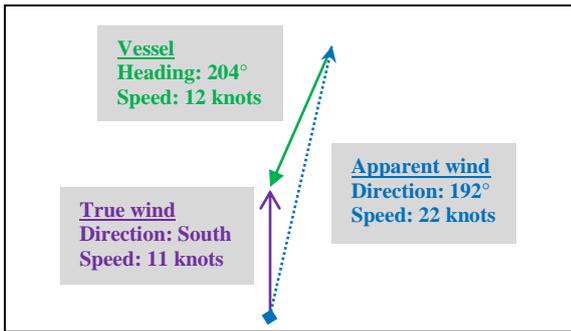
Heating up of the fuel closer to its flashpoint must have resulted in an increased generation of gases, which would ultimately be vented to the atmosphere via the tank's vent head. It so happened that for most of 18 March 2021, the vessel was heading on a course of 204° (T), at a speed of about 12 knots. Wind was blowing from the South at a speed of 11 knots (Figure 6). This would have created an apparent wind of around 22 knots approaching the vessel at a close angle on its port side (Figure 7).

Figure 7: Sketch indicating the approximate apparent wind experienced by the vessel at the time of occurrence.

7. The vessel was experiencing an apparent wind of 22 knots from her port bow. This wind did not assist in the dispersion of the concentration of the flammable gas at the vent head. This suggested that the vent head was somewhat protected from this wind and/or the formation of eddies affected the dispersion of flammable gas.

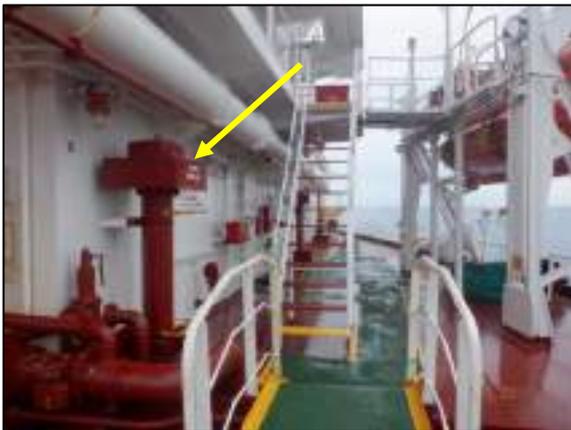
Considering that FOT no. 2P vent head was in a somewhat protected location, *i.e.*, against the port side bulkhead of the accommodation block (Figure 8), the safety investigation hypothesized that the direction of the apparent wind would have not been effective to disperse the vapours emanating from, and around the vent. One must also bear in mind that due to the motions of a vessel at sea, and the variable characteristics of the true wind itself, the direction and speed of the apparent wind would not be constant but would tend to fluctuate.

Figure 8: The vent head of FOT no. 2P against the accommodation block on port side

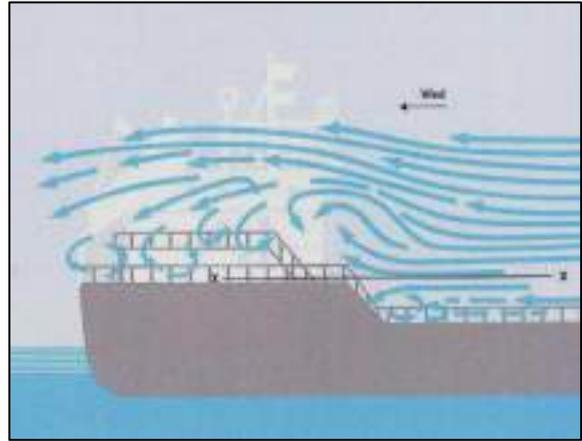
The safety investigation also considered the semi-protected location of the vent head, which may have led to the formation of eddies in its vicinity (Figure 9). This would have increased the risk of ignition of the vapours due to their concentration in one

area. The ISGOTT⁸ cautions on how eddies formed by turbulence (produced by obstructions to the wind flow), would adversely affect the effective dispersion of emitted vapours.

Figure 9: Typical pattern of airflow around the accommodation block

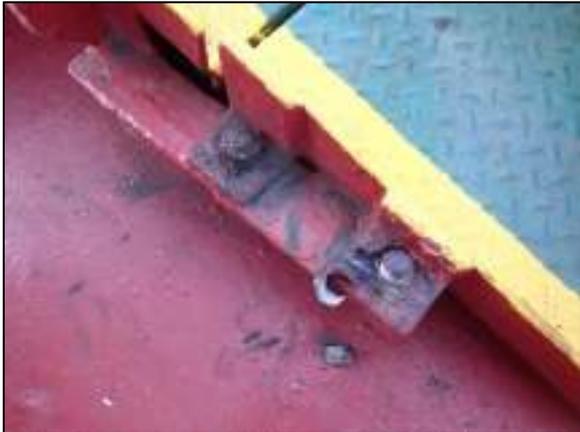
he took an angle grinder from one of the workshops, with the intention of cutting off the two remaining bolts (Figure 10).

Figure 10: One nut had been successfully cut by the angle grinder, before the explosion occurred

8. The last two bolts on the deck ramp were heavily corroded and could not be removed with conventional hand tools.
9. The technician's decision to use the angle grinder was influenced by his willingness to finish the task in time, prior hours of darkness and the vessel's arrival in dry dock.
