REDUCING THE RISK OF PROPULSION LOSS

Operational guidance for preventing
blackouts and main engine failures

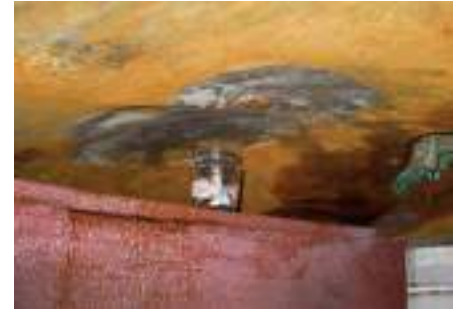
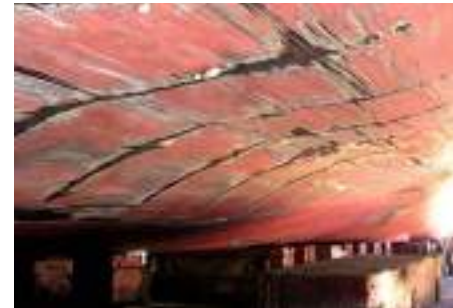
▲ Bottom damages as a consequence of machinery failures¹

¹ On the top photo, the glass jar is here to highlight the degree to which the shell plating is set in.

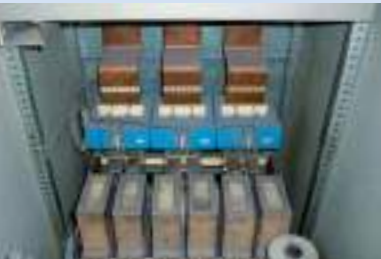
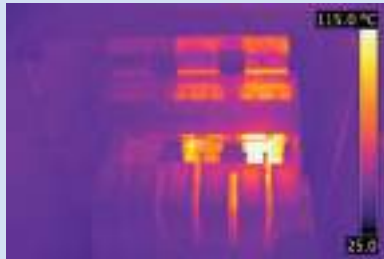
▲ Digital and thermal images of a switchboard breaker fault

- A regular thermographic survey of the switchboard should be carried out to monitor for loose connections or overheating equipment.
- The alarm printer, where fitted, should be maintained correctly, such that the printout is legible, as this is often a valuable source of information regarding the cause of the blackout.
