Issued February 18, 2022

MIR-22/05

Engine Room Fire aboard Towing Vessel *Miss Dorothy*

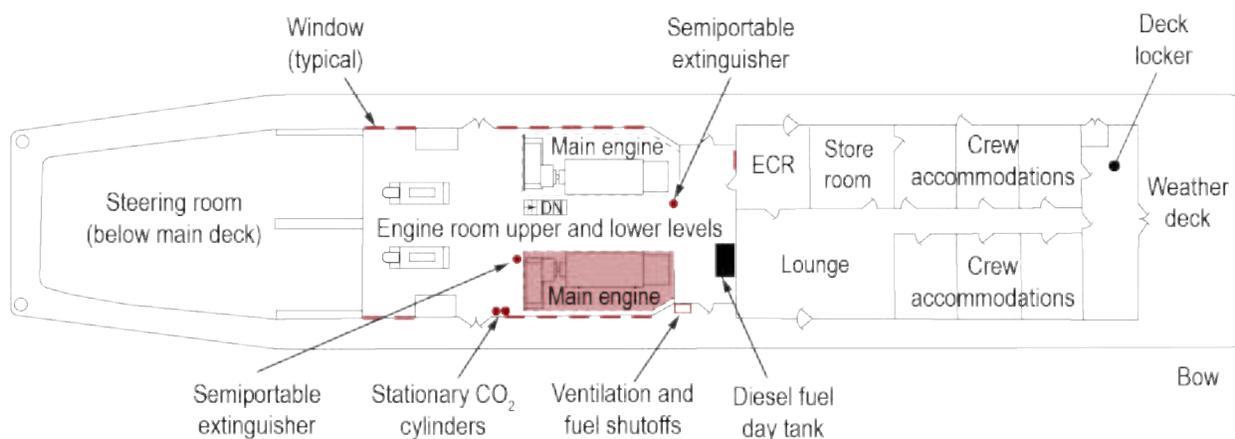
Figure 3. *Miss Dorothy* main deck layout. The area where the fire was discovered is highlighted in red.

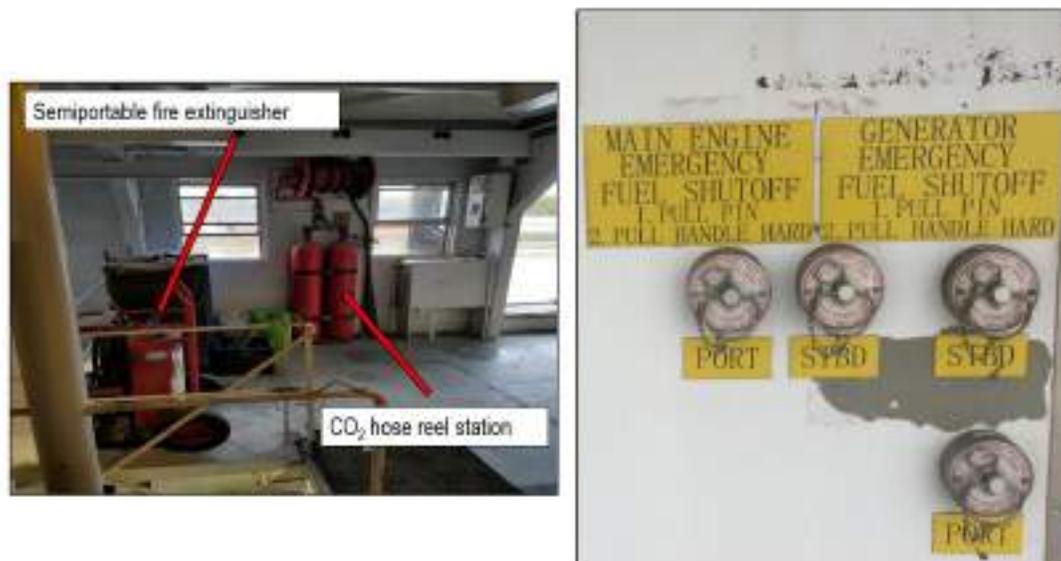
The chief engineer stated that he was able to pull the shutoff for the starboard main engine, but, due to the fire, the cable handles for the port main engine and the online generator were too hot for him to pull. He believed that the starboard main engine stopped several moments after he pulled the wire. (During a postcasualty examination, investigators discovered that all four fuel oil shutoff valves were open, and the metal cables connected to the valves had been severed during the fire.)

Figure 4. Engine room fire-extinguishing equipment (*left*). Emergency fuel oil shutoff pull station (*right*). (Source: WRBM)

pull the shutoff for the starboard main engine. However, after the fire, investigators discovered that the emergency fuel shutoff valves located on the fuel oil day tank remained open and that the wires leading to the remote activation pull station were severed and partly consumed by fire. Because these valves remained open, fuel oil would have remained available to the engines so long as the integrity of the fuel supply system was maintained and the engine-driven fuel pumps remained operational. If the engine continued to operate after the fire was well-established, the brazed joint on the starboard main engine 0.5-inch fuel return line would have de-brazed, causing fuel to leak from the joint while the engine was running, which likely contributed considerably to the severity of the fire. Additionally, throughout the fire, up until the point when the electrical system ceased to operate due to failure of the onboard electric generator or electrical circuitry, the automatic electric fuel oil transfer pump would have continued to fill the 500-gallon diesel fuel day tank when the low-level switch was activated. This perpetual supply of fuel would have contributed to the size and duration of the fire.

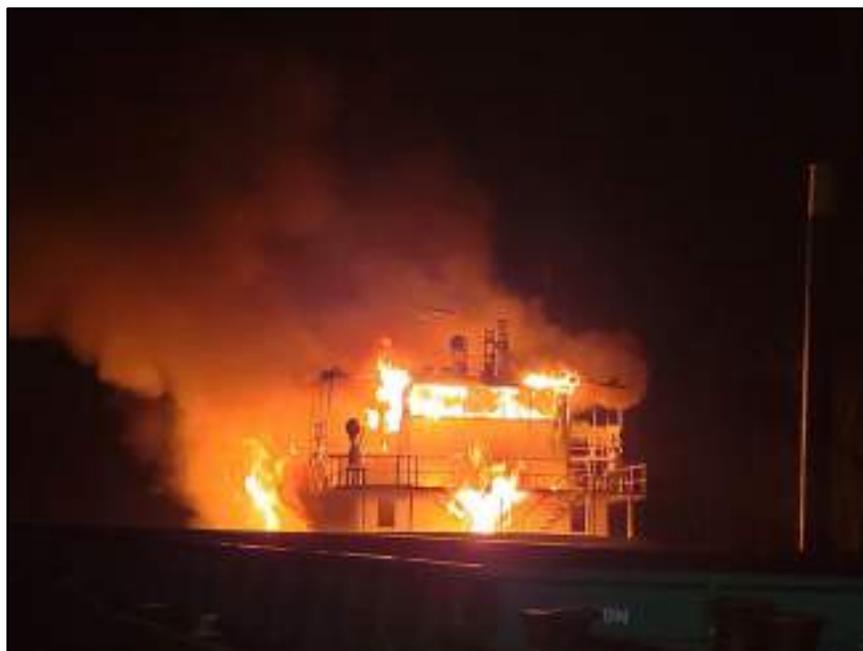
Figure 5. *Miss Dorothy*'s wheelhouse and superstructure consumed in flames following the crew's evacuation to the tow's barges. (Source: WRBM)

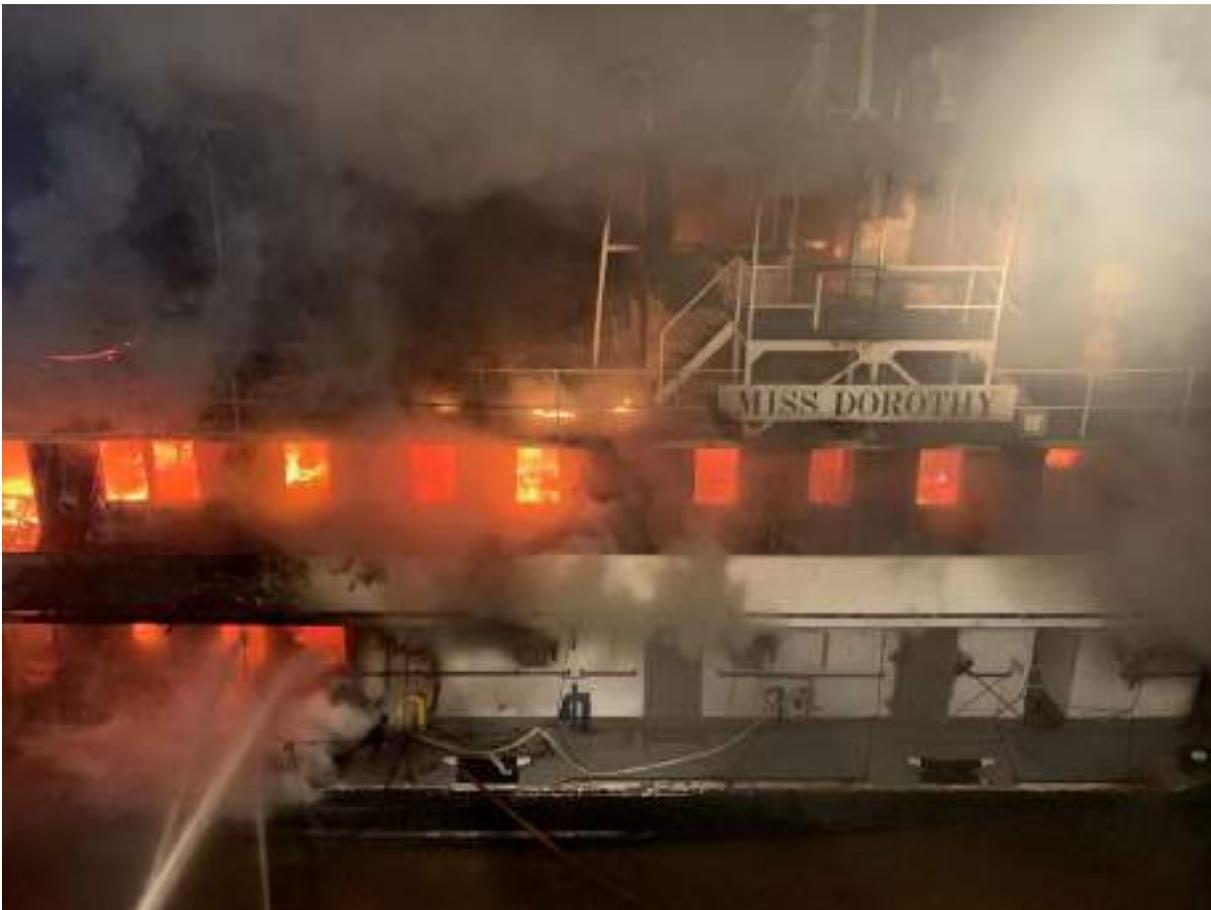
Figure 6. Starboard side of the *Miss Dorothy* during firefighting efforts from the Good Samaritan towing vessel *Christopher Wilson*. (Source: WRBM)

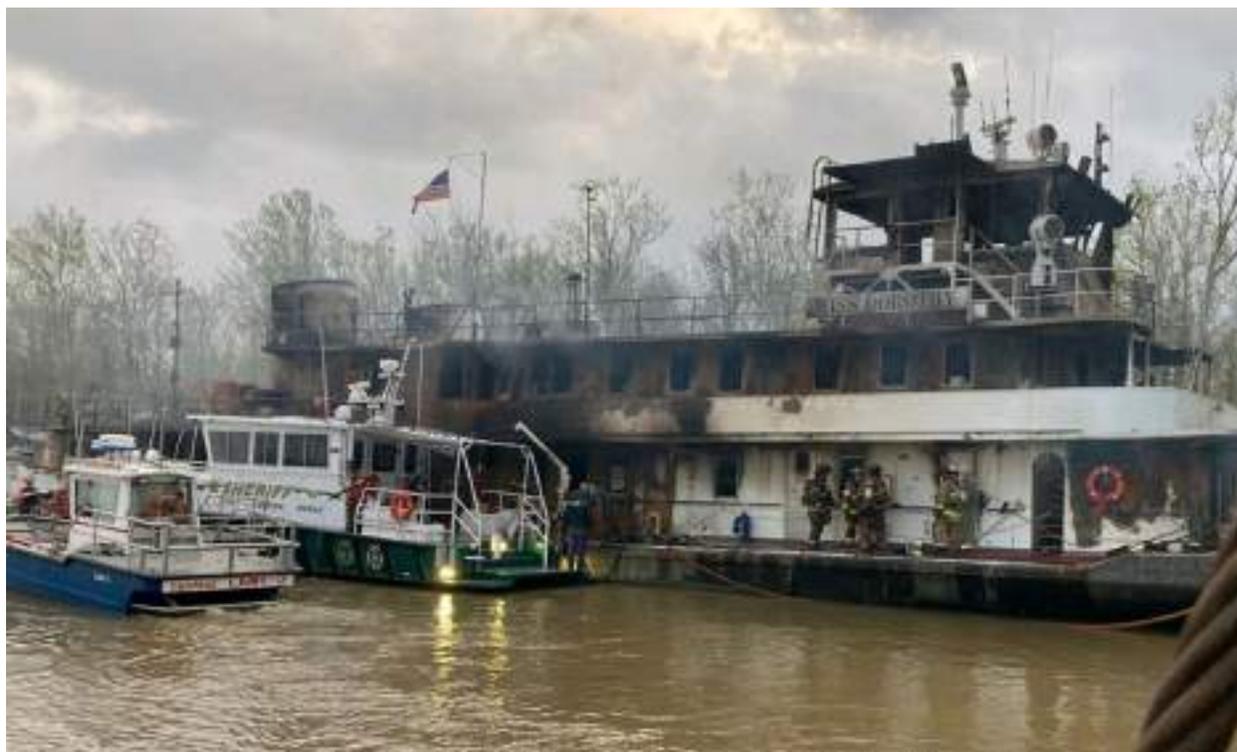
Figure 7. East Baton Rouge Sheriff's Office and ExxonMobil fire boats alongside the burned-out *Miss Dorothy* after the fire had been extinguished. (Source: WRBM)

The fire destroyed much of the vessel, including the engine room, storerooms, accommodation spaces, and the wheelhouse. A postcasualty examination of the *Miss Dorothy* showed that the level of severity of fire damage was highest on the forward end of the starboard main engine. Heat damage in this area was also more severe, and the aluminum valve covers and the aluminum engine governor control housing were all

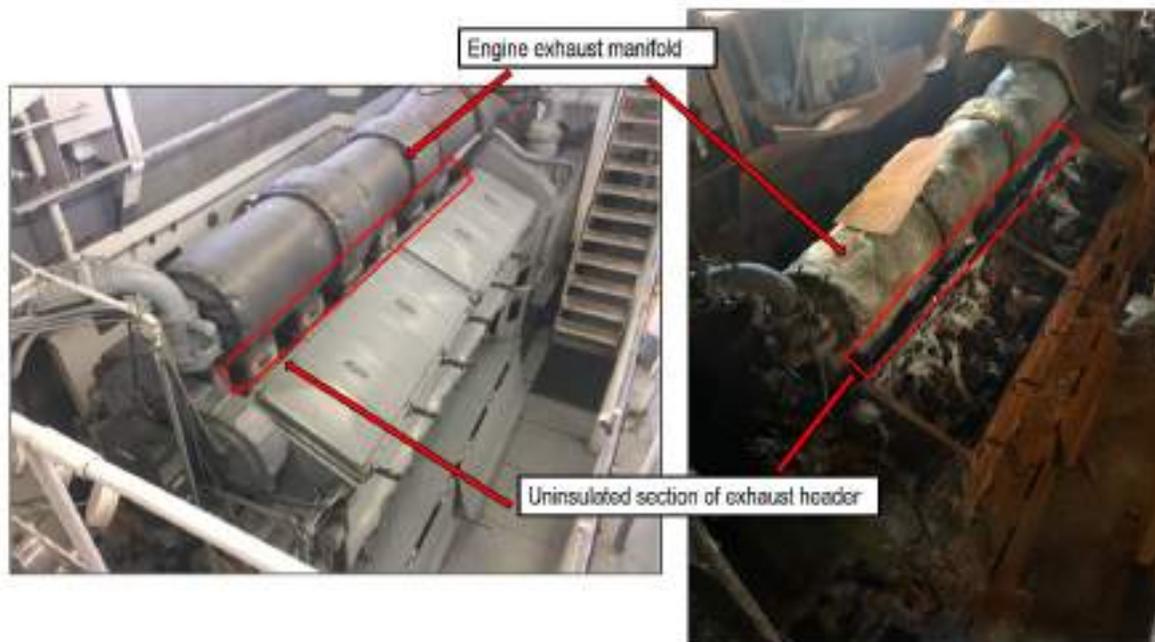
During the postcasualty examination of the vessel, investigators discovered that the 0.5-inch fuel oil return line from the left bank of the starboard main engine, located on the forward end of the engine, had become displaced from its connection flange. The starboard engine exhaust manifold was lagged with insulation, but the section of exhaust header between the engine block and the horizontal portions of the exhaust manifold were not shrouded, insulated, or lagged. This section of exhaust header for the forward inboard cylinder of the starboard engine was about 36 inches from the fuel oil pump end of the starboard main engine and the fuel oil return line that was discovered to be disconnected. WRBM management stated that the engine exhaust surfaces could reach "north of 600°F" when the engine was operating loaded (similar to the night of the fire) and that the fuel pressure in the return line varied between 15 and 30 pounds per square inch gauge.

Figure 8. Starboard main engine before (*left*) and after (*right*) the fire, with the uninsulated section of exhaust header indicated. (Source: WRBM)

The fuel used in the engine at the time of the fire was ultra-low sulfur diesel, a highly combustible liquid with a standard flashpoint of 140°F and an average autoignition temperature of 428°F.⁴ To prevent combustible liquids, such as diesel fuel, from contacting piping and machinery components that exceed temperatures of 428°F, regulations require that such components be insulated. However, after the fire, investigators found that the exhaust header leading from the individual cylinder heads to the exhaust manifold—which were subject to temperatures greater than 428°F (often higher than 600°F)—near the suspected origin of the fire were uninsulated. Therefore, it is likely that the uninsulated exhaust header acted as an ignition point for the atomized or spraying diesel fuel.

The National Transportation Safety Board determines that the probable cause of the engine room fire aboard the towing vessel *Miss Dorothy* was the ignition of spraying diesel fuel from a main engine's fuel system onto an uninsulated section of the engine's

exhaust system. Contributing to the severity of the fire and damage to the vessel was the inability to effectively secure ventilation to the space and fuel to the affected engine.

Engine rooms contain multiple fuel sources, making the spaces especially vulnerable to rapidly spreading fires. Regulations for towing vessels state that “piping and machinery components that exceed 220 °C (428°F), including fittings, flanges, valves, exhaust manifolds, and turbochargers, must be insulated.” Uninsulated engine exhaust surfaces can provide an ignition source for flammable liquids that can easily develop into fires that are difficult to contain. Towing vessel owners and operators, Coast Guard marine inspectors, and third-party organization (TPO) towing vessel examiners should be aware of these dangers and fire risks and should regularly and thoroughly inspect equipment to ensure that measures are in place to prevent flammable liquids from coming into contact with hot surfaces.

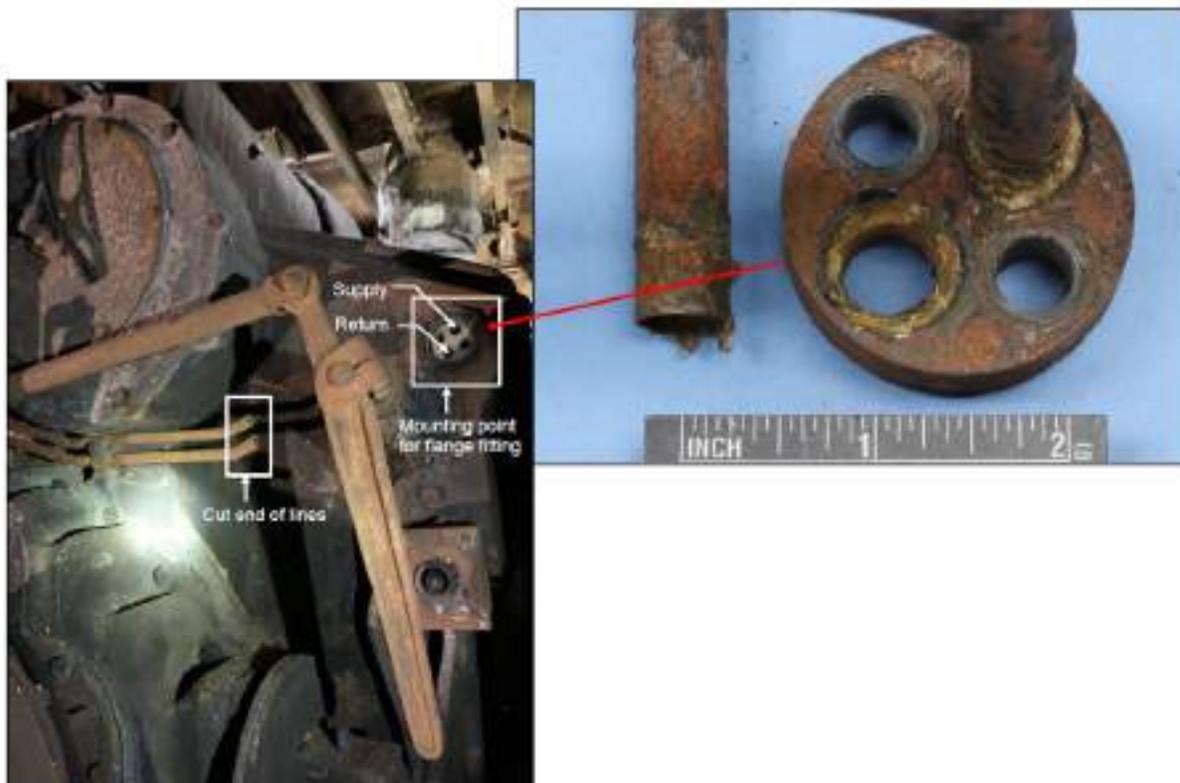
Materials engineers from the National Transportation Safety Board examined the fuel oil supply and return lines from the left banks of both the starboard and port main engines. The lines for the starboard main engine were pressure-tested for leaks; none were found. The fuel pipes and flanges were examined for other notable features (such as cracks, crevices, or dents), but none were found. In addition, the chemical composition of the starboard main engine flange, fuel pipes, and brazing metal was examined using a scanning electron microscope equipped with an energy-dispersive X-ray spectrometer. The flange material was consistent with a low-carbon steel. The fuel lines were made of a double-wall construction, and the material was consistent with mild or low-carbon steel. The brazing compound used to secure the supply and return fuel lines to the flange was determined to have a composition very similar to a commercially available silver alloy brazing material, which had a brazing range between 1,205°F and 1,400°F. The brazing material on the displaced starboard main engine return line was “denuded of braze metal on its top side, and the braze material had accumulated on underside.” The supply line on the starboard main engine showed signs of extrusion but did not become displaced similarly to the return line.

Figure 9. Starboard main engine after the fire with section of fuel oil supply and return lines removed (*left*). Laboratory image of flange and de-brazed and separated fuel oil return line (*right*).

A forensic fire investigator concluded that the rapid growth and spread of the fire was indicative of a fuel oil fire. In the area of the starboard main engine, investigators found a 0.5-inch fuel return line that had a de-brazed joint that had separated; however, a laboratory examination of the line showed no signs of loss of integrity, fatigue, or material failure, other than the de-brazed joint. Due to the chemical composition of the brazed joint, temperatures exceeding 1,200°F would have been required to de-braze it and only would have been present in a well-established fire. Therefore, the return line likely separated as a result of the fire, and it is probable that the source of fuel oil did not originate from the examined section of the return fuel line nor the brazed joint. Instead, the fuel likely came from another undetermined pressurized source (near the forward end of the starboard main engine) capable of spraying or atomizing the fuel, such as a faulty flange connection, gauge line, pressure gauge, or pump seal.
