Issued March 2, 2022

MIR-22/06

Diesel Generator Engine Failure aboard Ferry *Wenatchee*

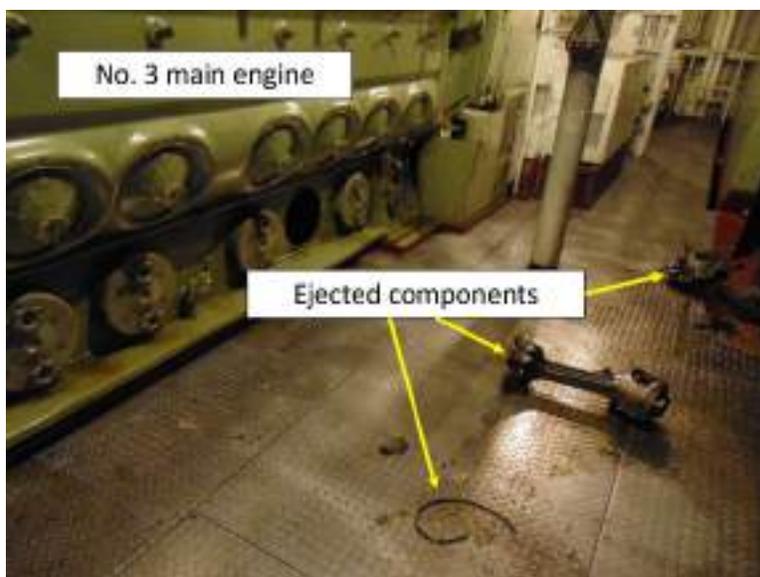
Engineers inspecting the affected engine room found a broken connecting rod, part of a piston, and an inspection cover laying on the deck outboard of the no. 3 engine. Inside the engine, part of the piston had fallen down and was resting on top of the crankshaft.

Figure 5. Ejected components from the no. 3 main engine. (Source: Coast Guard)

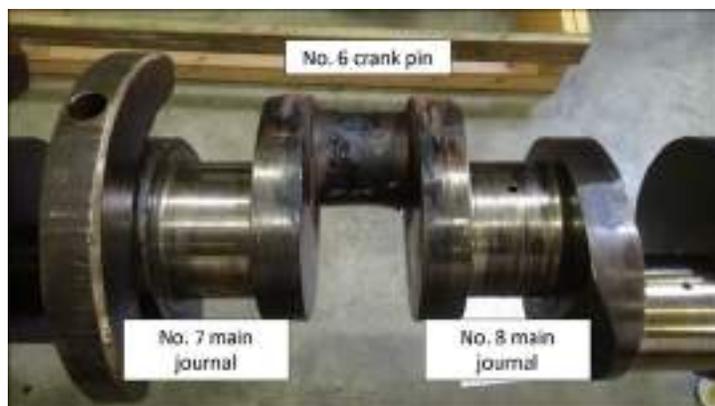
The ejected connecting rod, cylinder, and cover portion were determined to be from cylinder no. 14. Engineers examined the crankshaft and found the most severe damage in the area of the no. 6 crank pin, which was destroyed "with deep impressions of hard contact," and its lube oil passage was plugged with "coked oil, ash, and metal shavings." Adjacent to this crankshaft pin, the no. 8 main journal had "spun its main bearing shells and had undergone some material loss."

Figure 6. Damaged crankshaft from no. 3 main engine. (Source: Dynamark Engineering)

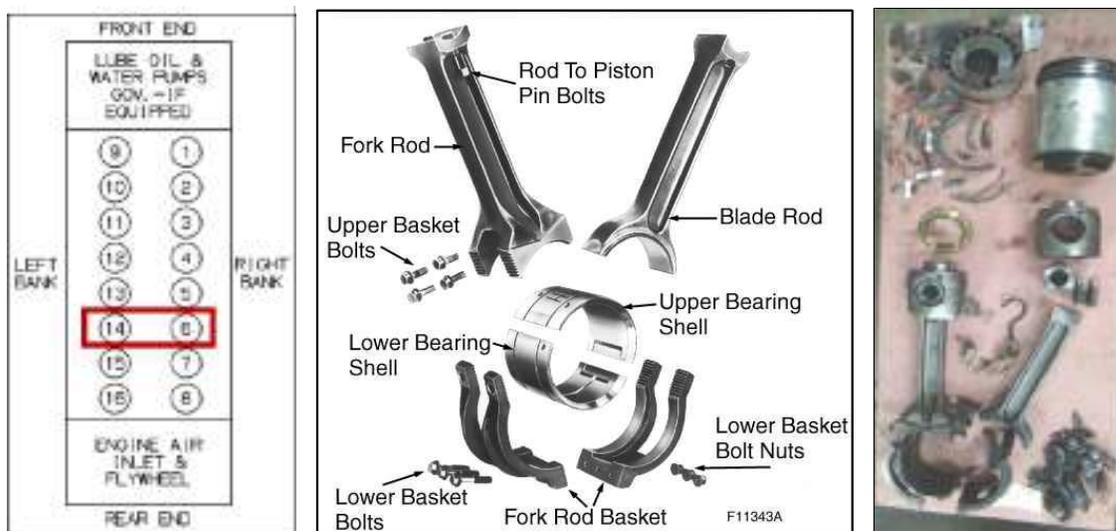
Afterward, engineers examined each of the connecting rod and cylinder pairs throughout the engine. All were undamaged, except for the nos. 6 and 14 connecting rod and piston pair, which had been clamped to the crankshaft at the destroyed no. 6 crank pin. The pair (consisting of two connecting rods: one called a fork rod, and the other a blade rod) was determined to be in a “state of complete destruction,” with broken blade and fork rods (connecting rods) and basket, and also showed evidence of overheating. The four upper basket bolts (which clamp the connecting rod pair around the crankshaft pin) were found in position but deformed in a “manner consistent with overload.”

Figure 7. Left: EMD 710 cylinder arrangement showing the affected area in red. Center: EMD 710 connecting rod arrangement. Right: Damaged components recovered from no. 3 main engine no. 6 and 14 cylinders. (Source: Dynamark Engineering)

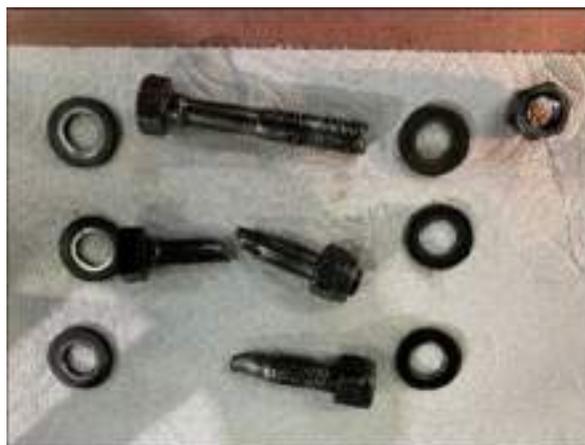
The three lower basket bolts were out of position; several damaged pieces of the bolts were found in the no. 3 engine’s oil pan. The bolts were examined, and engineers determined that two bolts were deformed and showed evidence of being

pulled apart (tensile overload). The third bolt was found separated from its securing nut and relatively undeformed compared to the other two bolts.

Based on the condition of the third bolt, engineers determined that the nut had backed off (unfastened) while the engine was running. These nuts were required to be torqued to 75 foot-pounds during assembly using a torque wrench connected to a special extension tool that rotated the nut via a socket. Under magnification, engineers inspected the condition of the grooves on the lower basket nuts. Flattening was observed on properly torqued exemplar nuts but was not seen on the recovered nut that had unfastened from the no. 3 engine's lower basket assembly, indicating the nut had not been properly torqued.

Figure 8. Damaged lower basket bolts, washers, and nuts from no. 3 main engine's nos. 6 and 14 connecting rod and piston pair. (Source: WSF)

The report concluded that the root cause of the catastrophic engine failure was an "engine assembly error," which occurred because one of the three nuts on the no. 14 fork rod lower basket had not been fully tightened. The bolt unfastened during operation, which caused the lower sections of the nos. 6 and 14 connecting rod and piston pair to become misaligned with the crankshaft. This misalignment caused the rod bearing to lose its oil film and resulted in a loss of lubrication in the lower bearing shells, generating severe heat and destroying the rod bearing shells of the no. 6 crank pin. The high temperatures were then transferred along the crankshaft, which thermally expanded, damaged nearby journal bearings, and caused the no. 8 journal bearings to be spun, generating more heat. Once all oil flow had ceased at the no. 6 crank pin and its rod bearing shells were destroyed, the no. 14 connecting rod broke and became deformed. The rotating parts of the engine struck the broken components and ejected part of the connecting rod and piston out of the engine through the lower inspection cover. As a result, hot pressurized crankcase gases were released into the engine room and ignited.

The NTSB has investigated several recent casualties that likely were caused by a failure to tighten fasteners on marine engines to the manufacturer's recommended torque settings. Undertorqueing a fastener may cause excess vibration or allow the fastener to come loose, while overtorqueing may lead to failure of the fastener or the machinery component being secured. When installing fasteners, personnel should use a calibrated torque wrench, follow the manufacturer's recommended tightening guide and torque values, and verify that all required torque requirements have been completed.
