# Fire aboard Roll-on/Roll-off Vehicle Carrier *Höegh Xiamen*

Pier 20, Blount Island

Jacksonville, Florida

June 4, 2020

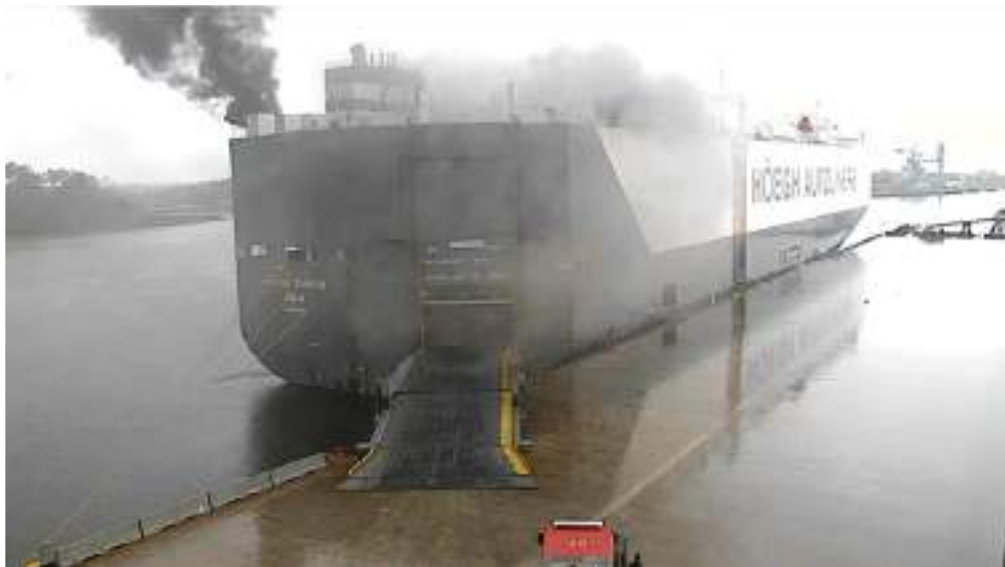
**Figure 4.** Smoke coming from aft cargo deck ventilation housing exhausts about 1603.

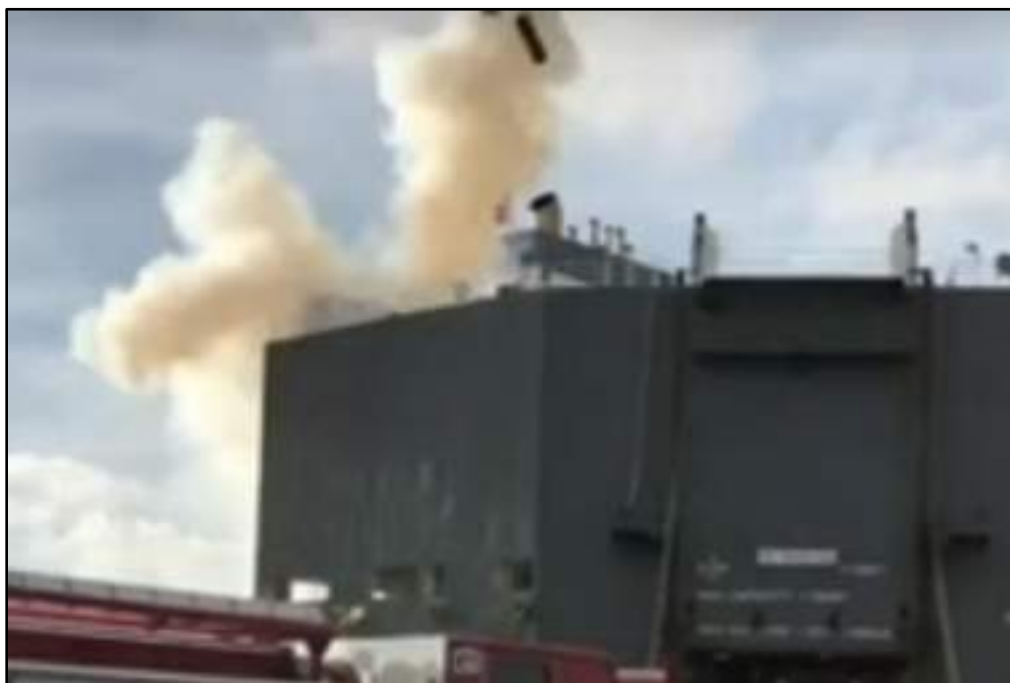
Upon opening the access door to the portside exhaust ventilation housing for deck 9, firefighters on deck 12 heard “a loud roar that sounded like a jet engine” as the exhaust housing “exploded” (see figure 5). The ventilation housing threw debris in the air. From the exterior of the ship, firefighters witnessed a tall column of grey-white smoke projecting from the stern on the weather deck and debris flying. According to firefighters, there may have been multiple explosions of varying magnitude. Firefighters in the port aft stairwell and on deck 5 described feeling intense heat and hearing a “roaring sound of rushing air.” Nine firefighters who were working in the stairwell or who had been staged on deck 5 were burned, five of them seriously, by the superheated air that rushed down the stairwell. Firefighters working on decks 7, 8, and 12 were unharmed.

**Figure 5.** Explosion of deck 9 ventilation exhaust housing. Note debris in air at top center of image. (Source: WJXT)

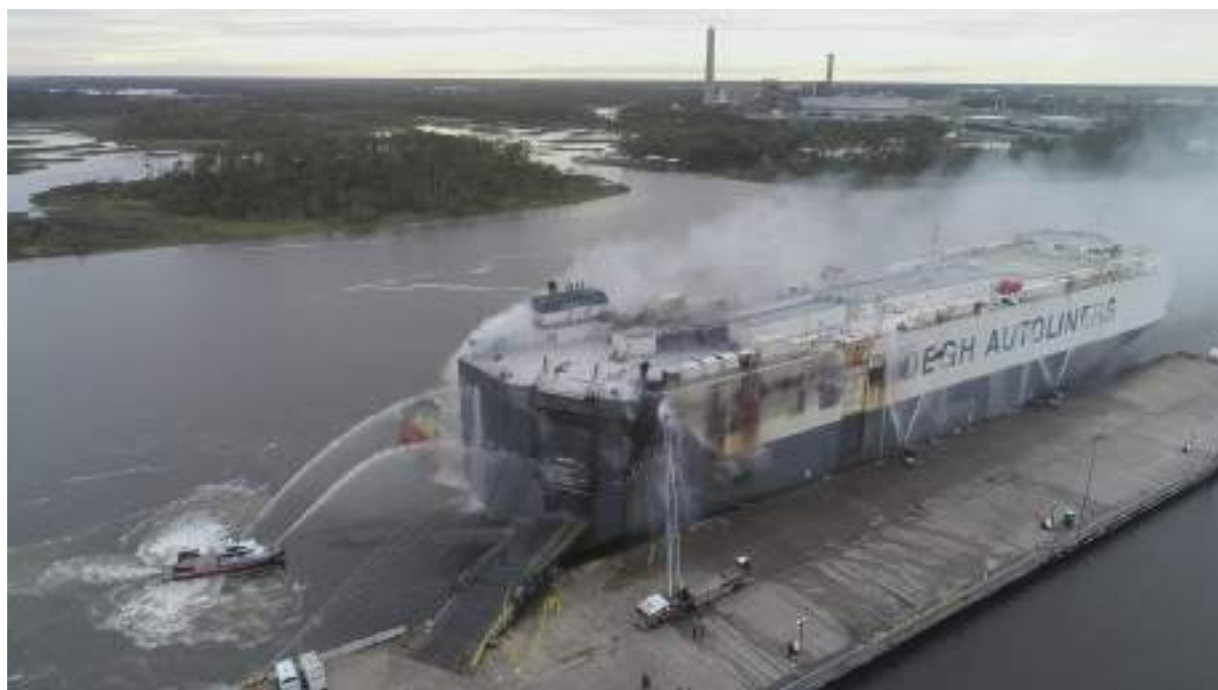
**Figure 6.** Firefighters conducting exterior boundary-cooling on June 5, 2021, the day after the fire was discovered. (Source: JFRD)

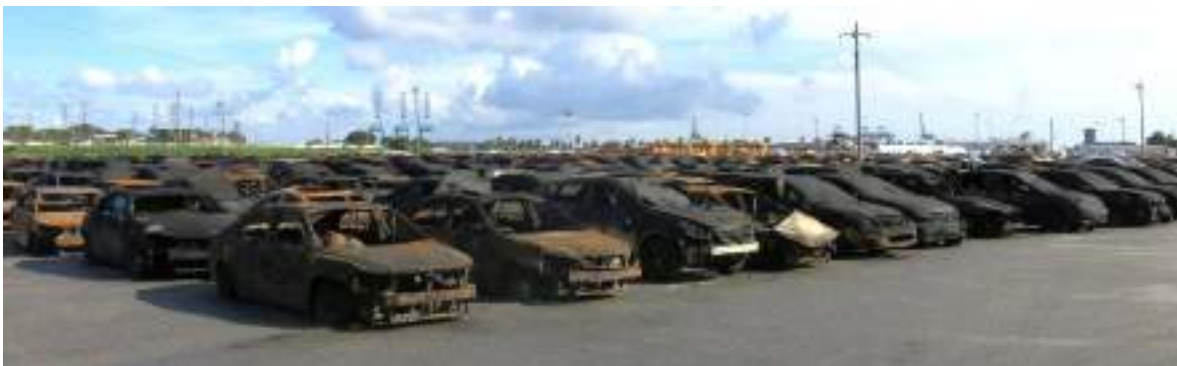
The *Höegh Xiamen* and its cargo of 2,420 used vehicles were declared a total loss valued at \$40 million (see figure 7). Salvage operations began on July 9, 2020. On August 30, after salvage operations were completed, the anchor-handling tug, *Alp Striker*, towed the ship from Jacksonville to Aliaga, Turkey, where the *Höegh Xiamen* was recycled.

**Figure 7.** Thermally damaged vehicles after removal from the *Höegh Xiamen*, Blount Island, Jacksonville, Florida, July 23, 2020.

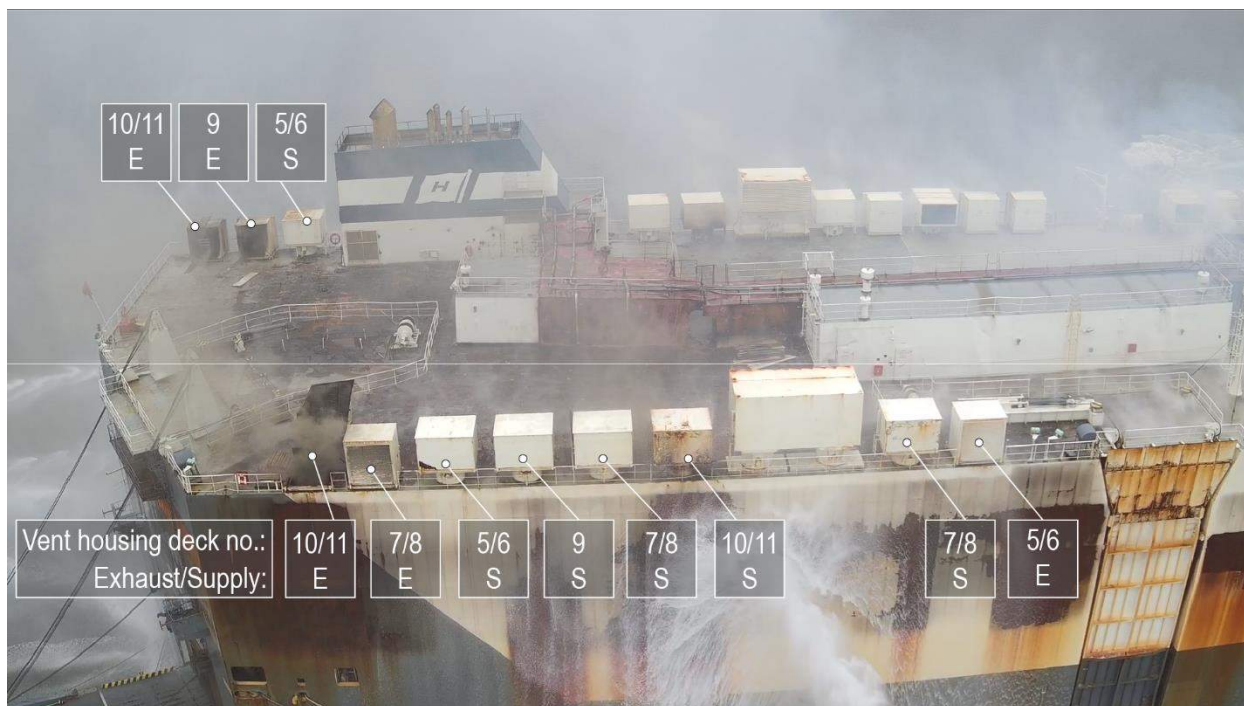
After the accident, the JFRD and the Coast Guard examined the vessel's ventilation housings during walkarounds of deck 12. (Figure 11 shows the damaged aft housings.) The condition of the housings fell into three categories: 43 had no signs of external sooting or mechanical damage; 8 exhibited external sooting but no mechanical damage; and 7 exhibited both external sooting and mechanical damage.

**Figure 11.** Damaged aft ventilation housings after the reported explosion of portside vent housing for deck 9 (9E in the photo). (Background source: JFRD)

The ventilation housings associated with decks 7/8, 9, and 10/11 exhibited sooting, and the housings associated with decks 9 and 10/11 exhibited mechanical damage. The ventilation housings for deck 10/11 exhibited greater levels of mechanical damage than those of deck 9.

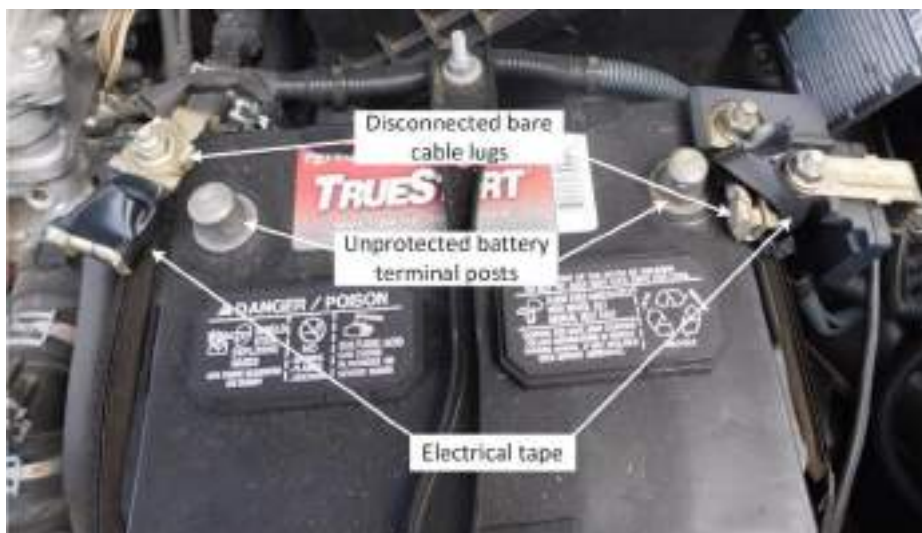
The sample of 39 forklift vehicles loaded in Jacksonville included 12 vehicles that did not have batteries and 3 vehicles with battery cables that had not been disconnected from the battery terminal posts. Of the 24 remaining vehicles, 22 had exposed battery terminal posts; none of these were protected with plastic caps. Instead, the battery cable lugs were partially wrapped with electrical tape, leaving exposed metal on the lug (see figure 14). Investigators also found 14 instances of disconnected and exposed battery cable lugs resting above or on top of the vehicle battery and touching or nearly touching the exposed battery terminal posts. All of the forklift vehicles examined (except those without batteries) were found to have batteries not secured in accordance with Grimaldi's procedures.

**Figure 14.** Battery in forklift vehicle removed from deck 5. The disconnected battery cable lugs were located near terminal posts, and the battery terminal posts were unprotected. (Source: Coast Guard)

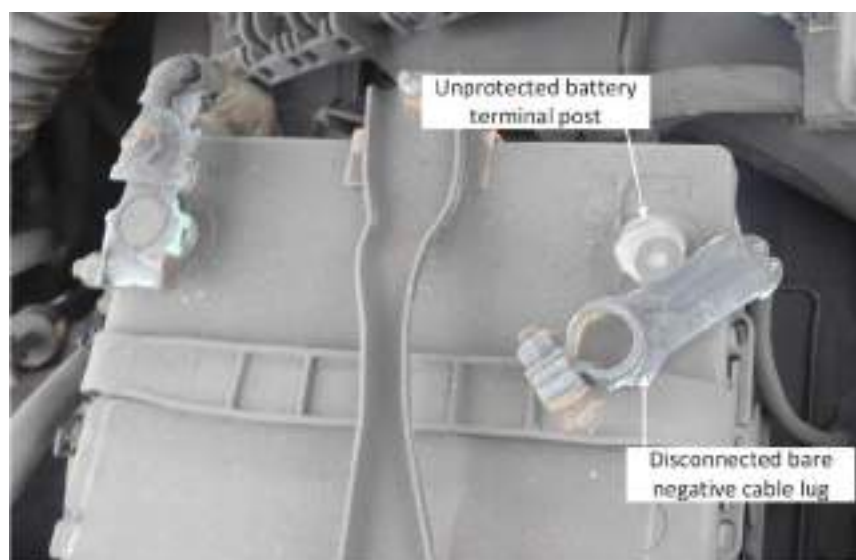
The sample of 20 towed vehicles loaded in Jacksonville included one vehicle that did not have any battery in the engine compartment and two vehicles with battery cables that had not been disconnected from the negative battery terminal posts. Sixteen of the remaining 17 vehicles were found with visibly exposed battery terminal posts that were not protected with plastic caps. Investigators also found 13 instances of disconnected and exposed battery cable lugs resting above or on top of the vehicle battery and touching or nearly touching the exposed battery terminal posts (see figure 15). All the towed vehicles examined (except the one without a battery) were found to have batteries not secured in accordance with Grimaldi's procedures. Table 4 summarizes the towed vehicle examination.

**Figure 15.** Battery in towed vehicle removed from deck 7. The disconnected bare cable lug was in physical contact with unprotected battery terminal post. (Source: Coast Guard)

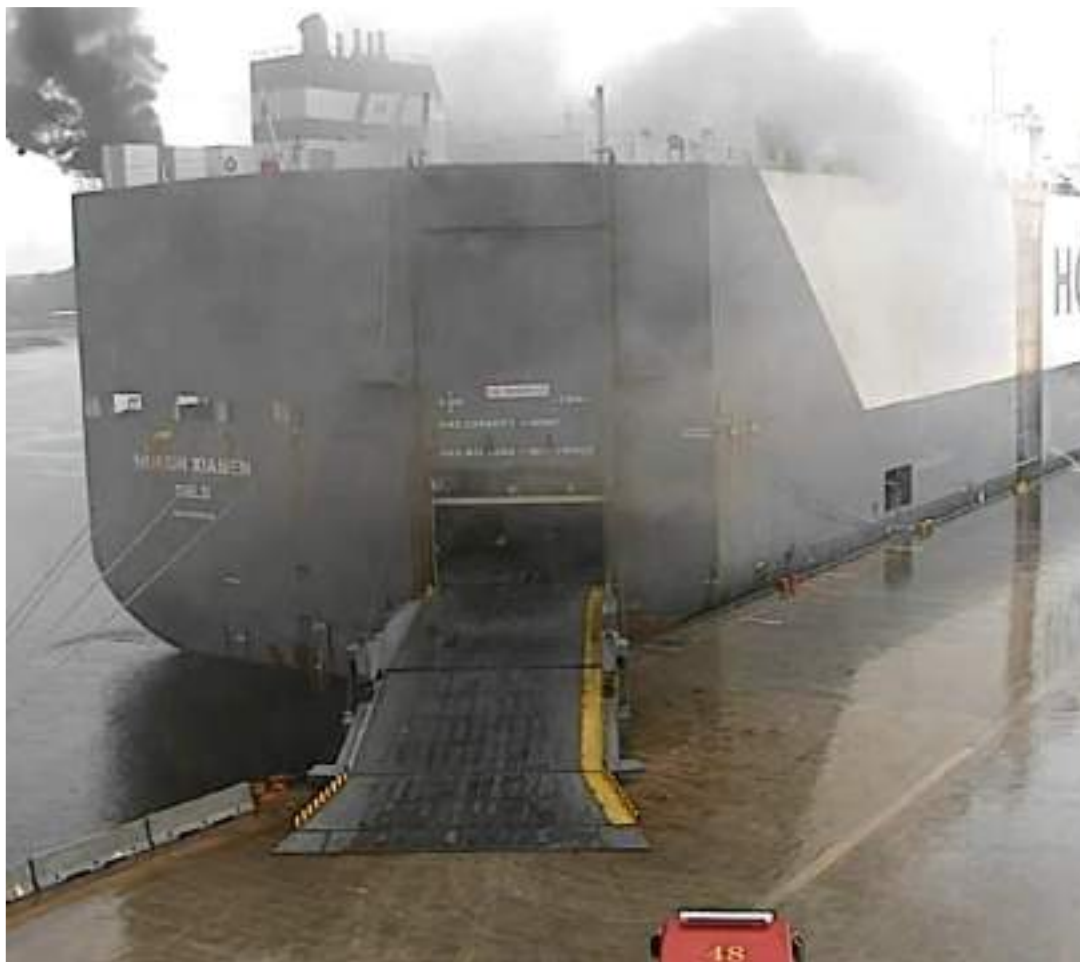
The video showed that when Engine 48 arrived, there was smoke flowing from the two aftmost exhaust vents on the port side (corresponding to decks 9 and 10/11) and the two aftmost exhaust vents on the starboard side (corresponding to decks 10/11 and 7/8) (see figure 16). At the time of Engine 48's arrival, the white paint on the starboard side of the *Höegh Xiamen* did not appear to have any thermal discoloration.

**Figure 16.** Engine 48 arriving on scene about 1603. Starboard vents 10/11E and 7/8E and port vents 10/11E and 9E exhibit smoke flow. (Source: Jacksonville Port Authority)

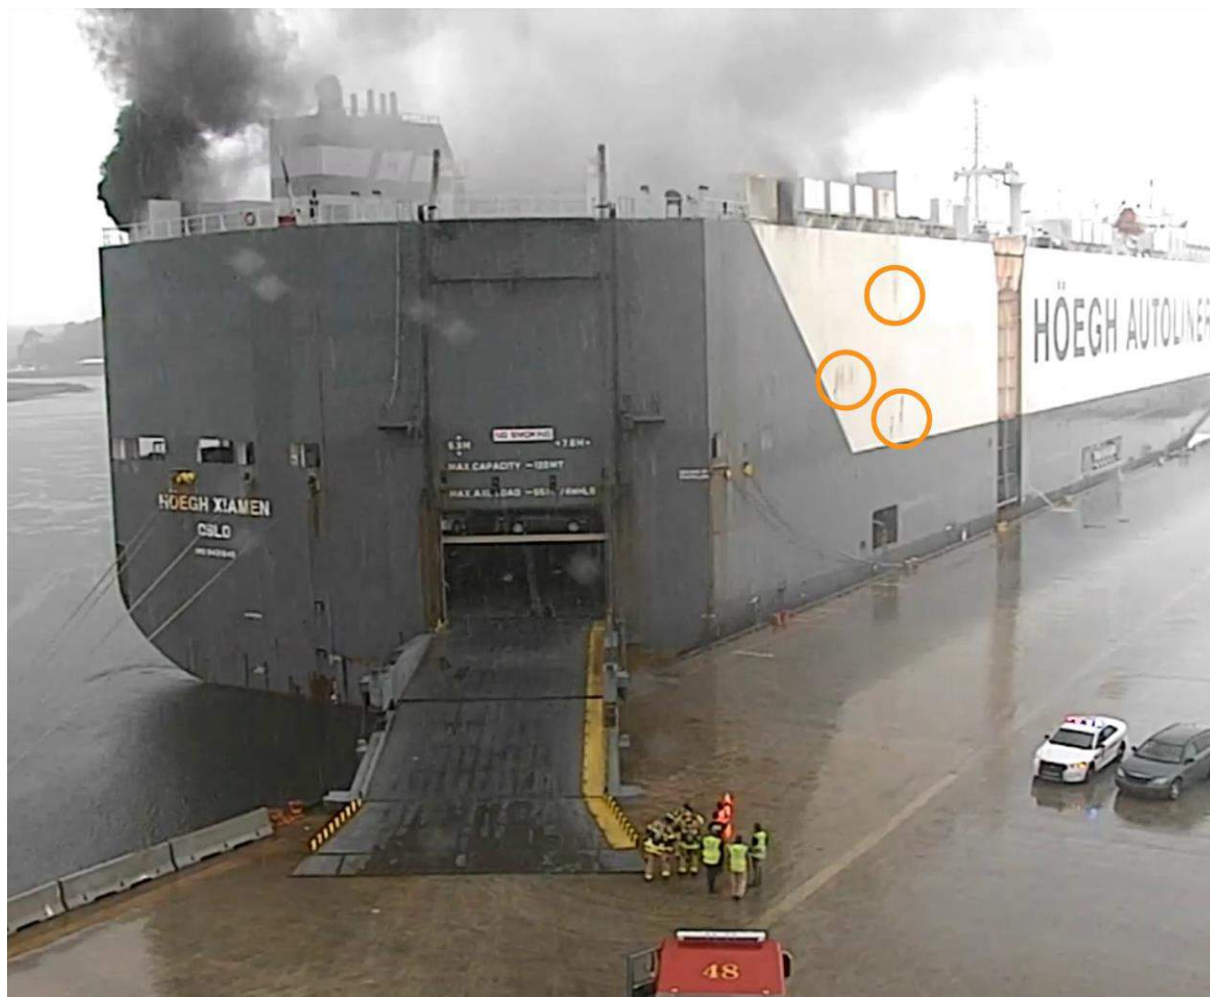
About 5 minutes after the fire department first arrived on scene, the video showed firefighters and one crewmember at the edge of the vessel's stern ramp. Smoke continued to rise from the vents on the ship's stern, with a much darker, thicker plume emitting from the port side. The video showed that, at this time, the white paint on the vessel's starboard side was beginning to exhibit thermal discoloration in areas corresponding to the fire zones associated with decks 7/8 and 10/11 (see figure 17). About 5 minutes later, the discoloration became more pronounced, and the discoloration continued to darken over the next 15 minutes.

**Figure 17.** About 1608, 5 minutes after Engine 48's arrival, the white paint on the starboard side of the vessel exhibits thermal discoloration (circled in orange). Starboard vents 10/11E and 7/8E and port vents 10/11E and 9E exhibit smoke flow. (Source: Jacksonville Port Authority)
