SAFETY DIGEST

Lessons from Marine Accident Reports

1/2022

MARINE ACCIDENT INVESTIGATION BRANCH

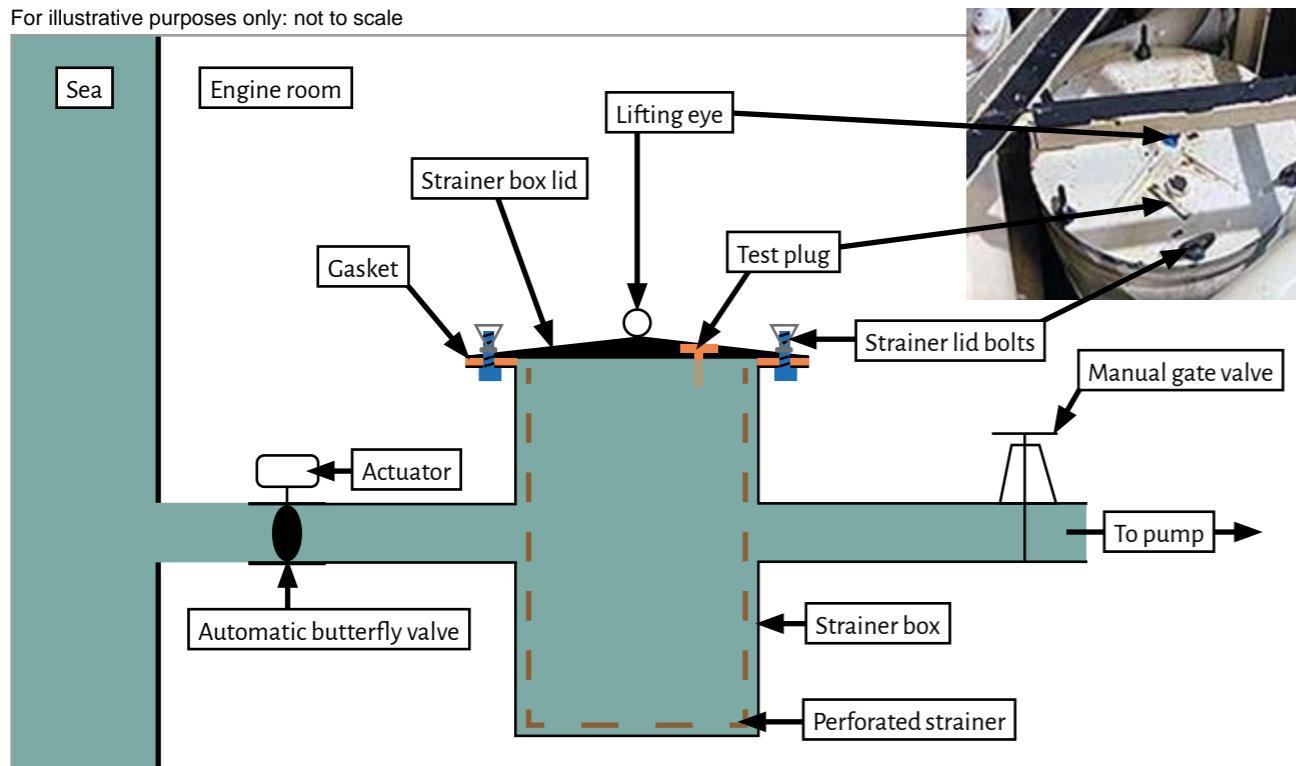
After the accident, a technical investigation identified that the automatic butterfly hull valve was defective, and had remained partially open when indicated as shut on the ballast control panel. This investigation also found that the strainer was clean but that a ballast pump defect had caused the slow ballasting operations. The company has provided a revised safe system of work for strainer cleaning.

Figure 1: Ballast water valve and strainer arrangements

1. Procedure → The strainer lid was fitted with a test plug (Figure 1), provided to make sure the system was not still under pressure before the lid was removed. However, the engineers involved in this accident neither followed an approved procedure for the strainer clean nor opened the test plug and so were unaware of the faulty hull valve that meant the system was still open to sea pressure. Additionally, when they tried to remove the lid with a screwdriver, the absence of any leakage underpinned their assessment that the system was isolated.

2. Check → Given that the hull valve indicated shut on the ballast control panel, it was reasonable of the engineers to assume this was correct. However, where there is doubt or, for instance, when reducing a system to single valve isolation to sea, it is good practice to visually inspect the valve's mechanical position indicator as well as checking its remote indication. A further precaution is to loosen the nuts, then use wedges to crack the lid open; if water floods out, the retaining nuts can be retightened to seal the strainer lid.

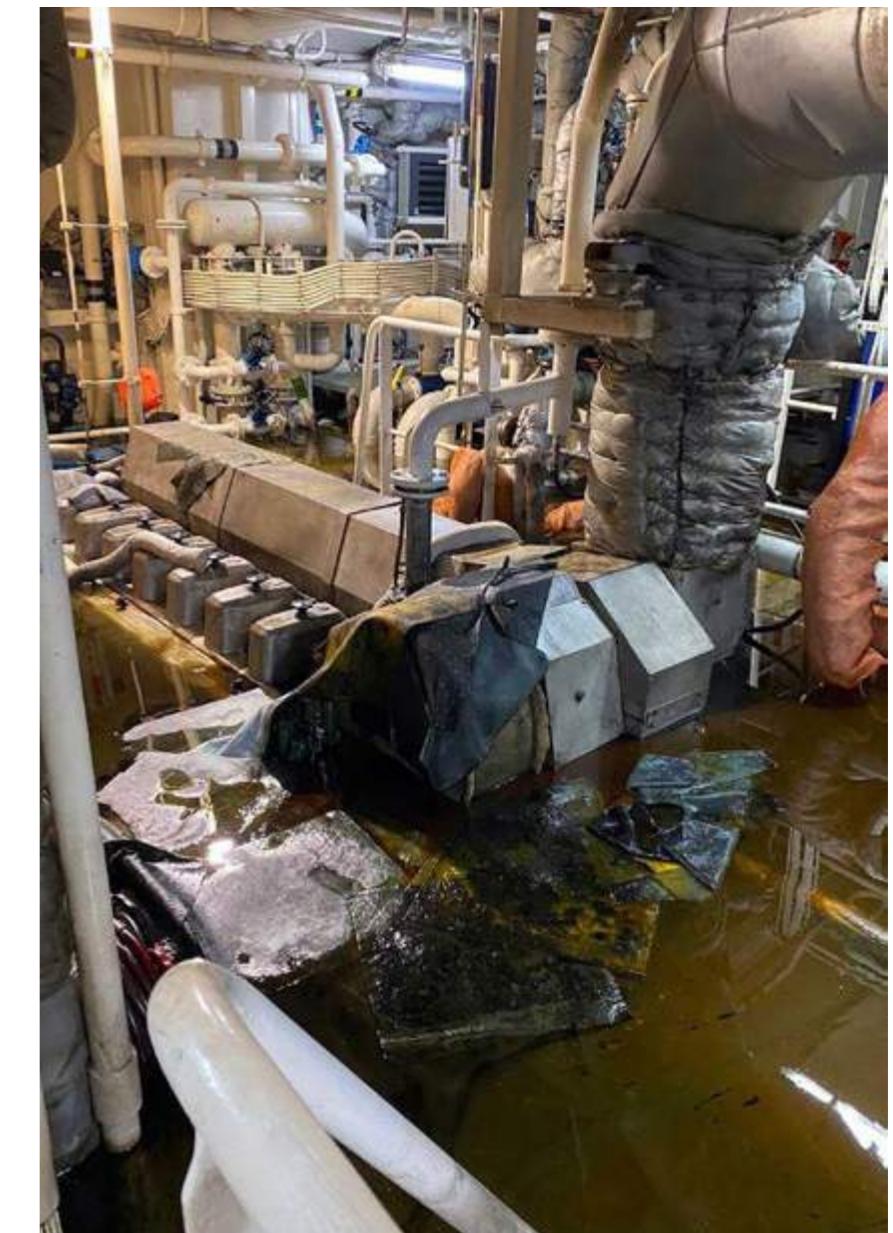
In the engine room, the water level rose over the bottom plates until the seawater pressure equalised and the vessel settled with the engine room partly flooded (Figure 2). The vessel was made watertight after a diver fitted an external patch over the hull valve. Thereafter, the contaminated water was pumped out to road tankers for disposal and the vessel was dry docked for repairs.

Figure 2: The flooded engine room

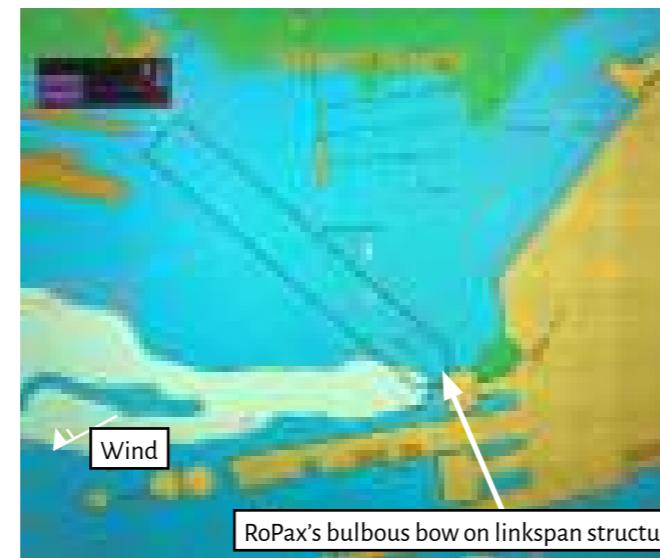
Unfortunately, the master was unable to regain control of the vessel and to prevent damage to the propellers the engines were declutched as the vessel’s stern grounded on a soft mud bank. The bow was held close to the berth by the linkspan structure (Figure 2).

Figure 2: RoPax's stern aground on a mud bank

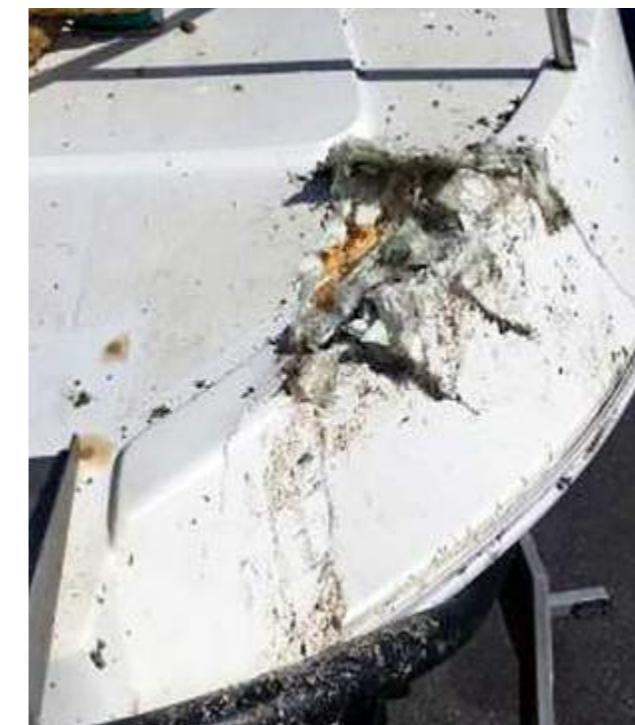
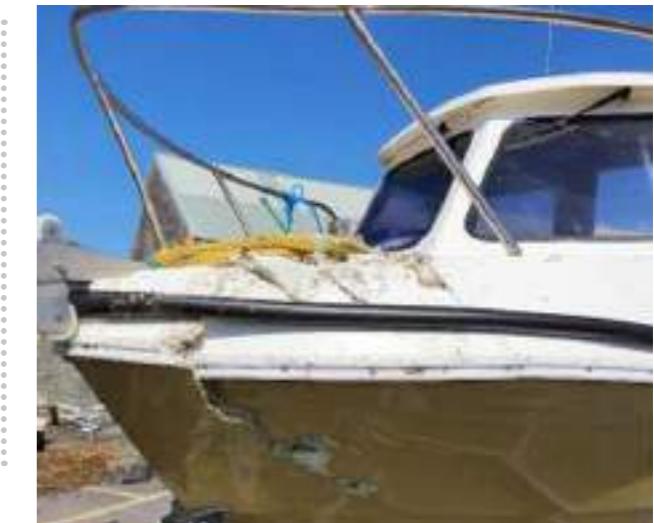
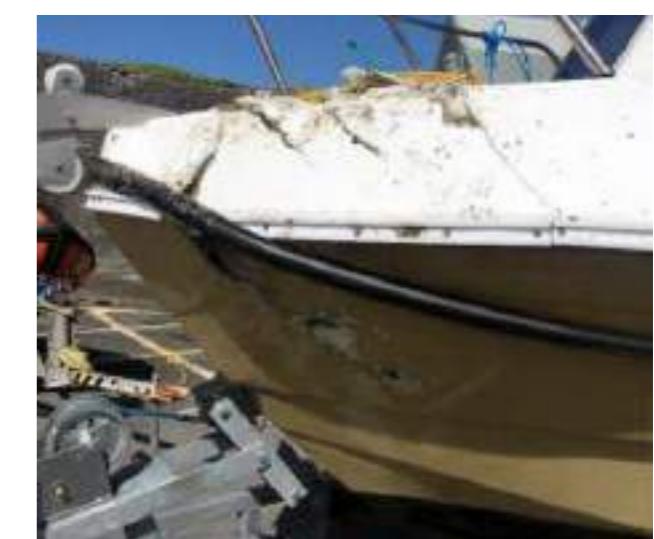
The patrol boat returned to its base when an escort was available and was taken out of the water the following morning. Subsequent surveys revealed significant damage to the bow, with delamination of the glass-reinforced plastic as far back as 2m from the bow (Figure 2). The boat was out of action for several weeks for repairs.

Figure 2: Damage to bow and deck delamination

1. **Margin of safety** → Due to the prevailing conditions, the crew had already decided to conduct the patrol on the outboard side of the main jetty. However, to speed it up the coxswain took the boat under the roadway access to the terminal berths. At night, the waves and pilings were more difficult to see, and in marginal conditions it would have been prudent to stay on the offshore side of the terminal throughout the patrol. This might have lengthened the patrol but would have increased the margin of safety and minimised the risk to boat and crew.

2. **Guide** → With the weather assessed by the crew as marginal for the relatively small vessel, a larger more capable boat, which was available, might have been a better choice. Incorporating a matrix into operational instructions, which matches suitable conditions for tasks against available assets, can assist crew to plan essential tasks in marginal conditions when there is limited onsite supervision.

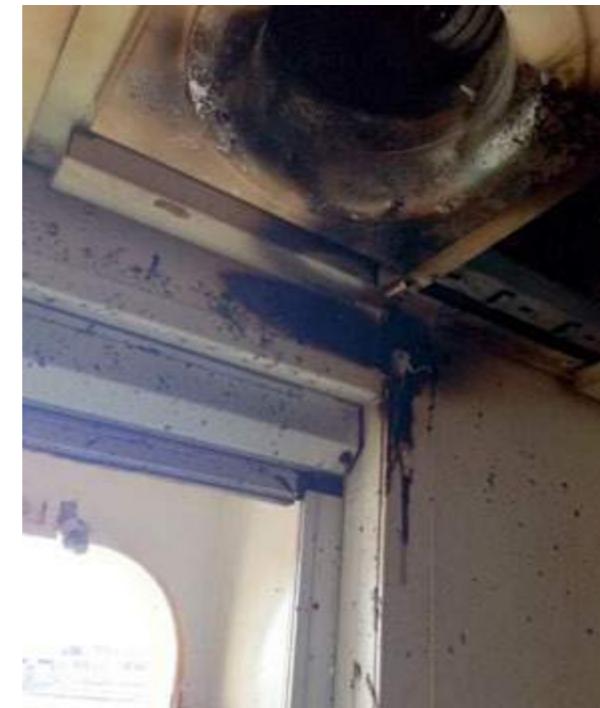
The shipping company conducted an internal investigation and found that a passenger had previously used the cabin and stuffed a towel into the ventilation duct to prevent a cold air draught (Figure 2). The towel caught fire when the ventilation duct's automatic heating element turned itself on.

Figure 1: The ventilation duct post-fire

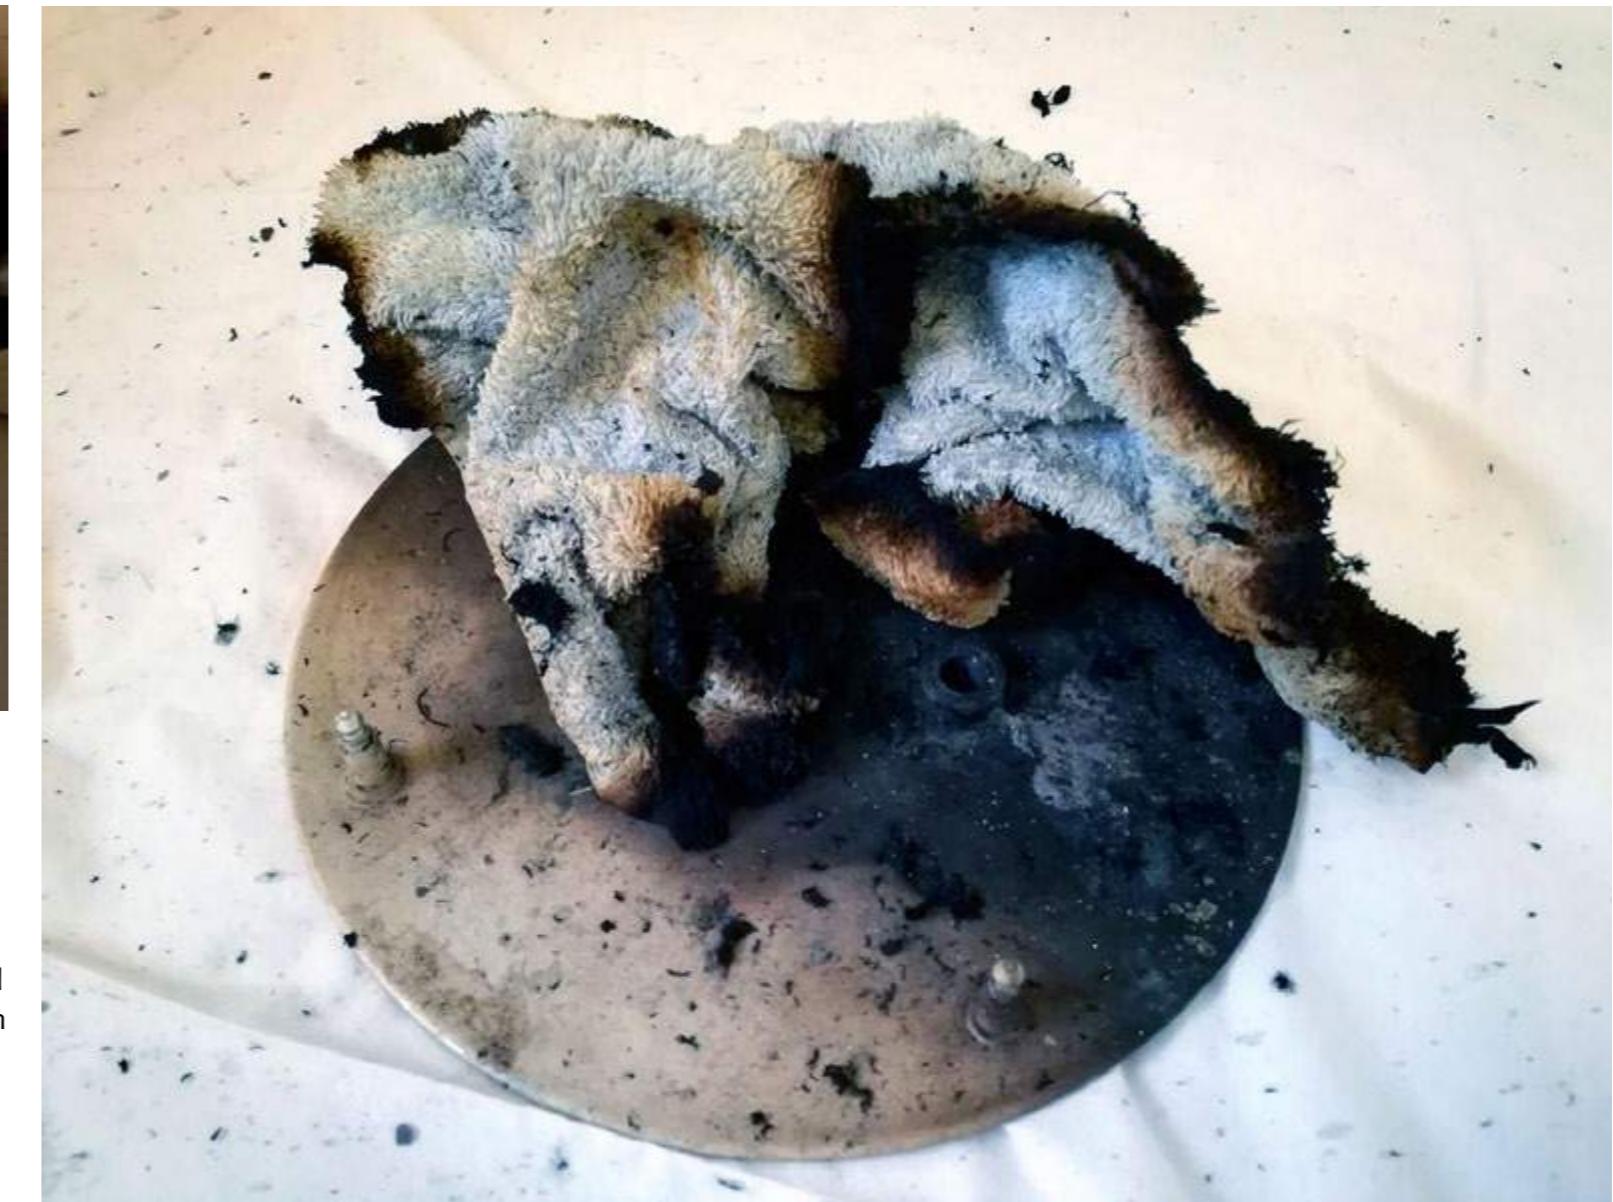
Figure 2: The towel that was stuffed into the ventilation duct

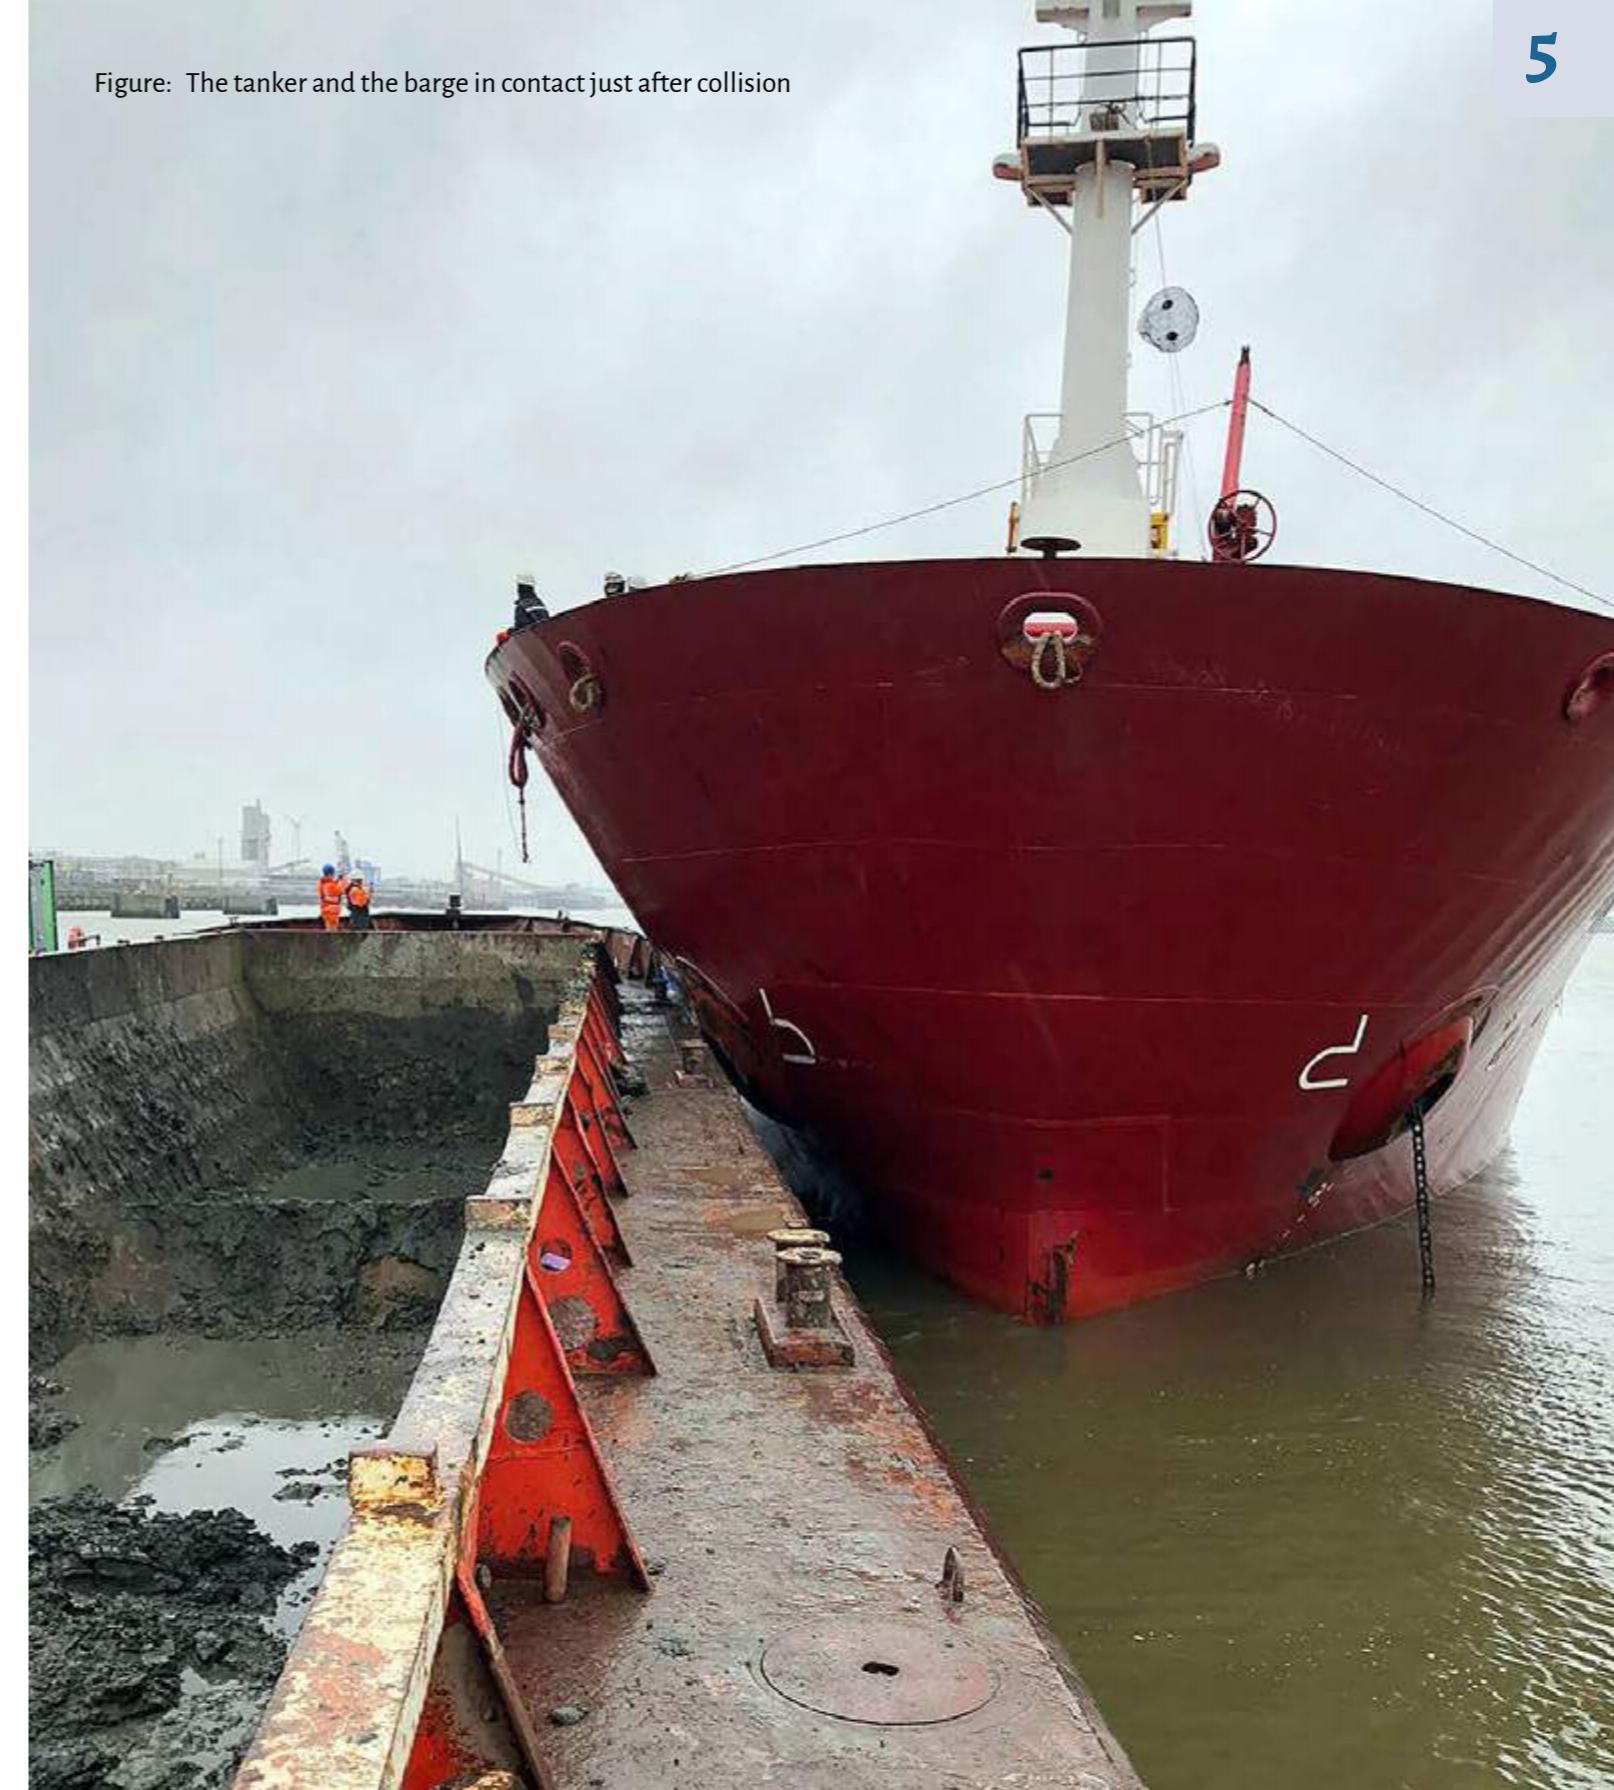
None of the crew's actions were successful in regaining CPP control, so the master activated the bridge main engine emergency stop and both anchors were dropped as the speed reduced. Despite these actions, the tanker eventually came to rest when it collided with a barge moored in the river (see figure). There was no significant damage to either vessel.

Figure: The tanker and the barge in contact just after collision

- Maintain** → A post-accident technical investigation found that a CPP hydraulic control valve had malfunctioned, resulting in a loss of system pressure and consequent loss of propeller pitch control. The defect was determined to be excessive wear and tear on the valve. However, the investigation also identified that, although probably not contributing to the loss of control, some 'non-approved' spare parts were found in use on the system. It is important that manufacturer-approved spare parts are used, particularly in critical systems such as propulsion and steering.

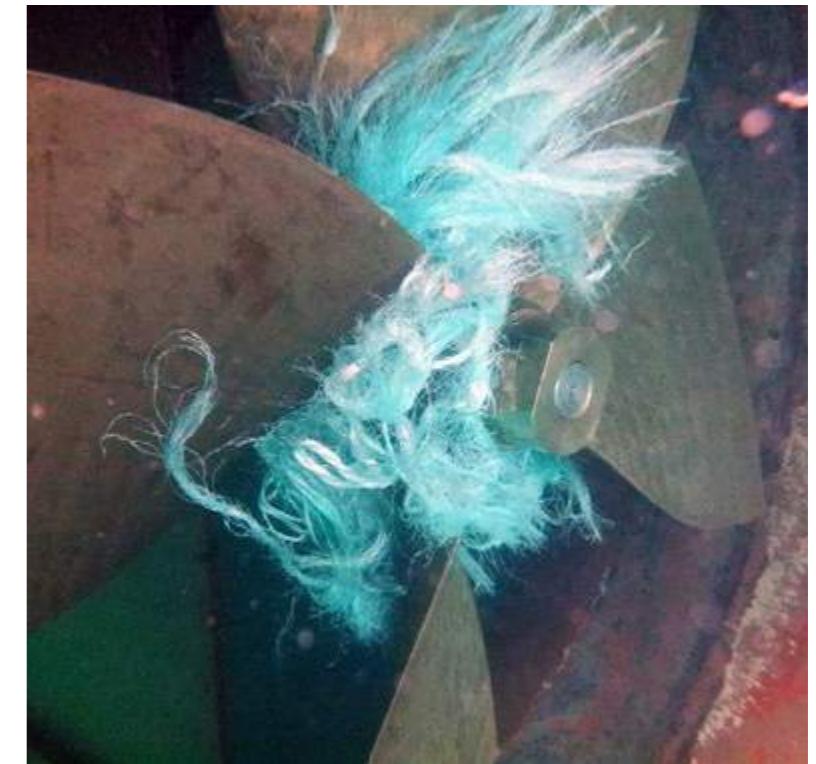
the situation, WB1's port propeller shaft became fouled by the emergency towline (Figure 2). Once the tow had been re-established and everyone safely accounted for, the coastguard agreed that the vessels could continue their passages.

Figure 2: The emergency towline caught in WB1's propeller

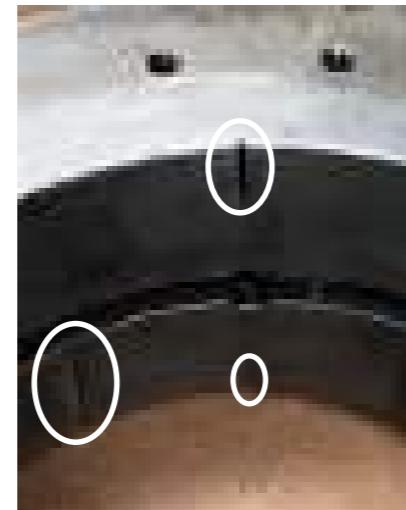
The contractor, having undertaken similar work on different manufacturers' engines, considered that the other manufacturers had a simpler and easier approach to the connecting rod bearing replacement. The contractor chose to remove the bearing shell with a disc cutter and use a gas cutting torch to heat up the bearing housing to slide the shell into position. In doing so, they introduced notches and heat marks into the bearing housing (Figure 1).

Figure 1: Bearing housing notches from disc cutter

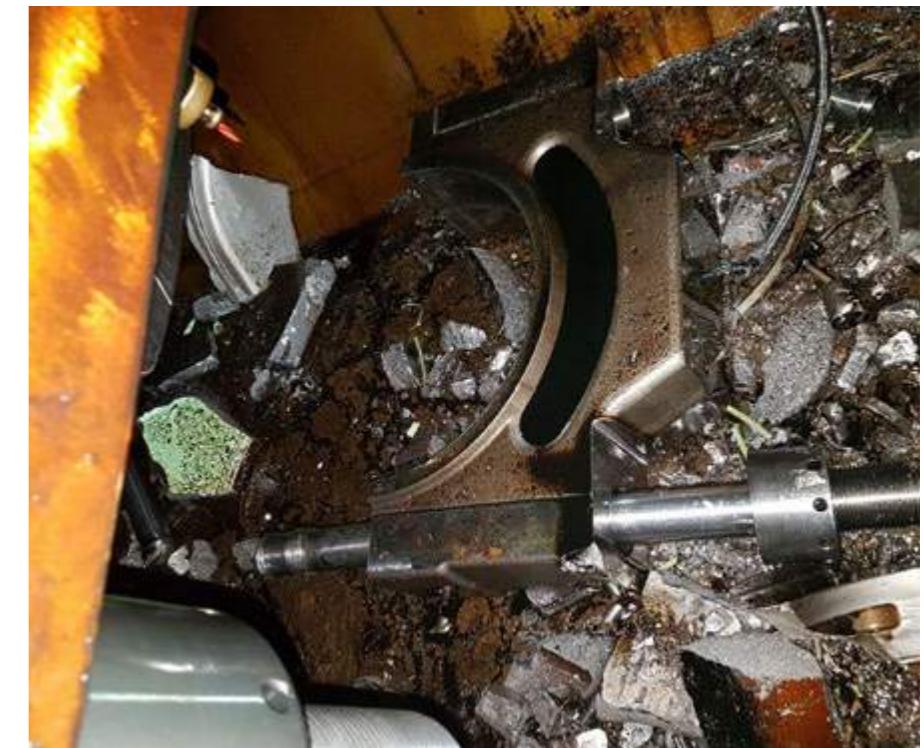
Figure 2: Post-failure engine component debris in sump

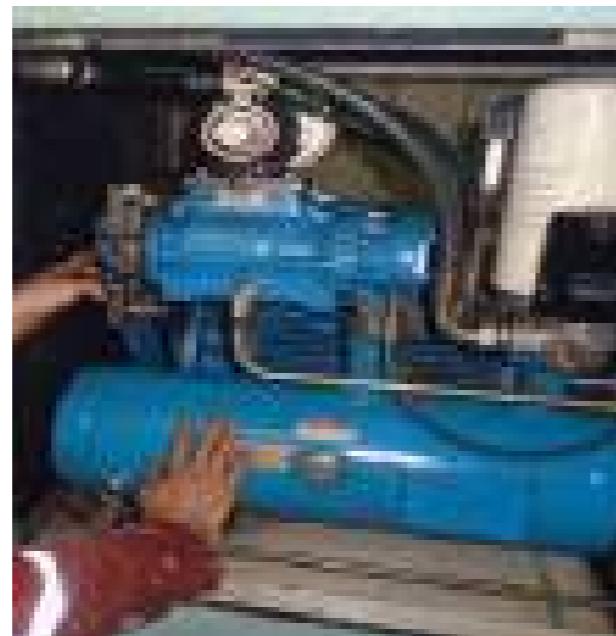
Figure 1: Deck air compressor belt

The company conducted an internal investigation and issued a safety bulletin that reminded ship's staff of its LOTO procedures and the importance of risk assessments.

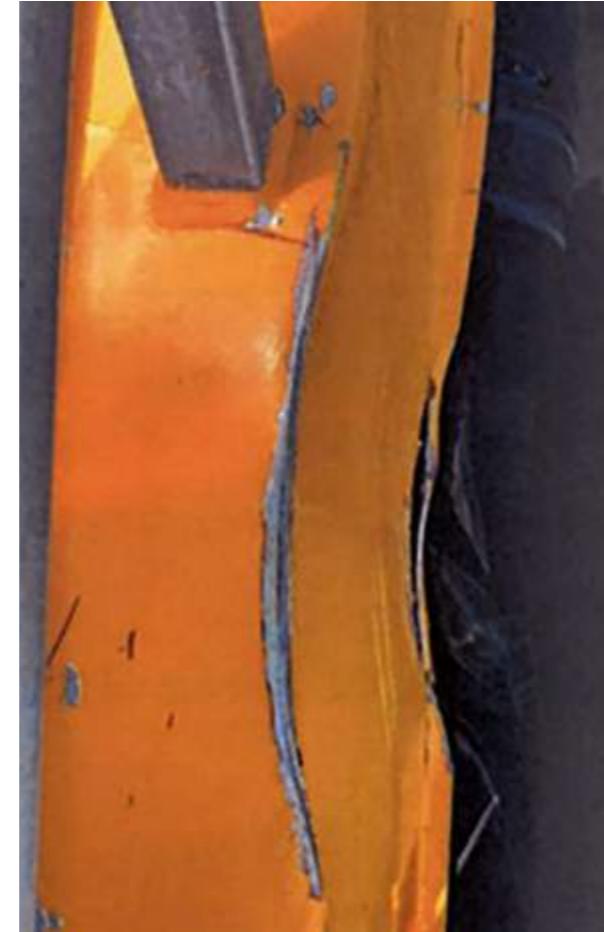
The impact caused a bow indentation (Figure 1) and buckling damage to the hull plating (Figure 2). One of the technicians was injured when he was thrown against the table in front of his seat; he was treated by ambulance paramedics when the vessel returned to harbour.

Figure 1: Indentation damage to the passenger transfer vessel's bow area

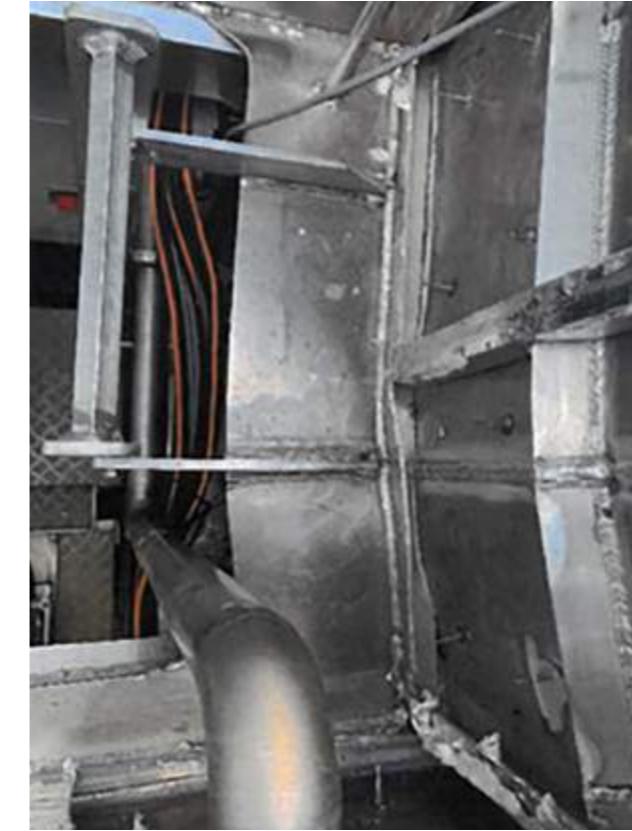
Figure 2: Deformed internal frames

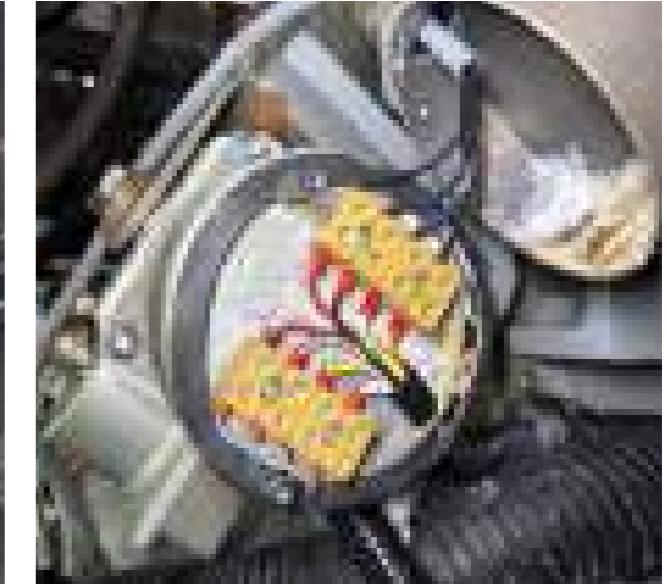
Figure 3: Water ingress damage (unrelated to the propulsion control loss)

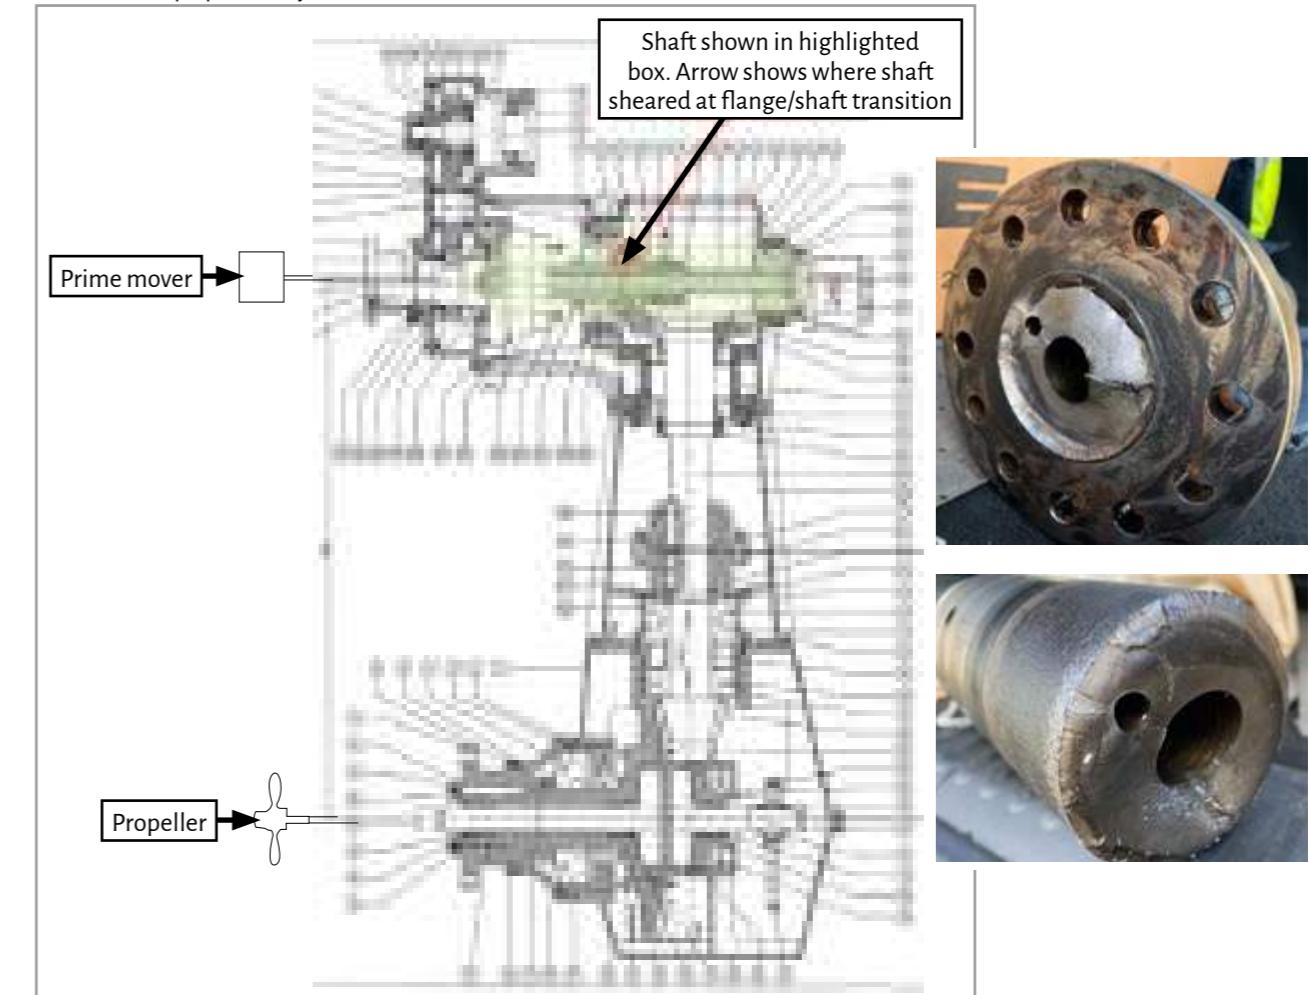
Fretting failure in gearbox

Figure: Gearbox damage and (inset) broken shaft

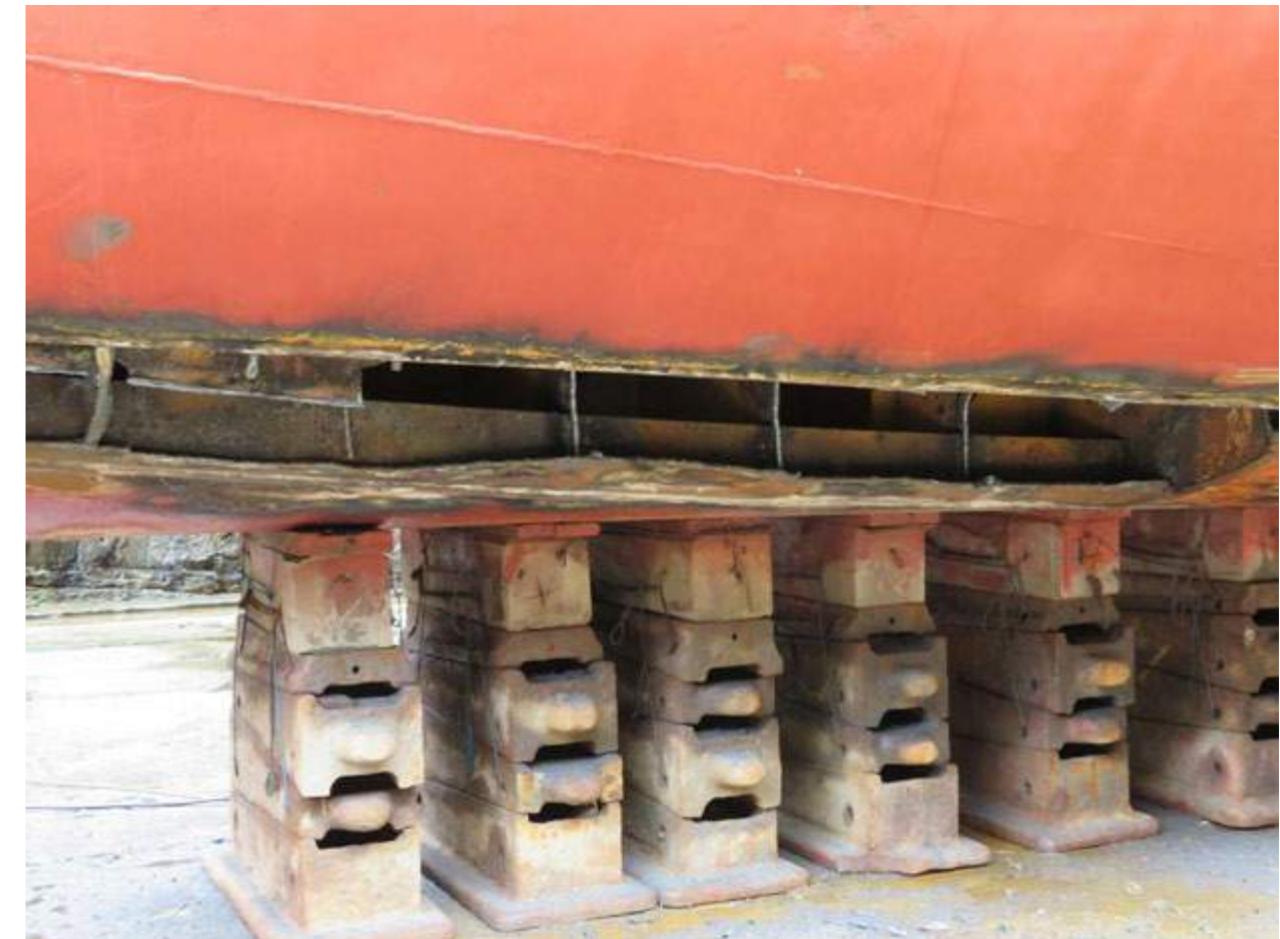
The ferry was eventually refloated with the assistance of a harbour tug, but not before suffering substantial damage to the port side of the hull (see figure), port propeller and rudder. There was no pollution and nobody sustained injuries.

Figure: Damage to the port side of the hull

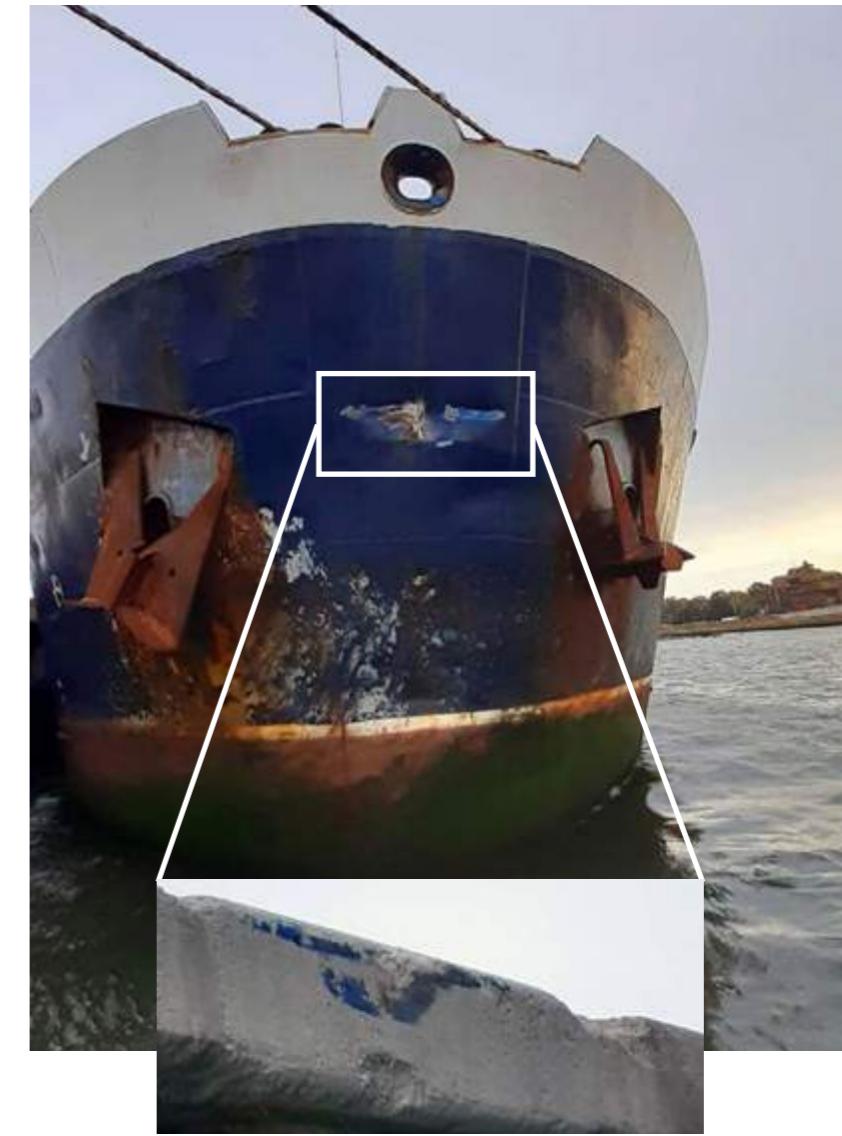
After swinging almost 90°, the second mate radioed the bridge, warning that the bow was passing too close to the quay; however, this came too late for the master to take effective avoiding action and the vessel's bow made heavy contact. The bow was scraped and dented and the impact left a paint mark on the quay wall, although it was undamaged (Figure 2).

Figure 2: Damage to vessel and (inset) paint mark on the quay

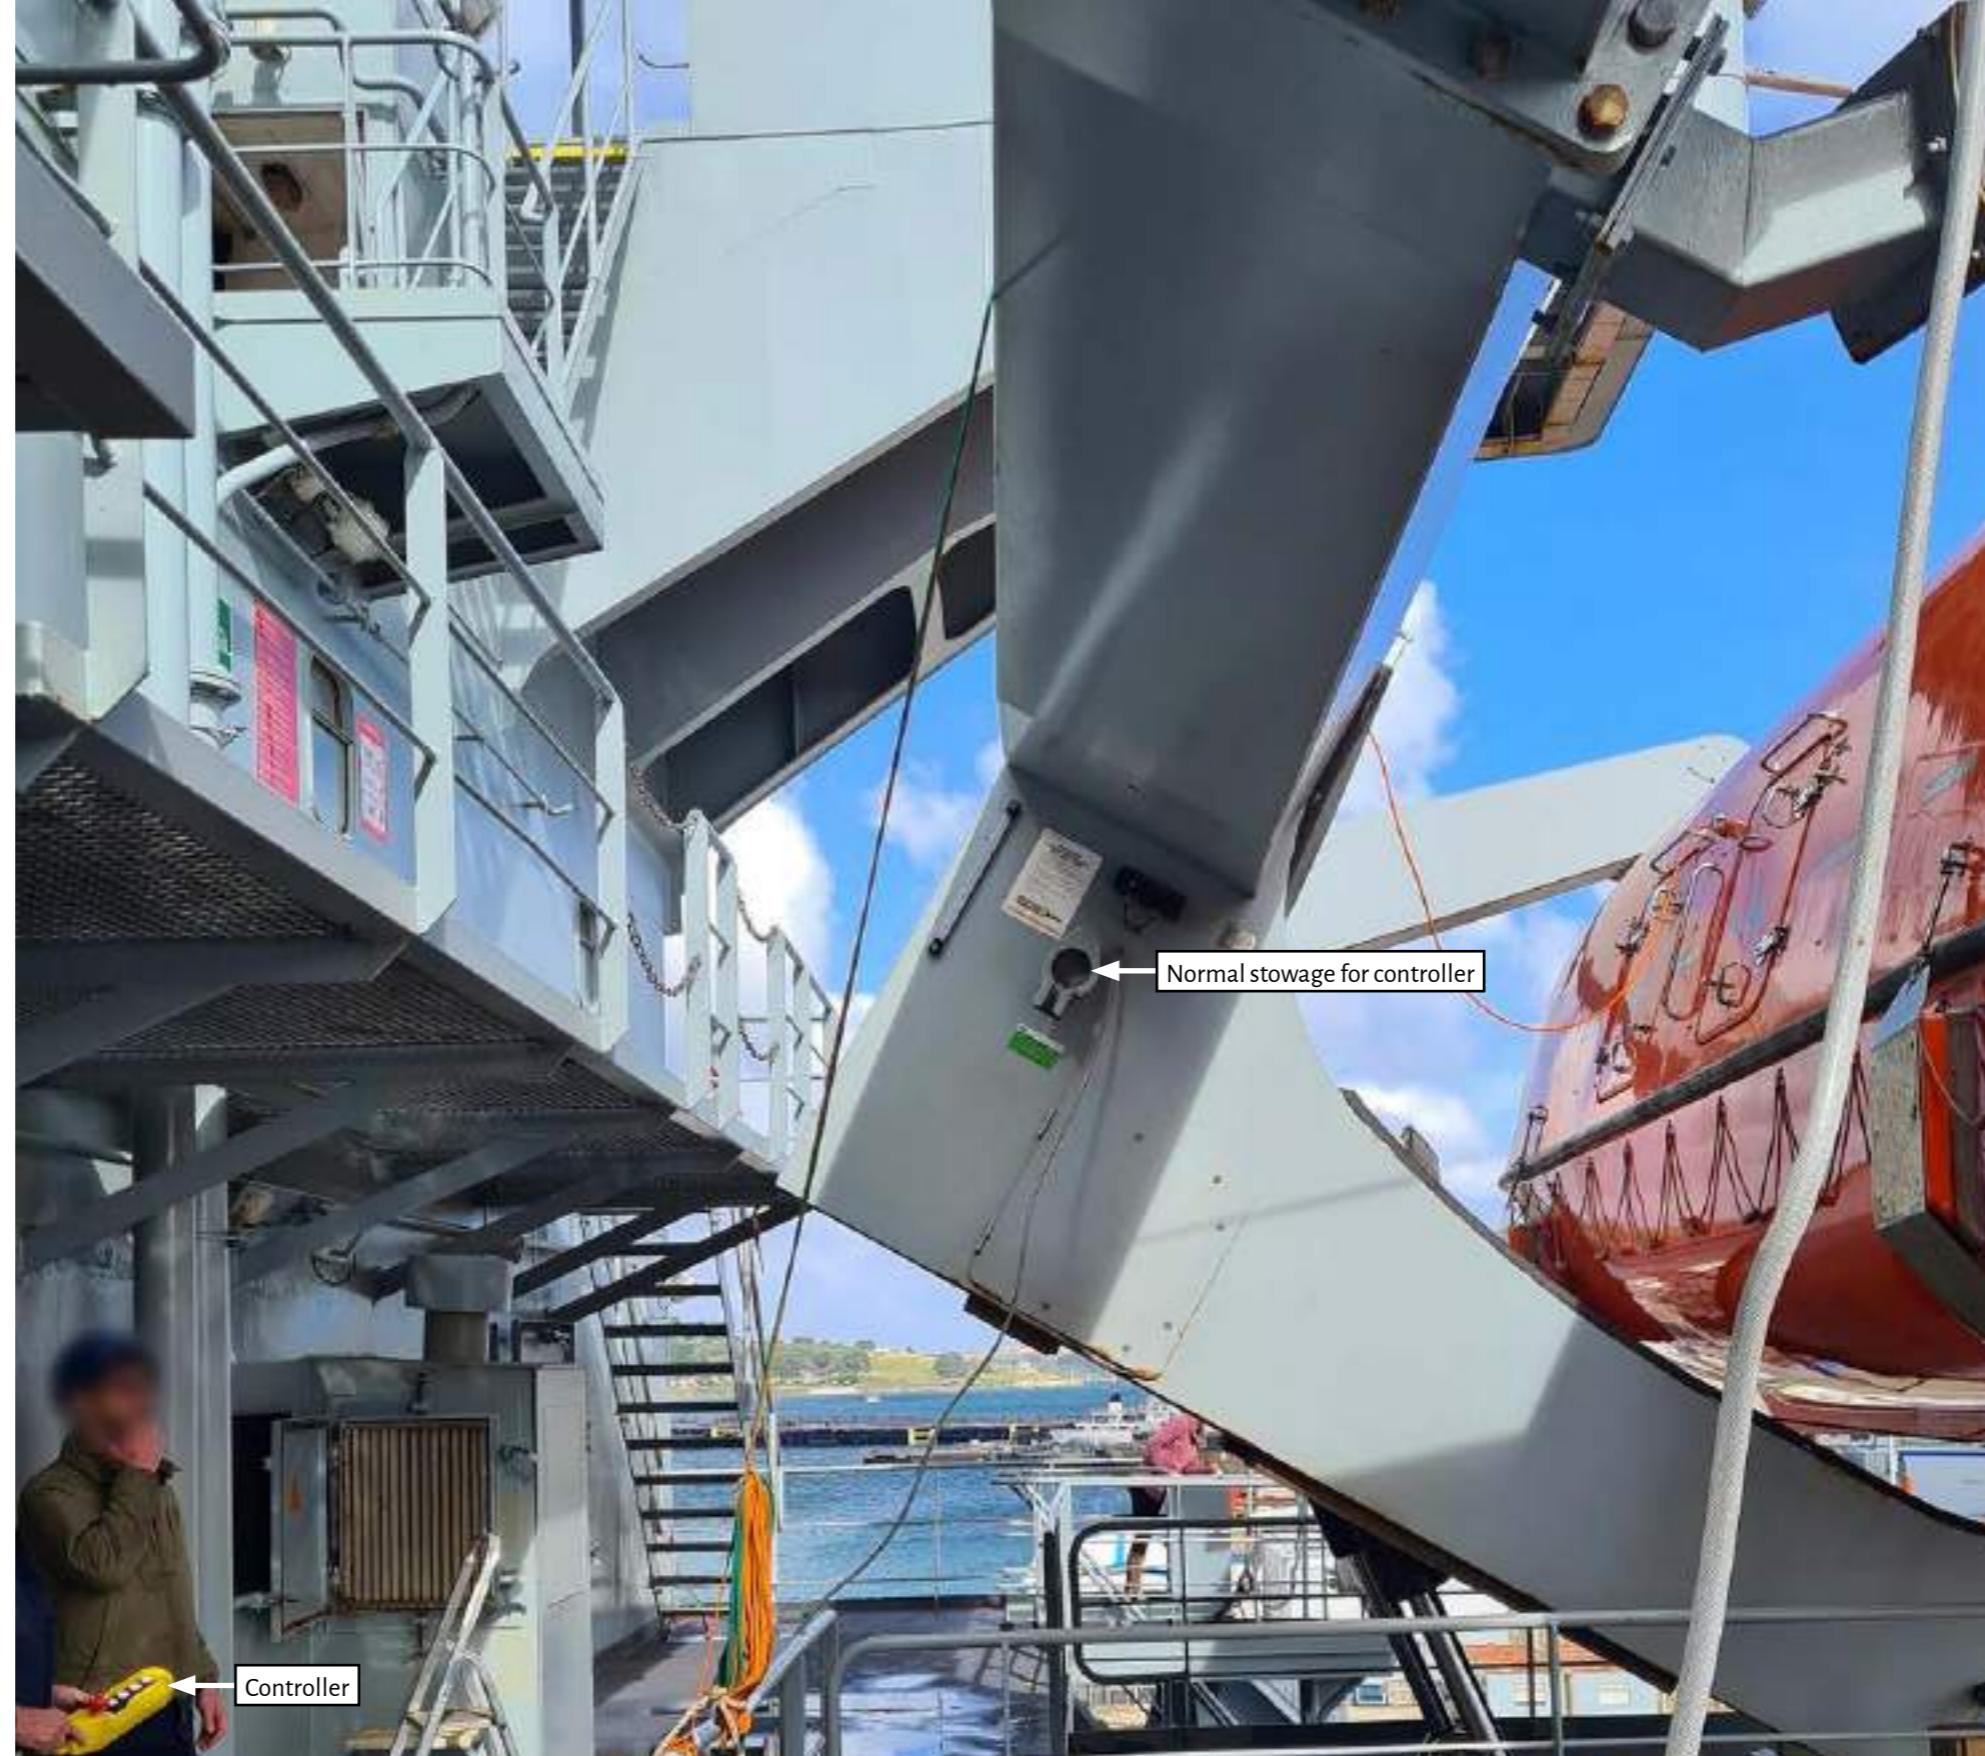
The alarm was raised and the chief officer, bosun and other duty personnel attended the scene. The lifeboat davit was found to have partially deployed (see figure) but with no control input. It was apparent that the loud bang occurred when the lifeboat's gripe pins sheared. After ensuring that the lifeboat was safely held on its wire falls, the bosun used the pendant operating controller (see figure) to return the davit and lifeboat to the stowed position.

Figure: The partially deployed davit and lifeboat

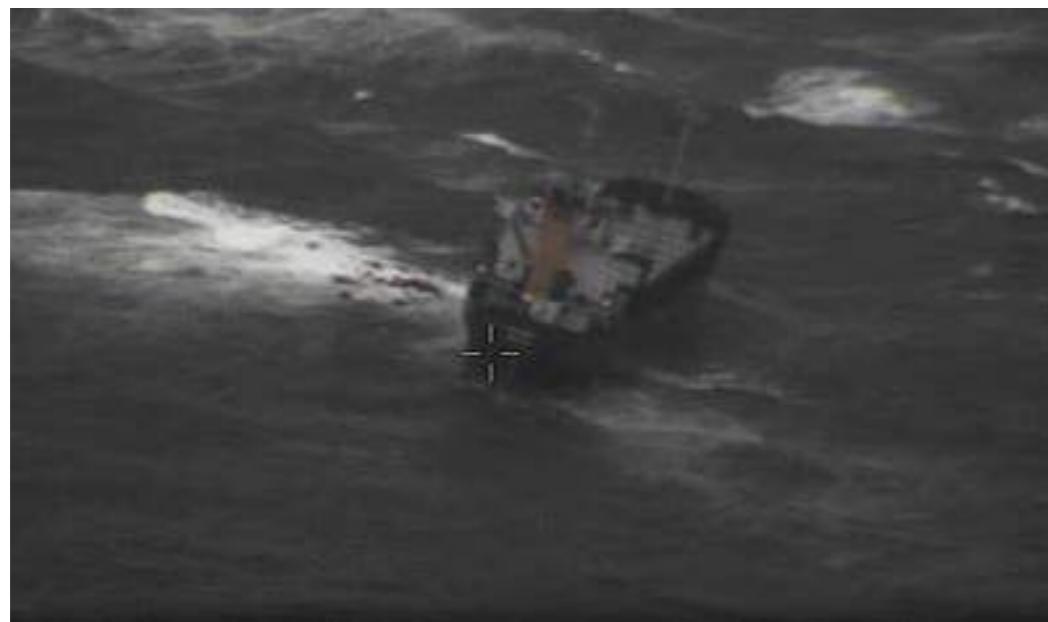
A general cargo vessel being navigated using an Electronic Chart Display and Information System (ECDIS) was sailing through coastal waters on a dark night with a large following sea. The chief officer (C/O) received a call from a local fishing vessel to warn him he was heading into shoal waters, which he acknowledged by replying that he was about to alter course. He then instigated a slight alteration to starboard as per the passage plan. Moments later the vessel came to a juddering stop as it grounded on a well-charted and marked shoal (Figure 1).

Figure 1: The general cargo vessel aground on the shoal

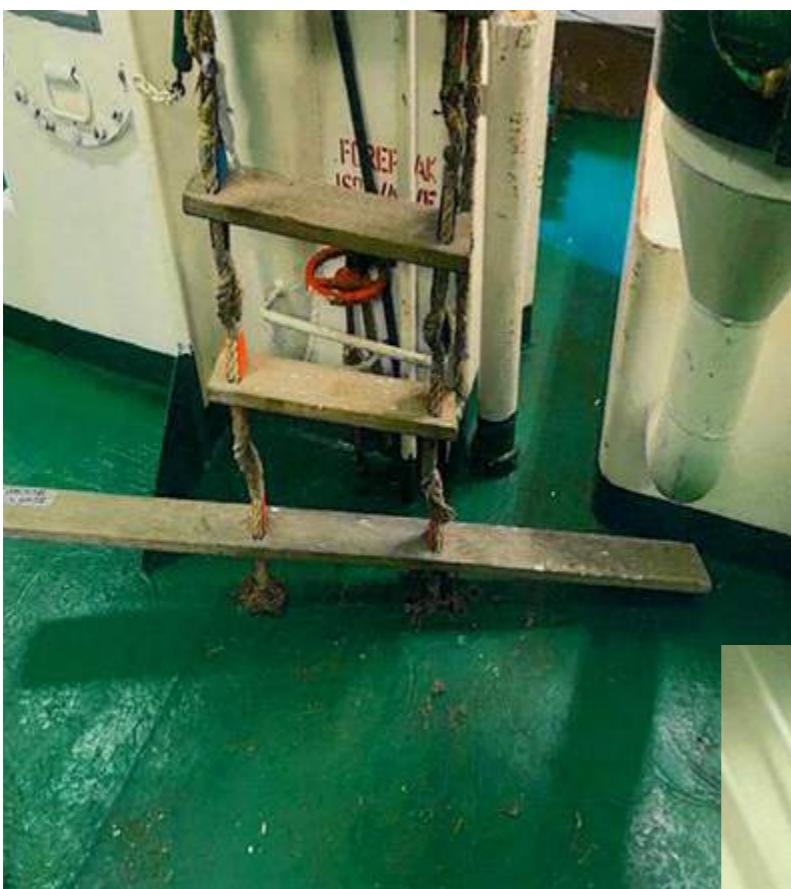
failures were a consequence of the side ropes' poor condition, which a routine visual inspection would almost certainly have detected. If the side ropes are frayed, or in any way degraded, do not use the ladder. Pilot ladders should be less than 30 months old; the year of assembly or reassembly can be found on the identification plate usually located on the lower spreader (Figure 3).

Figure 1: Example of an elderly ladder with its side ropes (inset) in an unsatisfactory condition

If the side ropes are frayed, or in any way degraded, do not use the ladder
