SAFETY DIGEST

Lessons from Marine Accident Reports

1/2022

MARINE ACCIDENT INVESTIGATION BRANCH

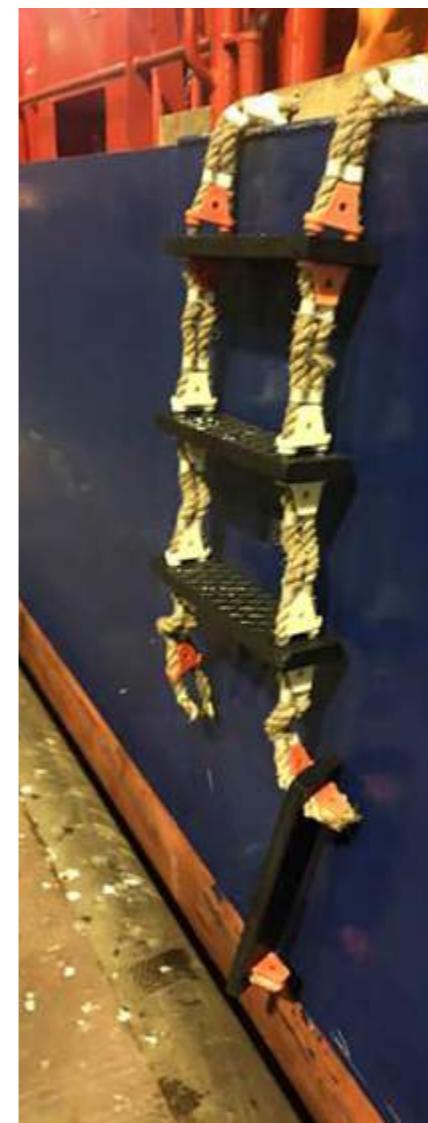
Figure 2: Example of a failed pilot ladder side rope

If the side ropes are frayed, or in any way degraded, do not use the ladder

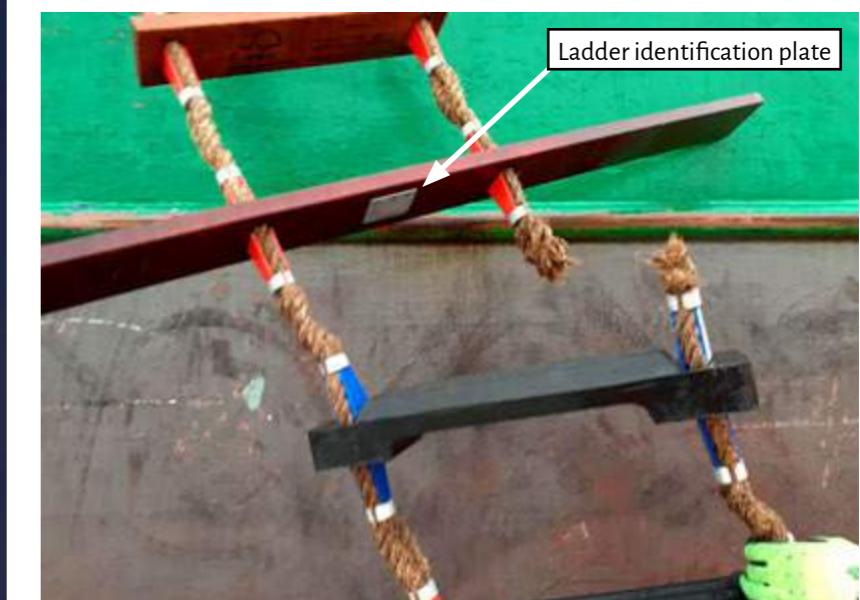
Figure 3: Failed pilot ladder, showing ladder identification plate location

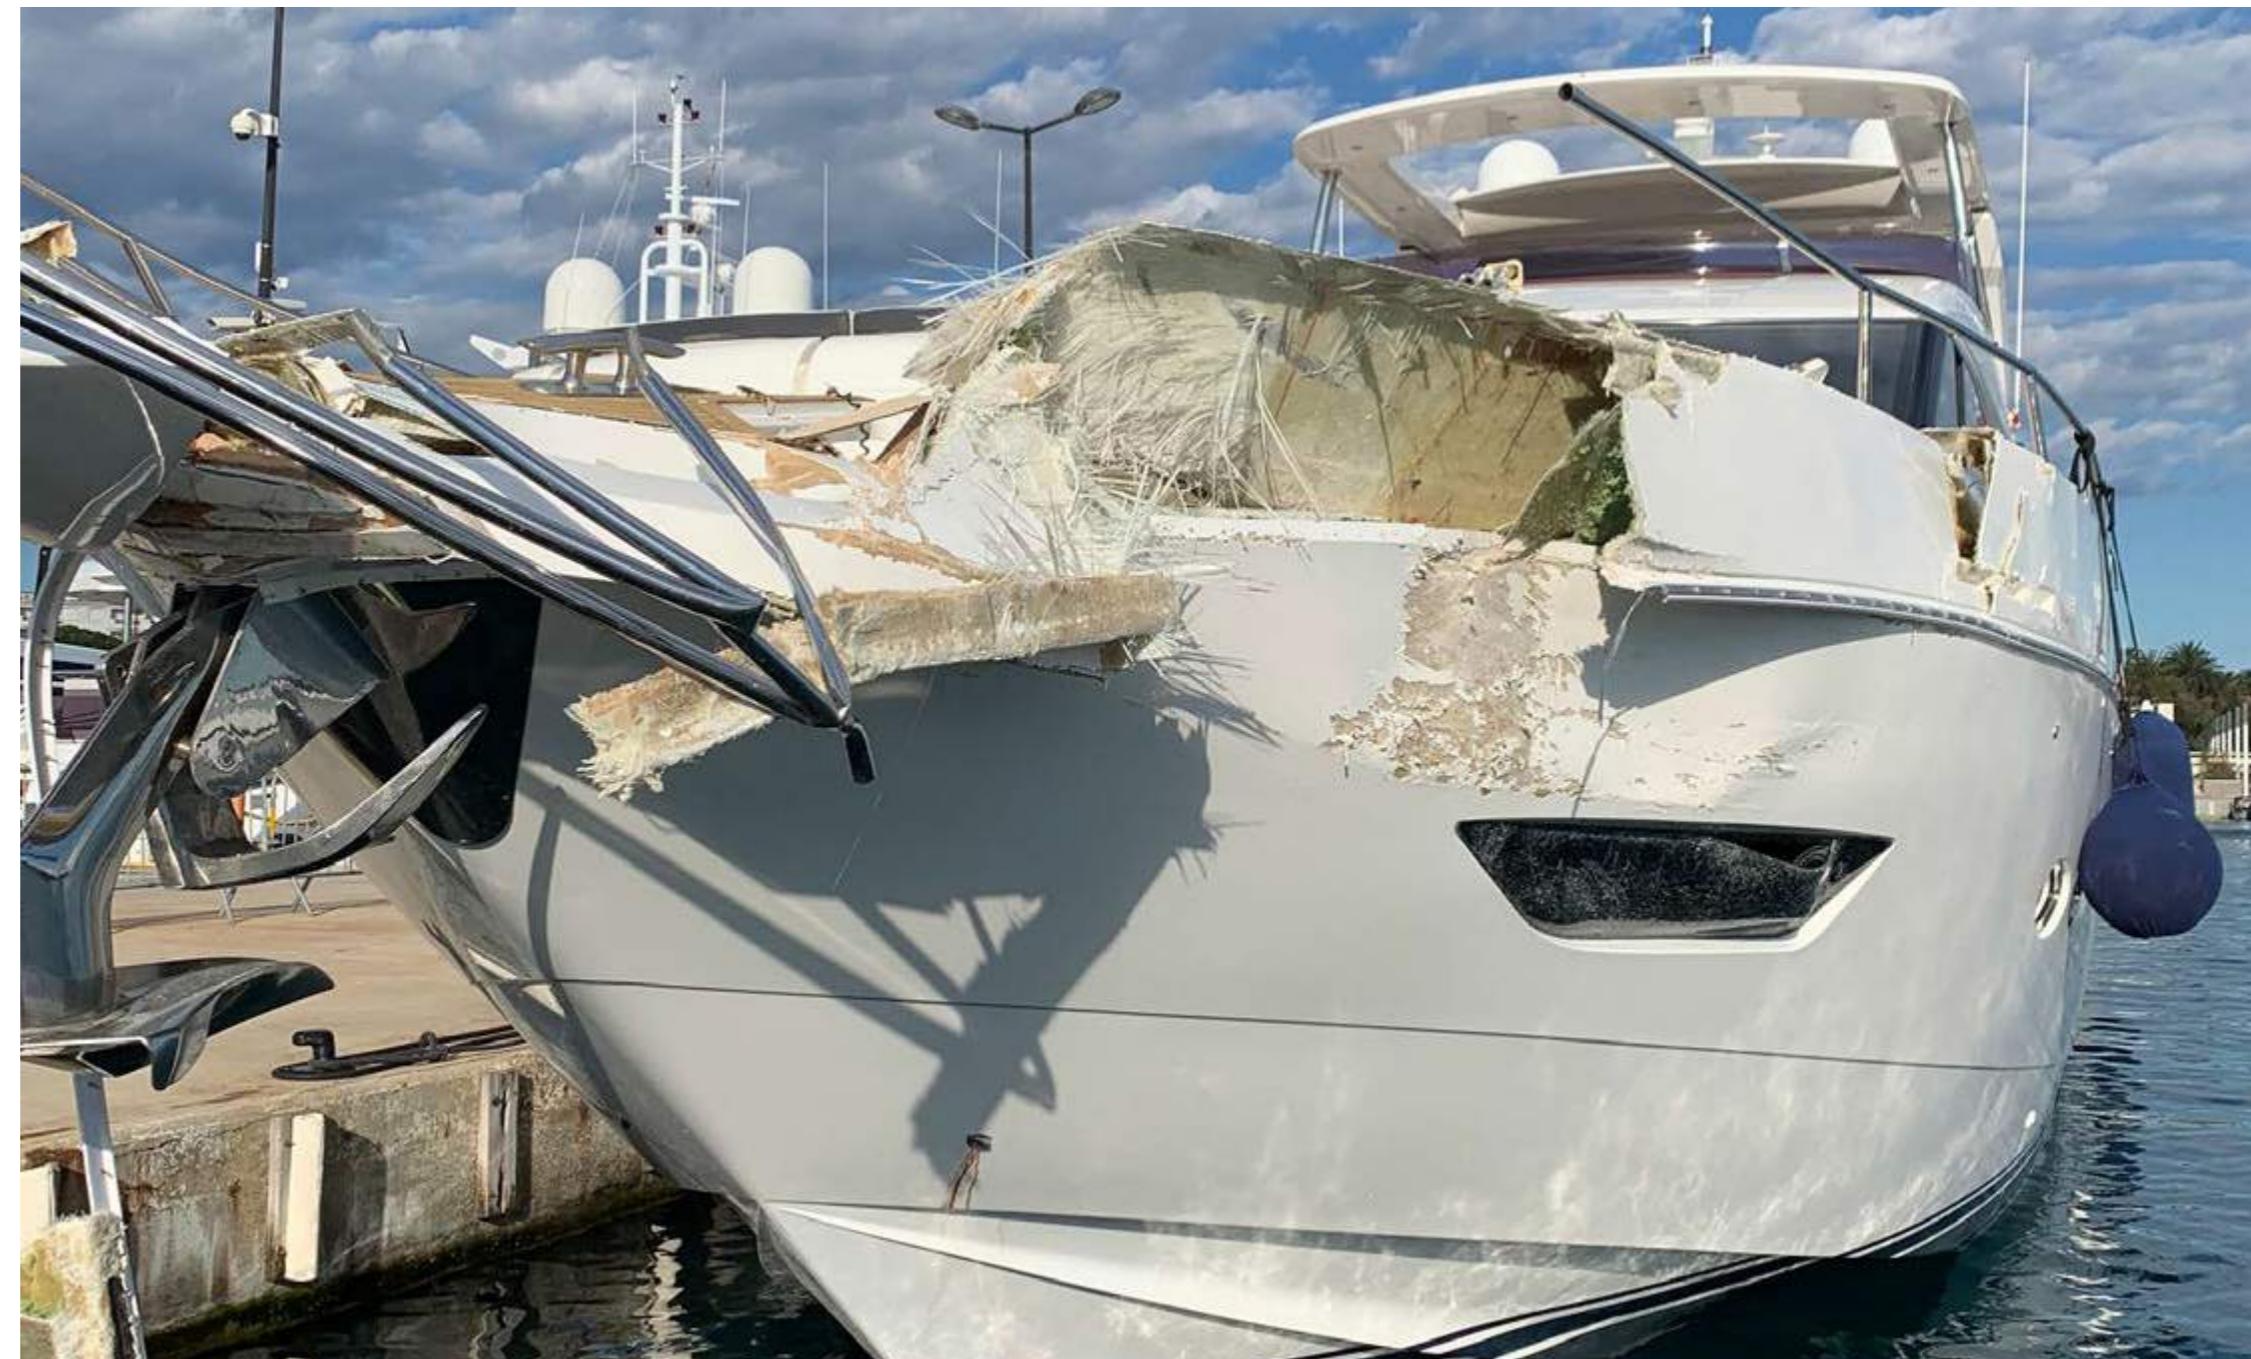
During the close pass manoeuvre yacht A's skipper lost control and collided with yacht B's bow (see figure), fatally injuring the crewman who was on the foredeck.

Figure: The damage to yacht B's bow

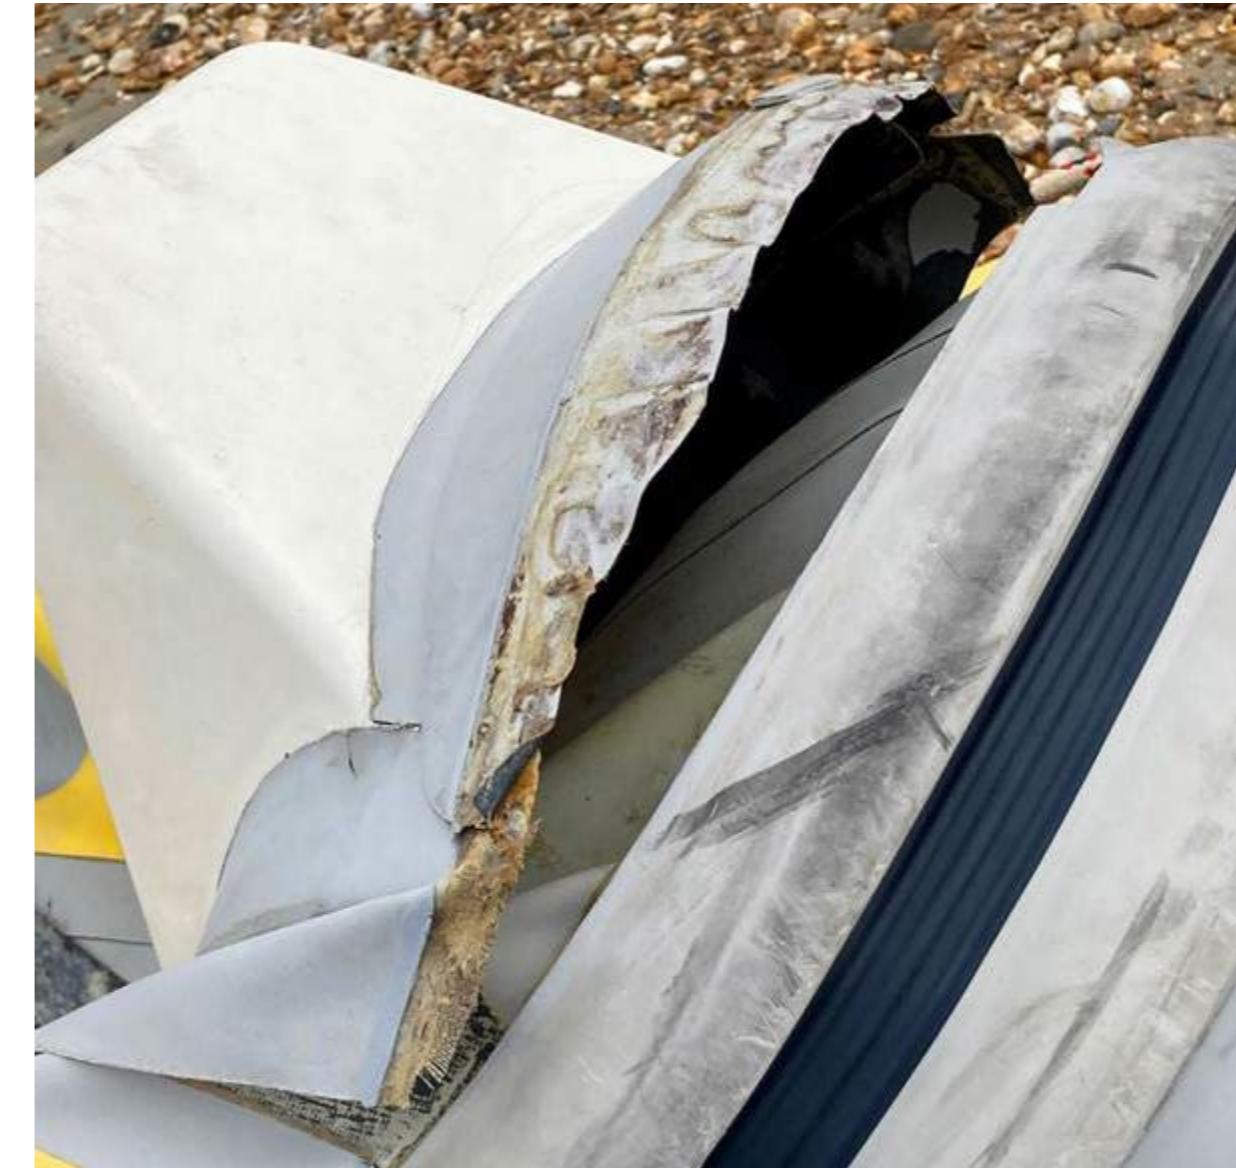
Figure: Detachment of fibreglass step from the buoyancy tube
