**INVESTIGATION INTO THE CAUSES OF AN ALLISION BETWEEN THE WINDFARM SUPPORT VESSEL
NJORD FORSETI AND A WINDFARM TOWER IN THE SOUTHERN NORTH SEA ON 23RD APRIL 2020.**

FINAL REPORT

Derrick A Thorrington

Jersey Maritime Administration

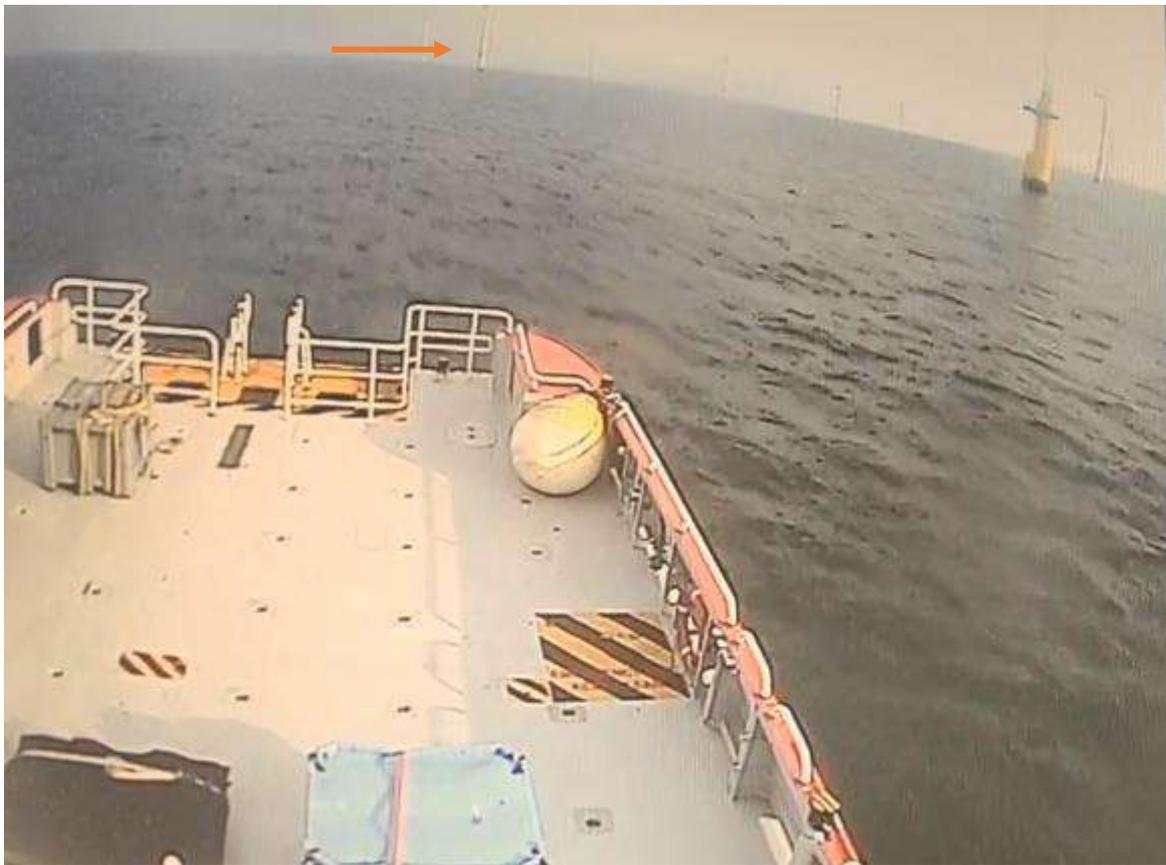
Vessel CCTV coverage showing Njord Forseti passing a turbine tower close to starboard shortly before impact with Tower Q05 (marked by the arrow).

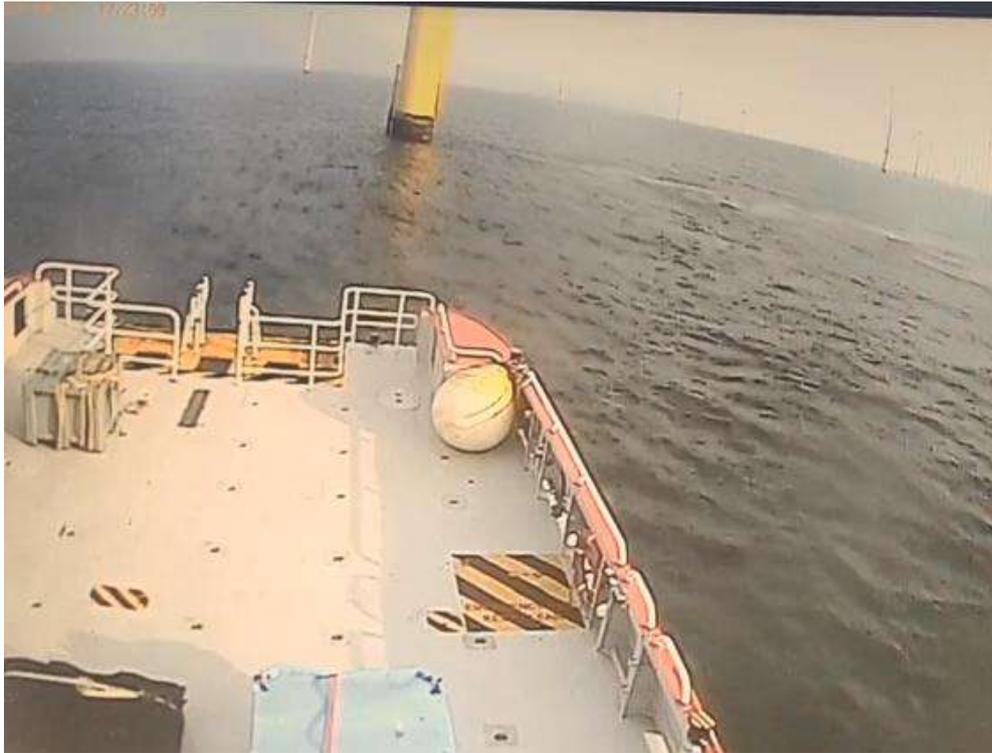
8.6 As has been acknowledged in the Njord commissioned incident report, CCTV footage of the turbine tower in the seconds before impact shows a slick orientated approximately in a WSW direction which suggests current flow in this general direction. It is therefore possible that when transiting between windfarms Borkum Riffgrund 1 and 2, insufficient allowance was made for this tidal set.

Vessel CCTV coverage showing Njord Forseti approaching turbine tower Q05 shortly before impact. A slick most probably caused by tidal flow can be seen running from the turbine tower across the direction of travel of the vessel.

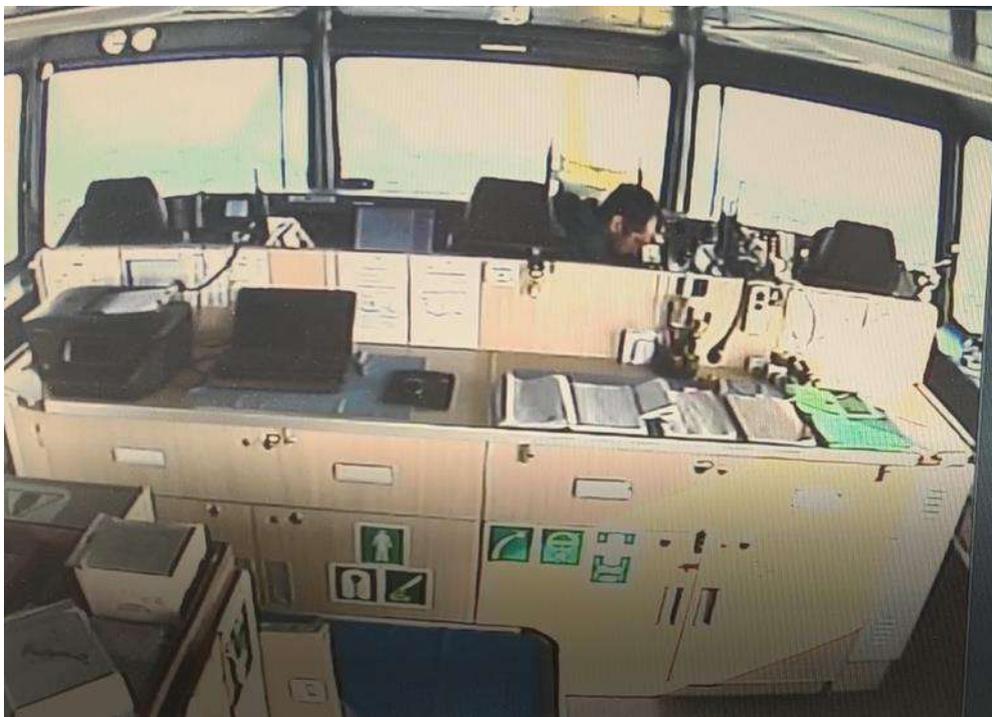
3.2 The primary reason why a proper lookout was not being kept was because the Master, who had the conduct of the vessel was distracted from this primary role.

3.3 It is possible that the Master was distracted from his primary role as he may have been adjusting of settings on the VHF radio which is mounted immediately to starboard of his seat. However, this has not been positively determined and distractions caused by other means cannot be ruled out.

8.4 For the period of coverage sighted by the undersigned up to the point of impact (approx. 1 minute) the Master was seen to be leaning over the starboard side of his seat, with his attention being almost entirely taken by something in this area. It is not entirely clear for how long he had adopted this position. The company reports that CCTV coverage suggests that this posture was adopted for at least 2 minutes. Although he adjusts his position during the footage, it cannot be determined objectively what task the master was engaged in. In the seconds immediately before the impact the master's attention is drawn to the wheelhouse front and at the point of impact, the CCTV

Vessel CCTV coverage showing the Master in the wheelhouse distracted by something to starboard of his seat in the seconds before impact. The turbine tower can be seen through the centre wheelhouse window.

4.2 The company should identify tasks, equipment and functions that may give rise to possible distractions for the person having the conduct of the vessel whilst underway. The company should implement measures to ensure that the safe conduct of the vessel is not impaired by these or other factors.

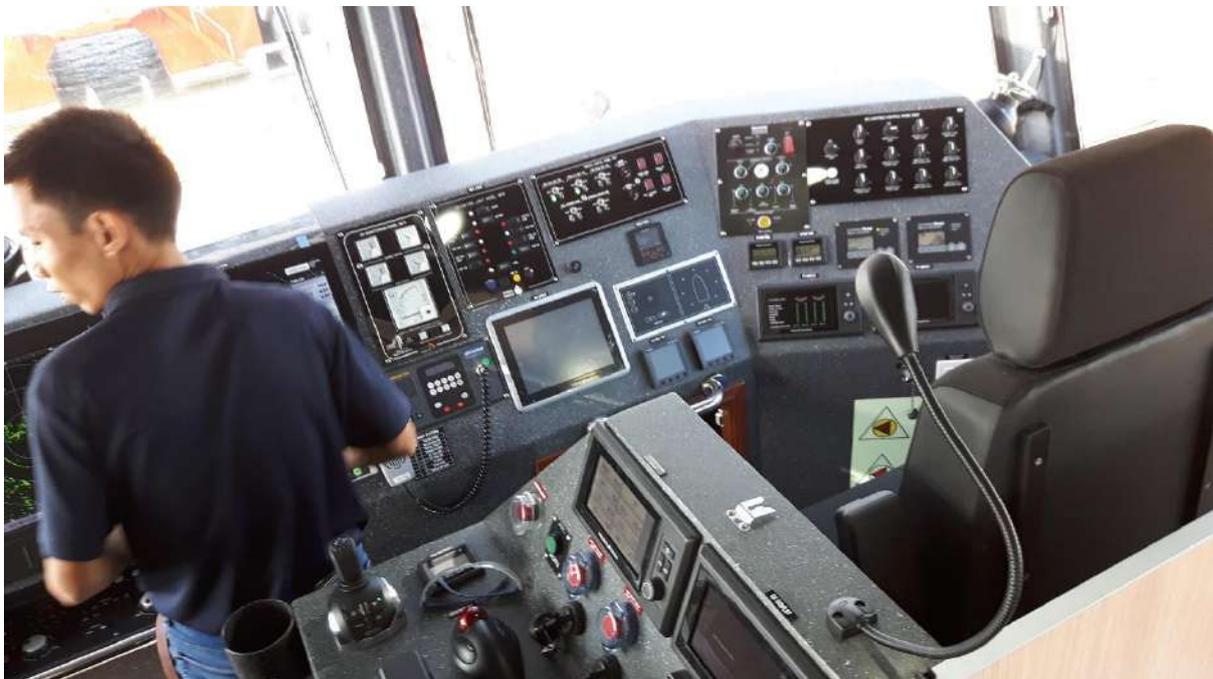
9.1 To the starboard side of the master's seat is a console to which engine and vessel controls are fitted. Engine panels are fitted at the high level on the vertical panel, and on the horizontal surface is fitted with a VHF radio. It is possible that the Master was distracted by this piece of equipment, although the CCTV coverage suggests that the Master was not using it for communication.

9.2 In the Njord commissioned incident report, the engineer reported that following the impact when he tried to use the VHF to summon assistance, the unit was not on its usual setting but was displaying a different screen. This supports the possibility that the Master may have been making adjustments to the settings of the set immediately prior to the incident.

Photograph of bridge front. The engineer's seat is to starboard, the Master's seat out of shot at the left-hand corner, the Masters console centre bottom with the VHF radio just out of shot.

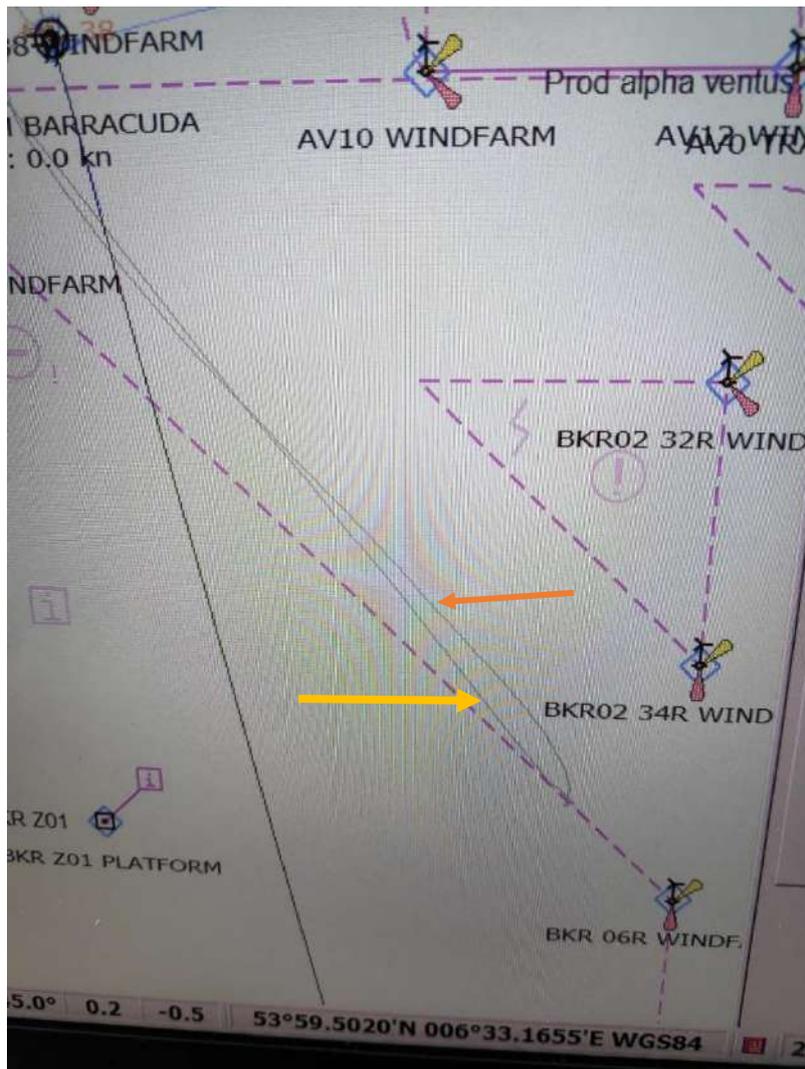
3.4 At the time of the incident the vessel was not following the established passage plan from the Merkur Offshore Windfarm to Emshaven but was undertaking an alternative route between Borkum Riffgrund 1 and Borkum Riffgrund 2 windfarms. Whilst this route was safe, ineffective monitoring of the vessels track, position and proximity to navigational hazards contributed to the incident.

10.4 The methods for monitoring the vessels position, course and track by visual means and using the vessels navigation aids prior to the incident have not been provided to the undersigned and therefore have not been positively determined. The extent to which the direction and strength of tidal current through the windfarm was known to the Master has also not been able to be determined.

Screen shot of the electronic chart system. The yellow arrow indicates Njord Forseti's outward track between Borkum Riffgrund 1 and 2 windfarms. The orange arrow indicates the return track to the Siem Barracuda following the collision. The consistent nature of the track suggests that tidal offset might not have been taken into account for the transit between windfarms, and that the effect of this offset has not been identified during the transit.

4.3 The company should review the methods by which masters monitor the safe progress of a vessels passage and make changes as necessary to its procedures. Where necessary additional training should be provided to masters and other relevant personnel in the associated techniques applicable to these vessels.
