MARINE TRANSPORTATION SAFETY INVESTIGATION REPORT M20P0353

ACCIDENTAL RELEASE OF FREE-FALL LIFEBOAT

Bulk carrier *Blue Bosporus*
English Bay, British Columbia
01 December 2020

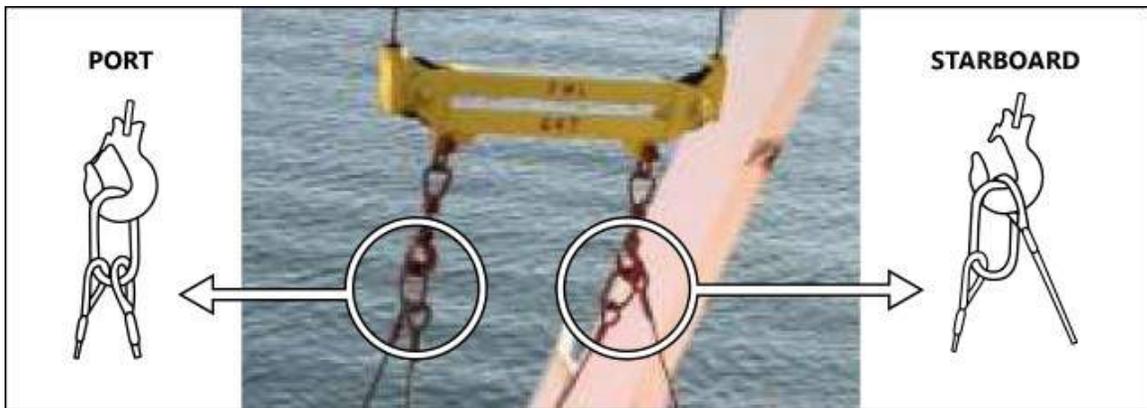
The third officer used hand signals to communicate with the bosun to lower the davit so that the lifeboat's slings could be connected to the hooks on the spreader bar. Once the hooks were within reach, the launching crew took the oval rings and attached them to the hooks on the spreader bar. On the port side, the crew placed the oval ring into the hook. On the starboard side, they placed the oval ring and the eye of the aft starboard sling into the hook, shortening the sling length (Figure 4).⁶

Figure 4. Photo and diagram showing how the slings were attached to the hooks during the occurrence drill (Source: Apollonia Lines S.A., with TSB annotations)

However, in this occurrence, the launching crew members unknowingly deviated from the instructions outlined in the manufacturer's manual when they placed both the oval ring and the eye of the aft starboard sling into the starboard hook. This caused the active length of the aft starboard sling to be shorter than the other slings. As a result, when the lifeboat was released, the shock load concentrated entirely on the aft starboard sling.¹⁹ This sling was held together by a weakened crimp sleeve which, in combination with the concentrated force, caused the sling to fail.

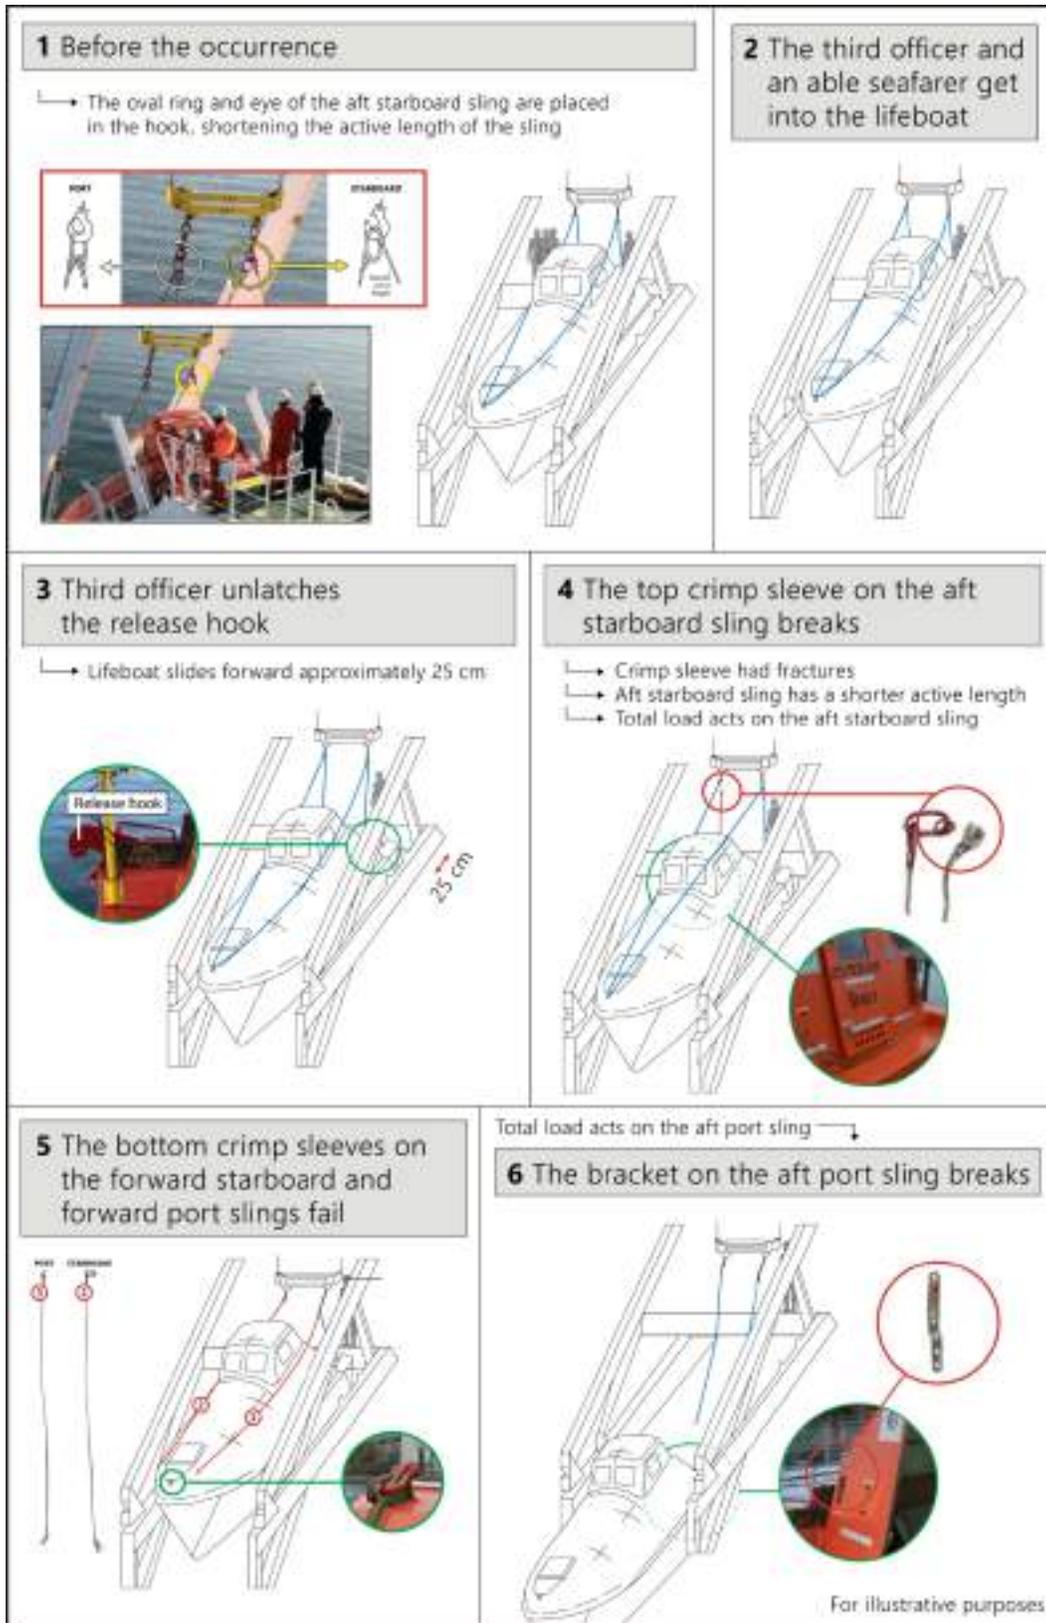
Once the hydraulic pressure was sufficient, the release hook unlatched, and the lifeboat slid forward approximately 25 cm. At this point, the aft starboard sling failed, followed by the 2 forward slings. The bracket holding the aft port sling onto the lifeboat broke off as well. The lifeboat fell about 14 m into the water.

Figure 6. Sequence of events (Source: TSB)

Once the aft starboard sling failed, the shock load shifted to the other slings, causing the crimp sleeves on the 2 forward slings to also fail. The load then shifted to the remaining aft port sling and its sleeve which, although cracked, remained intact. However, the bolts and the aft port bracket could not withstand the load and were pulled off the lifeboat by the force on the aft port sling.

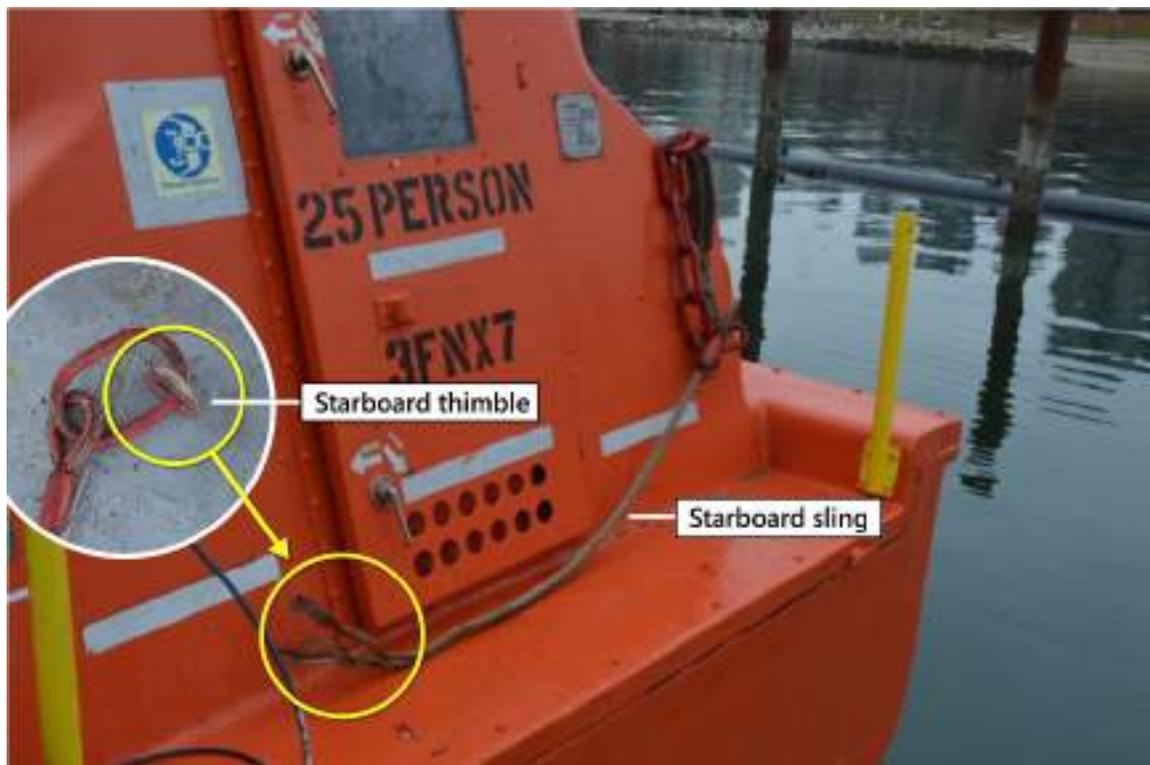
The crimp sleeve on the upper end of the aft starboard sling broke off, and the wire rope detached from the thimble (Figure 7). A portion of the broken crimp sleeve was retrieved. It was cracked in half.

Figure 7. Aft starboard sling detached from thimble (Source: TSB)

- replaced the failed sling assembly, including the failed lifting brackets, with a newly manufactured, load tested, and certified sling assembly and brackets;
- included the lifeboat sling assembly in the *Blue Bosphorus's* wires and ropes inspection log;
- sent safety management system circular 05/2020 to all vessels operating under Apollonia lines S.A. the day after the accident. This circular requested that an extra safety meeting be carried out with all crew participating in order to update them on the occurrence and avoid a recurrence.

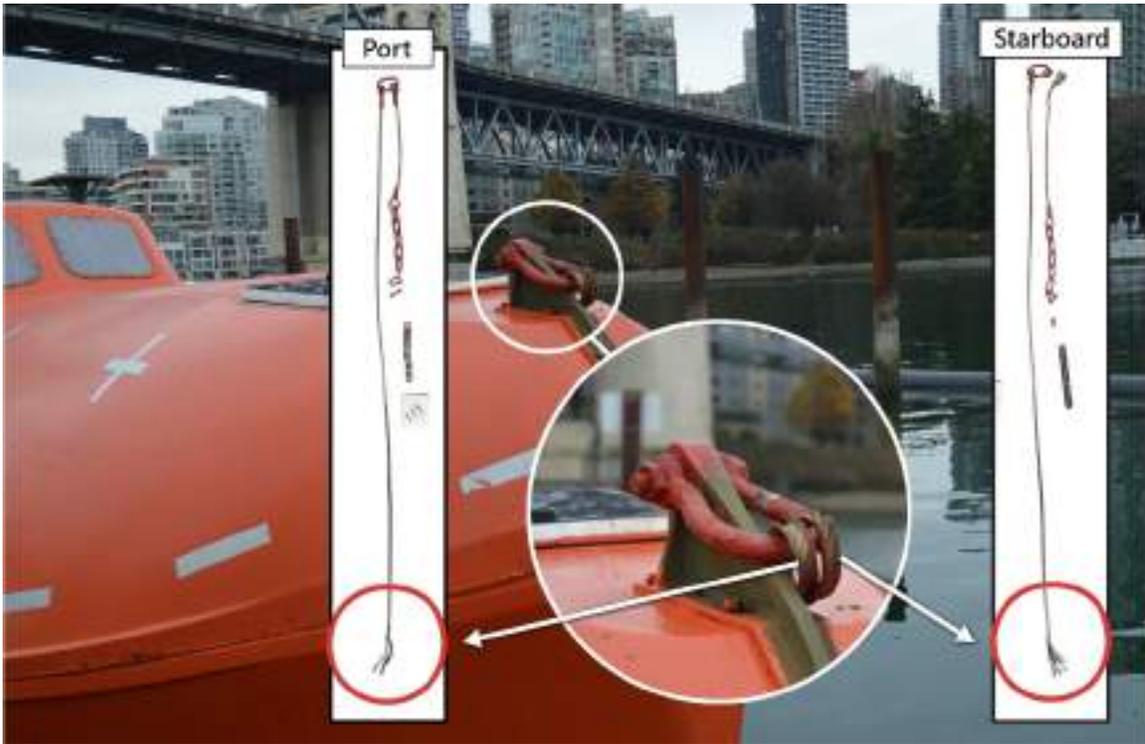
Both of the crimp sleeves that attached the 2 forward slings to the lifeboat broke off and the wire ropes detached from their thimbles (Figure 8). These crimp sleeves were lost in the water.

Figure 8. Forward port and starboard slings detached from their thimbles on the forward shackle of the lifeboat, with inset images showing the frayed ends of the slings (Source: TSB)

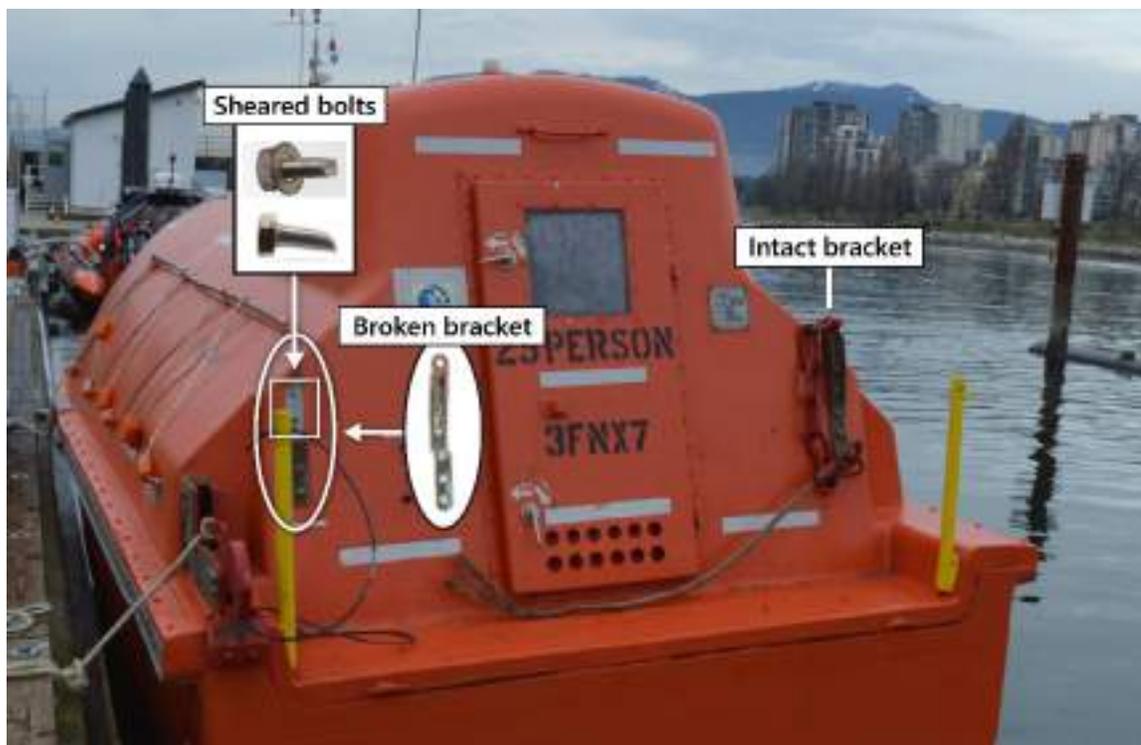
The aft port sling remained intact, but the bracket that attached the sling to the lifeboat broke off (Figure 9). The bolts that were securing the bracket to the lifeboat were retrieved and were found to have sheared off (Figure 9).

Figure 9. Broken bracket and sheared bolts on port side (Source: TSB)

The brackets used to attach the aft slings to the lifeboat were made of aluminum bronze. Aluminum bronzes have a strength similar to low alloy steels, and they are typically resistant to corrosion. Post-occurrence examination of the bracket indicated that it had bent significantly and had fractured at the middle bolt hole.

The bolts were made of austenitic stainless steel similar to the AISI 300 series. Post-occurrence examination of the bolts by scanning electron microscope showed signs that the bolts sheared off as a result of overstress applied when the bracket bent and broke.

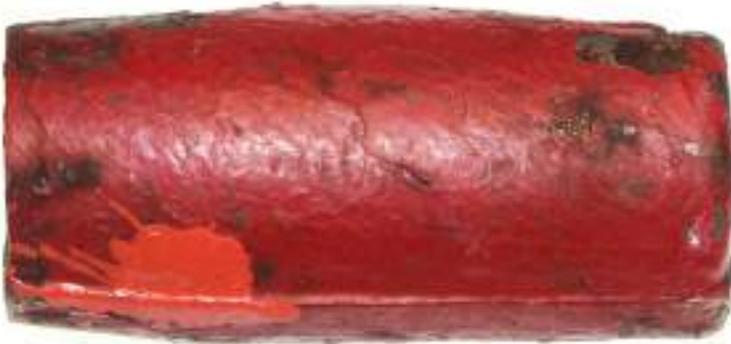
The crimp sleeves on the slings were also made of an austenitic stainless steel similar to AISI 304 grade steel. They were about 9 cm in length and were painted. After the occurrence, some of the crimp sleeves remained on the slings. The TSB recovered these crimp sleeves, as well as a broken portion of the aft starboard crimp sleeve (Figure 10).

Figure 10. Broken portion of aft starboard crimp sleeve from upper end of sling (Source: TSB)

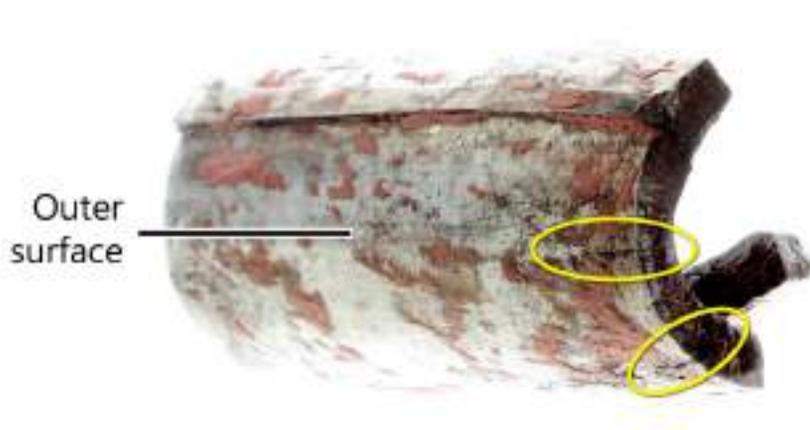
The TSB laboratory removed most of the paint⁸ from these crimp sleeves using commercial paint-stripping paste. A close visual examination of the crimp sleeves identified that the sleeves on the aft port sling had small cracks, the largest of which was approximately 1 cm in length. The cracks extended inward from the outer edges of the crimp sleeves. Similar cracks were visible on the broken portion of the aft starboard crimp sleeve. Figure 11 shows some of the cracks on one end of the aft starboard crimp sleeve.

Figure 11. Outer surface of the broken aft starboard crimp sleeve with paint removed showing cracks (circled) (Source: TSB)

The results of the laboratory examination indicated that the failure of the crimp sleeves was due to intergranular stress-corrosion cracking. Stress-corrosion cracking is a type of cracking induced by a combination of stress and a corrosive environment. The cracks can result from stress that is either directly applied or residual. In the case of mechanical splices such as crimp sleeves, residual stress may result from the original pressure applied on the crimp sleeve to crimp it to the wire. Crimp sleeves may also come under directly applied stress if they are load-bearing. Stress-corrosion cracking is a progressive failure process that develops over time, but it may eventually cause the sudden and catastrophic failure of a component. Intergranular stress-corrosion cracking is a variant of this process that occurs when the cracks follow grain boundaries in the material. It is typical for austenitic stainless steel.

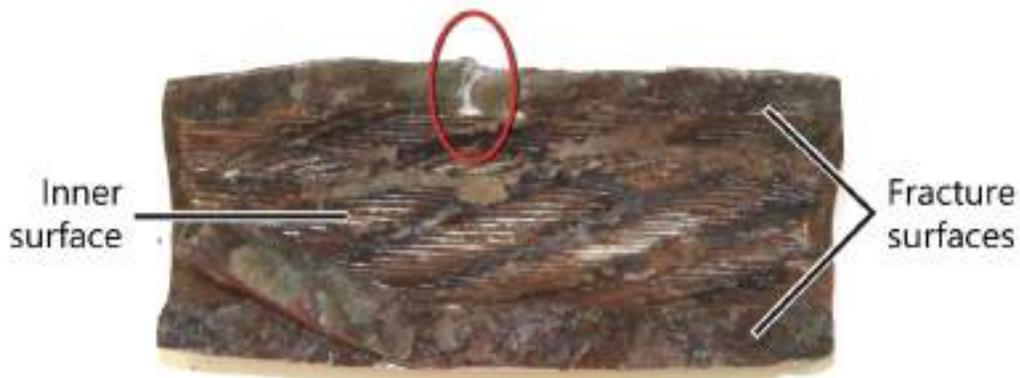
The TSB laboratory also examined the inner surface of the aft starboard crimp sleeve and the fracture surfaces created when it broke. Over 90% of the fracture surface on the upper side of the sleeve had an aged, corroded appearance. There was a small region of fresh fracture (circled on Figure 12) where a ledge about 3 mm high was visible. The ledge had formed when 2 cracks propagated on different levels. The fracture surface on the lower side of the crimp sleeve (Figure 12) also had an aged, corroded appearance.

Figure 12. Inner surface and fracture surfaces of the broken aft starboard crimp sleeve, as well as a small region of fresh fracture (circled) (Source: TSB)

The fracture surfaces were examined using a scanning electron microscope. The majority of the surfaces were covered by a thick corrosion scale with a dried mud appearance. Analysis of this scale showed that it consisted primarily of chromium oxide, with traces of sodium, chlorine, calcium, and sulphur. These elements are consistent with corrosion resulting from contact with sea water or humid sea air. Some corrosion was also observed on the inner surface of the crimp sleeve.

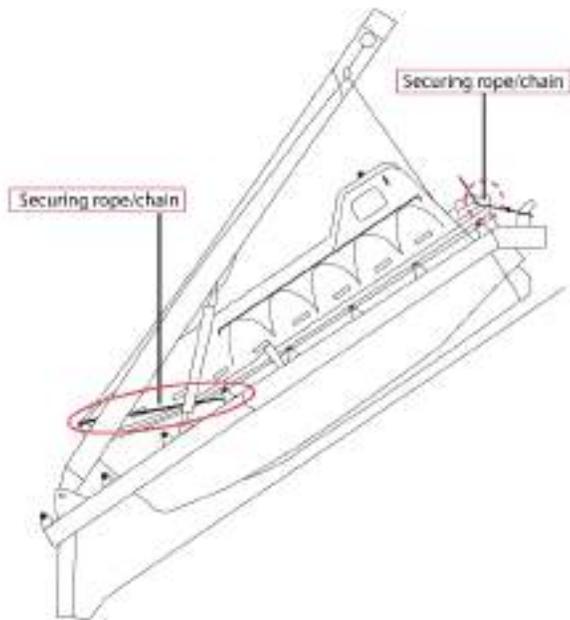
The lifeboat manufacturer's manual specifies that during a release test without launching (i.e. a simulated launching), the lifeboat should be additionally secured with applicable ropes or chains. The securing points for these ropes or chains are different from the points used for the slings. The manual recommends that the ropes or chains be secured from the forward hoisting shackle downwards and aft to the launching way on either side of the lifeboat and/or through cut-outs in the aft release arrangement to shipside retaining devices (Figure 13). This provides additional restraining devices with secondary securing points in the event that the slings fail.

Figure 13. Additional restraining devices (Source: Shigi Shipbuilding Co., Ltd., with TSB annotations)

There was no additional restraining device in use to protect the crew on the *Blue Bosporus* from falling when the slings failed.

An additional restraining device ensures redundancy and thereby safeguards against single-point failure. In a case such as this, where the slings unexpectedly failed, an additional restraining device can provide an extra defence to protect crew members.
