Annual Digest

Reports and Insight Articles

2021

Annual Digest of Reports and Insight Articles 2021

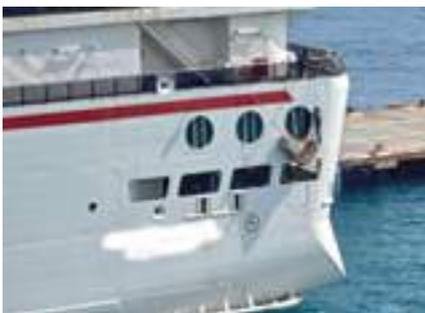
A cruise ship was moored on the pier opposite my ship. I noticed a stage which was rigged on the port shoulder being relocated laterally whilst a crew member was standing on it. Although the person on the stage was wearing some PPE, (safety harness, safety shoes, gloves, and an inflatable lifejacket), I consider it quite an unsafe act. The crew member working on the stage should have vacated it to a safe position on deck before attempting to reposition the stage. (See photos below).

Figure 1 of 3 – Unsafe repositioning of a stage

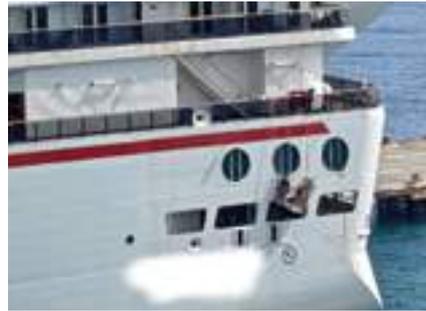
Figure 2 of 3 – Unsafe repositioning of a stage

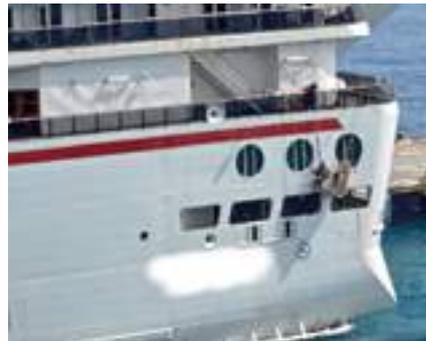
Figure 3 of 3 – Unsafe repositioning of a stage.

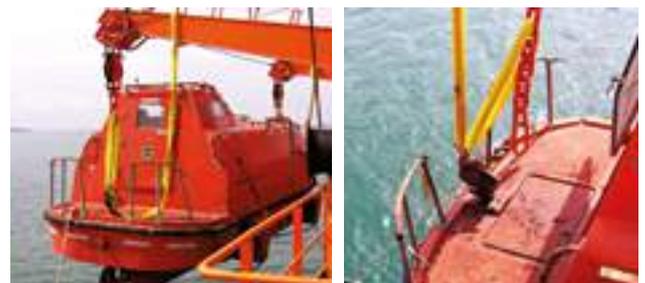
Undertaking maintenance on the lifeboat hooks - the hanging-off strop is rigged along with the fall prevention device (FPD). Once the weight of the boat is taken by the

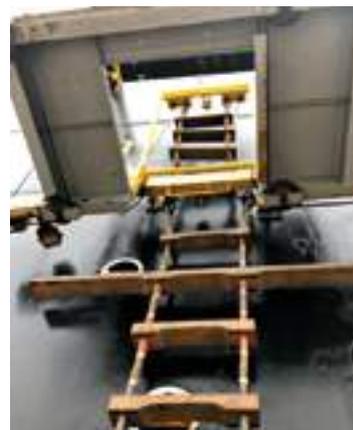
Figure 5.
PBA as presented:
Pilot ladder presented in two sections. Both sections are secured solely to the accommodation ladder platform instead of to the ship.

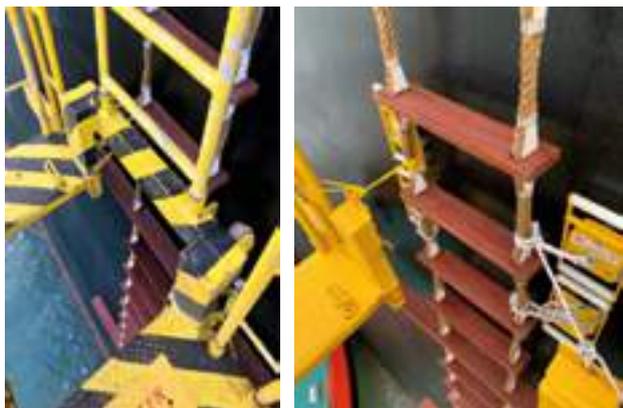
The vessel arrived at pilot station at night, pilot refused to board on arrival as ladder appeared to be non-compliant. (Figure 6).

Figure 6 (left) original arrangement as presented. Figure 7 (right) after modifications

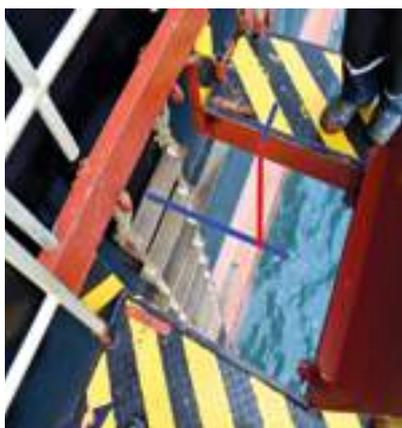
A trap door arrangement with the pilot ladder secured to the underside of the platform, so the ladder did not pass up through the hatch. Dialogue took place but no adjustments had been made, on arrival at port limits the vessel was refused pilotage until boarding arrangements were compliant and safe. After 3 days at anchor the arrangements had been adapted to a combination arrangement with the pilot ladder secured to strong points on the main deck.

Figure 8 (left) What was presented originally (rejected)

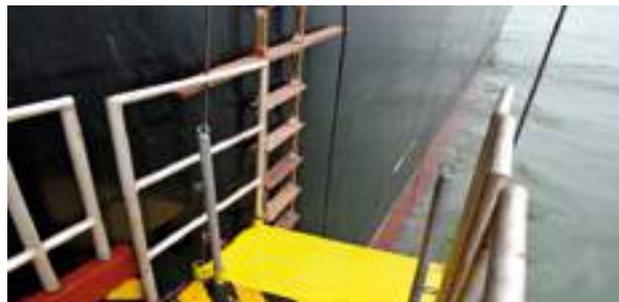
Figure 9 (below) This was the final arrangement (minus the securing magnets which were in place when used by a pilot)

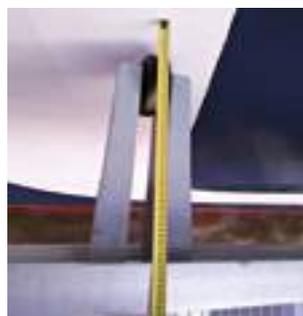
Combination ladder, the gap between the pilot ladder and the lower platform was greater than 20cm (when measured it was 50cm). Dialogue took place with the vessel who originally stated this could not be modified. Sorry captain, but there will be no pilot boarding your vessel. They found a solution on board and reduced the gap to 20cm. A pilot boarded.

Figure 10 Before modification

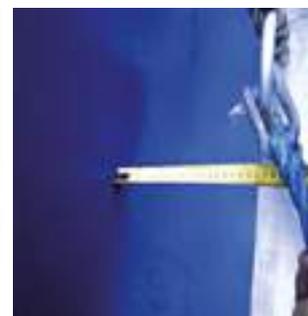
Figure 11. After modification

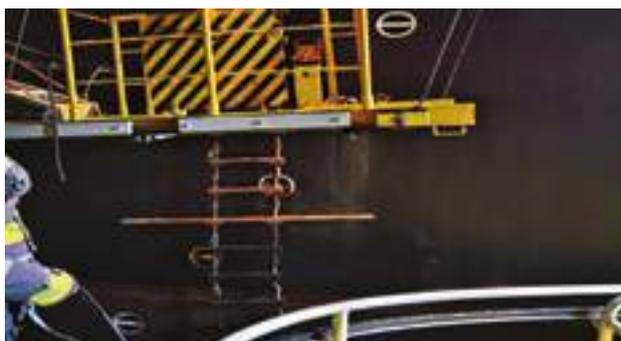
Initial Report (1)

Trapdoor type combination, accommodation ladder platform less than five metres above the sea.

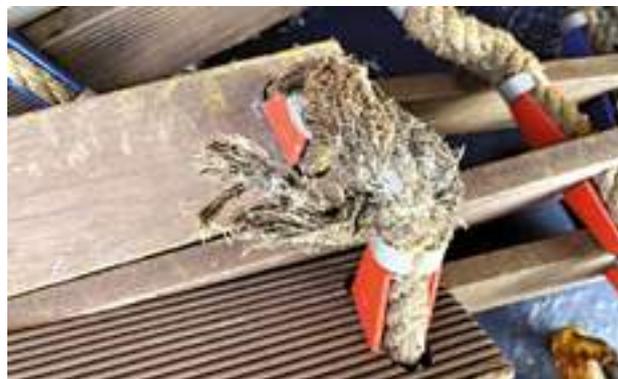
Initial Report (2)

Pilot ladder did not meet SOLAS standards.

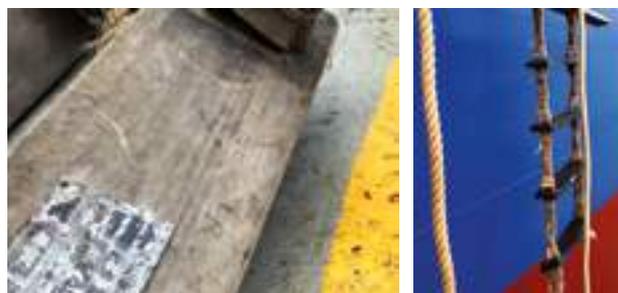
Initial Report (3)

Comments from reporter: When disembarking from this vessel I found that the ladder appeared well-used, and the chocks and steps were loose. I advised the attending officer that the ladder should be replaced or repaired. The vessel was less than three years old, so I assume it was in use from her maiden voyage. The corrosion on the manufacturer's plate made it impossible to check details. (See photo)

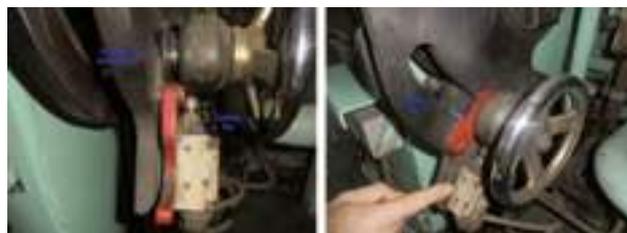
The emergency manoeuvring system located on the side of the engine is fitted with a locking arrangement which under normal conditions rests firmly inside the groove indicated in the photos below.

The investigation revealed that the direct cause of this incident was the disengagement of the emergency manoeuvring system's locking arrangement.
