## ACCIDENT REPORT

VERY SERIOUS MARINE CASUALTY

REPORT NO 9/2022

### Mooring deck accident on board the cargo vessel *Teal Bay* resulting in one fatality at Kavkaz South anchorage, Russia on 30 August 2021

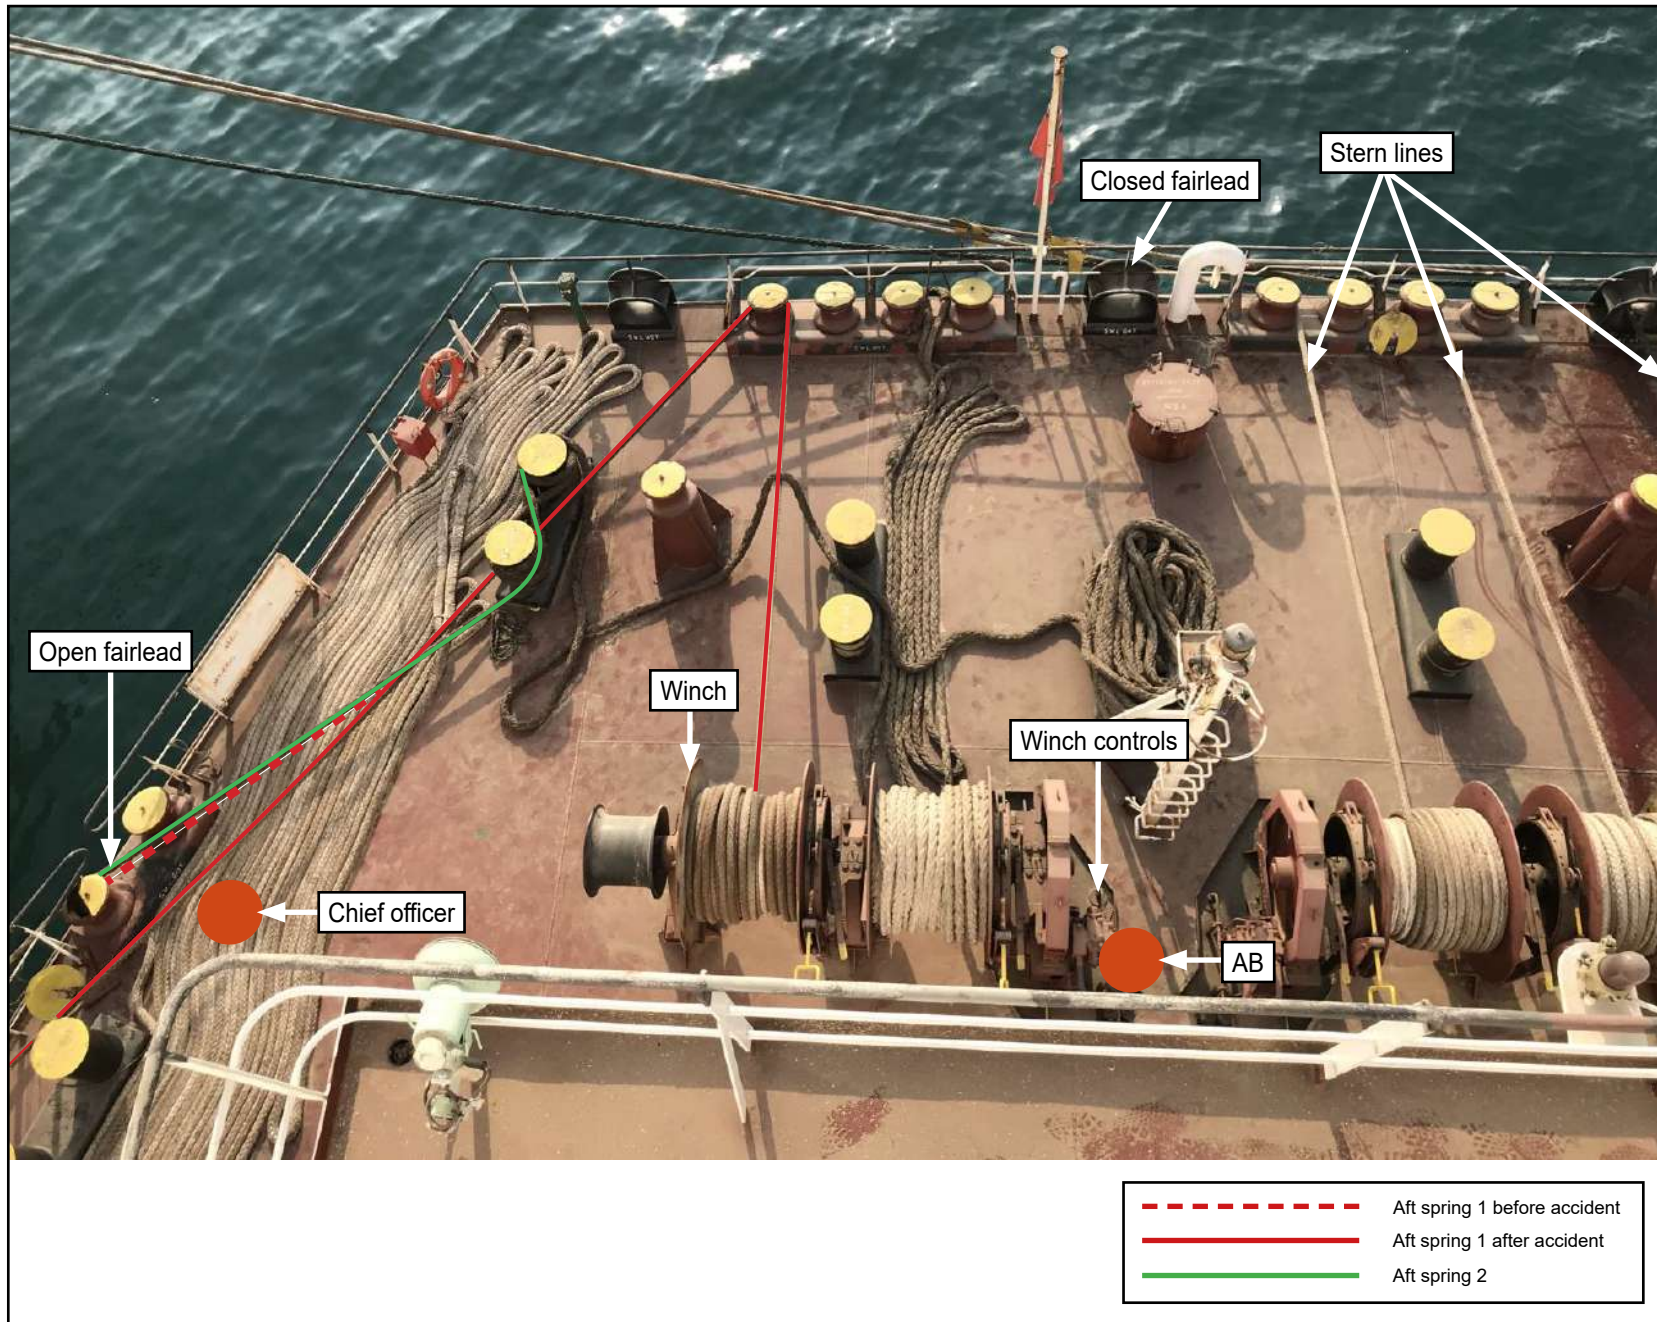
**Figure 1:** *Teal Bay's* aft mooring arrangement (dotted line indicates position of aft spring 1 before the accident)

The aft spring lines were rigged from the starboard side of the aft mooring deck. One (aft spring 1) was attached to the starboard mooring winch outer drum and led around an open roller fairlead at the stern, back through a set of double bitts and then forward through an open roller fairlead on the outer edge of the mooring deck. The second aft spring (aft spring 2) was secured above aft spring 1 on the double bitts and led forward through the same open roller fairlead (**Figure 1**). Both springs passed through the same closed fairlead on *Kavkaz V's* main deck.

The decision to lead two lines through the same roller fairlead was unsafe and the presence of a second line restricted the available space and limited the fairlead's containment ability, almost certainly contributing to the aft (upper) spring 1 jumping out under tension.

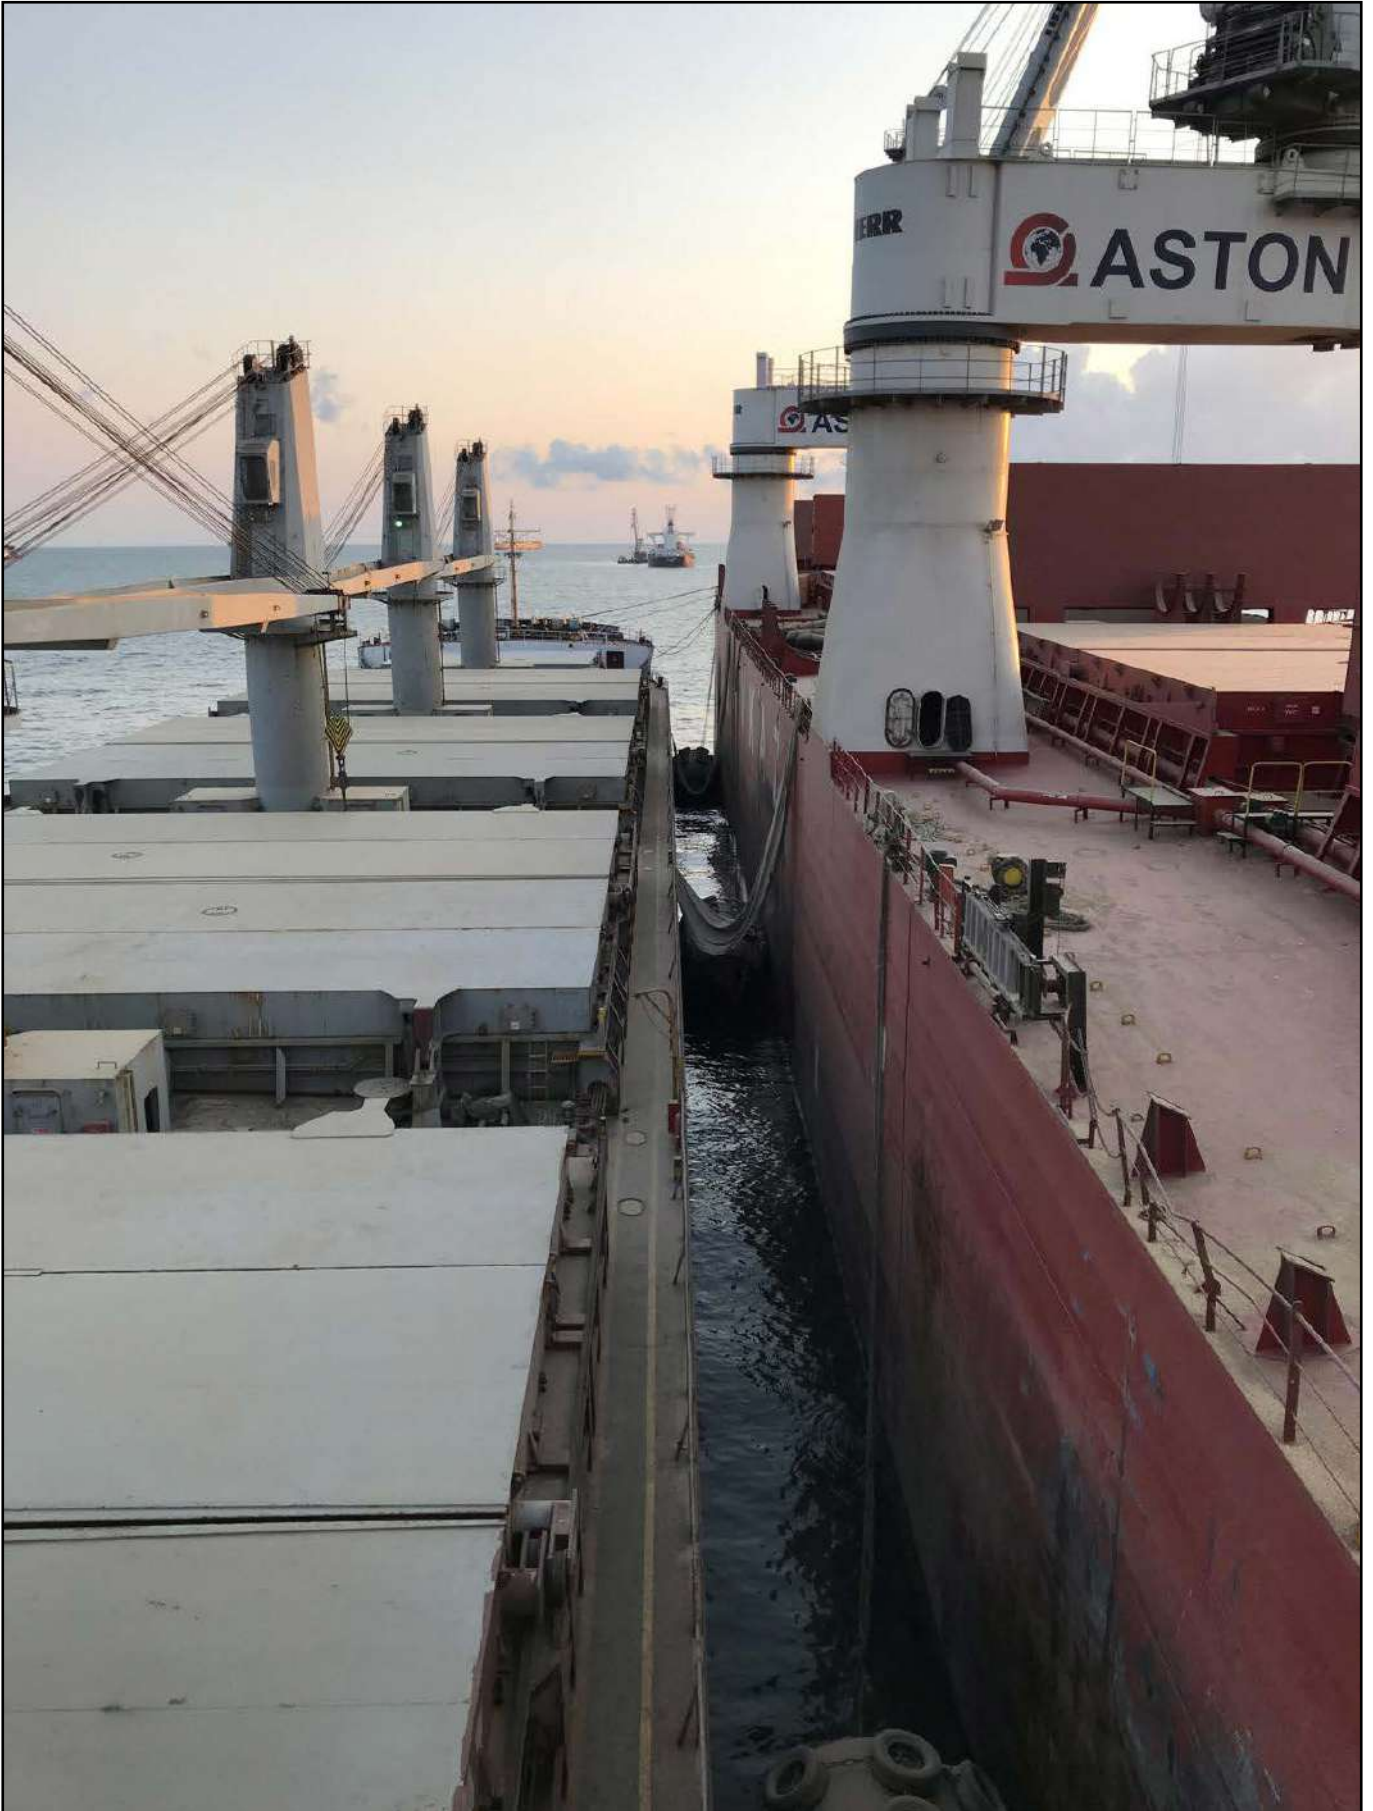
*Teal Bay* was moored starboard side to alongside *Kavkaz V* (**Figure 2**). The three stern lines were rigged from the port side of the aft mooring deck. Two were attached to the port mooring winch drums and led through open roller fairleads at the stern; the third was secured to a set of double bitts and led through a closed fairlead (**Figure 1**). All three stern lines were led through a single closed fairlead on the port side of *Kavkaz V's* aft mooring deck and placed over bitts.

**Figure 2:** *Teal Bay* (left) moored alongside *Kavkaz V* (right)

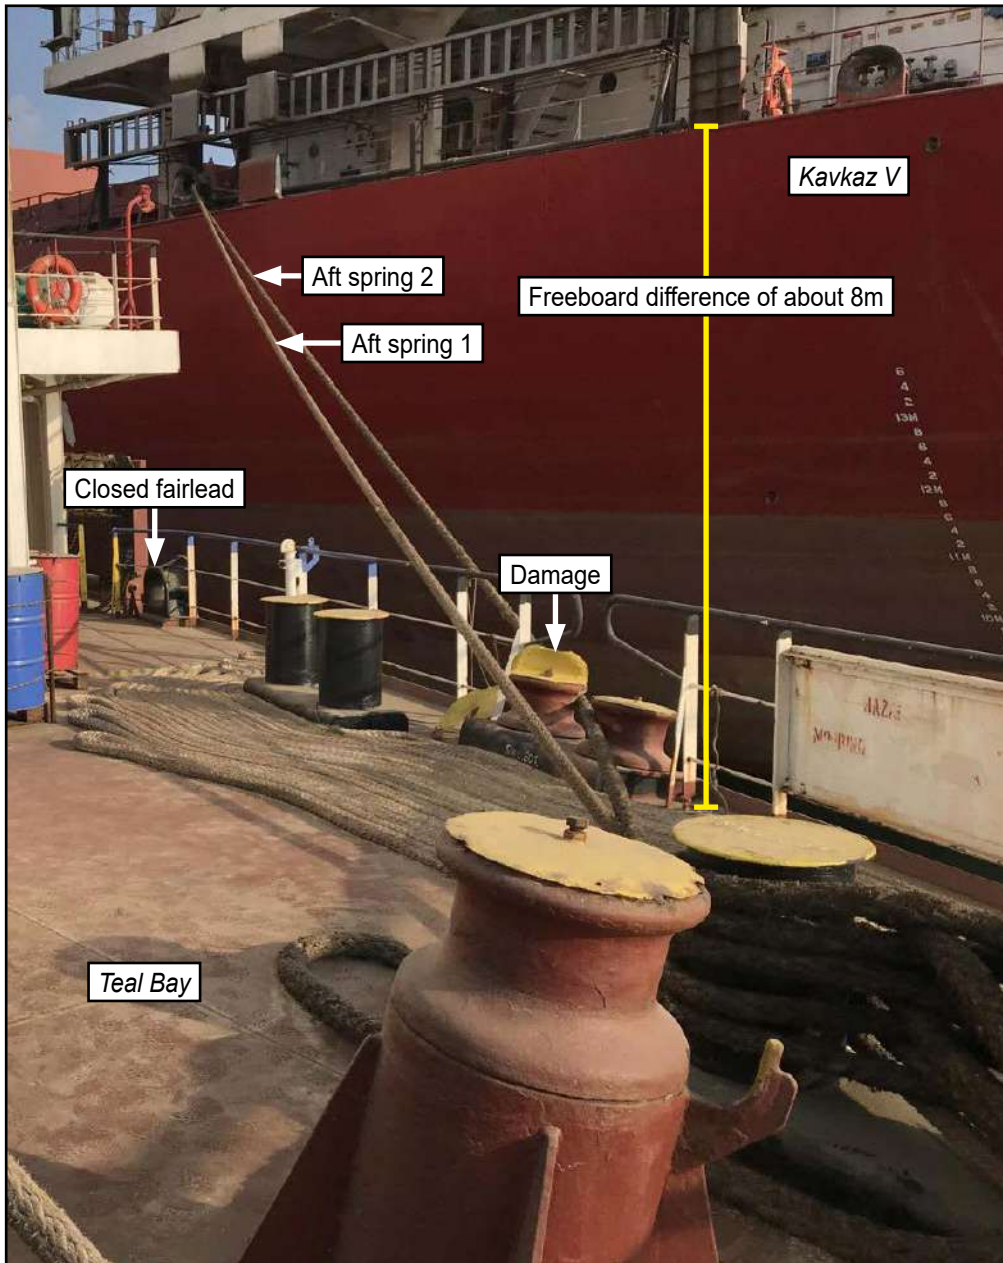
**Figure 4:** *Teal Bay's* aft deck, showing the nearest closed fairlead, freeboard difference, damage and location of aft spring after the accident

Although *Teal Bay's* aft deck mooring equipment included several closed fairleads (**Figure 4**) the springs were led through an open one. This was probably because, constrained by the position of mooring equipment on both vessels, *Teal Bay's* crew judged that the open fairlead provided the most suitable arrangement for the aft spring and had not considered the additional hazards introduced by the loading method. This lack of hazard recognition was further demonstrated by the fact that *Teal Bay's* mooring risk assessment did not include reference to STS loading.

- Conducted additional safety training with *Teal Bay's* crew, including modules on safe mooring operations and STS.
- Issued a work instruction setting out a plan to remove open fairleads from the fleet and replace them with a closed type or universal type of fairlead and directed managers to make allowance for this within the dry dock specification for vessels scheduled to dry dock.
