Issued August 9, 2022

MIR-22/18

## Contact of Bulk Carrier *Ocean Princess* with Oil and Gas Production Platform SP-83A

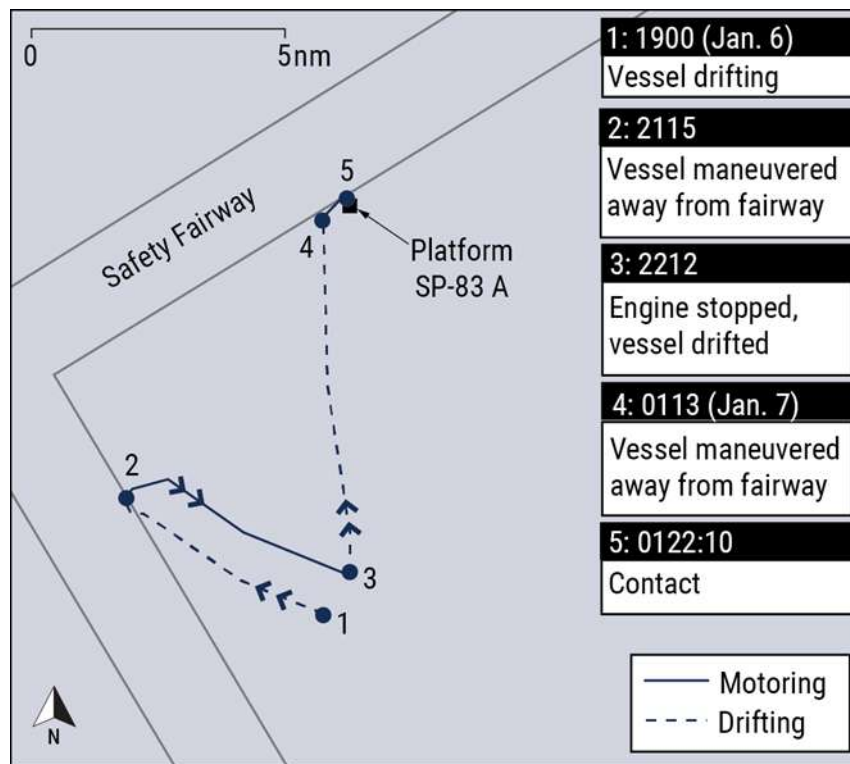
**Figure 3.** Plot of the *Ocean Princess* automatic identification system history shows the vessel's path from 1900 until the time of the casualty.

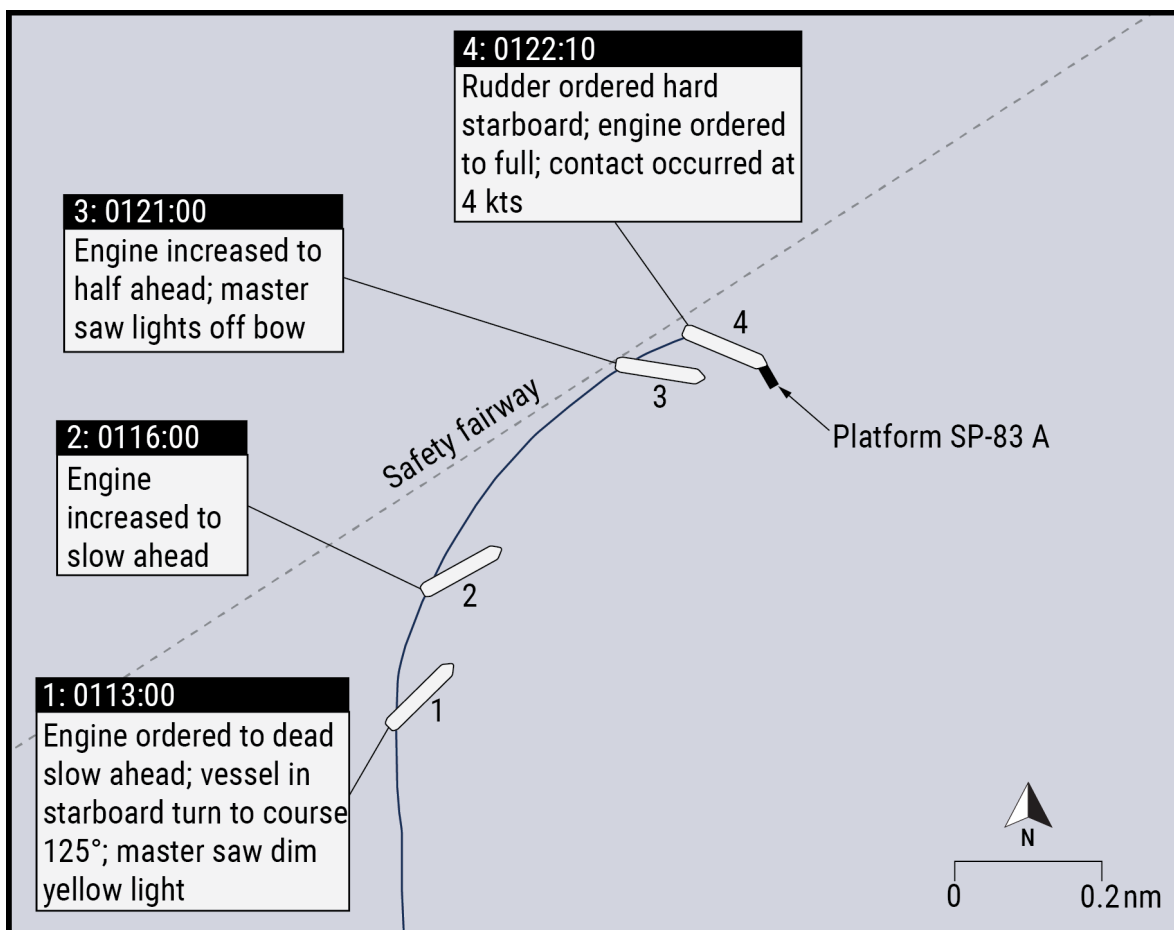
starboard bow struck platform SP-83A at 4 knots speed over ground. The S-VDR captured the master saying, "Had a collision" at 0122:23.

When the vessel struck the platform, the anchor flukes and the anchor windlass were both affected. The starboard anchor became caught in the platform upon contact. Because the starboard anchor was on the brake rather than secured for sea, once it became entangled with the platform, the chain was pulled out as the vessel attempted to maneuver away from the platform.

**Figure 4.** The final events leading up to the *Ocean Princess* contact with platform SP-83A.

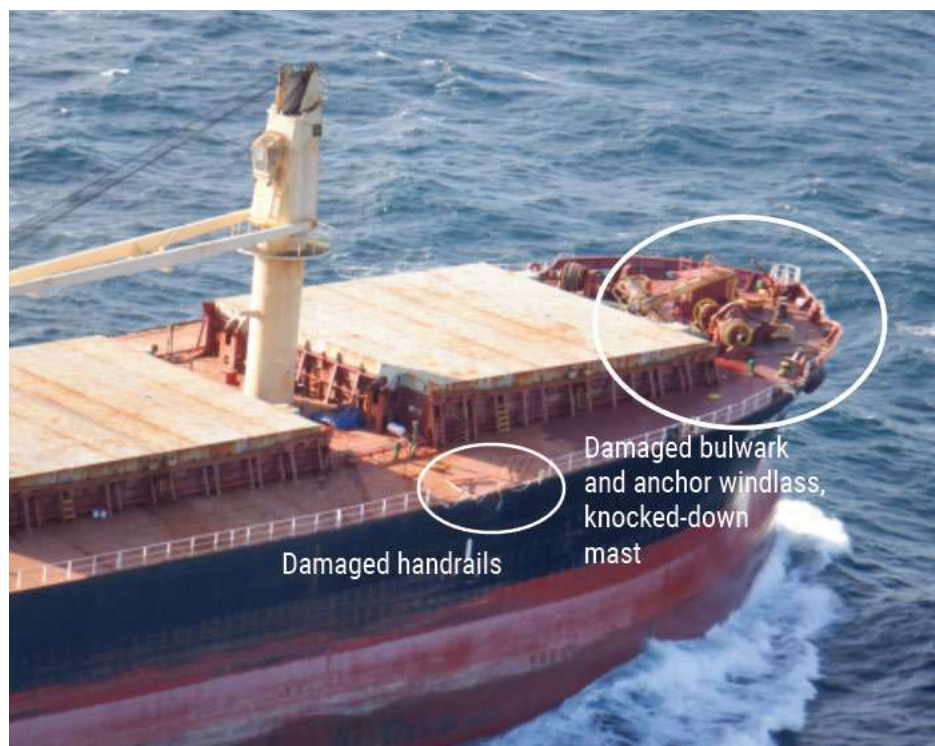
The *Ocean Princess* sustained damage to the starboard bow, including starboard-side handrails, the starboard anchor windlass, and the bulwark. The forward mast was knocked down. There was also damage to portside handrails. Damage to the vessel was estimated to be over \$500,000.

**Figure 5.** The damaged *Ocean Princess* after the casualty. (Background source: Bureau of Safety and Environmental Enforcement)

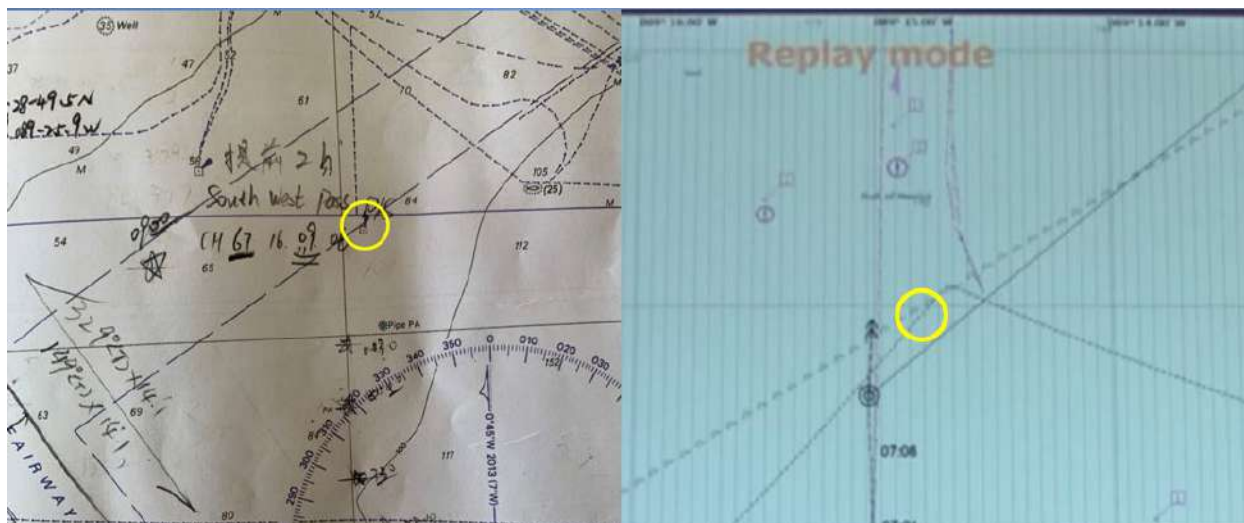
After the casualty, the master and the second officer noted that platform SP-83A was on the paper chart used on the bridge by the mate on watch, but SP-83A did not appear on the ECDIS. The second officer stated that during the time leading up to the casualty he did not notice SP-83A was missing on the ECDIS. The paper chart used on the bridge was British Admiralty chart 3857, *Southern Approaches to the Mississippi River*, 5<sup>th</sup> edition, December 20, 2012. The chart was up to date and corrected with the most recent British Admiralty weekly notice to mariners.

In the casualty location, the ECDIS drew its electronic navigation chart (ENC) information from the National Oceanic and Atmospheric Administration (NOAA) Nautical Information System (NIS) database. When reviewing the vessel's ECDIS correction record for the previous year, investigators found that the automatic updates to the electronic navigation charts were received and loaded weekly to both ECDIS units aboard the *Ocean Princess*. The last update before the casualty was 53/21 (January 1, 2021). Neither of the two applicable NOAA ENC vector charts covering the area where the casualty occurred contained platform SP-83A. Although the *Ocean Princess* ECDIS unit was up to date with chart corrections, the two ENC vector chart updates did not contain platform SP-83A, and therefore SP-83A was not shown on the *Ocean Princess* ECDIS unit.

**Figure 6.** Navigation aids used by the *Ocean Princess* bridge team, with the location of platform SP-83A shown annotated by NTSB with a yellow circle (images are at different scales). A photo of the British Admiralty chart 3857 (left) and ECDIS screenshot from the *Ocean Princess* fed by NOAA ENC's (right), which were up to date at the time of the casualty. The British Admiralty chart shows SP-83A while the ECDIS image does not.

After the casualty, Coast Guard District 8 (CGD08) issued a Broadcast Notice to Mariners via VHF radio from January 26 to February 9, which provided platform SP-83A's position and notified mariners that the platform was not displayed on electronic charts. On February 3, CGD08 issued weekly Local Notice to Mariners 05/21 with the chart correction to add "Platform (Arena Offshore-107-1)" to the two large-scale paper NOAA charts covering the area where the casualty occurred. On February 11, NOAA released the automatic corrections that added platform SP-83A to the two ENC vector charts covering the casualty area.
