Fire on board *BBC Rhonetal*

Port Hedland, Western Australia on 25 March 2021

ATSB Transport Safety Report
Marine Occurrence Investigation (Defined)
MO-2021-002
Final – 21 September 2022

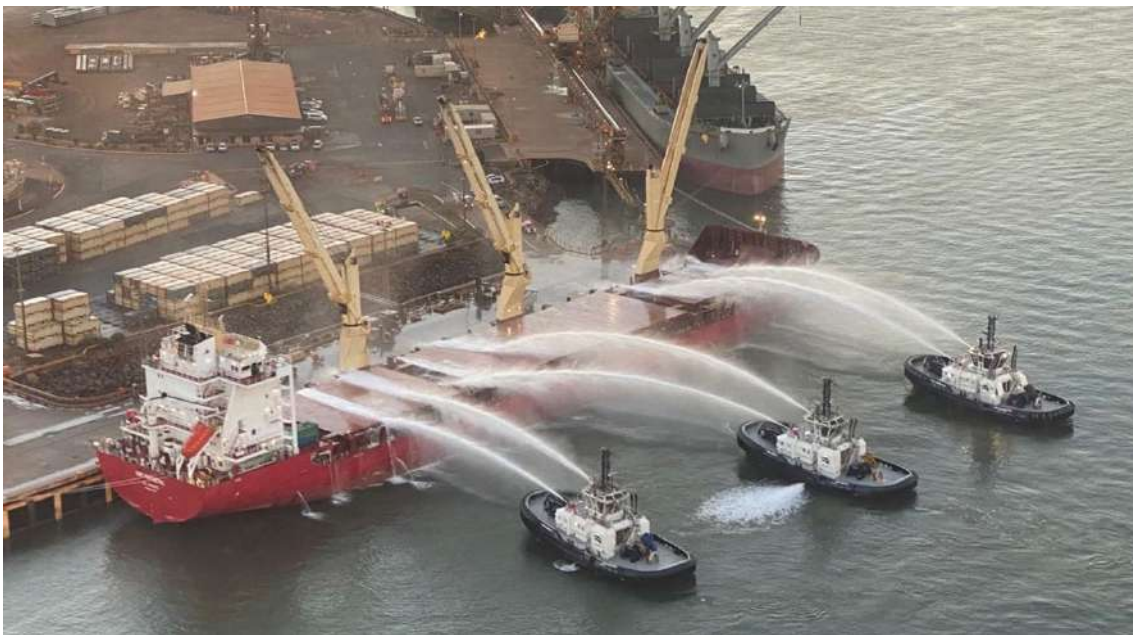
Cover photo: Western Australia Department of Fire and Emergency Services

Meanwhile, three harbour tugs had arrived and began directing water on to the ship for boundary cooling (Cover image). At 0337, firefighters from local units of the Western Australia Department of Fire and Emergency Services (DFES) also arrived.

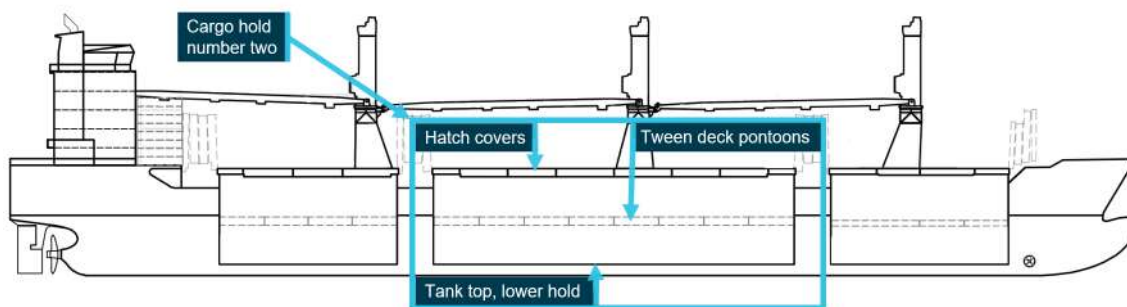
Figure 1: Profile view of *BBC Rhonetal*

At about 2358 on 24 March, the bosun and an OS, along with the second mate as supervisor, arrived on deck to assume the cargo watch. Shortly after, they started preparations as planned to cut the sea fastenings. In anticipation of this hot work, several crew members on the earlier watch had opened the hatch covers to number two cargo hold and prepared firefighting equipment on the tween deck in the hold (Figure 1).

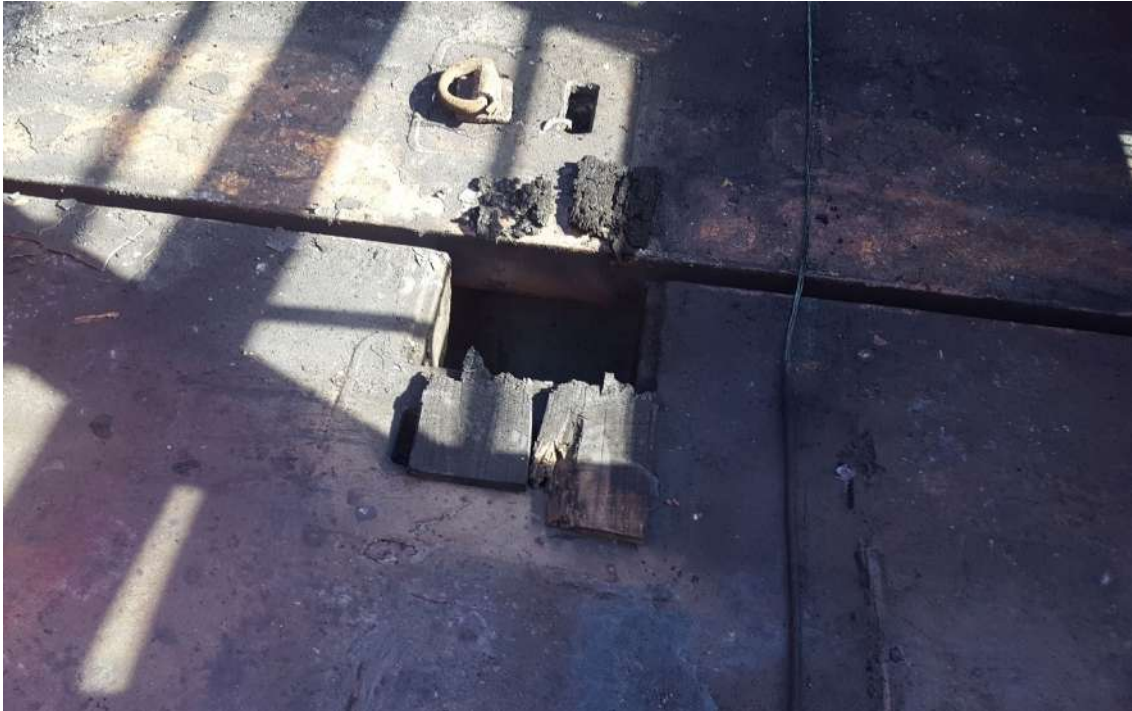
Figure 2: Tween deck gaps

The firefighting equipment included three fire hoses which were pressurised (using the ship's fire main line) and ready for immediate use by opening their fire nozzles. There were also two fire extinguishers, two spark arrester drums and four fire blankets close by. The fire blankets each measured about 2 m in length and were to be used to cover the gaps in the tween deck (Figure 2)

near the work areas to prevent sparks and molten metal produced by the cutting work from falling through to the lower hold.

Among those identified scenarios, the risk matrix documented the hazard of molten metal from hot work on deck falling between gaps in the tween deck into the hold below. The assessment identified that this could result in major consequences, such as a fire on the cargo or in the hold and damage to cargo and other equipment.

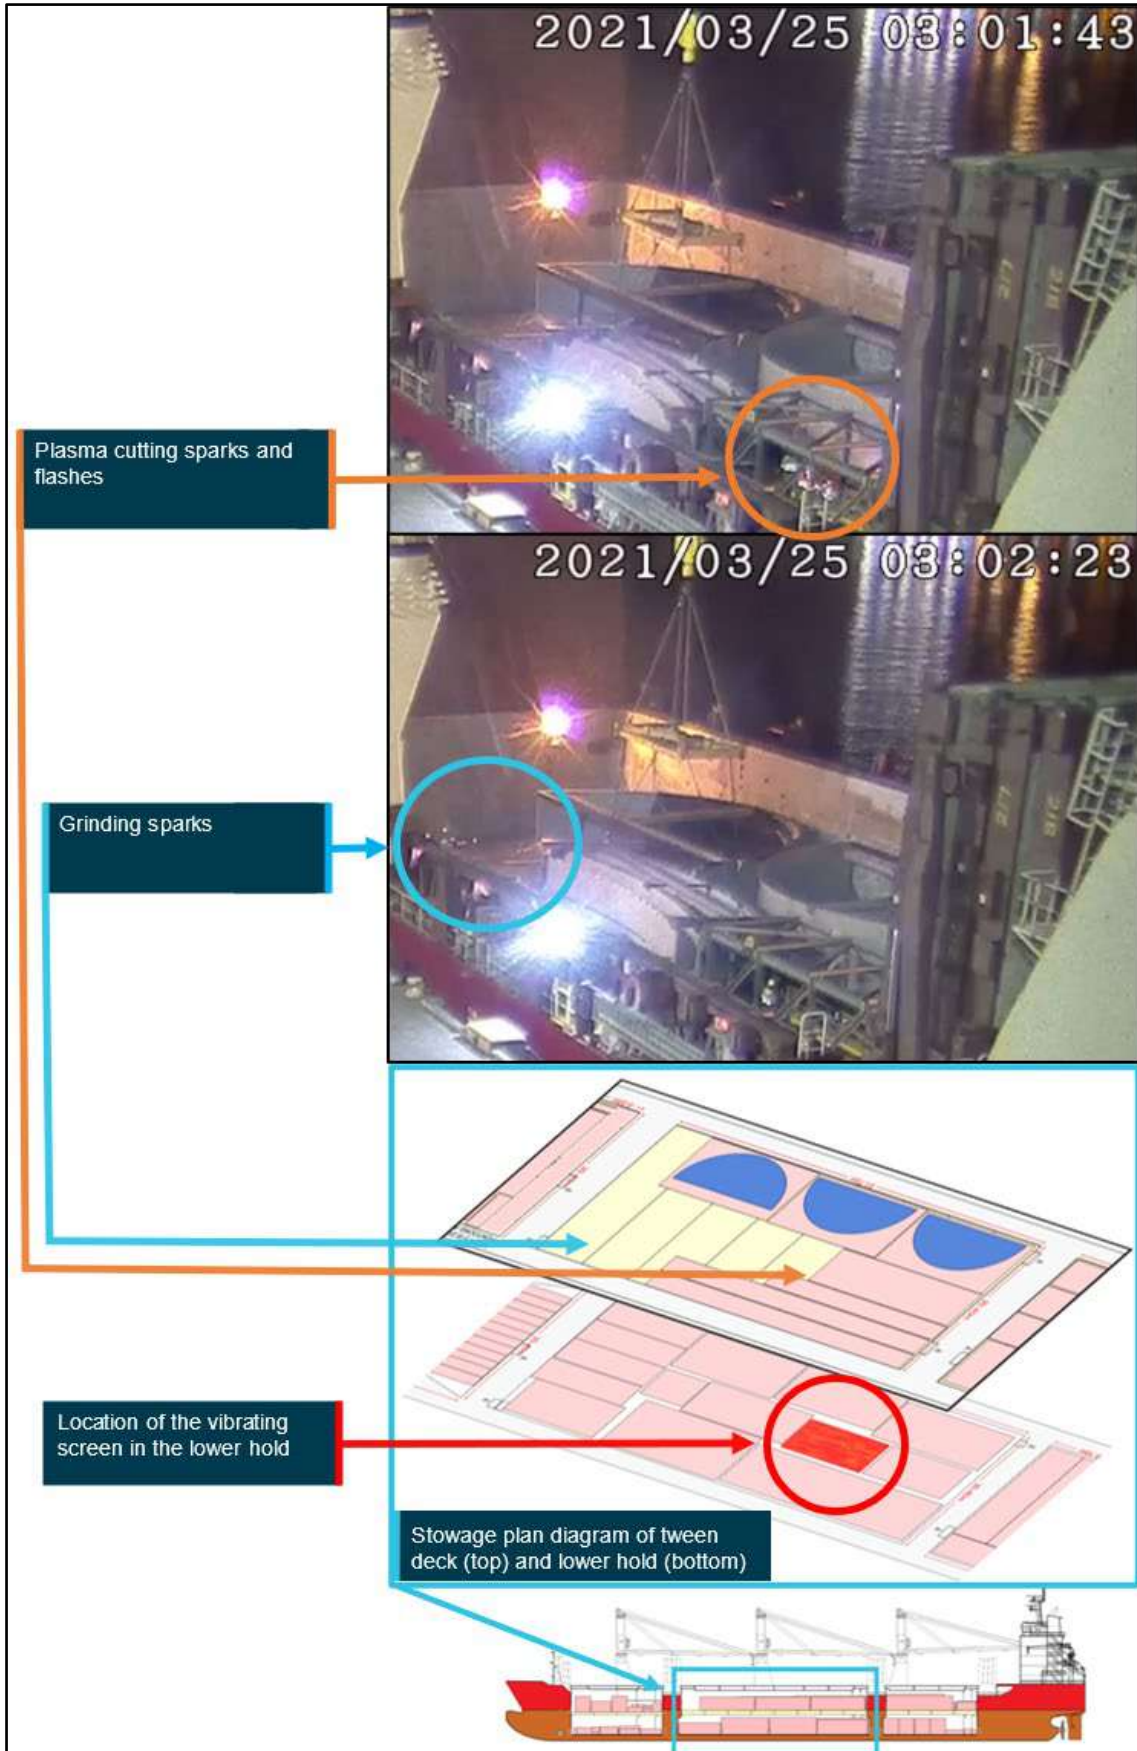
Figure 3: CCTV images of the hot work with the locations indicated on the stowage plan

Meanwhile, the bosun continued using the plasma torch and had progressed to the aft part of the tween deck, located above the plastic-wrapped screen assemblies in the lower hold below. At that time, sparks from the plasma cutting were spreading across a broad area. A smaller quantity of sparks was also generated by the grinding work forward (Figure 3).

Shortly before smoke was observed rising from the lower hold, the bosun had been cutting fastenings with a plasma torch in an area on the tween deck which was located above a vibrating screen assembly stowed in the lower hold. The screen was later identified by firefighters from the Western Australia Department of Fire and Emergency Services as the origin of the fire.

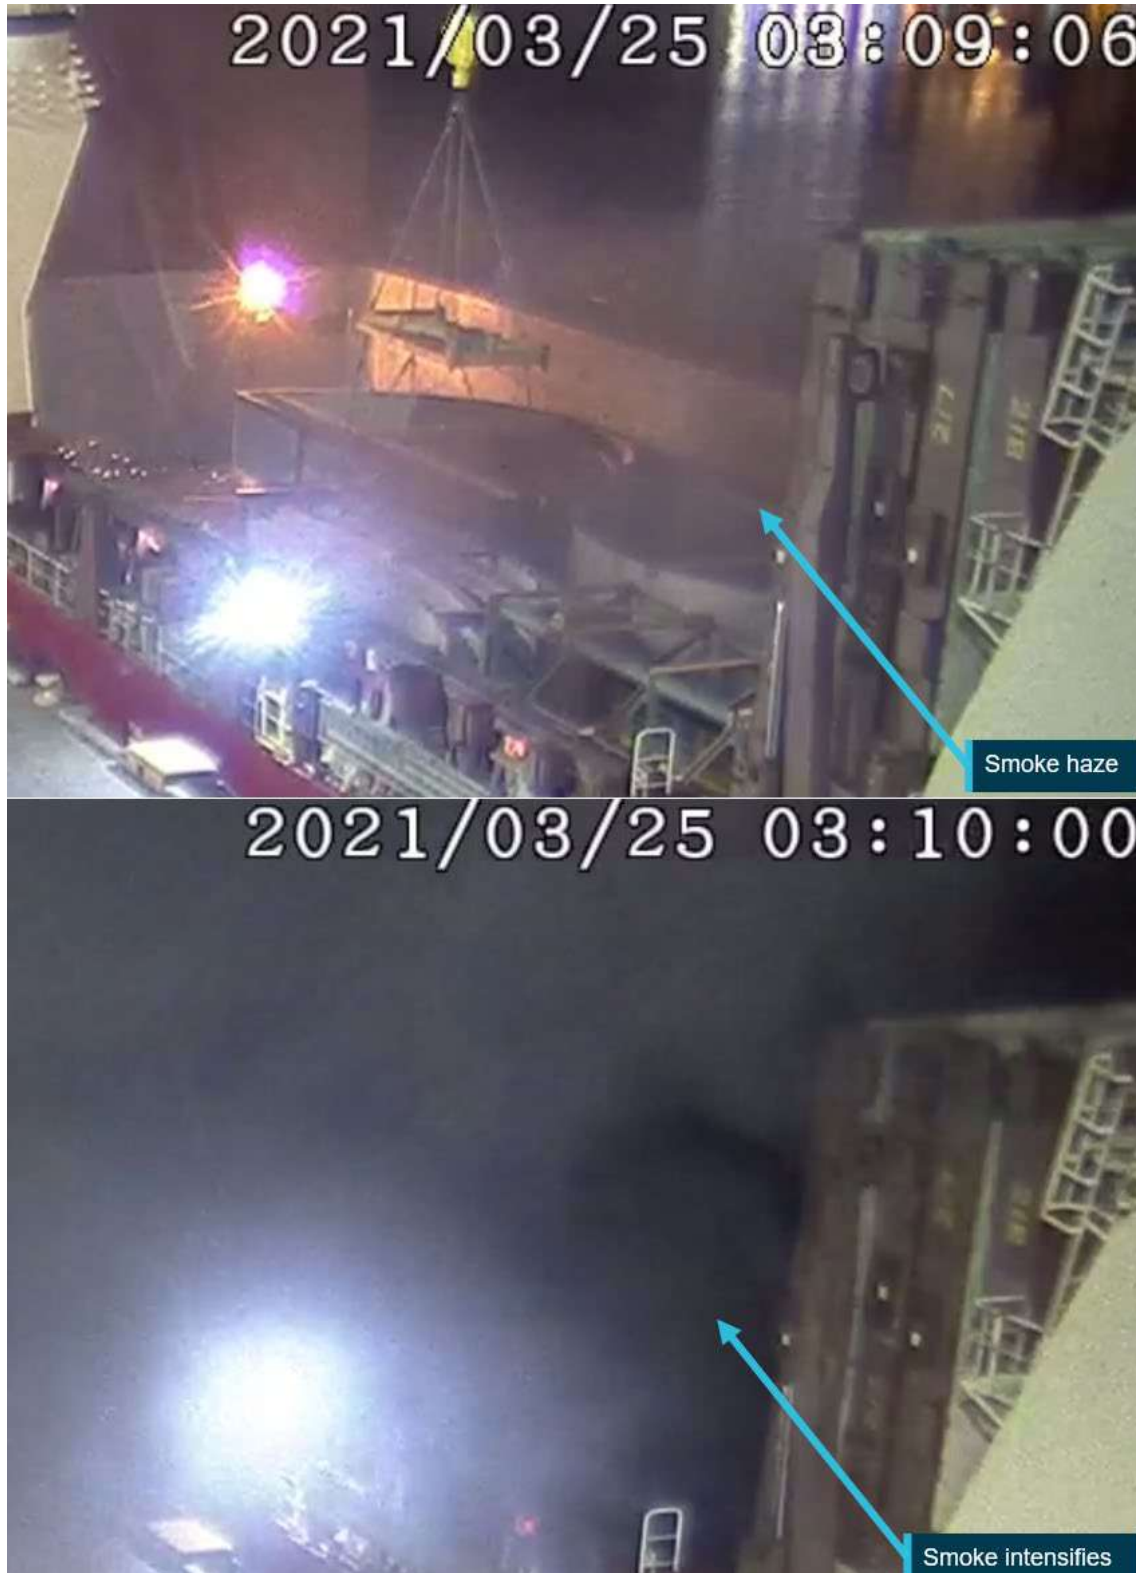
Figure 4: Intensifying smoke from the lower hold (CCTV frames at 0309 and 0310)

At 0309, the second mate on the tween deck saw smoke rising from the aft part of the lower hold. The smoke intensified quickly and began billowing over the cargo hold and the wharf (Figure 4). The stevedores also saw the smoke and quickly left the ship, leaving behind an item of cargo on the tween deck connected to the crane hook in preparation for discharge.

The second mate, bosun and OS immediately directed water towards the area where the smoke was rising using the available fire hoses. Shortly after, they also saw flames coming through gaps in the tween deck.

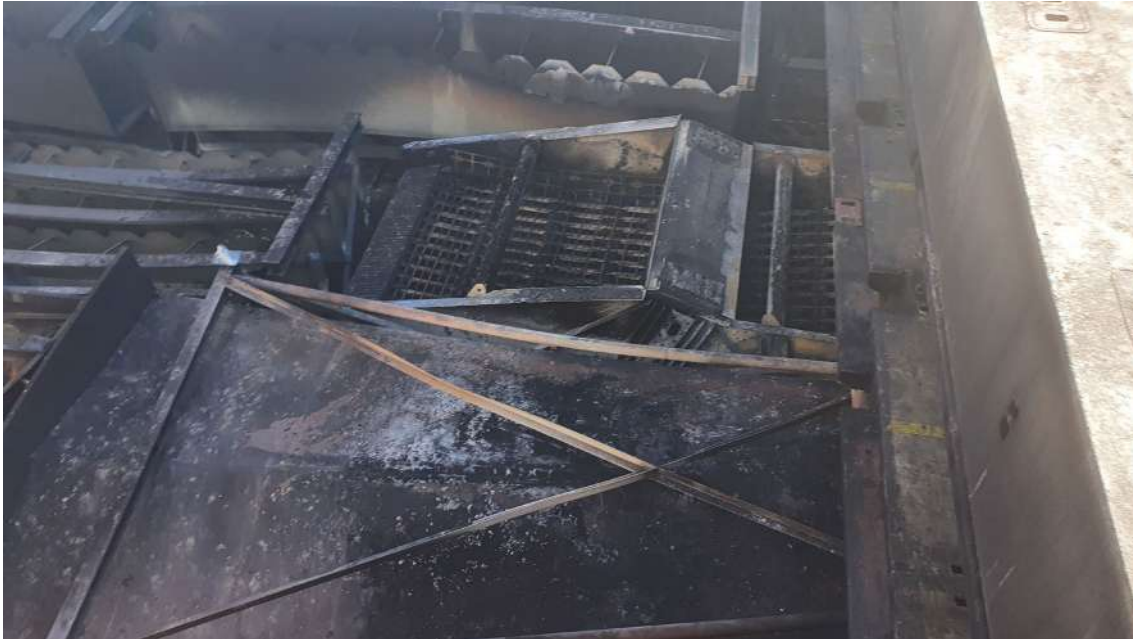
Figure 5: Burnt remains of the vibrating screen assembly

At 0804 on 28 March, DFES firefighters declared the fire extinguished. Post-fire inspections identified that the fire started on one of the linear vibrating screen assemblies stowed in the lower hold, directly below where the bosun was last seen plasma cutting before the smoke and flames were sighted (Figure 5).

The fire destroyed the vibrating screens. Photos taken after the fire showed that the intense heat from the blaze had left scorch marks on surrounding areas in cargo hold number two and on several items of cargo on the tween deck above the fire. The firefighting efforts had resulted in the accumulation of 600 cubic metres of water in the bottom of the hold. This wastewater was transferred into the ship's water ballast tanks and later disposed of in compliance with marine pollution prevention regulations.
