# MAERSK ESSEN

Marine accident report on loss of cargo

16 JANUARY 2021

**MARINE ACCIDENT REPORT ON MAERSK ESSEN'S  
LOSS OF CARGO ON 16 JANUARY 2021**

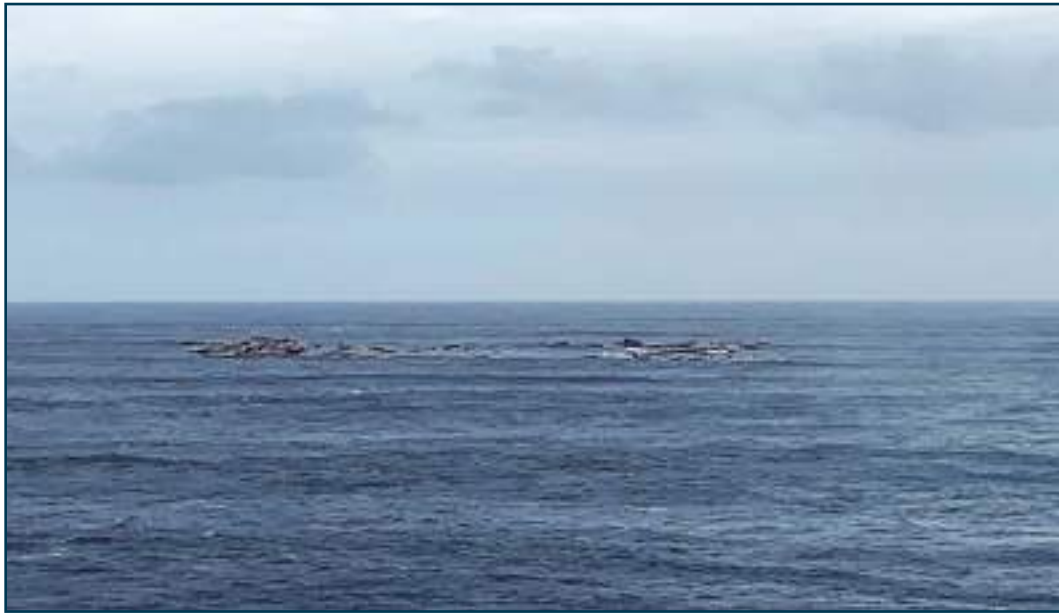
He went to the bridge wing and looked aft and saw containers hanging over the ship's side and floating in the sea (Figure 7). He rushed back into the bridge and instructed the officers to fetch a camera to document the lost containers and to log the time and position. The heavy weather emergency response flowchart was put into use, and the 2<sup>nd</sup> and 3<sup>rd</sup> officer assisted the master in communicating with relevant authorities and the company.

*Figure 7: Lost containers floating in the water*  
Source: Maersk A/S

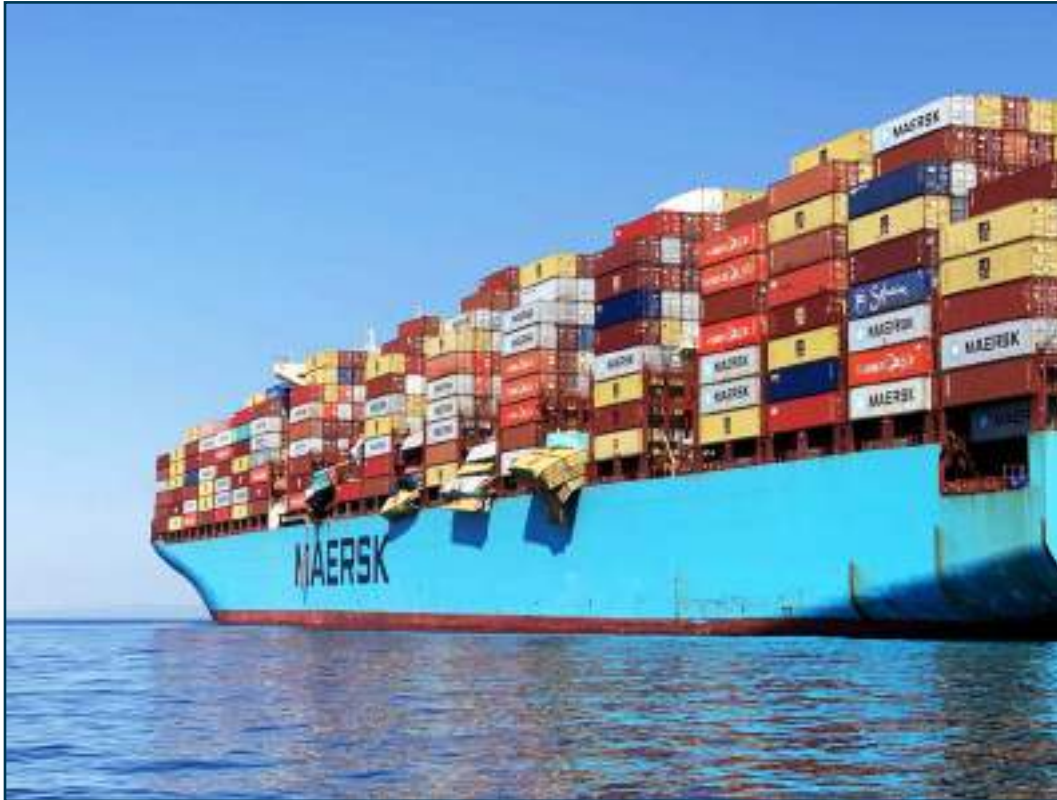
On the cargo deck, the crew found that containers were damaged or lost overboard from eight bays. On some bays few containers were lost, while on others all containers were lost or damaged. During the discharge of the damaged cargo, it was concluded that a total of 689 containers were lost overboard and that 258 were damaged (Figure 8).

Figure 8: MAERSK ESSEN at anchorage off Lázaro Cárdenas, Mexico  
Source: Maersk A/S

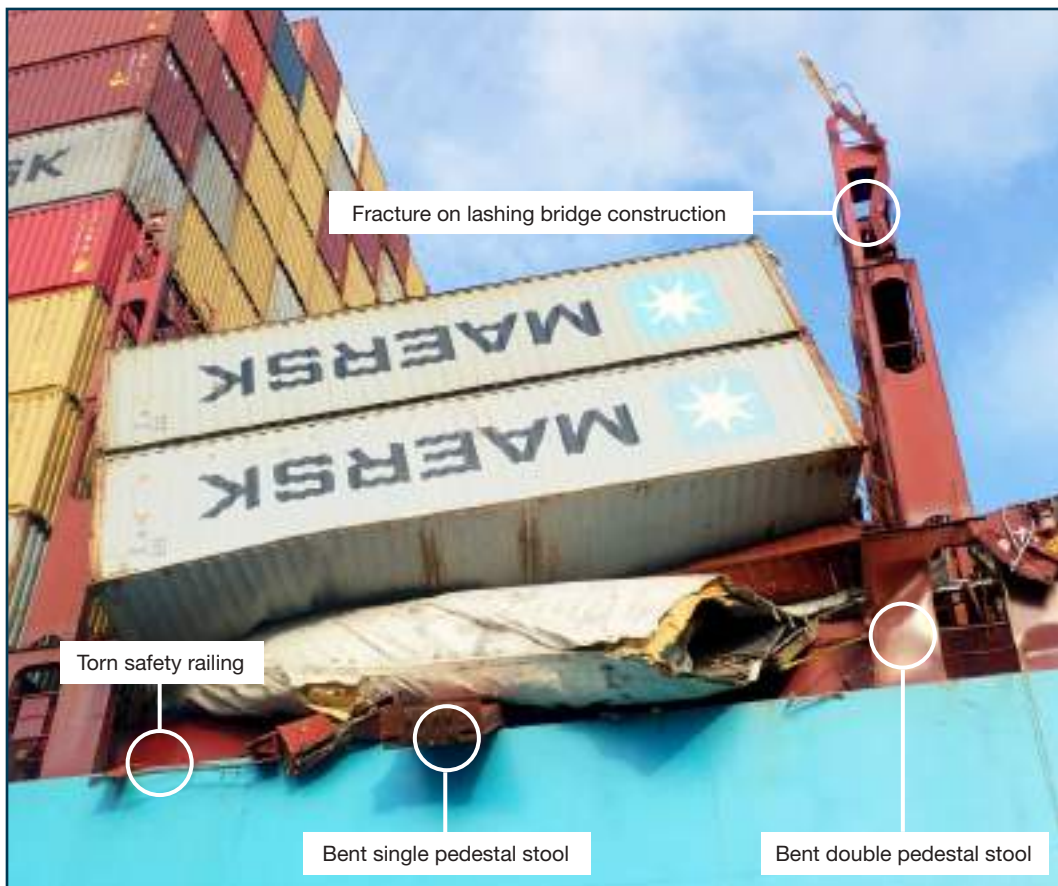
On bays where containers were lost overboard, the container stacks had collapsed and toppled over, causing damage to deck structures. On other bays, where container stacks had also collapsed, containers were hanging over the ship's side, blocking the deck passageways. Pedestal stools were bent, safety railings torn off, and the accommodation ladders on both port and starboard side were damaged (Figures 9 and 10). Several lashing bridges were deformed and fractured having being struck by falling containers, and the passageways on the lashing bridges were blocked and damaged (Figures 11 and 12).

Figure 9: Example of damages on deck structures  
Source: Maersk A/S, modified by DMAIB

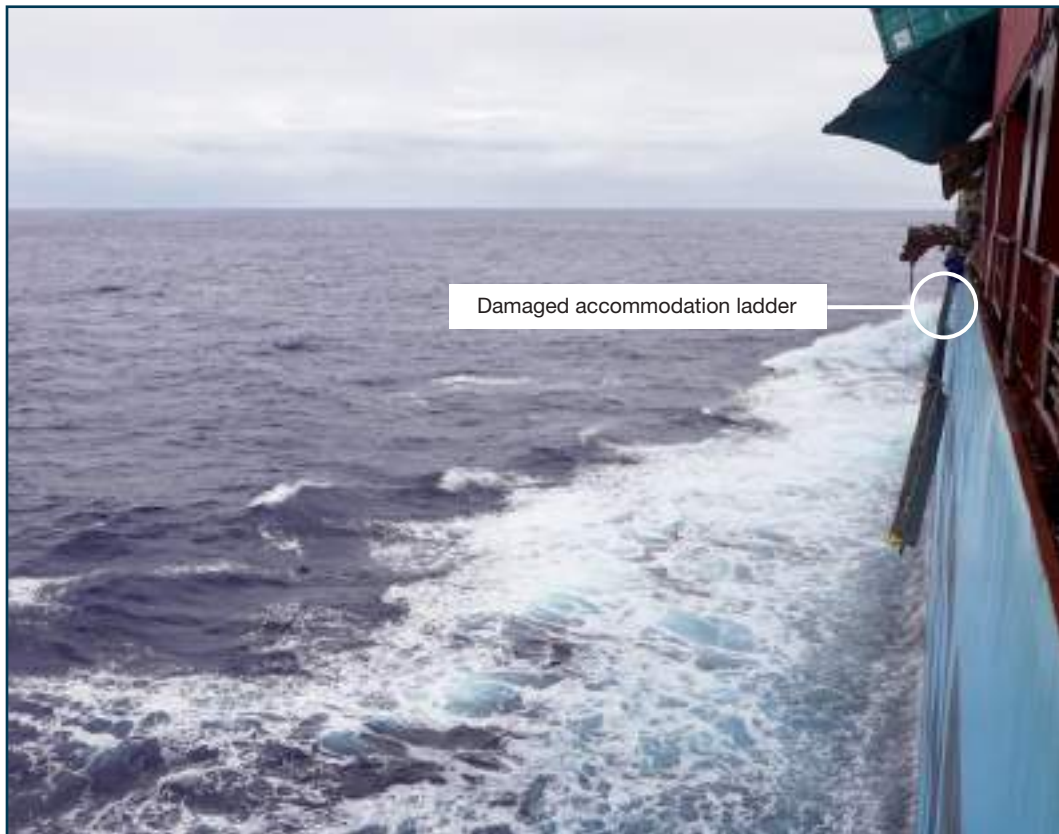
Figure 10: Damage to port side accommodation ladder  
Source: Maersk A/S, modified by DMAIB

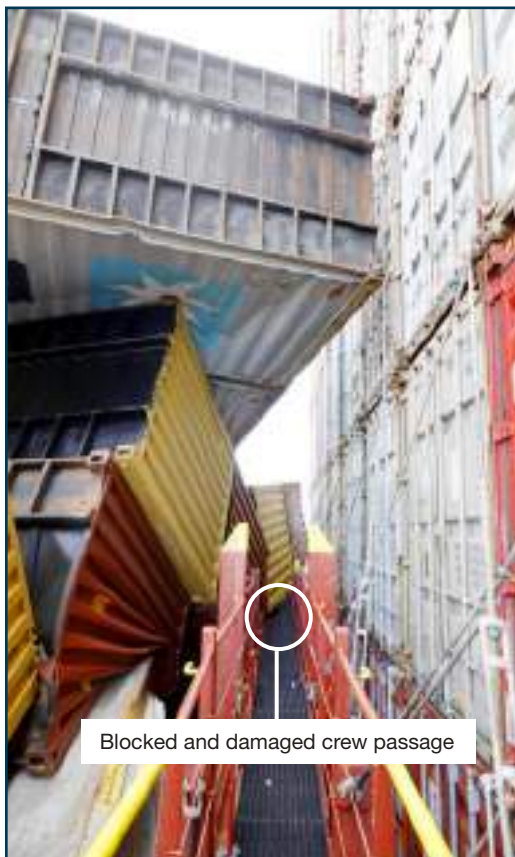
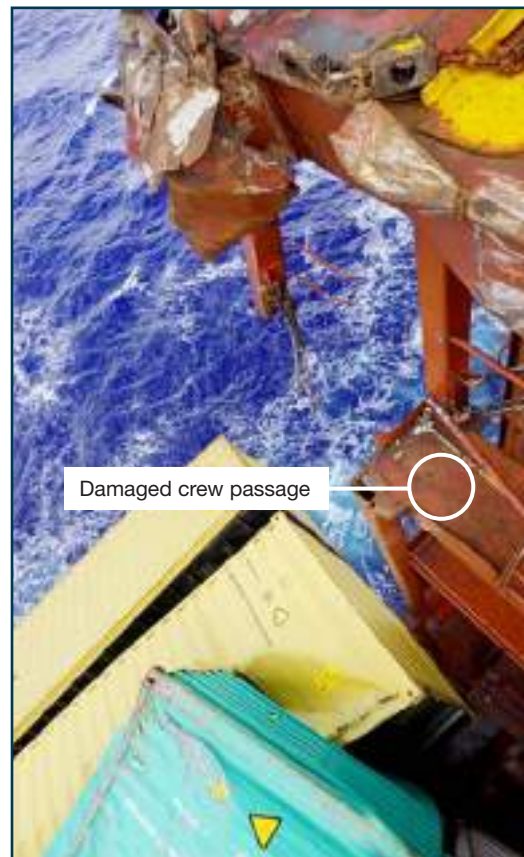
Figure 11: Example of lashing bridge damages  
Source: Maersk A/S, modified by DMAIB

Figure 12: Example of lashing bridge damages  
Source: Maersk A/S, modified by DMAIB

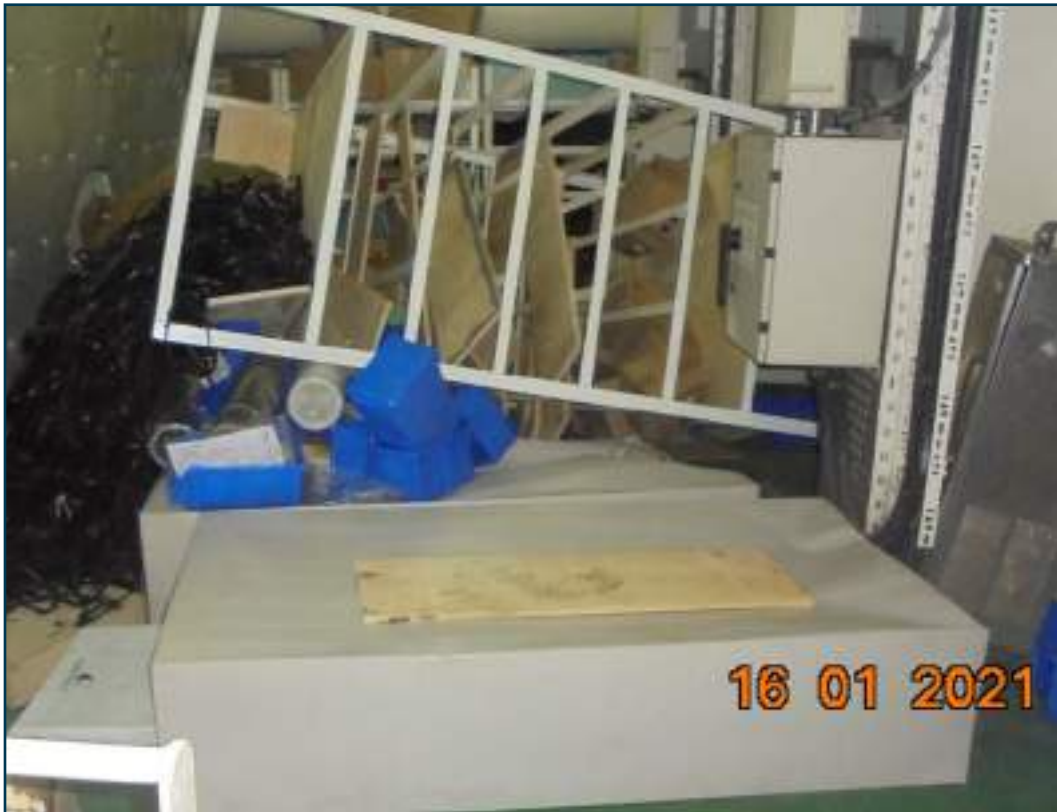
Figure 13: Overturned storage racks  
Source: Maersk A/S

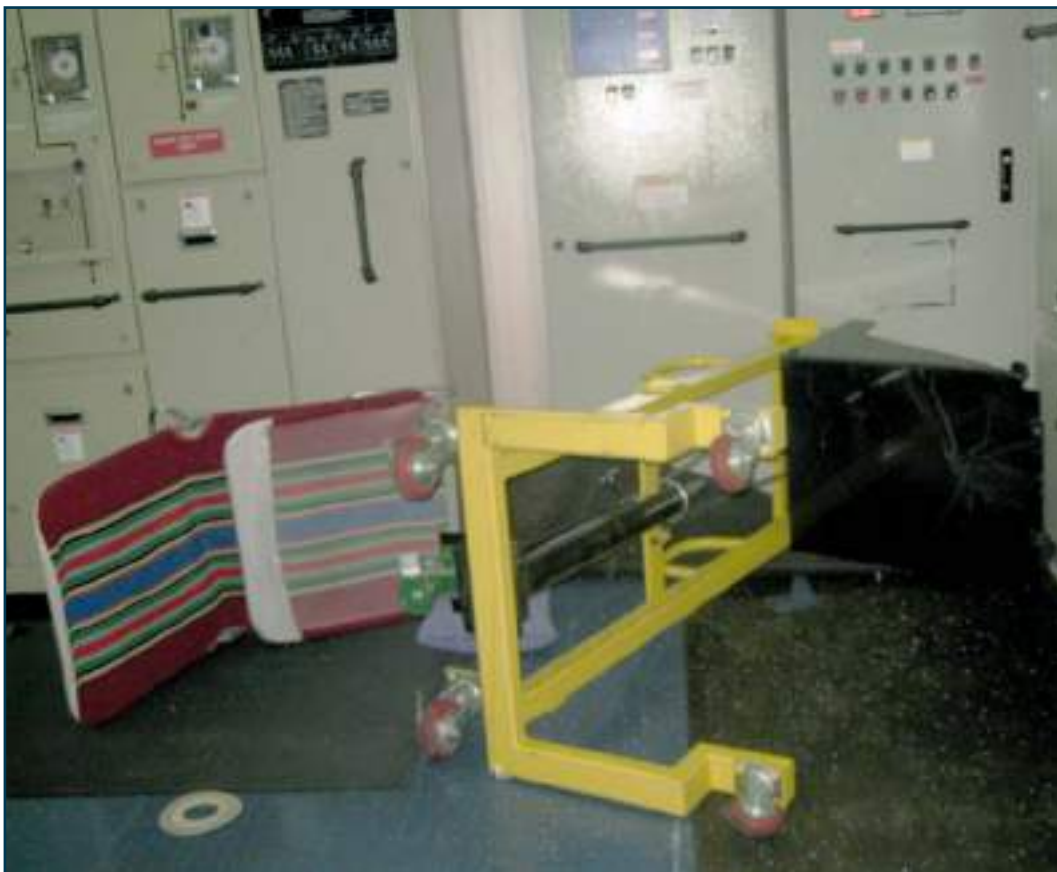
In the accommodation, all compartments were affected. Items which had not been secured had been hurled around, and office equipment, furniture and galley machinery had fallen over. In the paint shop, barrels and cans had fallen to the floor from the shelves. In other storage rooms, entire racks were overturned, and their content hurled off the shelves (Figure 13). In the engine room, the compartment's heavy equipment, including a lifting device and a spare electrical motor, had loosened and slid across the floor (Figure 14 and 15).

Figure 14: Overturned and displaced lifting device near control panels in the engine control room  
Source: Maersk A/S

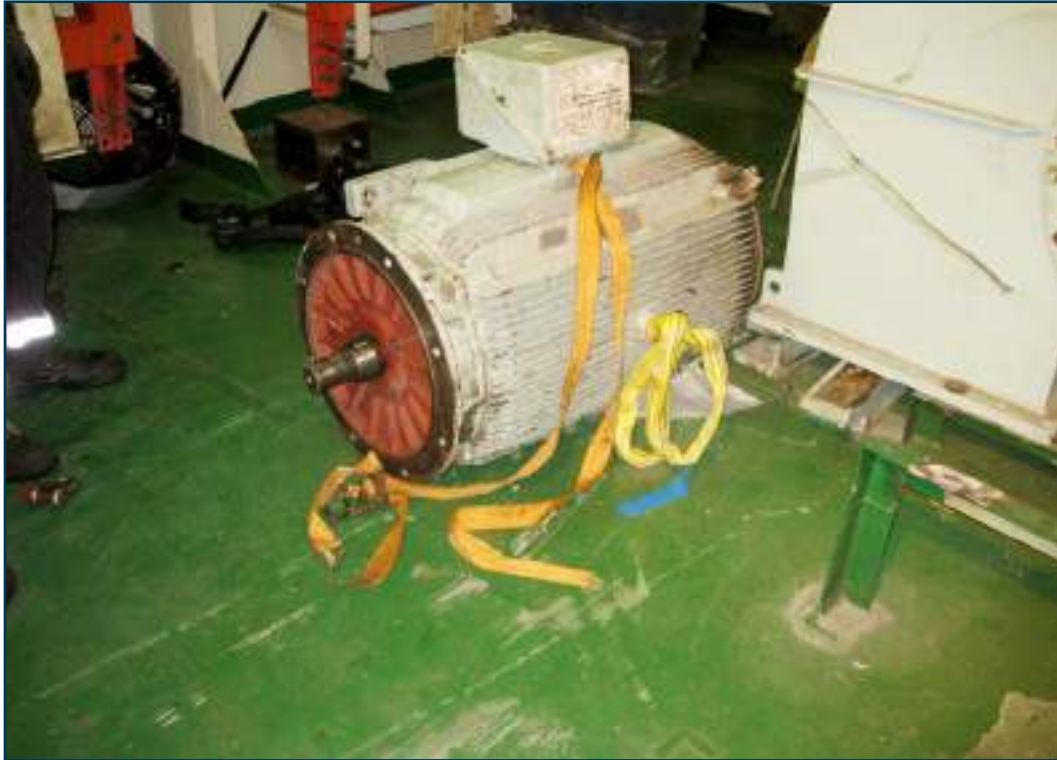
*Figure 15: Electrical spare motor with broken lashings and damages from impact after having slid across the deck and hit other objects and structures.  
Source: Maersk A/S*

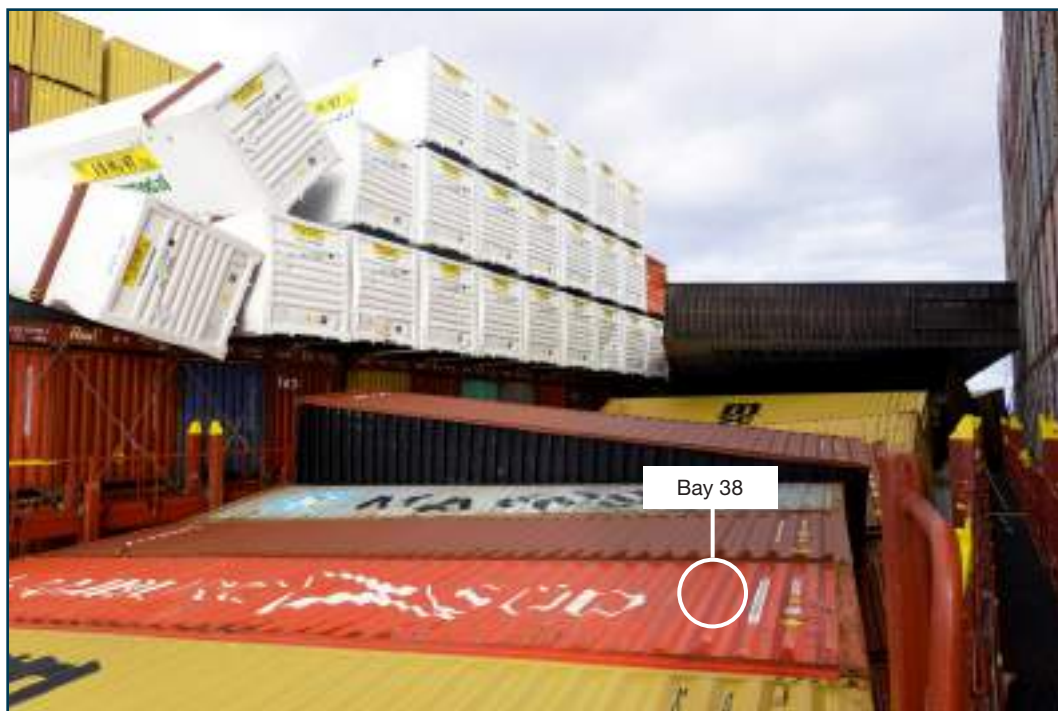
Bays 38, 50 and 66 suffered total collapse, with all containers lost or damaged. The containers remaining on board were fractured with indents to the side plating along with damaged corner posts and corner casts due to excessive loads or pressure compressing from other containers. Containers were hanging over both the port and starboard sides. On bay 50 and 66, the remaining containers were separated from the stacks and had toppled over in a chaotic pattern. On bay 38, containers were toppled over towards the port side and were still partly connected in stacks by twistlocks (Figure 44). This indicates that the bay collapse was mainly affected by a port side roll.

Figure 44: Bay 38 after the accident  
Source: Maersk A/S

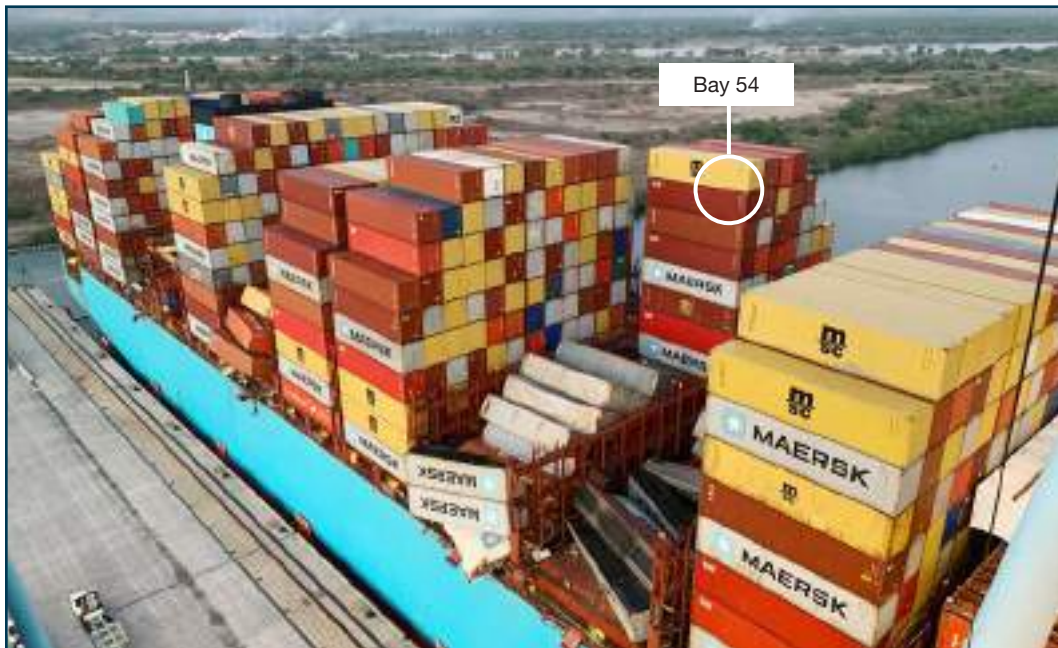
On bay 54 port side, the containers on the seven outermost rows were still in position, while the remaining twelve rows of containers were missing or damaged. The damaged containers were closest to the intact container rows on the port side, while the outermost containers on starboard side had fallen overboard. Figure 45 shows five rows had toppled over towards the starboard side, while still being partly connected by twistlocks, with the top of the stacks missing. This indicates that the entire row had collapsed when the ship rolled to starboard.

Figure 45: Bay 54 after the accident

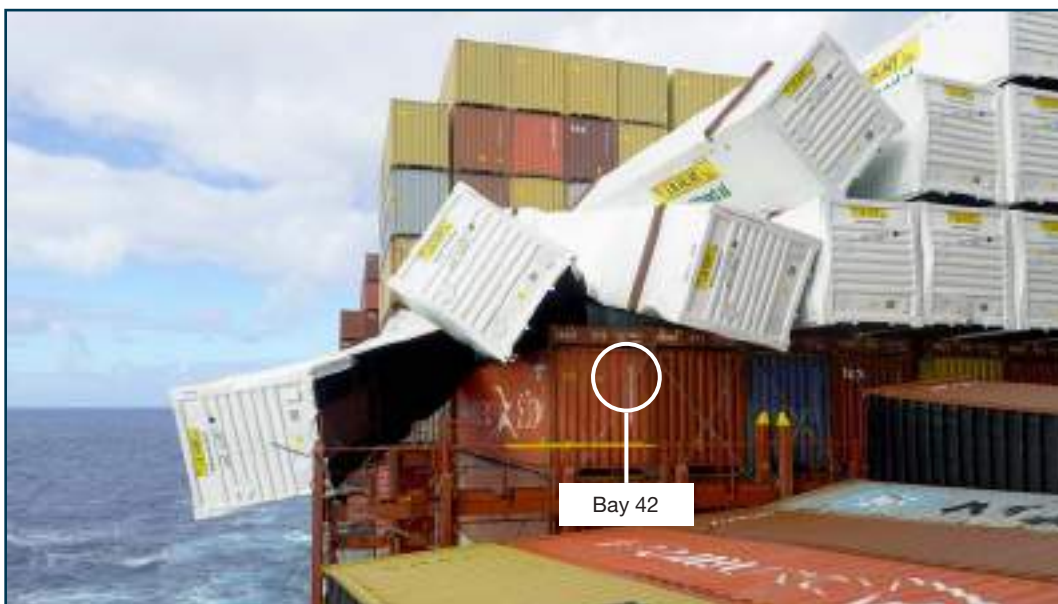
Bay 46 had lost one row on its starboard side, which could have resulted from either acceleration force overload during a starboard roll or from the row being struck by containers tumbling from bay 42 (Figure 46). The remaining rows were sitting in position with their lashings intact.

Figure 46: Bay 42 after the accident. Bay 46 behind the white containers.

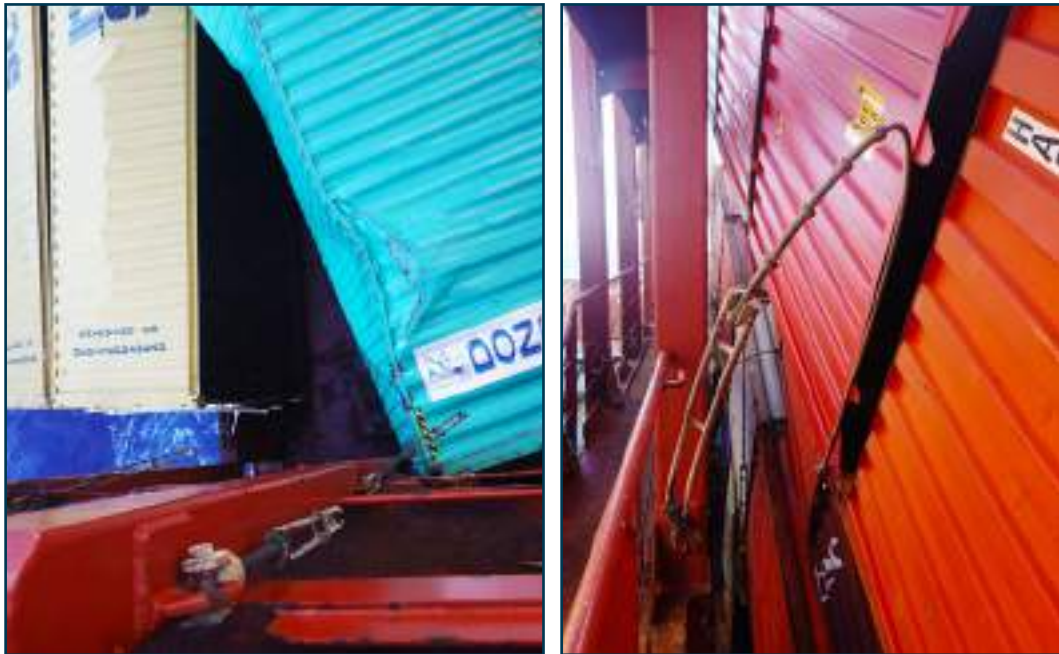
On all affected bays, turnbuckles and lashing bars were hanging loose from lashing bridges and containers, showing signs of having been torn apart (Figure 48). In other places, turnbuckles and lashing rods which were still connected had been bent out of shape, as the container stacks had collapsed (Figure 47).

Figure 47 and 48: Example of detached and bent lashings (bay 66 and 54)  
Source: Maersk A/S

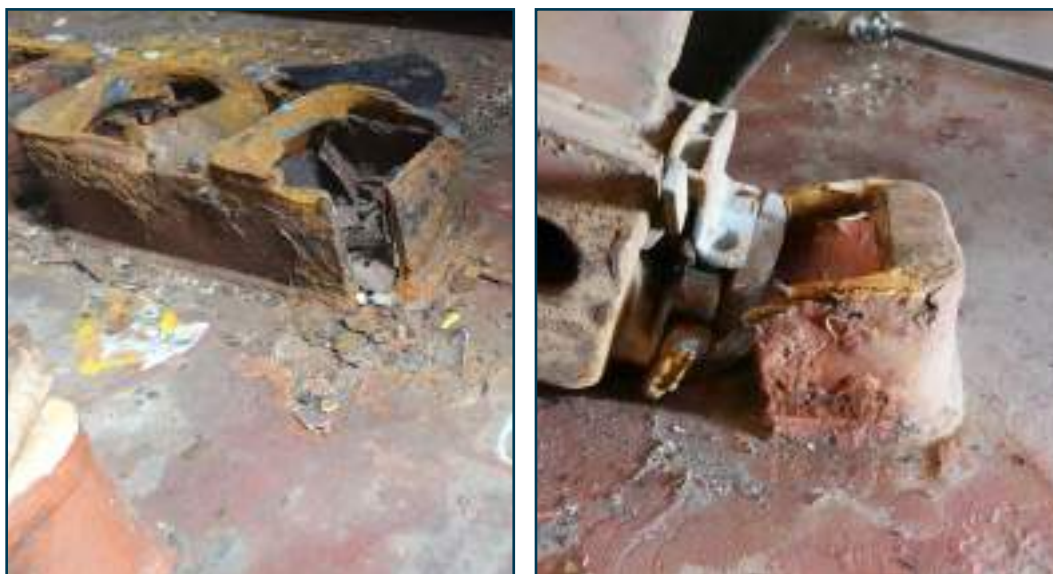
Figures 49 and 50: Example of socket fractures – bay 66 and 38  
Source: Maersk A/S

The ISO sockets, which had the lowest holding capacity, were damaged on most of the affected bays. Fractures on sockets, corner castings and base-locks often related to overload caused by lifting and separation forces induced by heavy rolling, which resulted in a tipping moment (Figure 53). However, the corner post load or lifting force might also have resulted from other dynamics within the individual stack, such as acceleration forces at the top leading to racking forces towards the middle of the stack, which then results in lifting/compression in the bottom of the stack (Figure 54). This type of dynamic will increase with stack height, especially for stacks with the tiers above the lashing bridge connected by twistlocks only. Furthermore, impact from collapsing adjacent stacks can also induce a tipping moment.

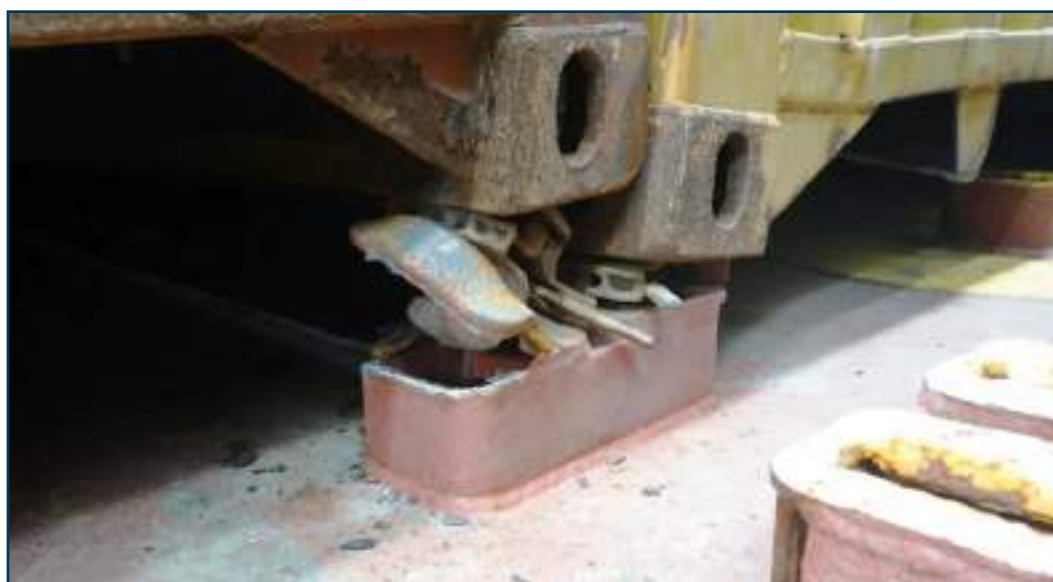
Both damaged and undamaged base locks were found in the sockets on the affected bays. In some cases, the locking pins seemed to be in the open position, but damages to container corner castings and twistlocks indicate they had been locked, but that the locking pins had been forced open when the container stacks toppled (Figure 51 and 52).

Figure 51: Example of twistlock in open position, though socket and twistlock are broken.  
Source: Maersk A/S
