The Bahamas
Maritime Authority

Marine Safety Investigation Report

into a crush incident onboard
Dole Chile with the loss of one life
on 19 March 2022

Date of Issue: 07 November 2022

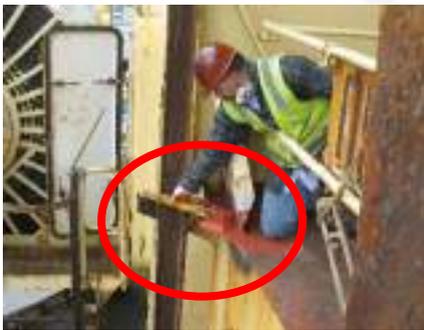
Stopper being deployed

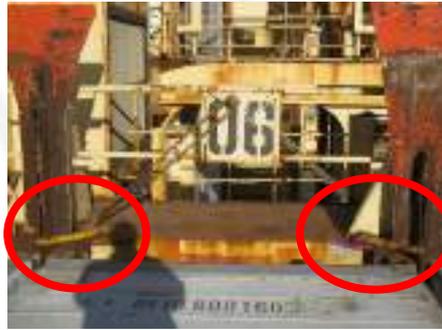
Stoppers deployed

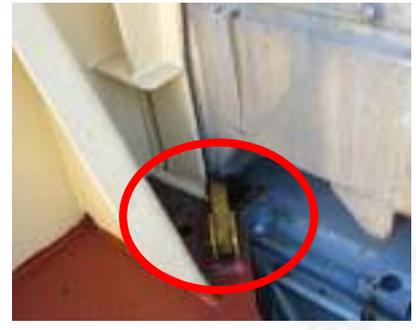
Container resting on stopper

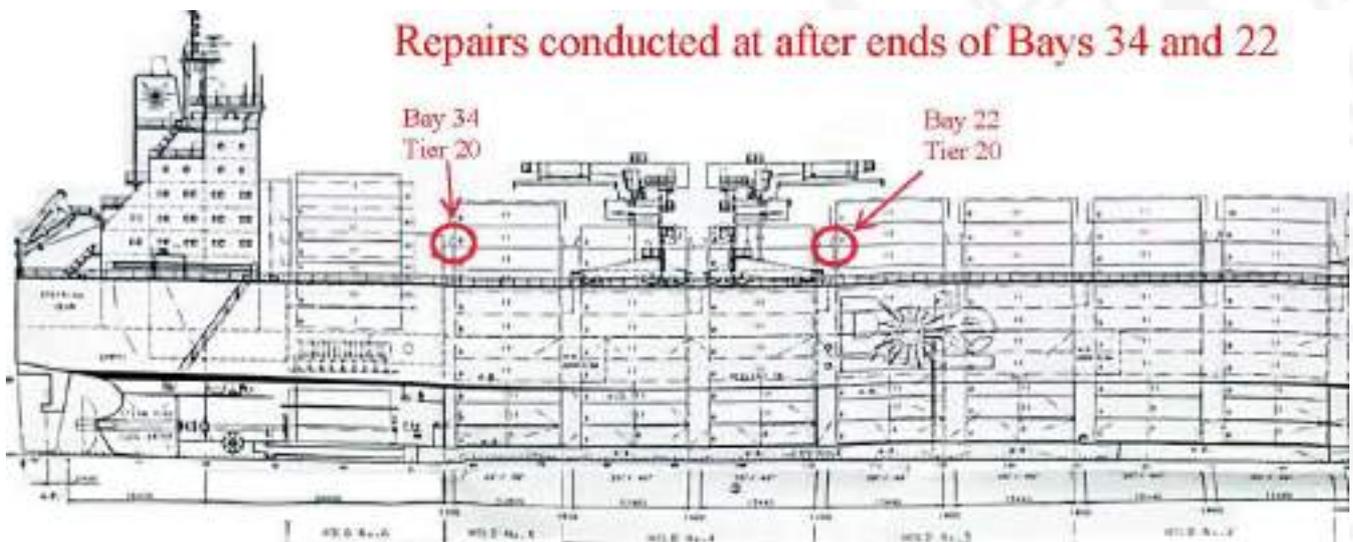
For the call in Santa Marta, it was intended to replace damaged stoppers on the port side (aft) of bay 22 (rows 06, 08 and 10) and on the starboard side (aft) of bay 34 (row 09). The work was considered crucial as full stacks of laden containers were scheduled to be loaded in these locations during the port call - the stoppers would be required to keep weight loading on the tanktop within allowable limits.

General arrangement showing locations of repairs to stoppers

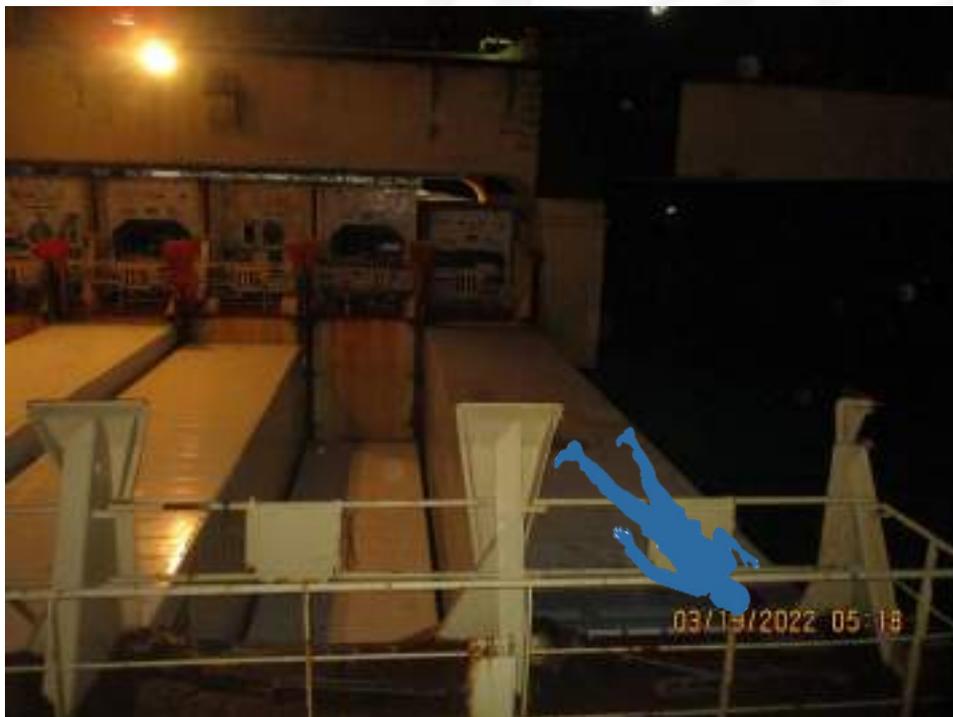
An autopsy confirmed the cause of death as head trauma, consistent with being struck by the gantry crane’s container spreader.

Scene examination and recreation suggests that the victim was hit by the outboard edge of the container spreader's girder as it was lowered when the victim was kneeling on top of container 340918 and facing aft. The presence of a slag removal hammer and the location of his welding equipment suggests he was inspecting his work or removing slag from welds.

Position of victim, as discovered by first responders (looking forward)

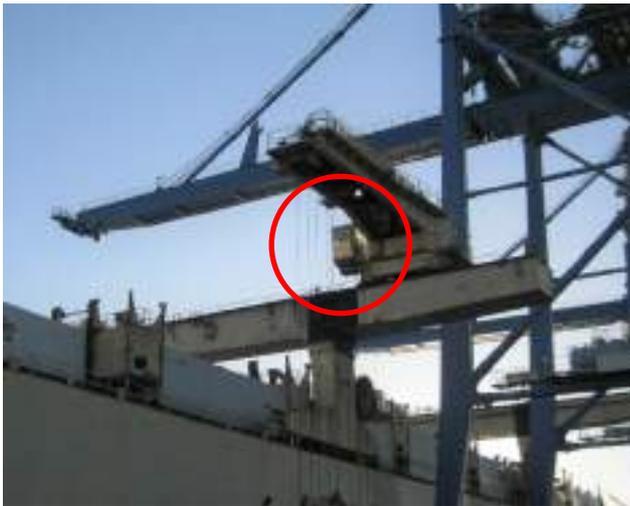
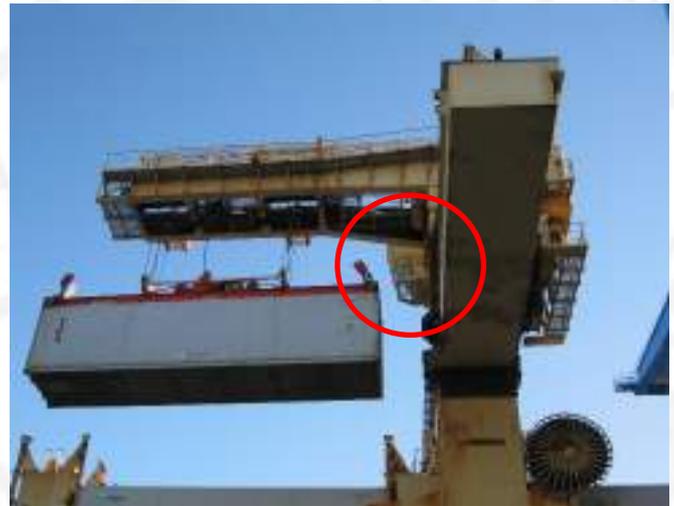
Views of aft gantry crane showing offset cab (looking from starboard)

The offset meant that the crane operator's view of the two rows to starboard of the cab was obscured. At the time of the casualty, the vessel was port side alongside, and the location where the victim was working would have been obscured when the spreader passed an area from Row 05 outboard as the gantry approached Row 09.

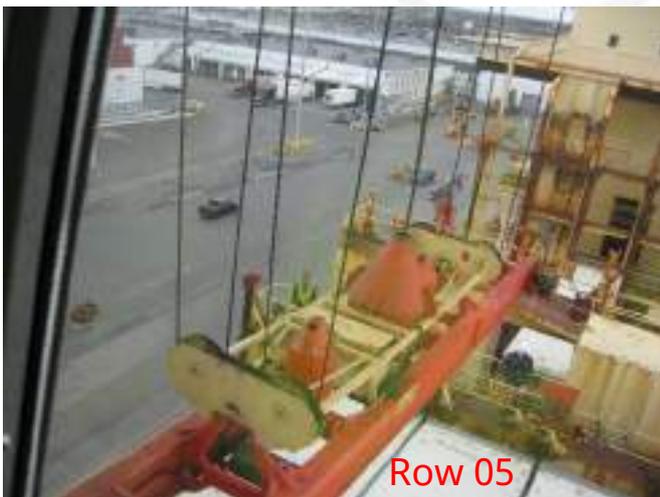
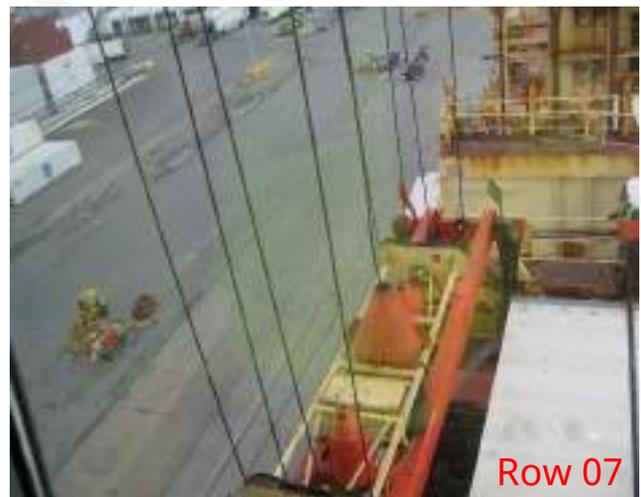
View from cab approaching, and at, location of casualty

At the time of the casualty there was no hatchman at bay 34. The gantry crane operator stated that he saw sparks at the after end of bay 34 and knew that work was being done but, after seeing no sparks for a period of time, assumed that the work had finished.

- Ensure that effective oversight is provided at all hatches when cargo is being worked.
 - Establish effective communication procedures between ship and terminal to facilitate repairs or maintenance of vessels moored at their berths. This should include agreement on the precautions to complete the work safely.
-
