# **Final Report**

## **FATALITY OF CREW ON BOARD NOZOMI IN BANGKA STRAIT, INDONESIA 1 APRIL 2022**

TIB/MAI/CAS.122

Transport Safety Investigation Bureau  
Ministry of Transport  
Singapore

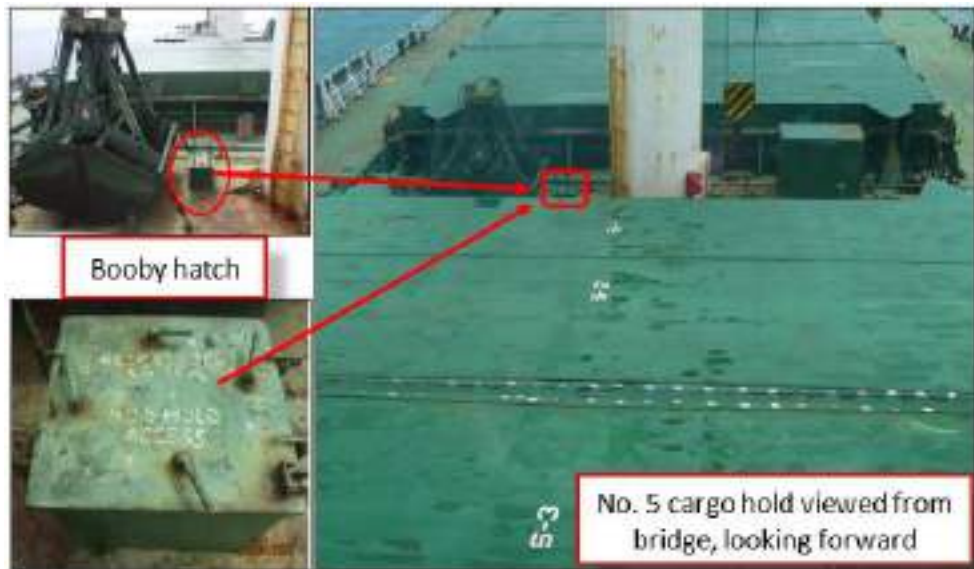
Figure 2 - No.5 cargo hold forward booby hatch - Source: the Company (Annotated by the TSIB)

1.1.4 The Bosun and the three ASDs transferred the grease and tools to the forward booby hatch (for accessing No.5 cargo hold, see **figure 2**). While turning the external dog handles to open the booby hatch cover, two out of the four were found to be seized. The deck crew used a short pipe to slot into the external dog handles and managed to turn them, and thereafter were able to lift open the booby hatch cover.

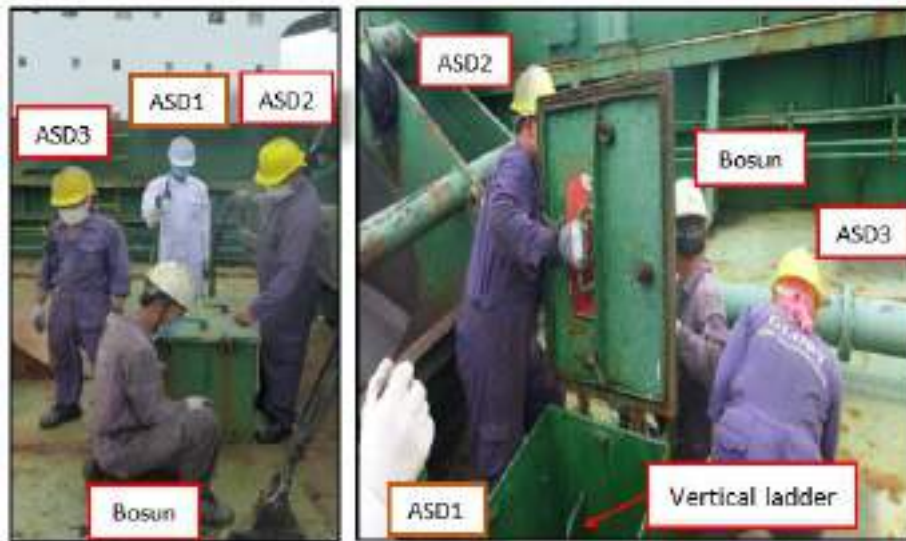
Figure 3 - Enactment of the positions of the deck crew  
(Source: the TSIB)

in open position, the ASD1 used a hammer to strike the internal dog handle of the other set of seized-up dog handles. After a few strikes, the external dog handle dropped onto the main deck and was picked up by the ASD3. **Figure 3** shows the enactment of the crew's positions at the booby hatch freeing up the dog handles prior to the external dog handle dropping on deck.

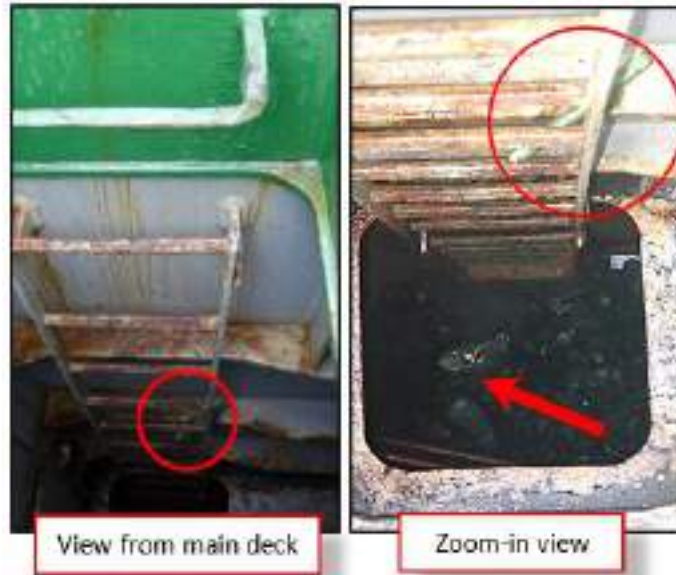
Figure 4 - Red-coloured circles indicating the dog handle and the arrow points to the safety shoes of ASD1 inside the cargo hold  
(Source: The TSIB)

- 1.1.6 At about 1030H, the ASD2 heard a sound from No. 5 cargo hold, he looked over the booby hatch and saw the ASD1 lying on the coal cargo. An internal dog handle<sup>7</sup> was found wedged between the vertical ladder and the side stringer of ship's structure (see **figure 4**). No one was aware that the ASD1 had entered the cargo hold. The deck crew assessed that the ASD1 could have dropped the internal dog handle into the cargo hold while hammering it and tried to retrieve it without informing anyone.

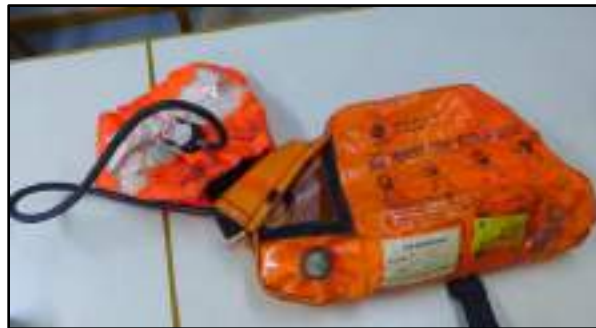
Figure 5 - EEBD set used by the 3O

- 1.1.11 When the 3O arrived at the booby hatch, he put on the EEBD (see **figure 5**) hood and entered the cargo hold through the vertical ladder while the two air hoses were being connected to the air supply. The investigation team gathered that the 3O subsequently came out of the booby hatch, citing that it was difficult to breath and hot in the cargo hold.

for escaping from a compartment that has a hazardous atmosphere and should not be used for entering oxygen deficient voids or tanks on board ships. In the attempt to rescue the ASD1, the 3O used the EEBD to enter the cargo hold and subsequently had to leave the cargo hold due to difficulty in breathing, in addition to the hot environment.

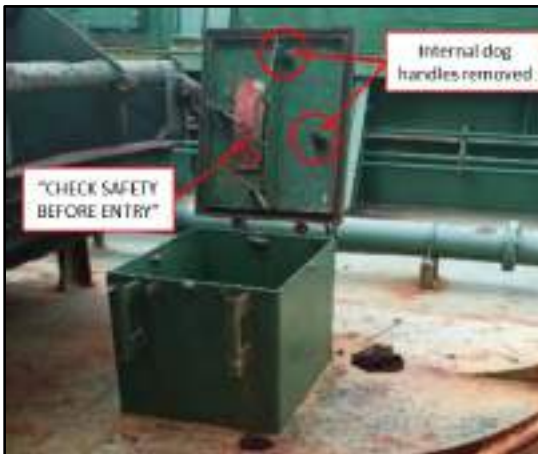
Figure 6 – The booby hatch cover for No.5 cargo hold  
(Source: The Company, annotated by the TSIB)

1.4.2 The outer side of the booby hatch was marked “KEEP CLOSE AT SEA” and “NO.5 HOLD ACCESS” (see **figure 2**). On the inner side, a red metal plate on the hatch marked the number of the cargo hold for access together with “CHECK SAFETY BEFORE ENTRY” (see **figure 6**). These markings were a part of the ship’s original design from the shipyard. There was no other sign or notice in the vicinity indicating that the cargo hold was an enclosed space or that the cargo hold was carrying coal at the material time.

2.5.4 The investigation team noted that there was no standard signage for enclosed spaces for use on ships, and while a standard is being developed by the IMO, there is merit for the Company to consider posting a graphic or infographic signage in conspicuous places on the ship. The signage should be in a manner that is understandable by all crew to provide a constant reminder of the risks of entering the cargo hold.

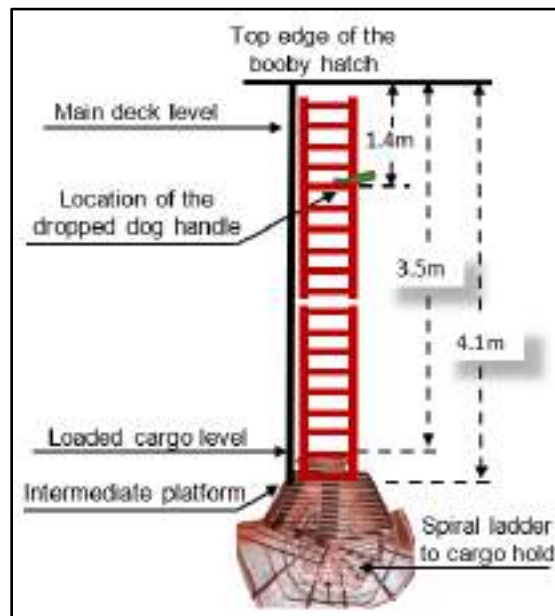
Figure 7 – Illustration of various heights (not to scale)

1.4.3 Access to the cargo hold from the booby hatch is via two connecting vertical ladders which end at an intermediate platform (with a grating) and from there, via a spiral ladder. The internal dog handle was wedged at about 1.4m from the booby hatch cover on the upper vertical ladder. The top of coal cargo was about

3.5m from the hatch cover, where the ASD1 was seen lying. The intermediate platform is about 4.1m from the hatch (see **figure 7**).

- 2.1.6 This hypothesis is further corroborated by the height of the ASD1 and the location where the dog handle was found. From the location where the dog handle was found to the coal level, it is about 2.1m (see **figure 7**). When a person climbs up a vertical ladder, both hands are extended to hold the sides of the ladder. With the height of 1.70m and the arms' length of about 0.5m, it is likely that the ASD1 was either about to climb up the ladder or making the first couple of steps on the ladder, before losing consciousness. The fall was from a low height which explains the reason for no visible injuries sustained by the ASD1. The investigation team opined that the ASD1 might have deemed the cargo hold to be safe for entry and that retrieving the dog handle was a simple task which could be done quickly.

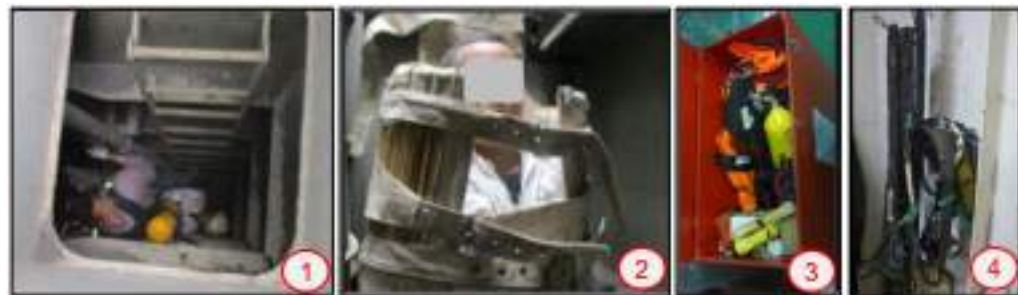
Figure 7 – Deployment of the SCBA, stretcher, rope and harness for the rescue drill (simulated at ship's duct keel)  
(Source: photographs 1&2 from the Company, 3&4 from the TSIB)

1.7.2 According to the records obtained by the investigation team, a physical enclosed space entry drill was conducted at the duct keel on 10 October 2021, where the pre-entry checks and risk assessment were carried out, the SCBA, stretcher and other equipment (See **figure 7**) were deployed, the rescuing operation was simulated, and the outcome of the drill was documented as satisfactory. All the crew listed in the table (paragraph 1.3.2) participated in that drill.
