SAFETY DIGEST

Lessons from Marine Accident Reports

1/2023

MARINE ACCIDENT INVESTIGATION BRANCH

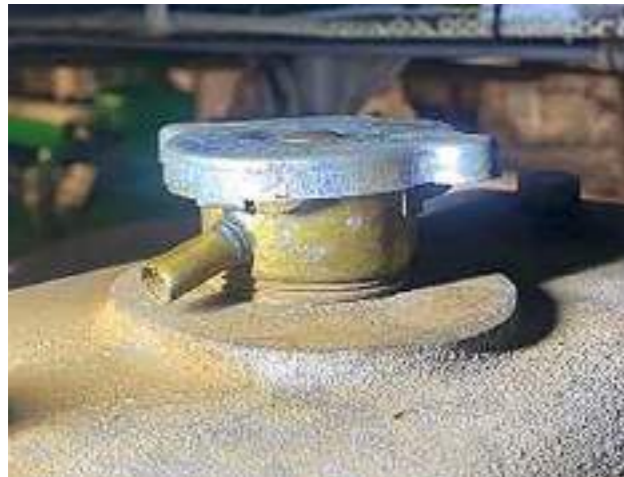
The propulsion engine of a small coastal passenger vessel began to overheat while on passage to its next port. One of the vessel's engineers stopped the engine and cleaned the sea water strainer, which had become clogged with debris and was restricting the flow of cooling water to the engine. The engineer also noticed that the engine's cooling system expansion cap (Figure 1) looked loose; he protected his hand with a rag and attempted to tighten the cap, which suddenly blew off. The engineer responded by instinctively turning his back to the unit but was sprayed with scalding hot water from the engine's pressurised cooling system.

Figure 1: Expansion cap in the fully closed position

1. **Observe** → Always allow an engine to cool down before attempting to conduct maintenance on a pressurised cooling system.
2. **Risk** → Ensure you refer to the risk assessments. These exist to alert operators to potential hazards and the mitigation measures that should be implemented before the task is undertaken. The risk assessment method statement is a clear explanation of how you are going to manage the identified risks.
3. **Procedure** → The company issued a safety flash that highlighted the dangers identified in this case. Familiarise yourself with manufacturers' manuals and ensure that you know how to complete a task correctly and safely.

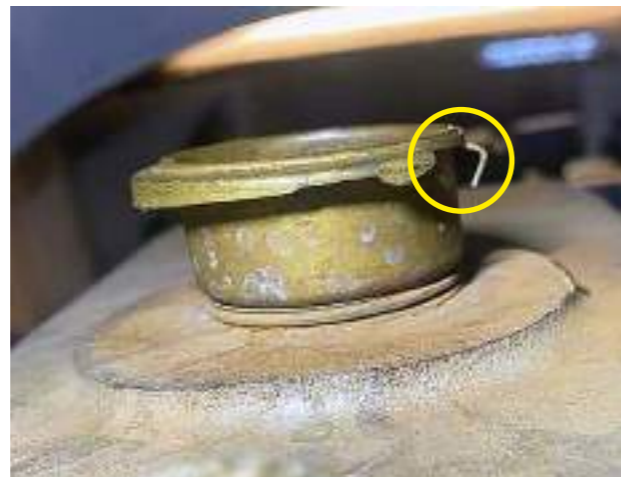
It was later found that the securing lugs for the engine cooling system expansion cap were bent (Figure 2), which had possibly prevented the cap from sealing correctly.

Figure 2: The bent securing lug

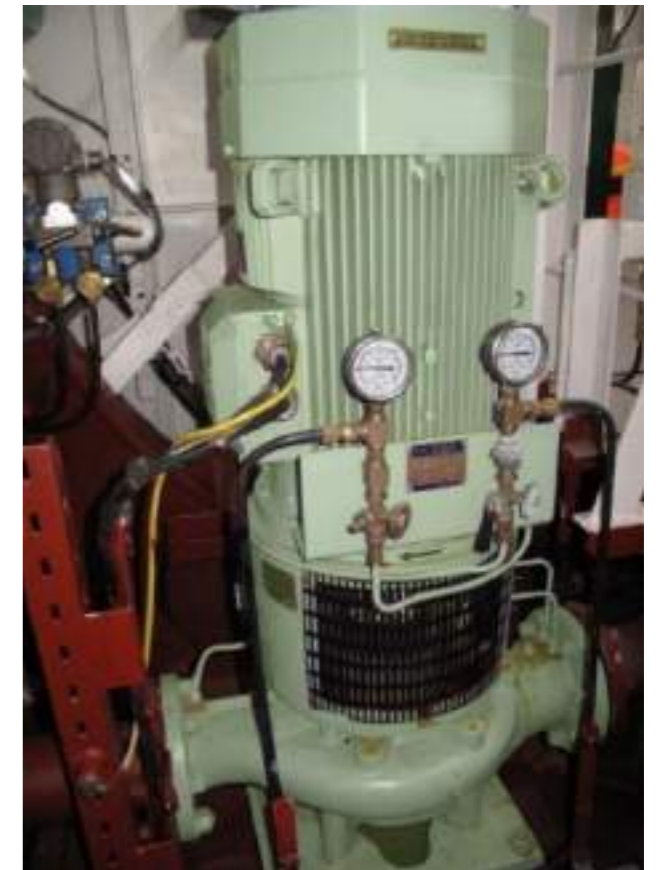
An oil tanker was anchored off the south coast of the UK when an auxiliary room fire alarm activated. The ship's firefighting team went to the engine room to investigate and discovered smoke emanating from an overheating sea water pump (see figure); they stopped the pump, allowed it to cool down and found that there was little damage.

The cooling water had nowhere to go when the valves were closed and there was no flow through the cooling pump, which caused its mechanical seal to gradually overheat and generate smoke.

Figure: The sea water pump

1. **Communicate** → Maintenance should be effectively planned and communicated. It is vital to consider the effects of isolation on running equipment that may not be directly related to the job in hand. The use of isolation logs and lock-out/tag-out notices can help engineers monitor the status of their systems and prevent mishaps.
2. **Aware** → All of the human senses play a part in the detection of issues that electronic or mechanical sensors may fail to pick up. The application of touch, smell, sight and sound while moving through a space are powerful tools in the armoury of a watchkeeping engineer and provide early warning of a developing problem.

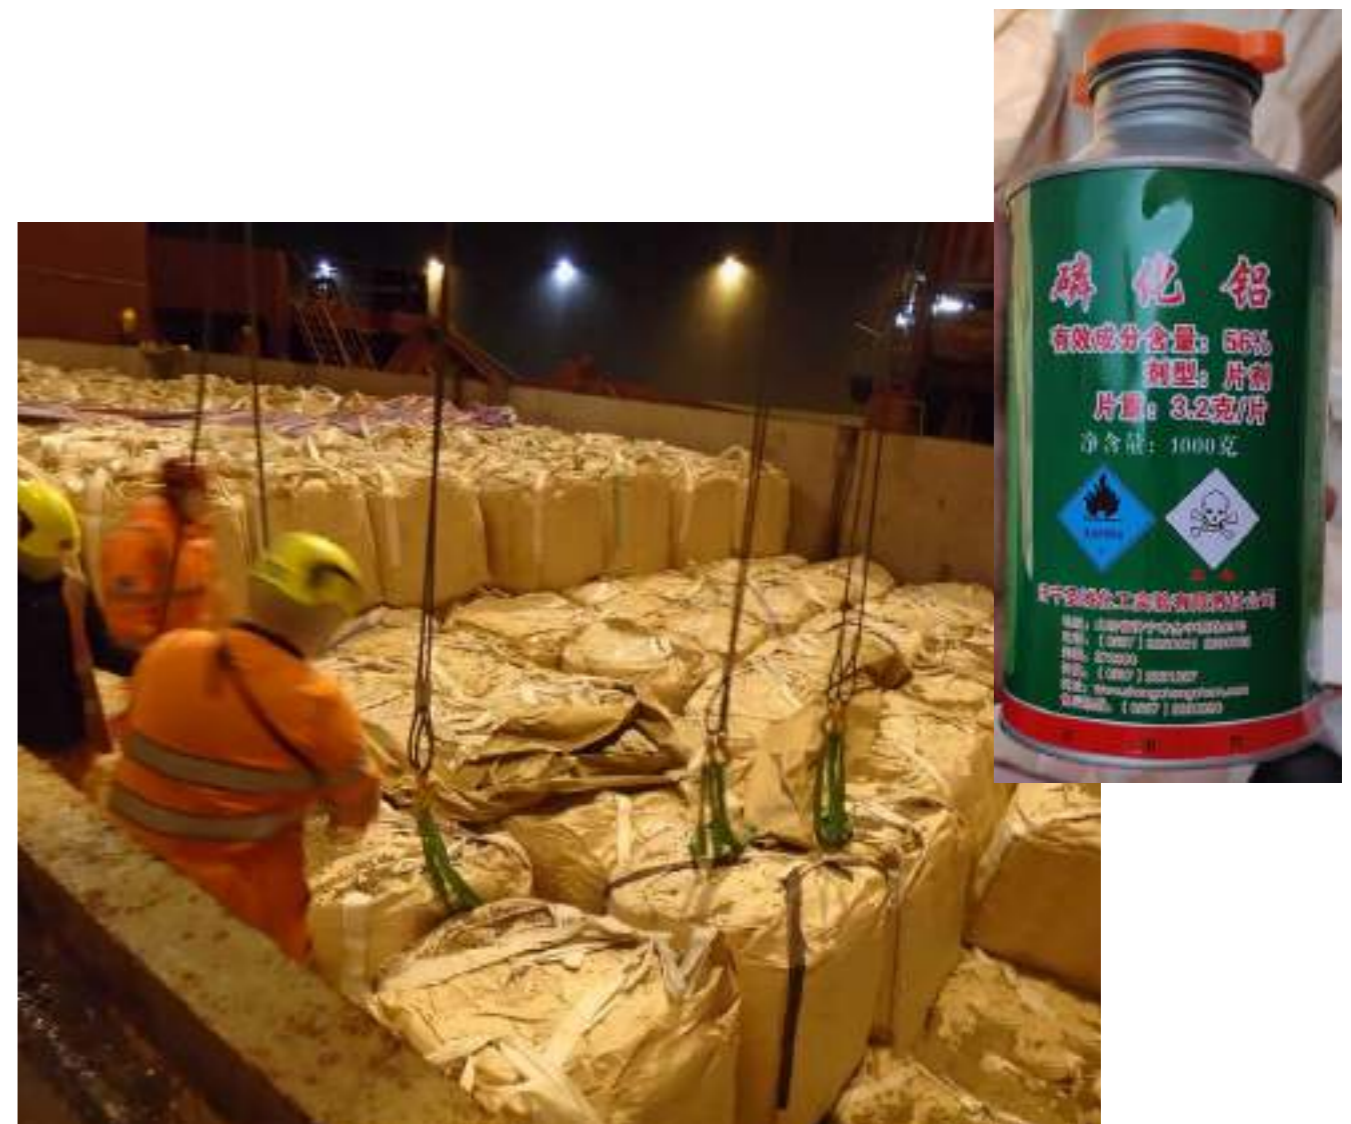
The untrained crew incorrectly deployed the fumigant, which did not fully volatilise or disperse during the 5-month voyage to the cargo's discharge port and so presented both a fire hazard and poisoning risk. The crew did not record the use of fumigant on board and the discharge port was unaware of its presence among the cargo. The ship's cargo holds were tested for oxygen levels, carbon dioxide, carbon monoxide, hydrogen sulphide and lower

explosive limit before the stevedores discharged the cargo. When the stevedores started working in the holds they soon began to find the cans of fumigant among the bags of sweet potato pellets (see figure). The cans were marked with hazard symbols and the stevedores showed them to their supervisor; however, the cargo work was not suspended for several hours, by which time some of the stevedores had been in contact with the aluminium phosphide. The next morning one of the stevedores became unwell and required hospital treatment for sickness, disorientation and nerve damage to his hand.

Figure: Stevedores unloading the bags of sweet potato pellets and (inset) a can of fumigant

- Hazard** → Cargo holds can be a hazardous environment; stop work if you find something unusual and check if it is safe to proceed.
- Equipment** → Appropriate personal protective equipment (PPE), including coveralls, gloves, face masks and respirators, must be worn when handling fumigants.

- Procedure** → Masters, owners and charterers are reminded of the contents of IMO Circular MSC.1/Circular.1264 – *Recommendations on the Safe Use of Pesticides in Ships Applicable to the Fumigation of Cargo Holds*, which details the safe use of fumigants, measurement of fumigant levels on board ships and the responsibility to notify port authorities of the potential presence of fumigants on board.

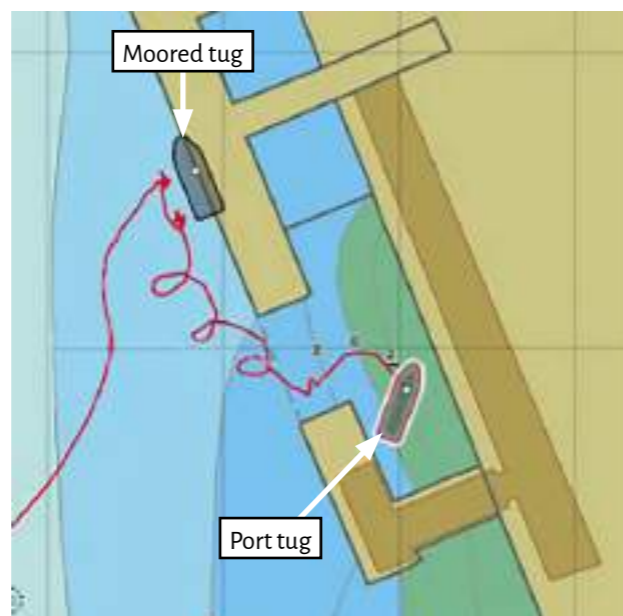
After accepting propulsion control from the engineer in the engine room, the master struggled to break clear due to the strong tidal stream. To prevent a collision with the other tug, full astern was being used on both engines when the port propulsion unit alarm sounded and the tug began to spin clockwise to starboard, narrowly missing both the moored tug and the floating pontoon (Figure 1).

Figure 1: Uncontrolled track and final position of the port tug

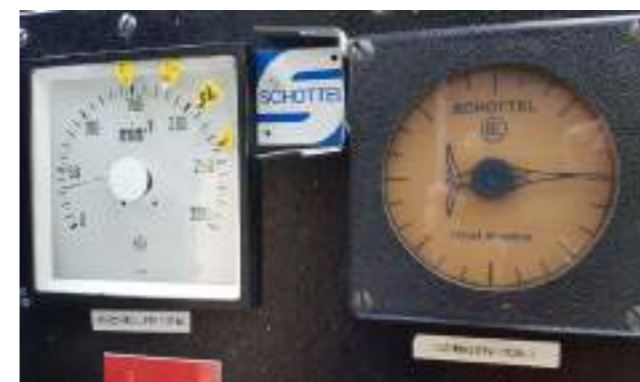
Figure 2: The azimuth direction indicators

3. **Risk** → The azimuth directional indicators were hard to read due to the glass covers becoming less transparent with age. The port shaft indicator had failed a day earlier after an attempt to replace the internal lamps resulted in a broken indicator needle. A temporary needle repair was unsuccessful and the master, unable to adjust the brightness of the new lamps, resorted to covering the indicator with a piece of paper. A defect report submitted on the same day stated: *(Still) able to operate equipment and requires repair asap*. As a result, the master relied on the starboard shaft indicator for both shafts. Risk assessments are essential to identify the potential hazards arising from inoperative or ineffective propulsion controls and indicators and when to keep the vessel in operation or withdraw it from service for repairs.

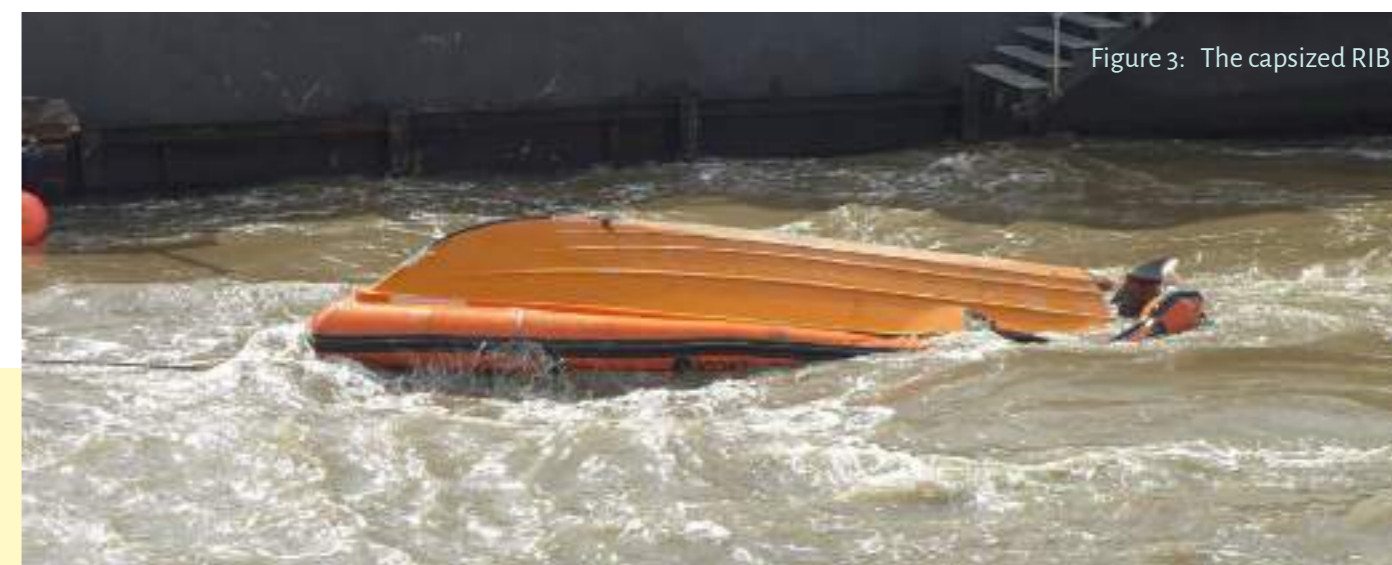
The tug's bow made hard contact with an adjacent floating pontoon's handrails and pontoon air tank. Its port quarter then made heavy contact with a moored rigid inflatable boat (RIB), the impact of which caused the RIB to capsize and its landing stage to sink (Figure 3). The tug's stern and starboard side then rotated close to the shore before full propulsion control was regained and the master manoeuvred the tug out into the river.

Figure 3: The capsized RIB

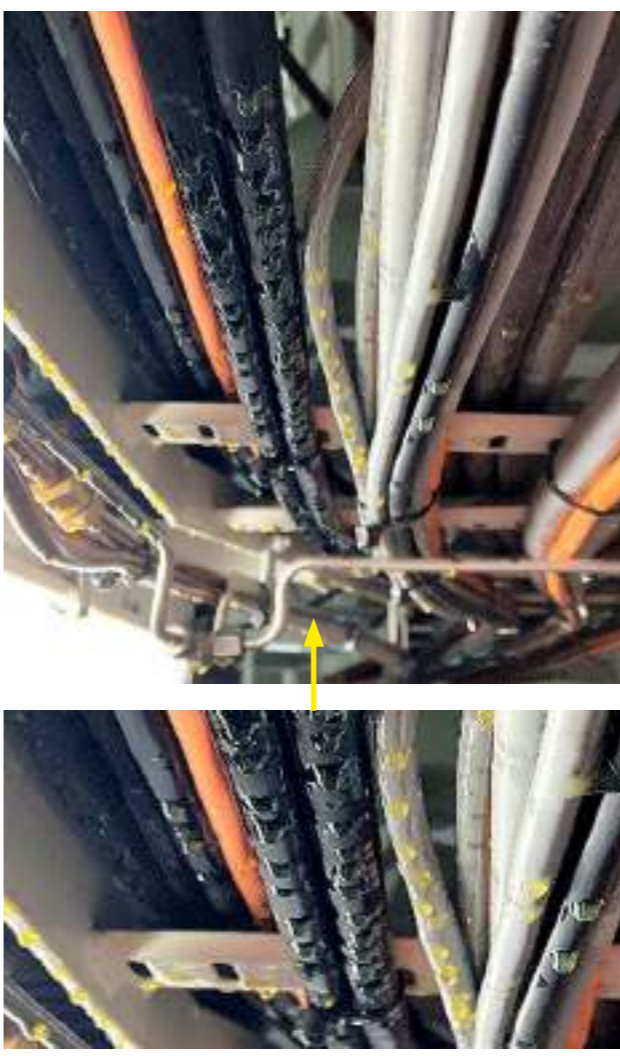
The vessel was able to make its way to port, where an investigation was started that involved the shipbuilder and gearbox manufacturer. Before the vessel could leave port, the contaminated lagging was replaced, electrical cable trays and affected electrical connections were cleaned and checked, various electrical motors were overhauled and the engine room was washed down.

Figure 1: Oil dripping from engine room cables

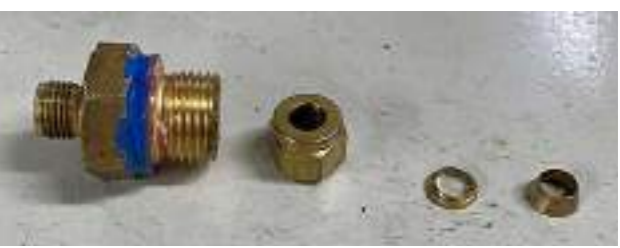
The investigation identified that the temperature probe was held in place by a pipe compression fitting (Figure 2) that had not been fully tightened during the vessel build. Once the fitting slackeden further, there was nothing to stop the oil pressure forcing the probe out of the gearbox.

Figure 2: The original temperature probe fitting

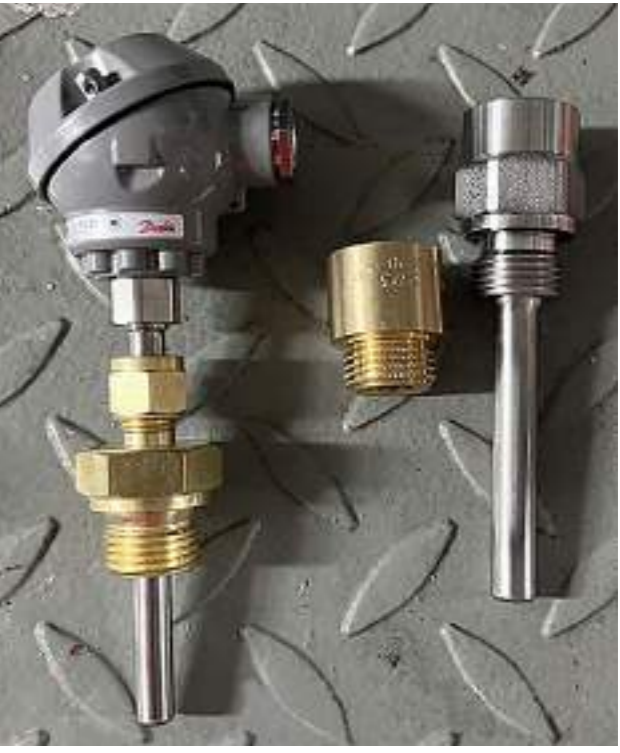
Figure 3: The new temperature probe fitting

- Equipment** → Although it was a marine gearbox, the design of the probe fitting was insubstantial in terms of the operating environment and the consequences of it coming loose. Poorly designed equipment increases the risk of injury to the crew and can force them into undesirable workarounds. In this case, the manufacturer produced a redesigned fitting and probe housing that would prevent reoccurrence and allow the probe to be changed while the propulsion system was working (Figure 3).

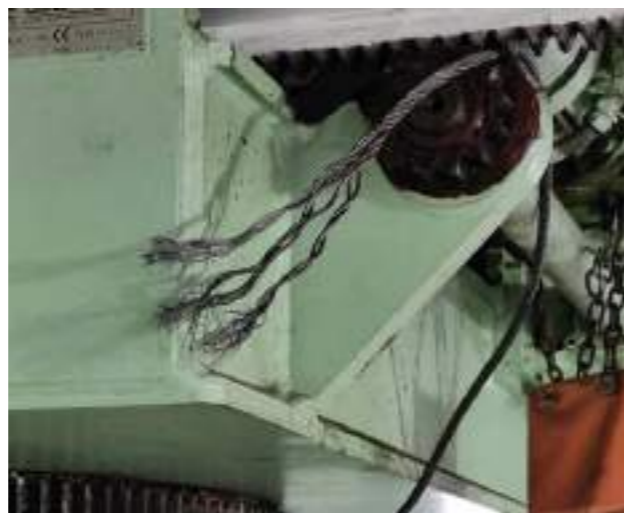
The failed hoisting wire had been renewed shortly before the engine maintenance work started but was 7m shorter than the wire length specified by the crane manufacturer in its technical manual. The shorter length wire affected the operation of the crane's hoist limit switch and prevented it from cutting power to the

winch electric motor when the hook was raised to the maximum lift height; the winch motor was therefore able to overload the wire and cause it to fail.

Tests of the three remaining engine room cranes established that all of the limit switches failed to stop power to the winch motors and thus failed to meet manufacturer requirements. The wire length recorded in the ship's planned

Figure 1: Failed crane hoisting wire

maintenance system (PMS) computer was found to be incorrect when compared with the manufacturer's specification. The cranes were taken out of service for repair and the ship's engineering team were instructed to conduct a

full inspection of engine room hoisting devices and take necessary steps to ensure that all equipment met manufacturer specifications; they were also reminded to test the hoist limit switches before operating the cranes.

1. **Hazard** → The crew member was lucky on this occasion but the first lesson here is to not stand under or near to suspended loads, regardless of whether the lifting equipment is new or has been recently overhauled. This incident is a reminder that equipment failure can occur at any time, potentially with severe consequences.
2. **Margin of safety** → It is unclear why the wire length documented in the PMS was incorrect. However, overreliance on hoist limit switches to cut power to the winch electric motor is risky, whether on cranes or lifeboat davits. A high torque electric winch motor has the potential to over-stress the hoist wire, causing it to fail. It is always safer to stop the lifting operation before overhead capacity is reached, even if the system is correctly set up and the limit switch has been tested.

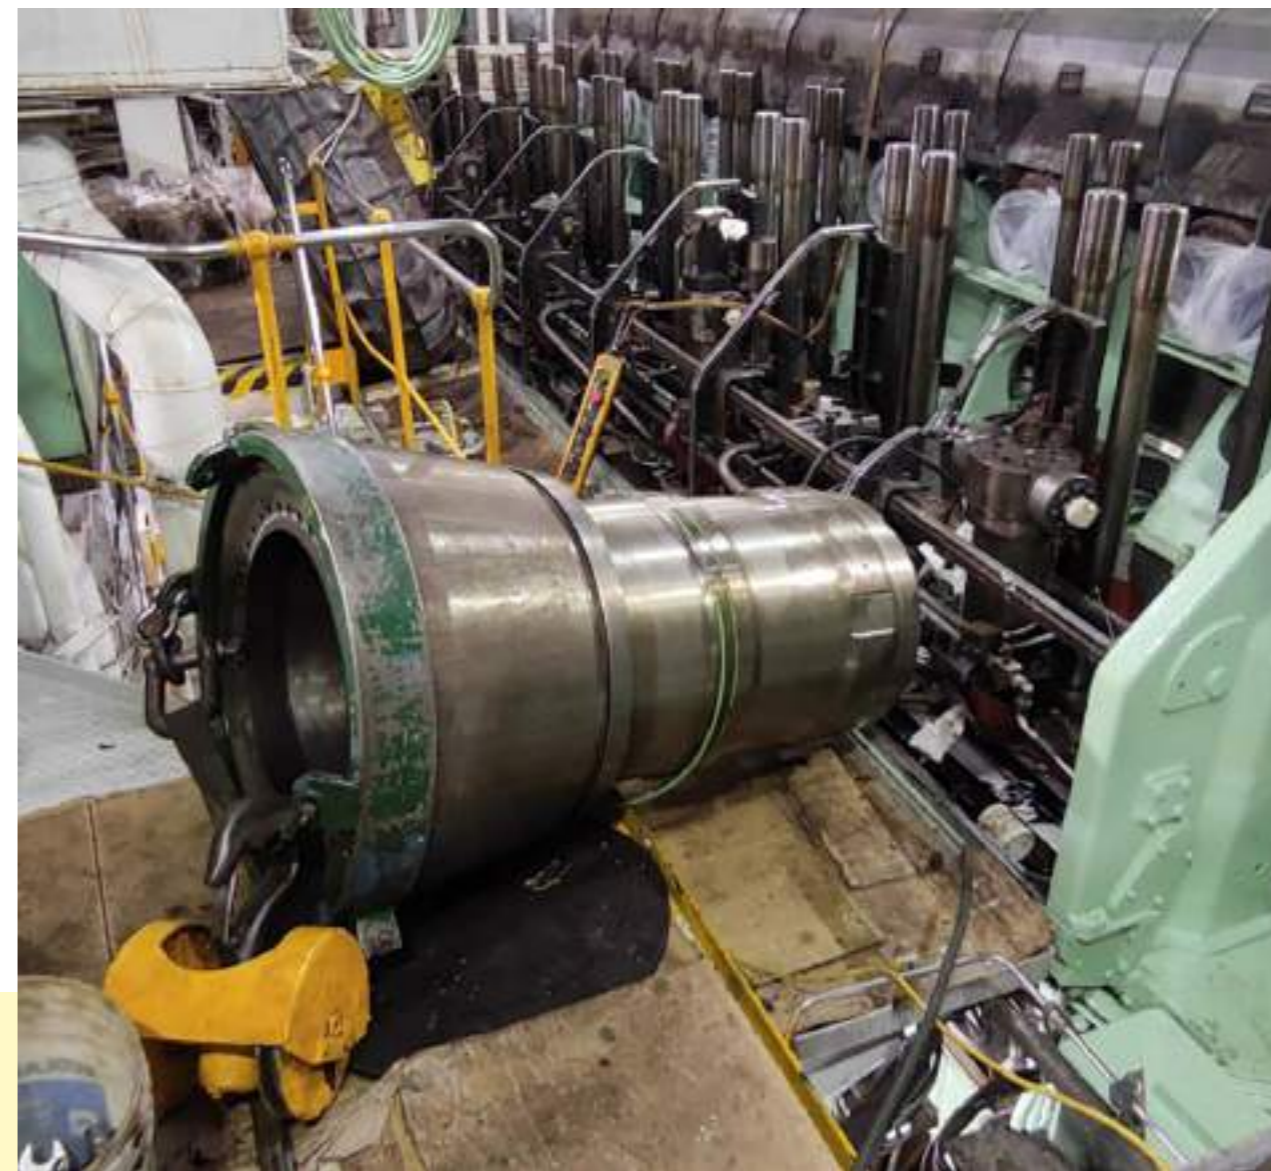
A cruise ship's engineering team were working with the engine manufacturer's technicians to overhaul a large diesel generator, using the engine room's overhead gantry crane to lift the heavy engine components. One of the 1200kg cylinder liners was being lifted into position above the engine, a process that required the electric winch motor to raise the crane hook to its maximum lift height, when the crane's hoisting wire suddenly snapped (Figure 1). The suspended cylinder liner fell onto the engine (Figure 2), causing damage to both pieces of equipment, and struck the left foot of an engine room fitter who was standing nearby. The crew member was treated in hospital for a broken toe and subsequently repatriated.

Figure 2: Position of cylinder liner after wire failure

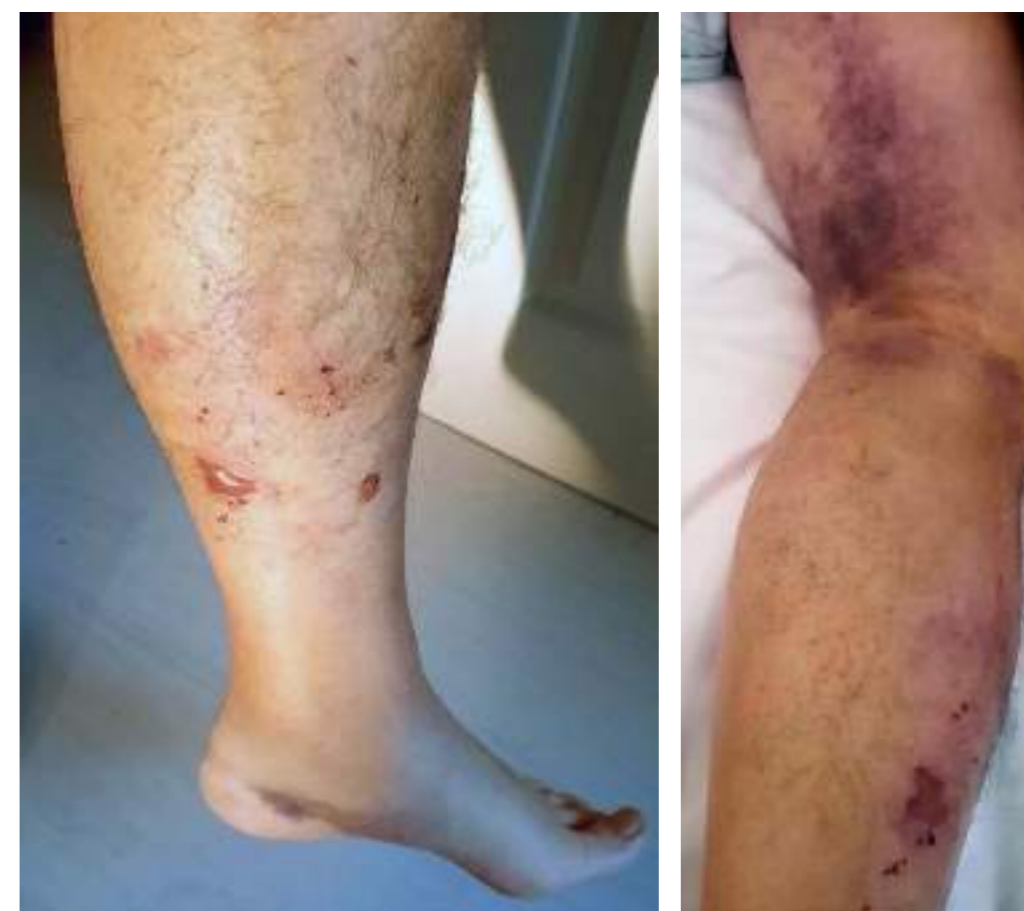
The AB suffered severe bruising and abrasions to his leg (Figure 2), but the injuries could have been much worse.

Figure 2: Leg injuries sustained by the able seaman

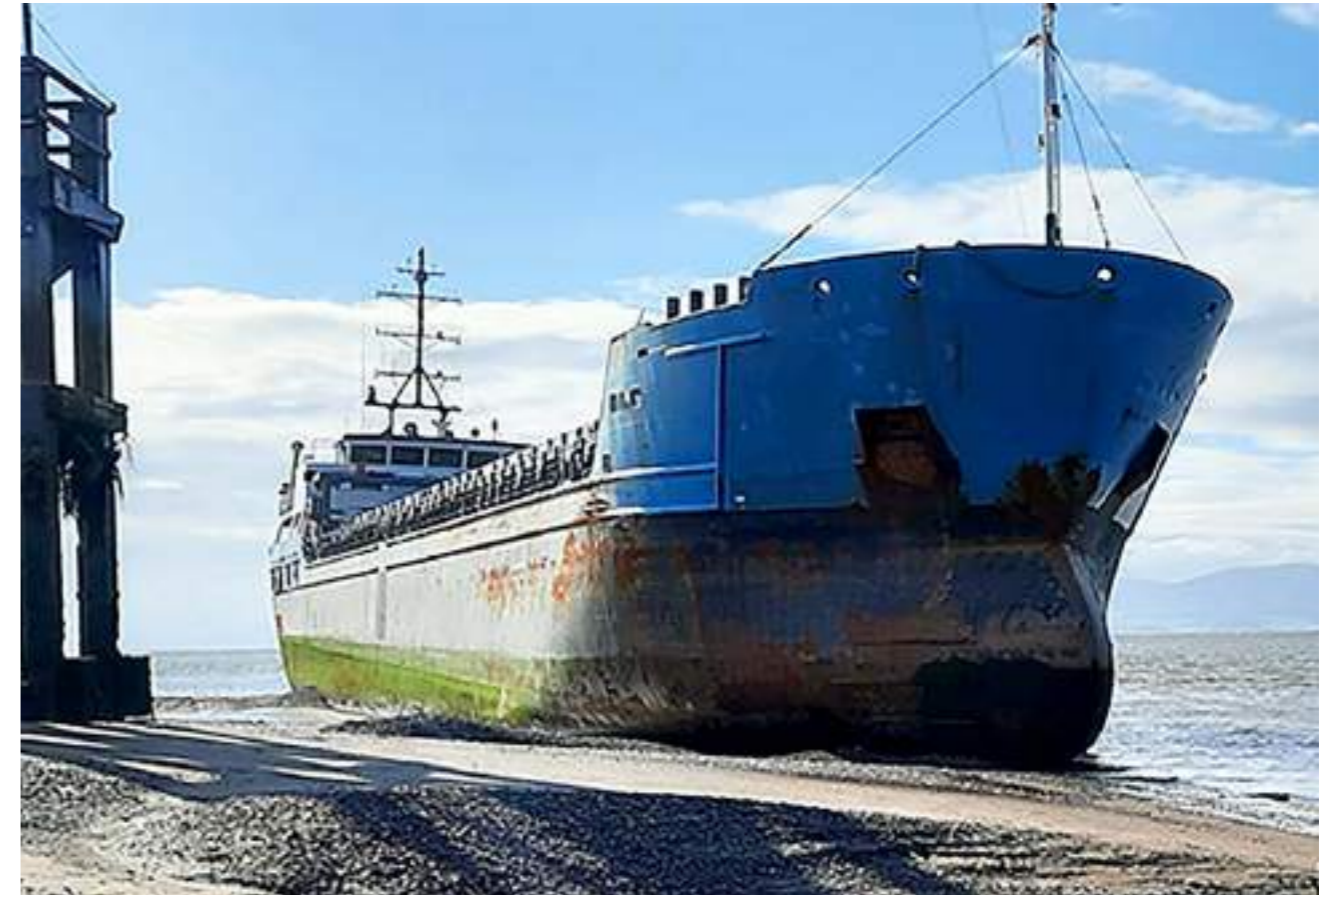
Figure 2: Bulk carrier aground on the shoal in the approaches to the lock entrance

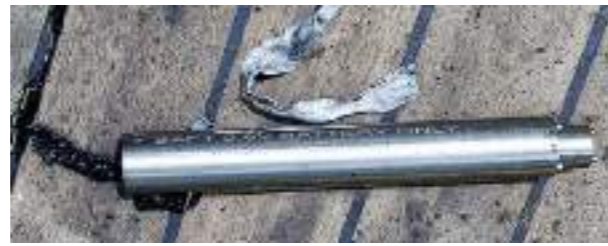
Seven hours later, the vessel's bridge team heard a loud bang followed by a fire detection system warning for the deepwater equipment storage area. The attending crew members discovered a scorched and damaged metal battery tube lying on the deck (Figure 1).

Figure 1: Damaged battery tube

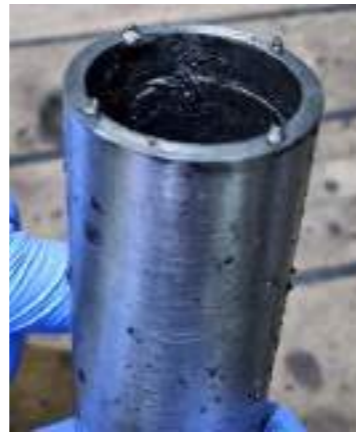
Examination of the battery tube indicated that sea water had leaked into the battery compartment (Figure 2) and contaminated the Li-ion battery, which caused pressurised gasses to build up and self-combust and resulted in a brief explosion. The remaining battery tubes were removed to a secure storage area for further checks.

Figure 2: Water ingress and damage

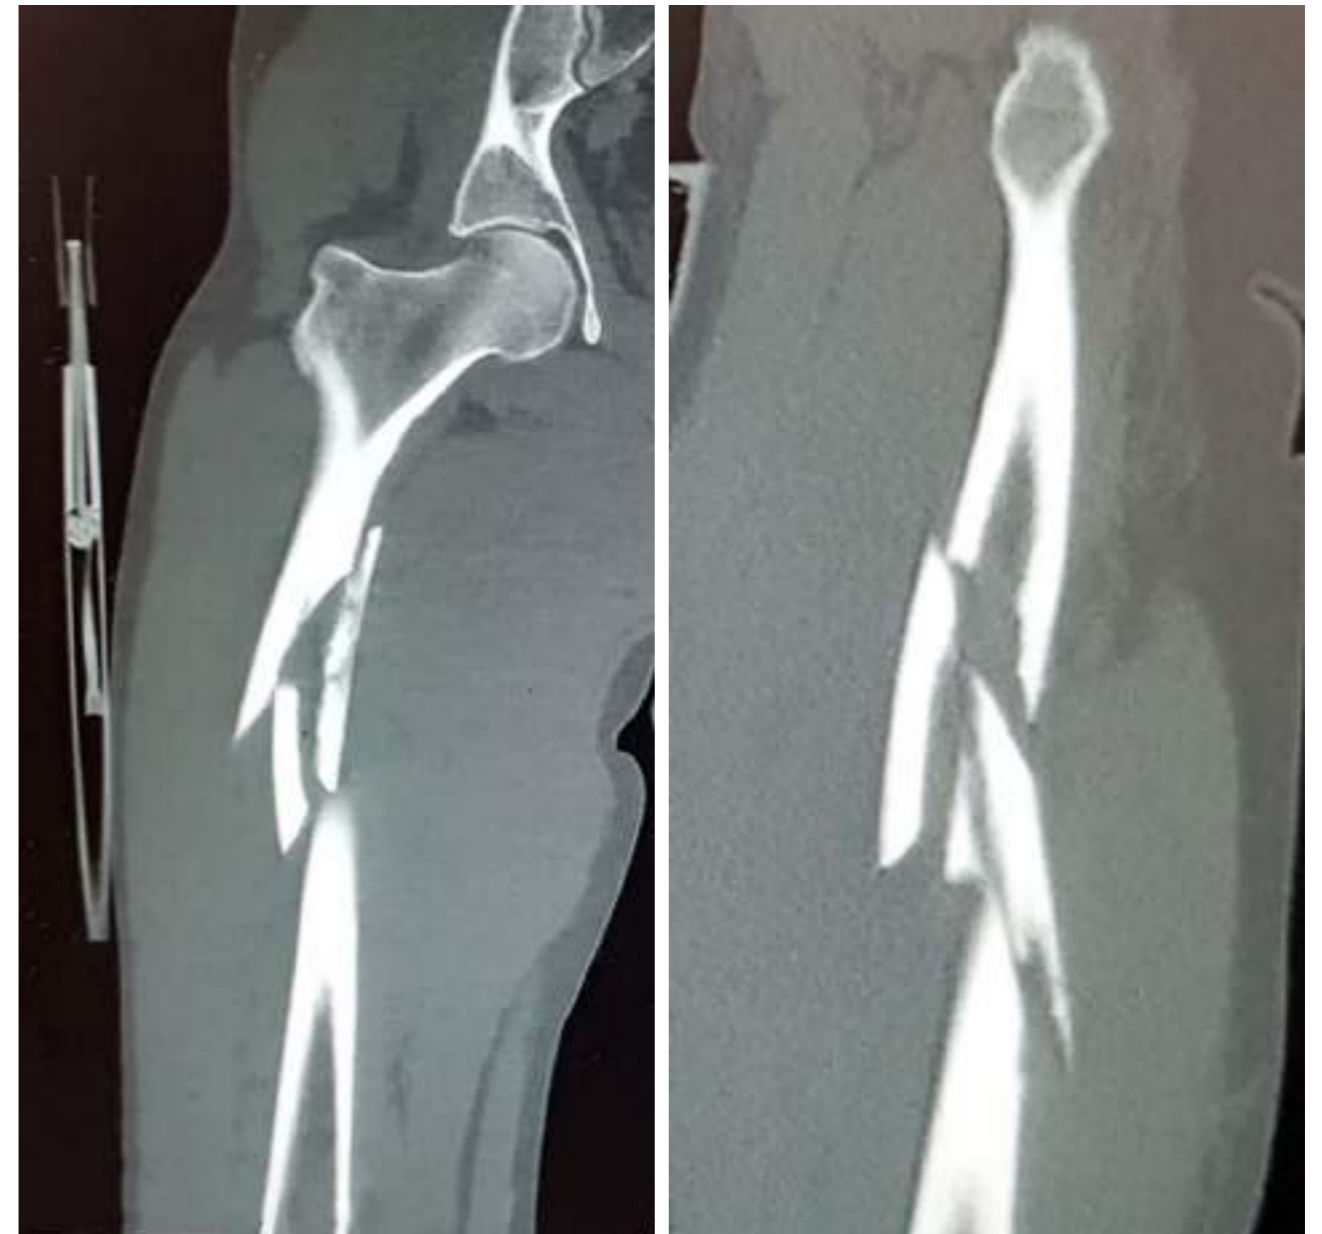
In considerable pain, the bosun managed to raise the alarm using his handheld radio. The crew mustered quickly, lifted the sheave off his leg and administered first aid. The dredger arrived at its berth and the bosun was transferred by ambulance to hospital, where he received treatment for multiple fractures to his leg (Figure 2). He was unable to return to work for several months.

Figure 2: X-ray images of the bosun's broken leg

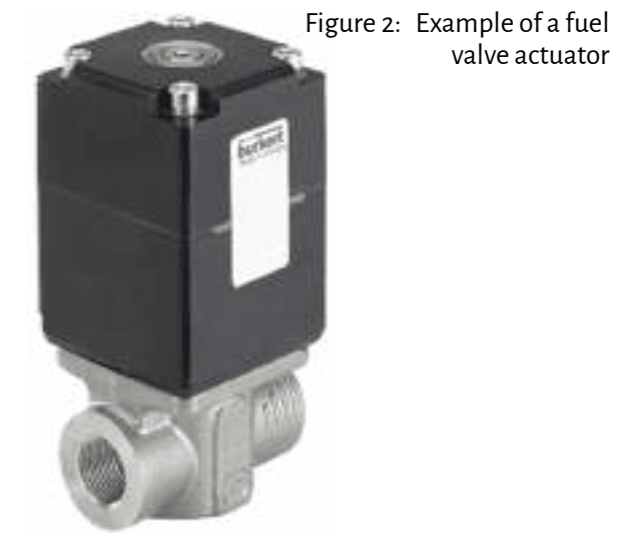
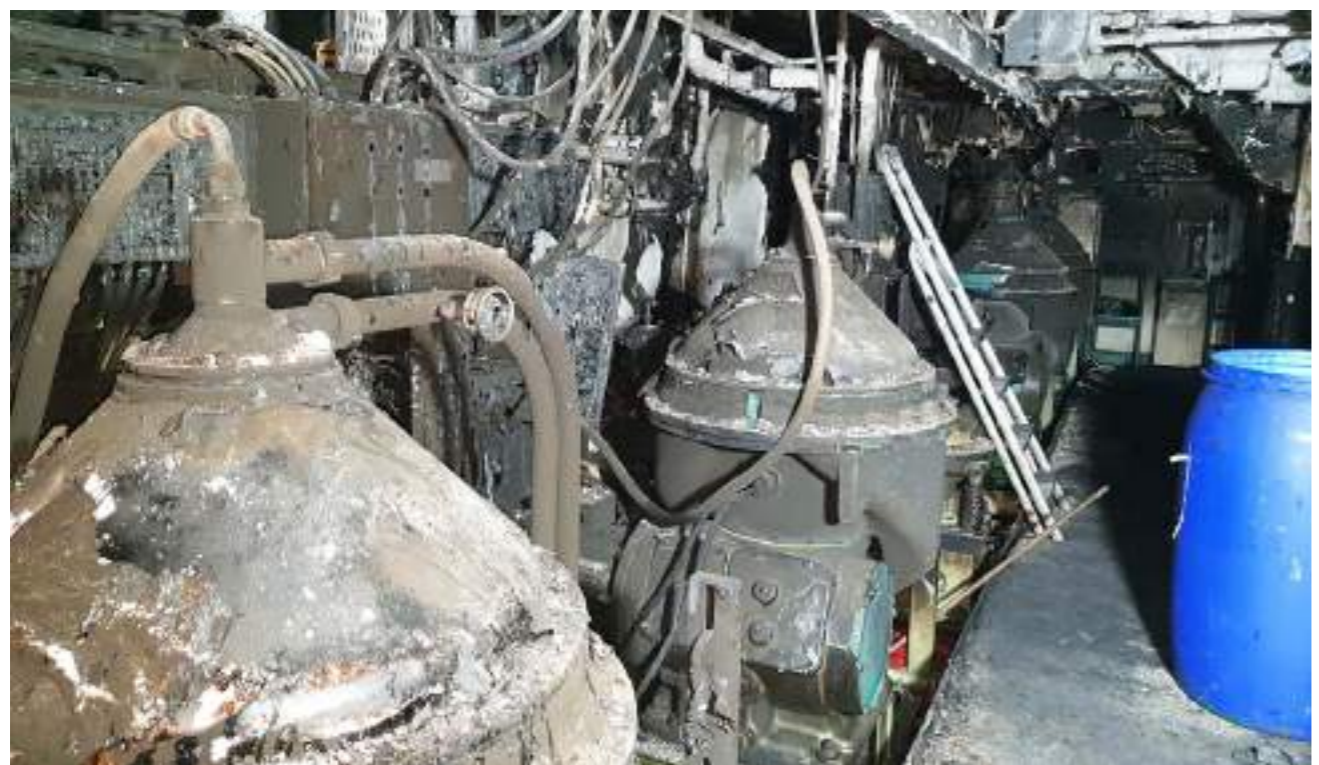
Examination of the equipment indicated that the fire had likely broken out due to gas oil spray emitted from a gas oil purifier system three-way

Figure 1: Fire-damaged fuel purifier room

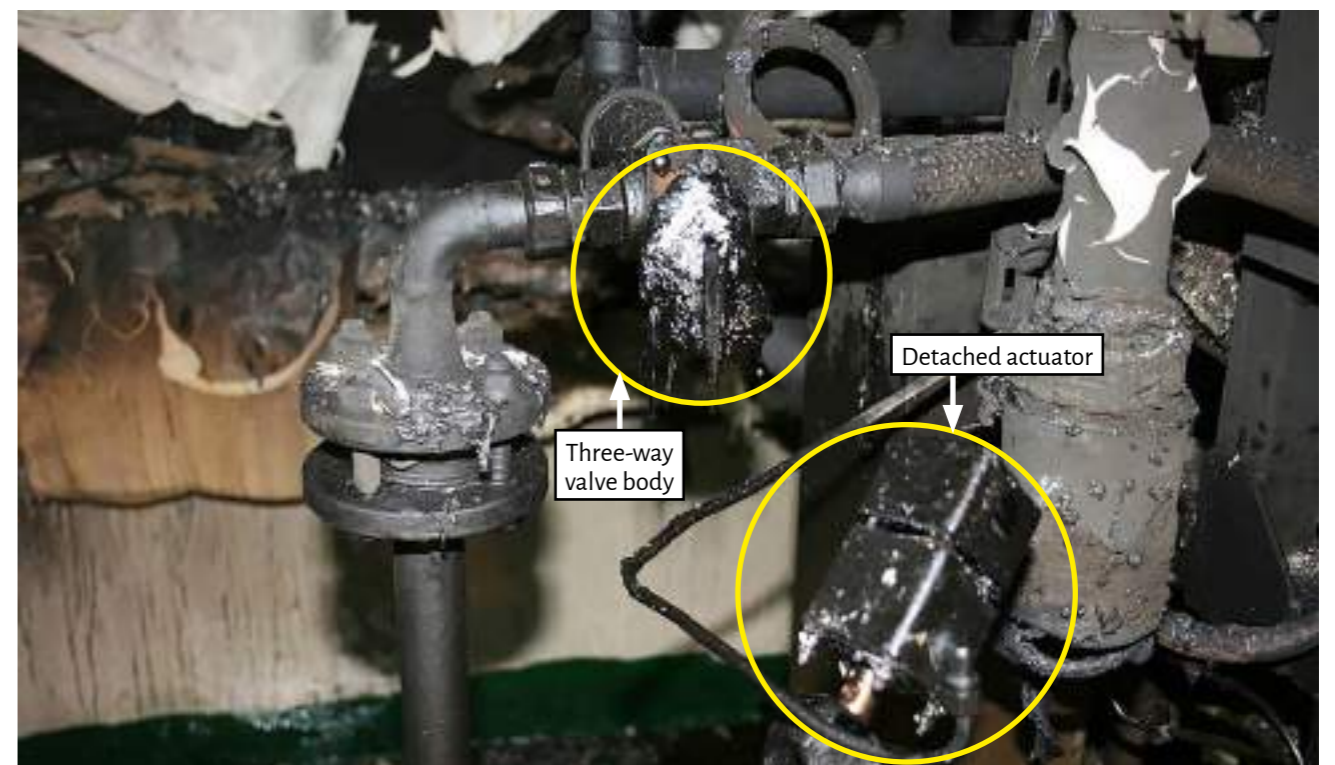
inlet fuel valve actuator (Figure 2). The actuator had become detached from the valve body and the whole assembly was severely damaged by fire and heat (Figure 3). Separation of the actuator and valve actuator spindle from the valve body allowed the fuel, operating at 2 bar pressure, to escape and spray over nearby heating and electrical equipment. On closer examination, the screws that secured the two parts of the actuator to the valve body were found to be slack.

Figure 3: Fire-damaged fuel valve actuator

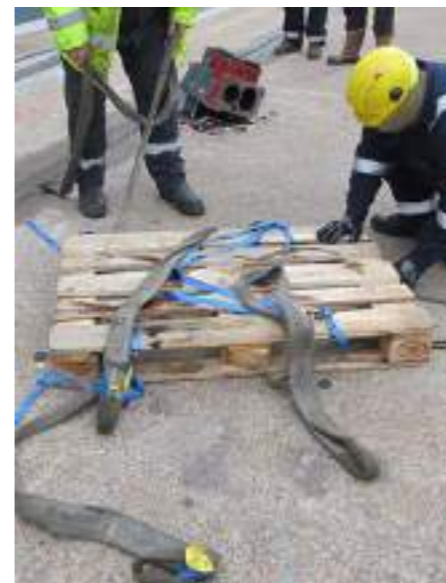
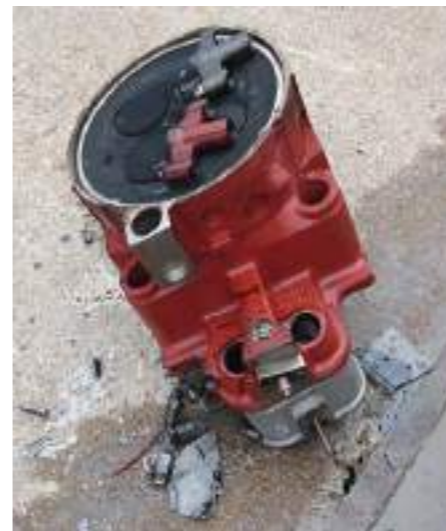
The initial lift of the wooden pallet was successful but when it was about 10m above the jetty the uppermost sling end slipped from the lower hook and flipped the pallet over, causing the cylinder heads to fall. Thankfully, the lifting operation plan ensured nobody was standing below the suspended load and damage was minimal; the falling cylinder heads caused a dent in both the jetty (Figure 2) and the operator's wallet.

Figure 2: Wooden pallet and damaged cylinder head

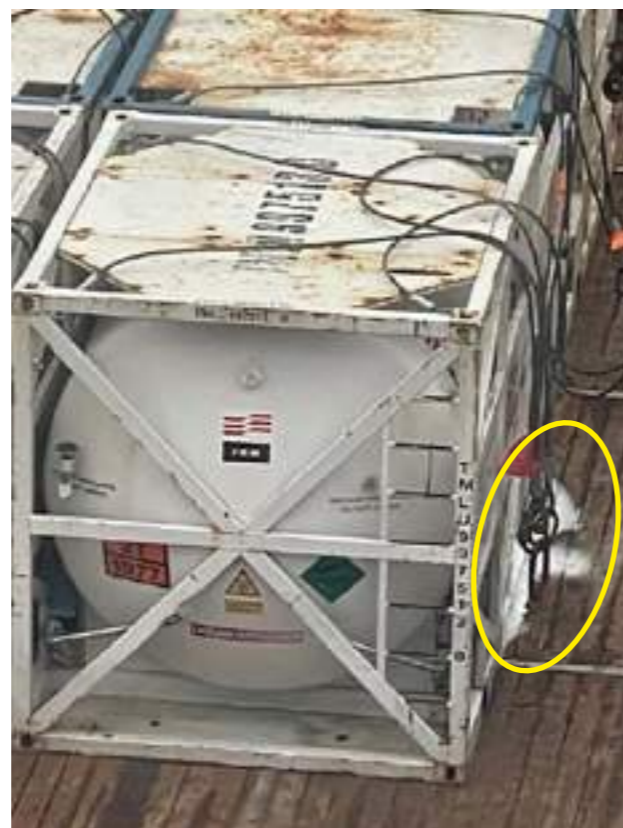
Figure 1: Icing of deck beneath nitrogen tank container

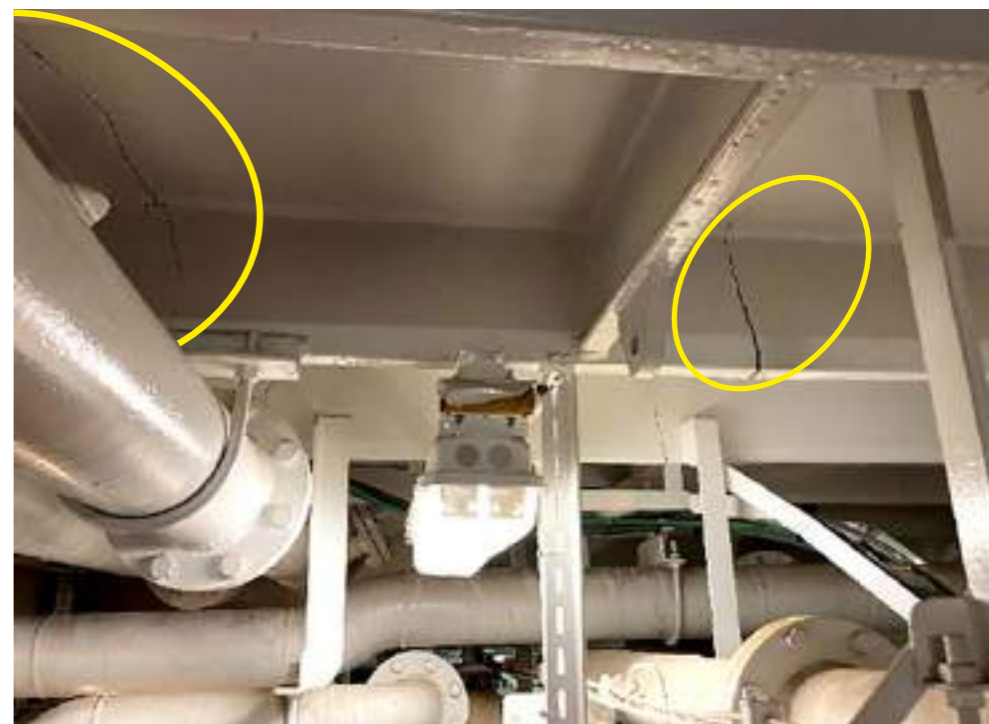
Figure 2: Cracks in the supporting steelwork

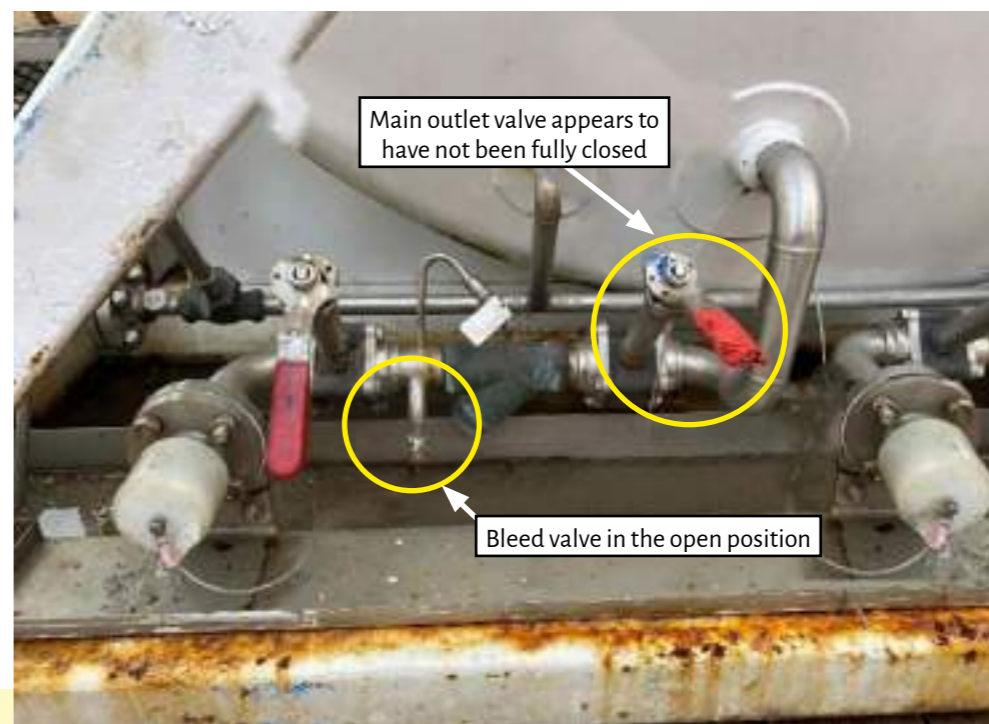
A post-incident inspection found that both the main outlet valve and the bleed valve on the nitrogen container, which was not locked, were slightly open and had allowed the nitrogen to leak out through the open bleed valve (Figure 3).

Figure 3: Tank outlet valves

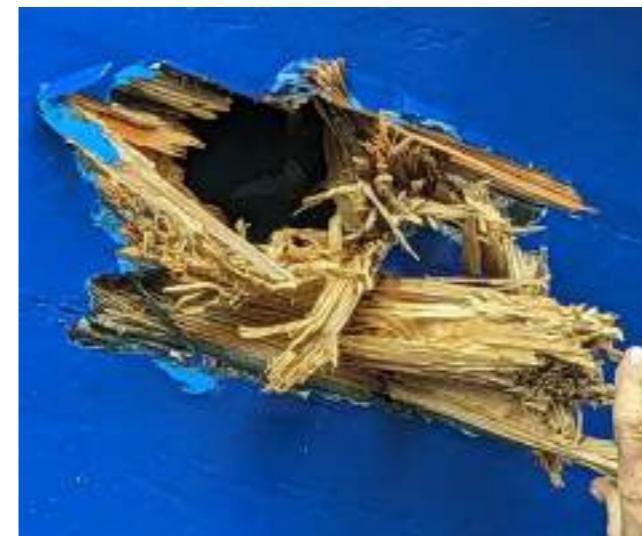
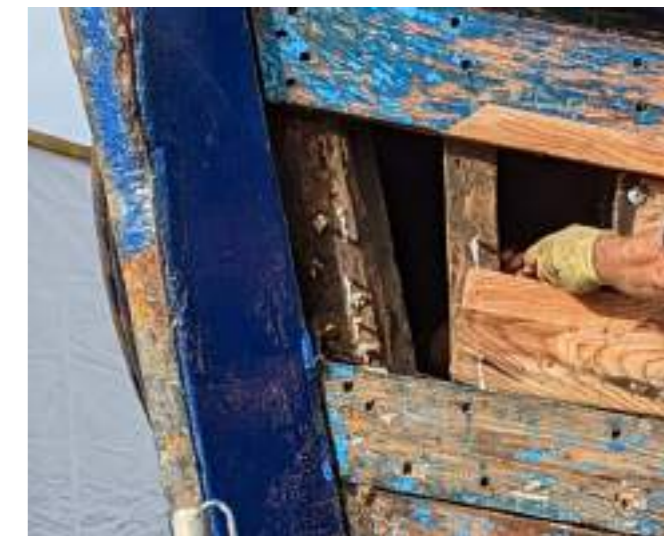
Although damaged (see figure) neither vessel was taking on water and both were able to return to port unaided to carry out necessary repairs.

Figure: The damaged fishing vessel (above) and yacht (below)

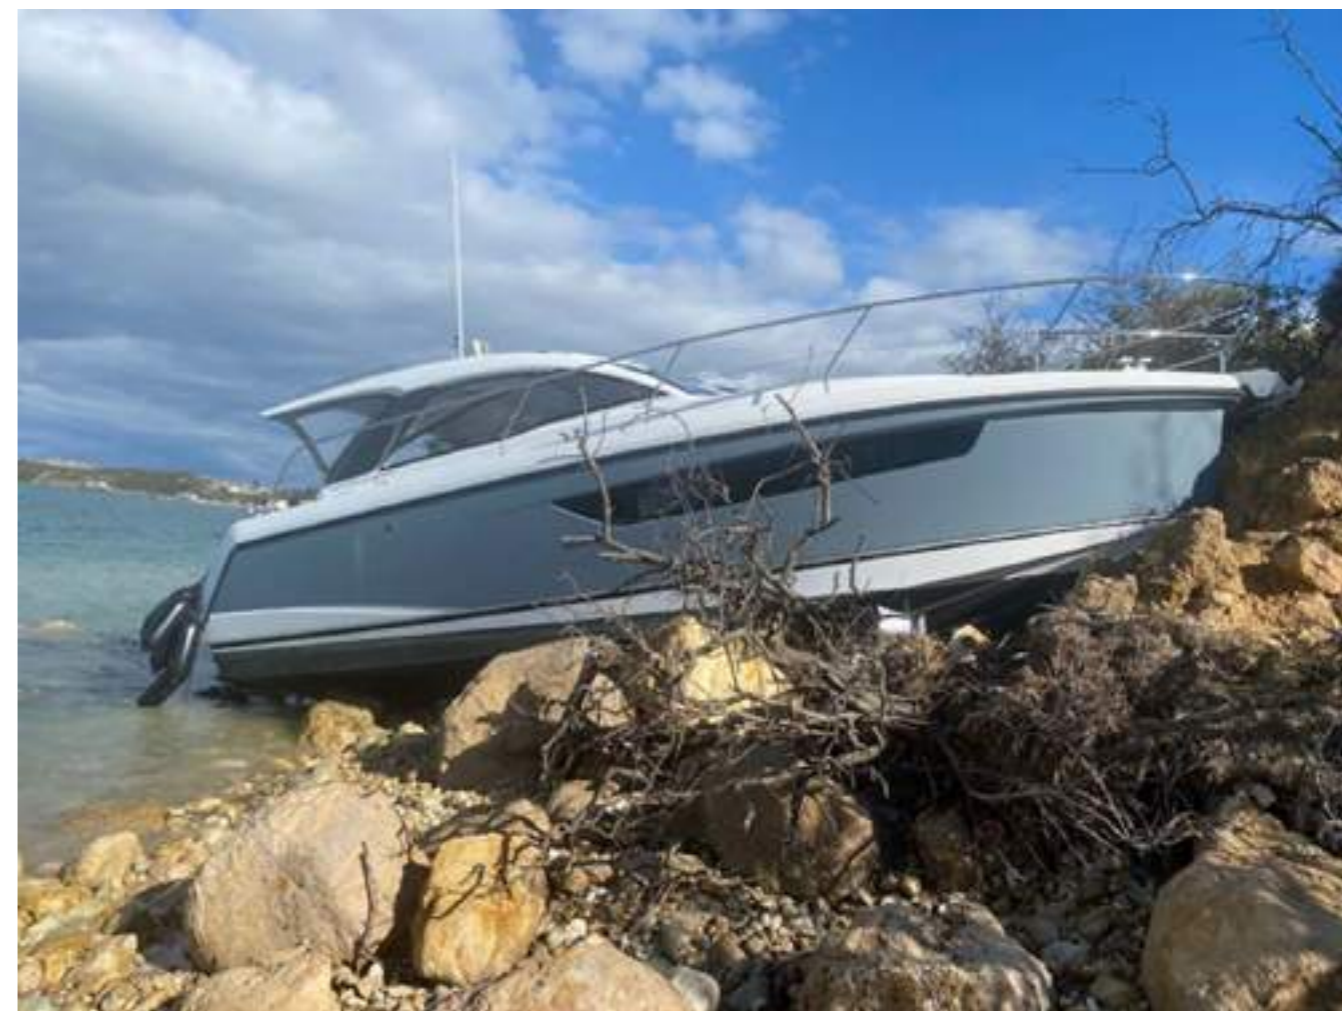
At least two crew members were found to need immediate medical attention when the group came to after the impact. Calls to the emergency services elicited a swift response and the two most seriously injured crew were airlifted to a specialist hospital for treatment. The remainder were taken to a nearby hospital for assessment. The motor cruiser was a write off.

Figure 2: Motor cruiser aground on rocky shoreline
