SAFETY DIGEST

Lessons from Marine Accident Reports

1/2023

MARINE ACCIDENT INVESTIGATION BRANCH

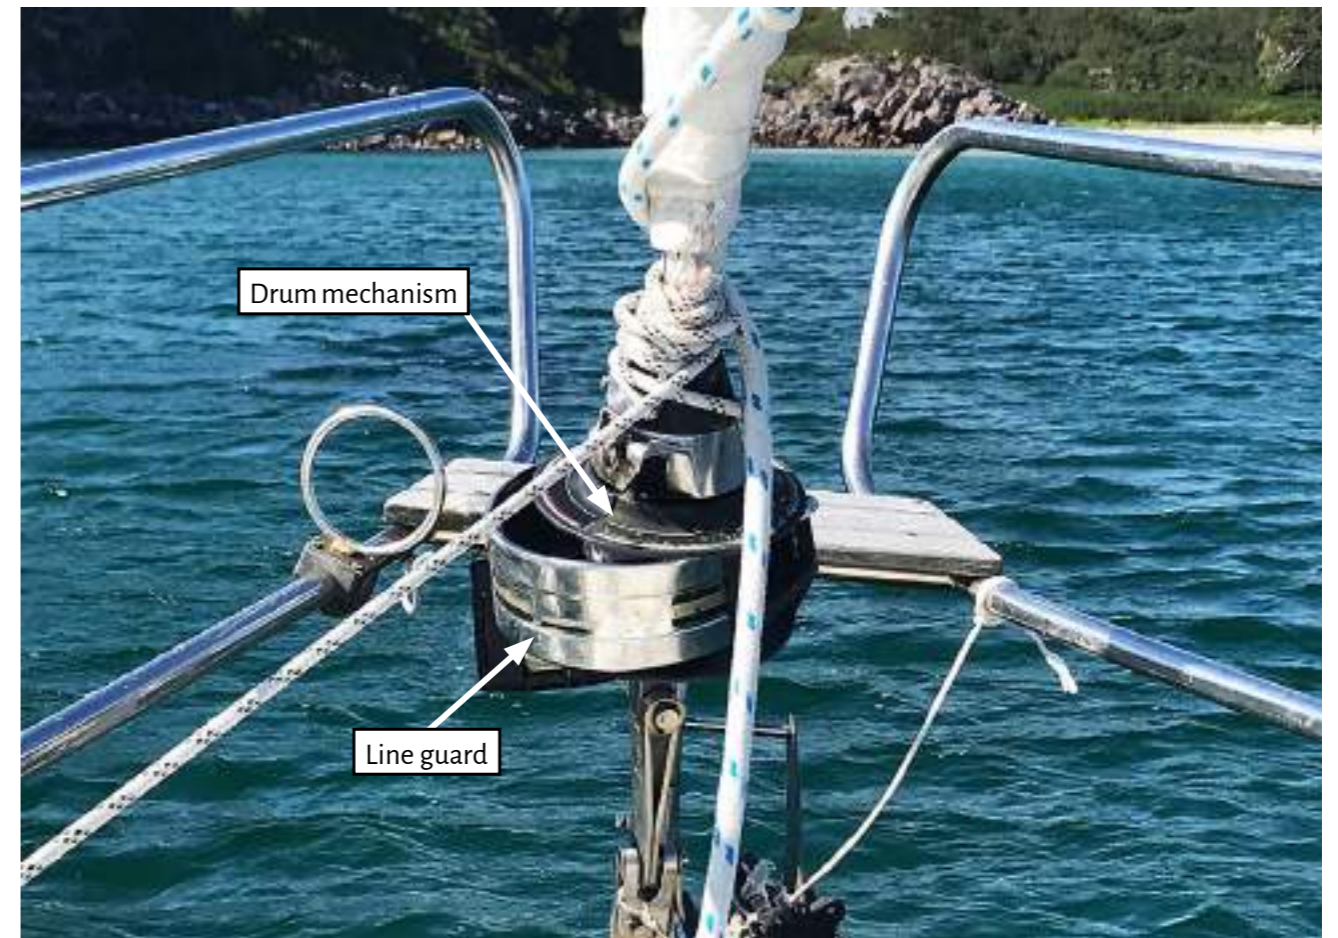
Figure: Defective furling gear with a gap between the line guard and the drum

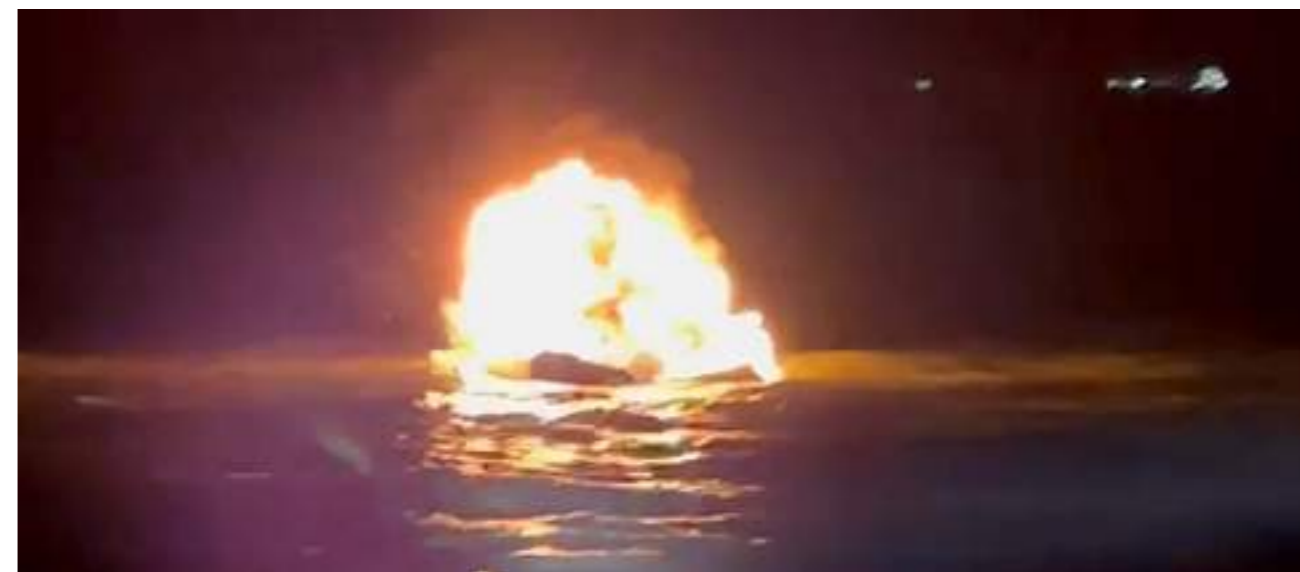
Once clear of the burning boat (Figure 1) the skipper called the coastguard on his handheld VHF radio and then attended to his crew member, who had badly twisted their ankle while scrambling to get into the liferaft. A nearby pilot boat diverted to attend the scene and was soon joined by the lifeboat. The skipper and crew member were recovered safe and well. The boat was lost (Figure 2).

Figure 1: RNLi video still, showing cabin engulfed in flames

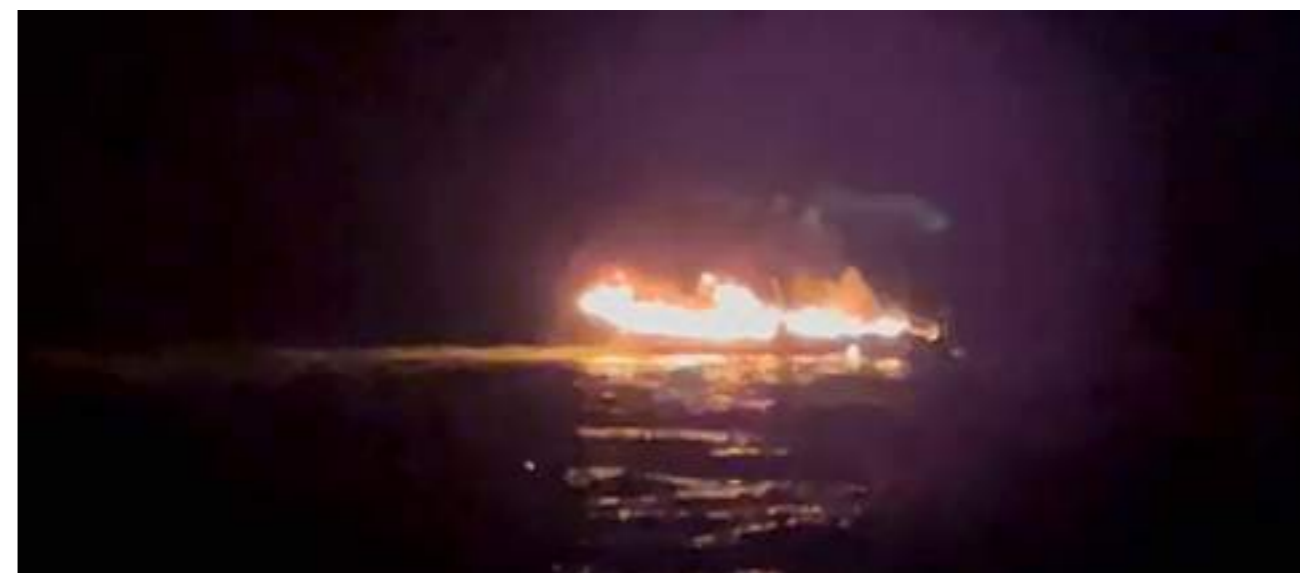
Figure 2: RNLi video still, showing whole cabin destroyed by flames with only the hull remaining intact

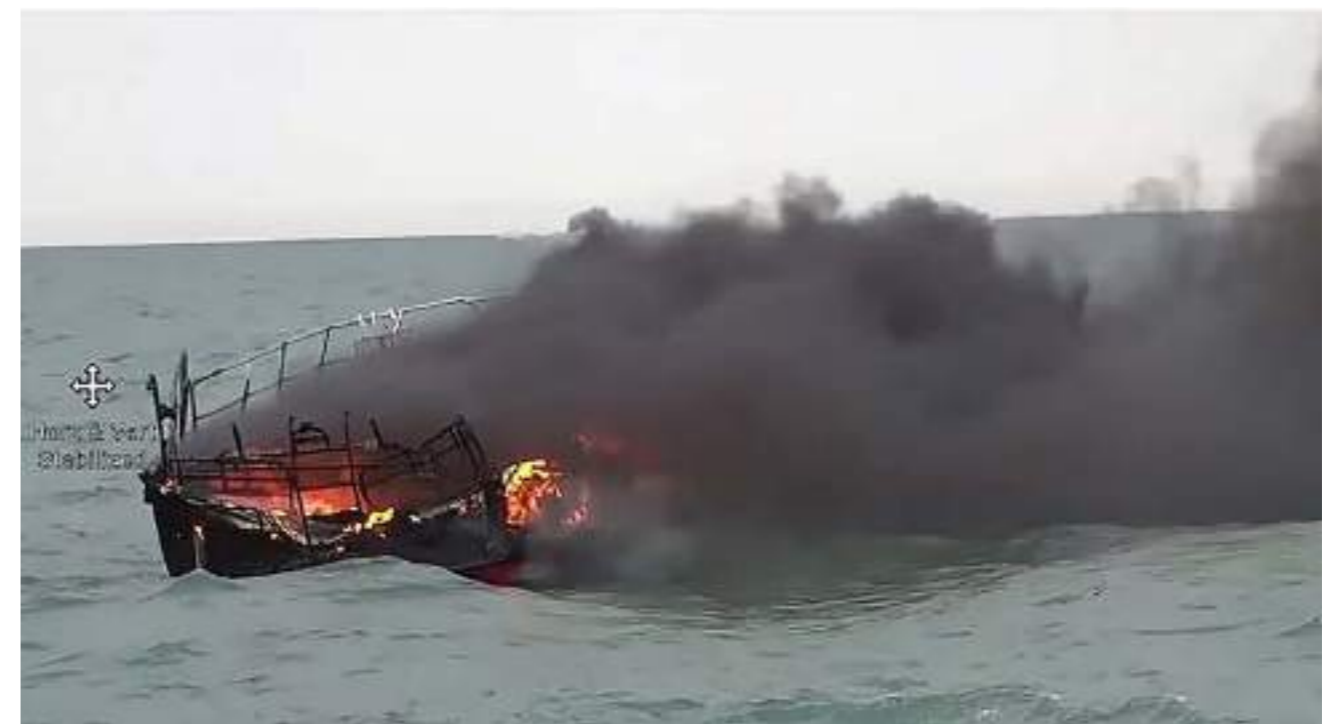
towline to set its anchor. A duty tug from the port also attended and attempted to extinguish the fire; however, this was unsuccessful and the vessel sank, extinguishing the fire and resulting in diesel fuel and debris entering the surrounding water (Figure 2).

Figure 2: Remains of motor cruiser before it sank
