SAFETY INVESTIGATION REPORT

REPORT NO.: 06/2023

MV CMA CGM RABELAIS **Fire in a cargo container on deck,** **leading to a serious injury to a crew member** **during the fire-fighting operation,** **in position, 06° 19' N 094° 30' E** **06 April 2022**

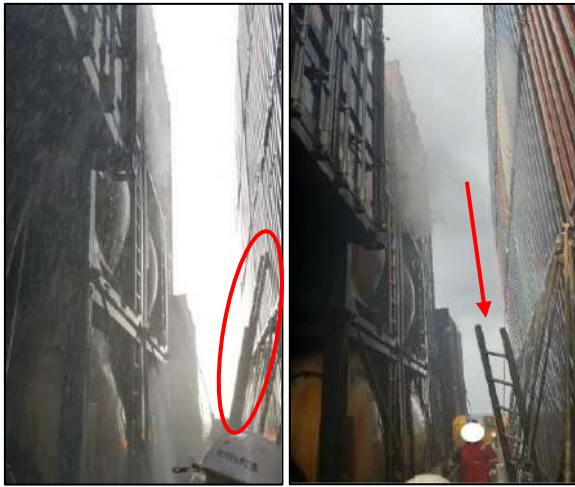
The C/O then placed a portable ladder⁸ (**Figure 1**) against a container in the neighbouring row and climbed it. His

Figure 1: The portable ladder used (photographs taken 07 April 2022)

At around 2250, whilst the C/O began to descend the ladder, the ladder fell with the C/O still on it. Consequently, the C/O fell down a height of about 6 m onto the lashing bridge, between bays 27 and 29.

As mentioned earlier, the C/O was injured when the portable ladder he had just started to descend, fell. While none of the crew members could identify the exact reason why the ladder fell, information received by the MSIU confirmed that the ladder had not been secured. Therefore, it was highly likely that, while the C/O was descending, the ladder either slipped or tipped over and fell, with the C/O landing on the railings and / or other fittings in the lashing bay.

Bearing in mind the circumstances the crew members were facing with the fire on board, it was likely that securing the ladder may not have been a priority, if not perceived to be time consuming during the uncertain instances surrounding the fire.

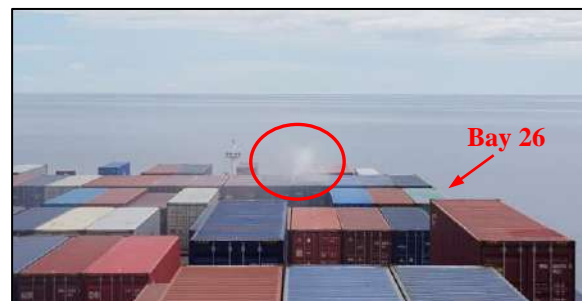
Figure 2: Location of the fire

Based on the crew members' accounts and other data received from the vessel, it was concluded that the fire started from within the cargo container stowed on the forward, starboard hatch cover of cargo hold no. 4, in location 27-05-82. This container was not marked as containing dangerous goods.

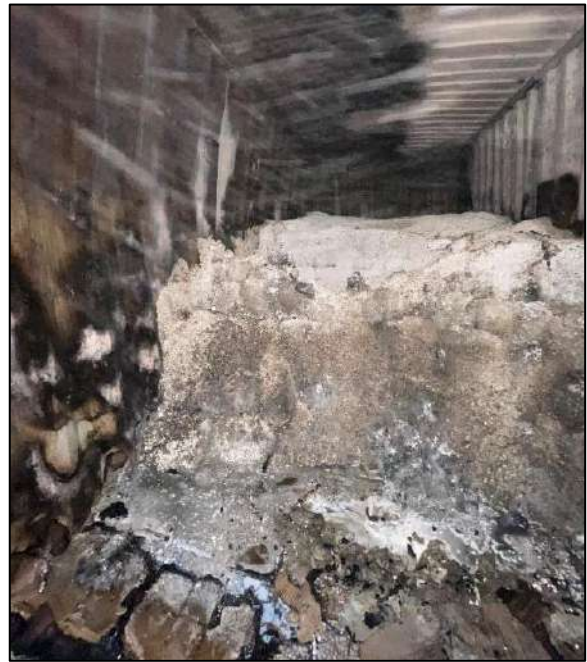
A total of 14¹⁰ cargo containers were confirmed to have sustained damages from the fire. The cargo in the container where the fire had originated, was found to have been decomposed and mixed with burnt packaging material (**Figure 3**), while the container was structurally damaged by the fire (**Figure 4**).

Figure 3: Decomposed cargo inside the container

Bearing in mind the hazards stated in the MSDS, in particular: *Damp material may decompose exothermically and ignite combustibles*, the safety investigation believed that the moisture coming in contact with the cargo may have likely caused it to decompose and ignite the packaging.

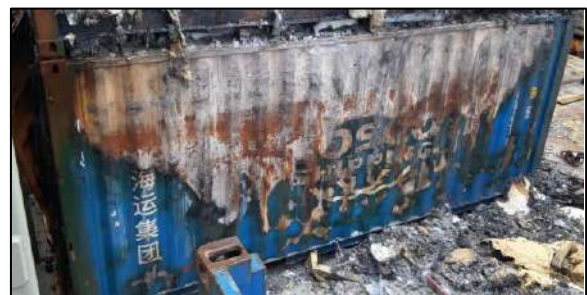
Figure 4: Container from where the fire originated
(seen in its actual stowed position: 27-05-82)

1. The fire started inside the cargo container stowed on the forward, starboard hatch cover of cargo hold no. 4, in location 27-05-82.
2. Although the exact cause of the fire could not be determined, considering the hazards of the cargo stated in its MSDS, the safety investigation believes that moisture coming into contact with the cargo may have likely caused it to decompose and ignite the packaging.

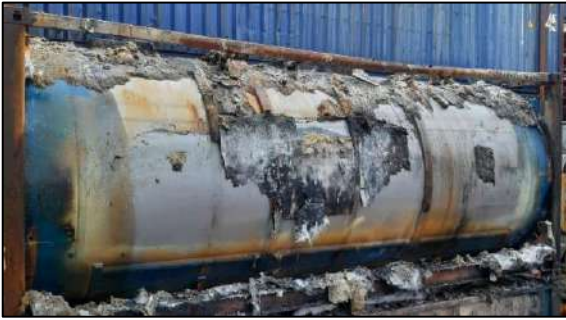
of TEUs loaded in this row of the bay, and the crew members observed the flames reaching the IMDG⁶ Class 3 tank containers in the two tiers directly above (tiers 84 and 86) and damaging the insulation of these two containers.

Figure 5: IMDG Class 3 tank container which was stowed immediately above (27-05-84)

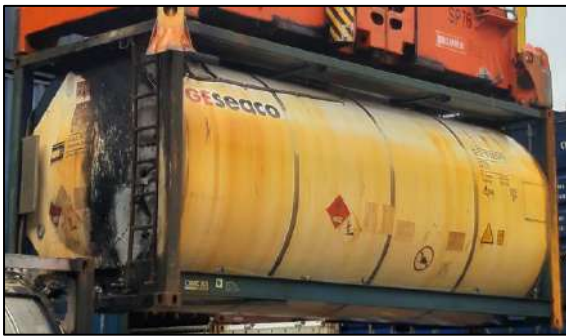
Figure 6: IMDG Class 3 tank container which was stowed immediately forward (25-05-82)

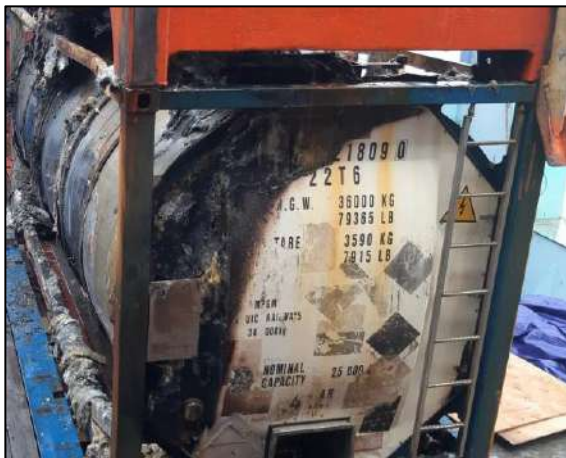
Figure 7: IMDG Class 3 tank container which was stowed at 27-07-84

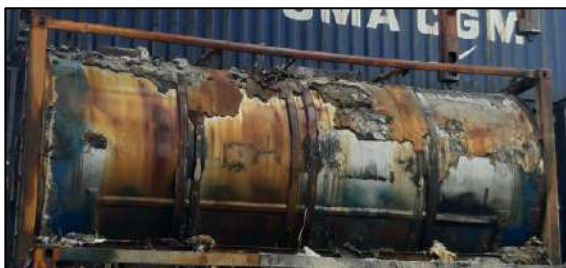
Figure 8: IMDG Class 3 tank container which was stowed at 27-05-86

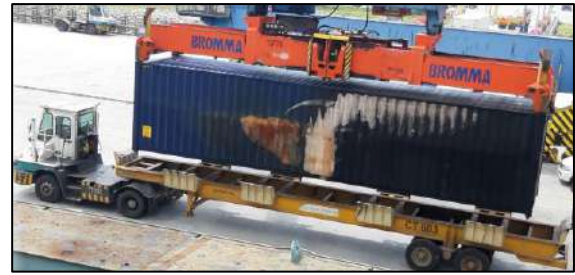
Besides this, the fire was restricted to the cargo containers loaded above the deck on bays 25, 26 and 27, extending mainly from rows 05 to 07 and tiers 82 to 88. A 40-foot container, loaded at 26-09-88, was also damaged.

Figure 9: 40-foot container stowed at 26-09-88, as seen after it was unloaded from the vessel
