Issued May 26, 2023

MIR-23-10

## Contact of Cruise Ship *Radiance of the Seas* with Sitka Sound Cruise Terminal Pier

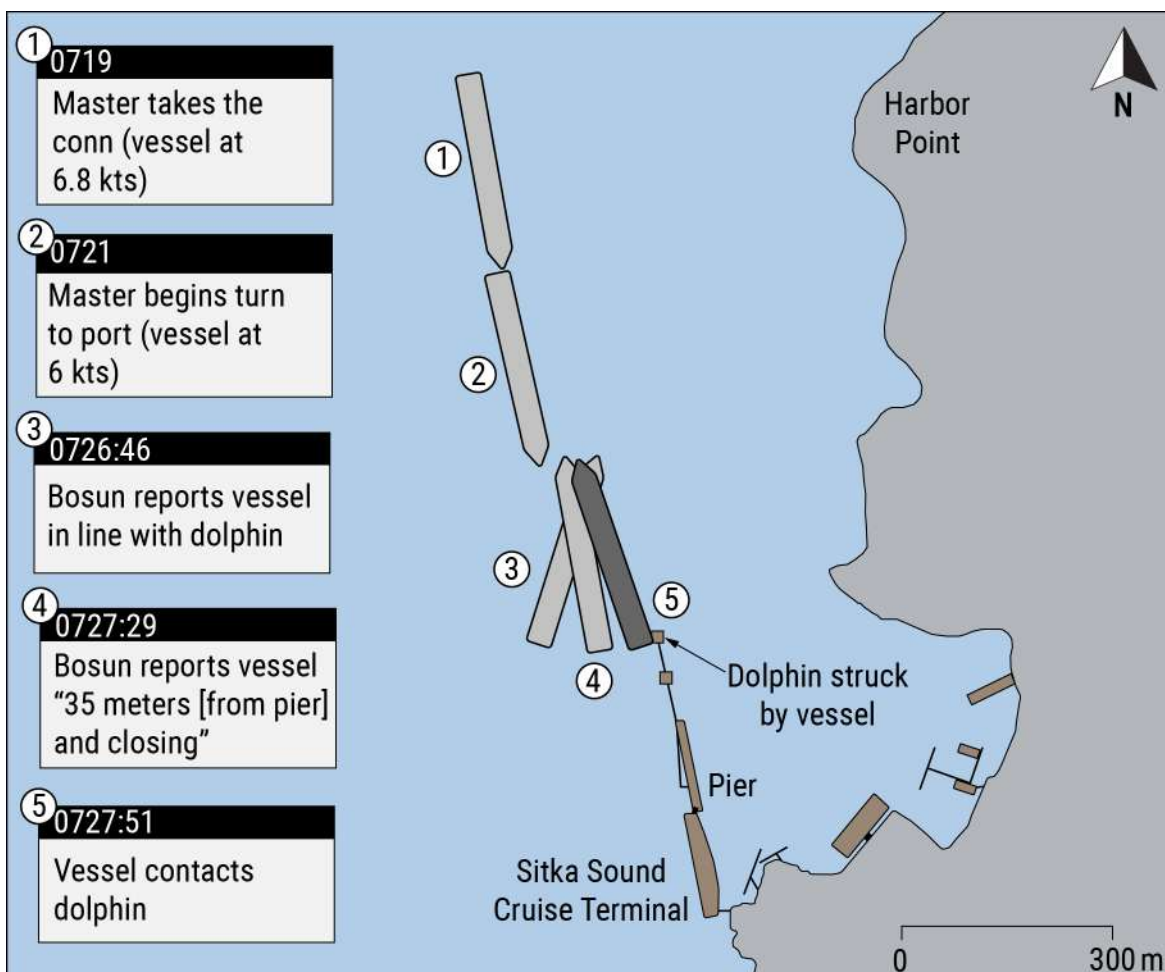
At 0726:46, the bosun reported the vessel was in line with the dolphin, and 13 seconds later, he reported the vessel was 56 meters (184 feet) away from the dolphin. About 30 seconds later, he reported the vessel was "35 meters [(115 feet) from the pier] and closing." The master stated that he believed the bosun was reporting the vessel's swinging clearance—the amount the ship would clear the dolphin. However, the bosun stated that he was reporting the estimated distance from his position on the stern to the mooring dolphin. (After the casualty, investigators reviewed the bosun's reports and noted that they correlated with what was displayed on the ECDIS). At 0727:51, the ship's starboard quarter struck the mooring dolphin at the end of the pier.

**Figure 3.** *Radiance of the Seas*'s approach and turn in relation to the lengthened pier (scale approximate). (Vessel position source: Royal Caribbean Cruise Lines)

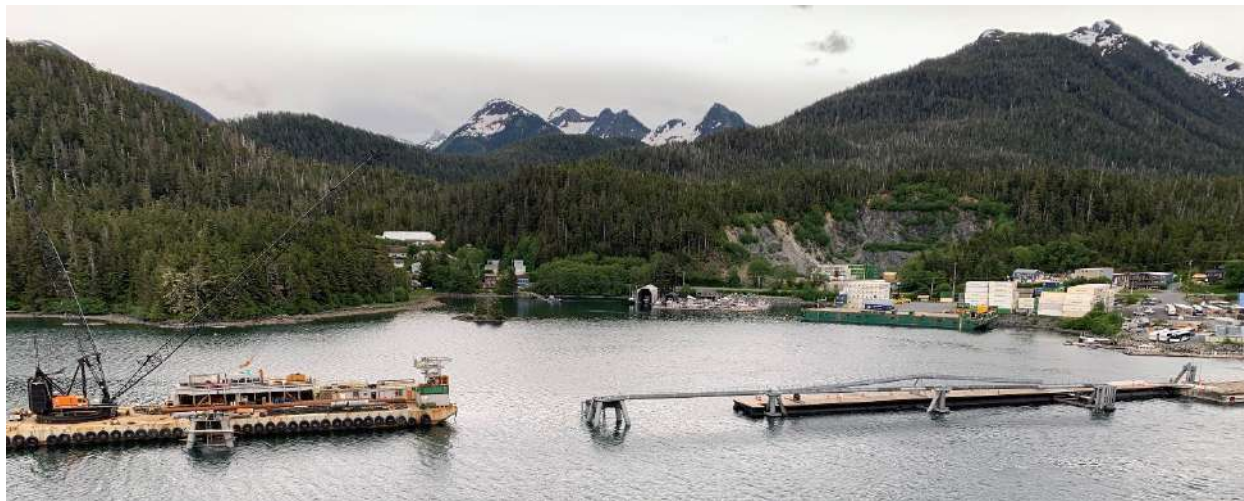
**Figure 4.** The Sitka Sound Cruise Terminal pier on June 9, 2022, with barge alongside the damaged dolphin for repairs (with catwalk between dolphins removed).

The *Radiance of the Seas* sustained minor hull indentation. The mooring dolphin struck by the vessel sustained damage to three of the four pilings supporting it. Larger cruise ship traffic to Sitka Sound Cruise Terminal was impacted for the remainder of the 2022 season until repairs to the mooring dolphin were completed.

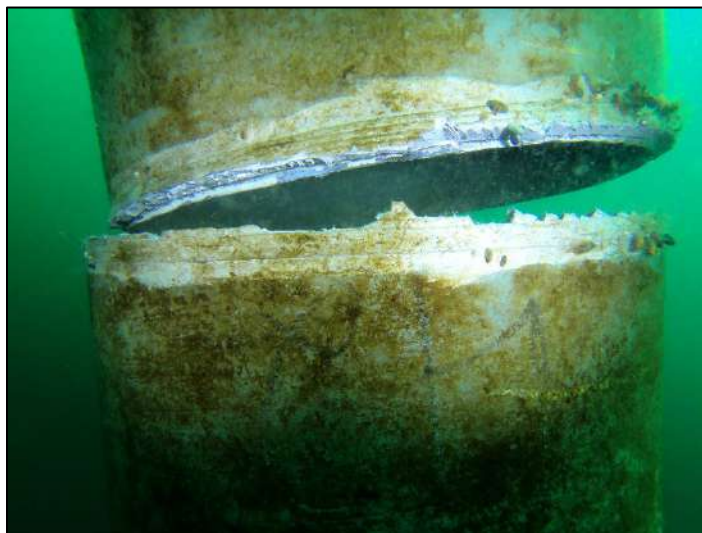
**Figure 5.** Damaged dolphin piling. (Source: Halibut Point Marine Services)

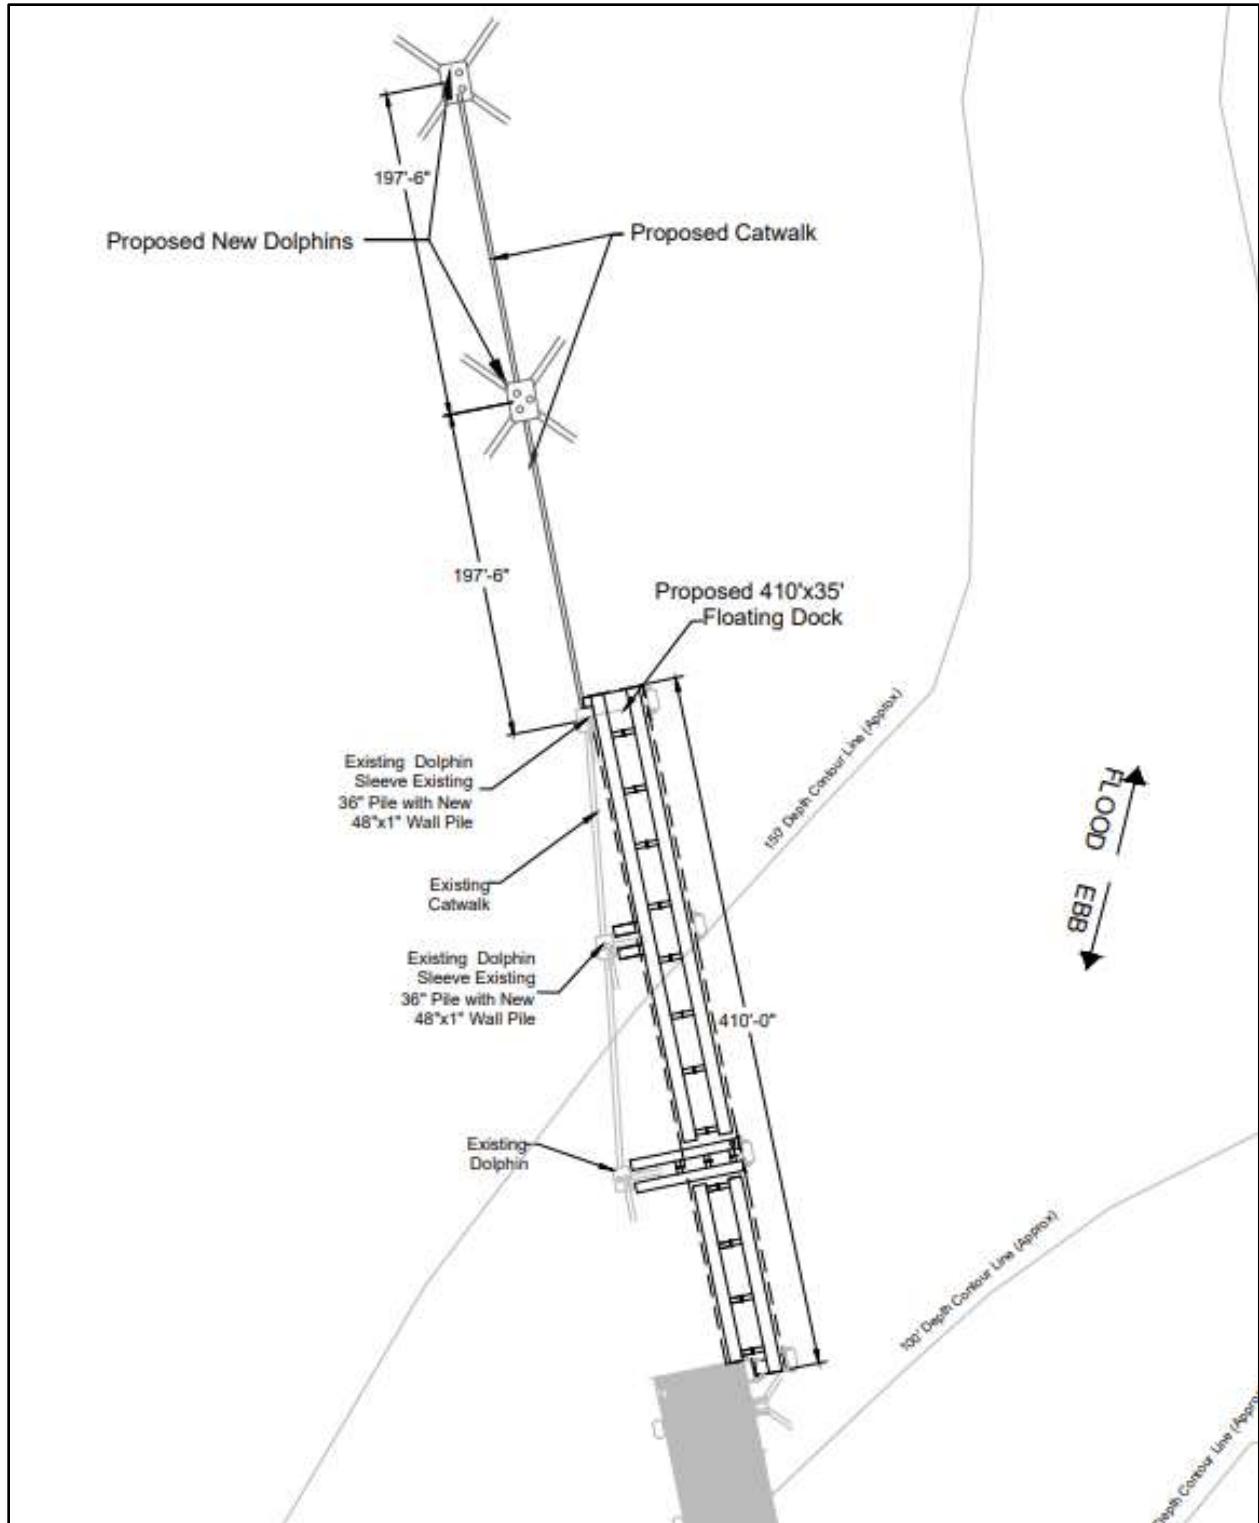
**Figure 6.** The proposed addition to the pier in the application to the US Army Corps of Engineers approved in 2020. (Source: Halibut Point Marine Services)

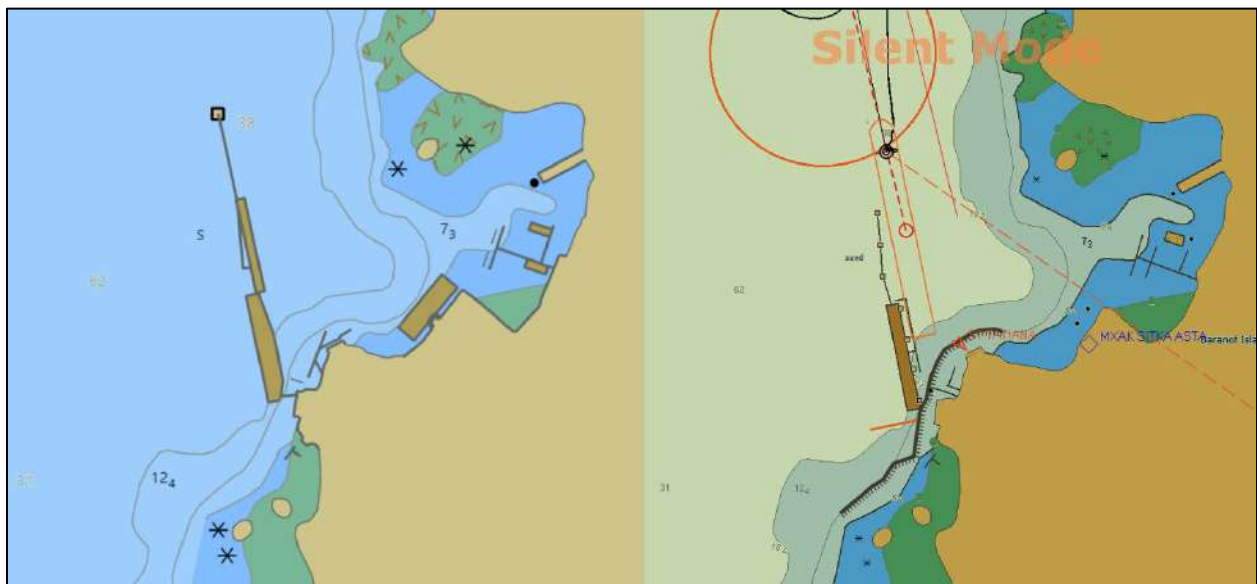
The National Ocean and Atmospheric Administration’s (NOAA) Office of Coast Survey is the hydrographic authority responsible for maintaining and issuing corrections to all US coastal nautical charts. NOAA had no record of the construction completed on the Sitka Sound Cruise Terminal pier until after the casualty, when investigators informed them of the pier’s extension. NOAA staff told investigators that they would have updated the chart if they had been informed. They also stated that it is the responsibility of facility owners to inform them when permitted construction is complete and to provide drawings of the construction as built so that corrections and updates can be made to nautical charts for that area (neither the Sitka Sound Cruise Terminal’s permit nor regulations required this). The electronic navigation chart (ENC) did not show the extended pier and added dolphins until September 8, 2022, when NOAA updated the chart.<sup>4</sup>

**Figure 7.** ENC updated postcasualty (left) and as seen on *Radiance of the Seas*'s ECDIS (right) with the ship's outline after mooring shown in orange. (Sources: NOAA [left] and Royal Caribbean Cruise Lines [right])

Ports and terminals should immediately report significant modifications to port or terminal configurations to the appropriate hydrographic authority (for example, the National Oceanic and Atmospheric Administration) so that charts can be updated and the changes made readily available to vessel owners, operators, and crews/bridge teams.

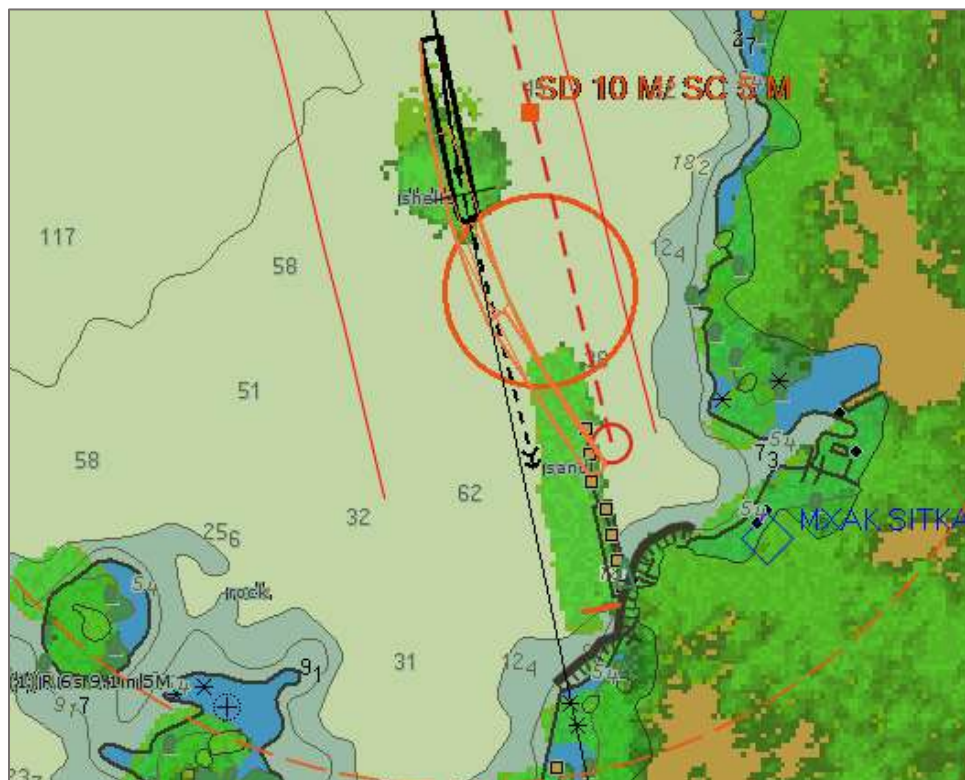
The *Radiance of the Seas*'s radar returns could be viewed on the vessel's ECDIS. After the casualty, investigators reviewed data captured by the vessel's voyage data recorder. Investigators found the radar returns shown on the ECDIS did not correspond with the charted position of the Sitka Sound Cruise Terminal pier and showed uncharted infrastructure.

**Figure 8.** Screenshot of *Radiance of the Seas*'s ECDIS with radar overlay during the vessel's approach to the terminal about 0723 on the day of the casualty. The radar return (shown in green) of the extended pier does not coincide with the charted position of the pier beneath. The larger orange circle shows the vessel's planned turn, and the smaller orange circle is the final waypoint of the route, at the end of the older pier. (Source: Royal Caribbean Cruise Lines)

to the terminal and mooring arrangement. The vessel was equipped with radar, and the bridge team was able to see the radar return on the vessel's ECDIS. However, investigators found that during the vessel's approach, the main radar image overlay did not match the ENC on the ECDIS—the radar showed the pier extending beyond its location on the ENC. The fact that the charted pier did not match the radar return overlay on the ECDIS should have raised concern amongst the bridge team regarding their planned turn point. However, no one on the bridge team reported the discrepancy to the master, who was conning the vessel, indicating they either were not using the radar or were not paying attention to the radar returns.
