CHIRP

An independent and confidential
reporting system for the Maritime industry

Annual Digest of Reports and Insight Articles 2022

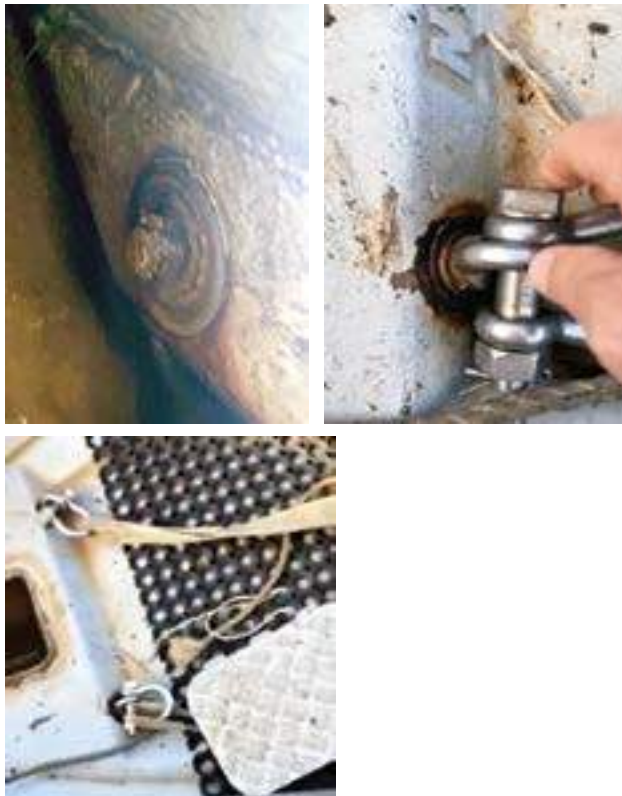
Unsafe lifting points for RIB Work Boat

A new crew member inspected the ship's lifesaving equipment to familiarise themselves with the equipment on board. They discovered that the lifting eyes in the ship's workboat were damaged and loose, which meant it was not the eyes carrying the load but a length of threaded bar which appeared poorly maintained. If the lifting eyes had failed while the boat was being lifted it could have resulted in serious injury to the two crew members who are ordinarily inside when it is lowered into the water.

The condition of the items in the photographs suggest that neither inspection nor maintenance routines were effective, and that the boat's crew were either unaware that the lifting eyes were in a dangerous condition or did not feel empowered to report their concerns.

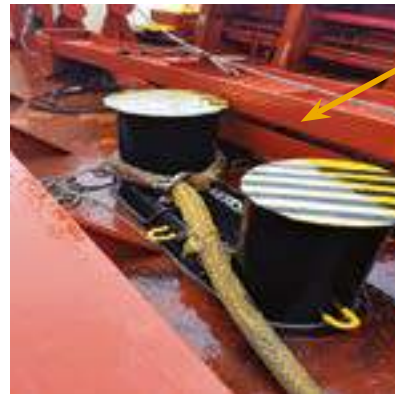
Log stanchion in lowered position

A lumber carrier embarked a pilot as it approached a loading berth where a tug waited to assist. The pilot requested that the vessel secure the tug's line to the mooring bits on the forward deck. After this was achieved, and as the tug came under the line to push up, the tug master realised that his line had been improperly secured: it had been wrapped around the bits and secured with a shackle, rather than the eye being dropped over the top of the bits.

When questioned the master explained that, when lowered, the log stanchions were so close to the bits that they obstructed the bits. The master was informed that they should not use a shackle in future, and that the bits should not be used when the log stanchions were lowered.

The vessel is relatively new, and the deck layout has not been modified since she was built. This suggests that the improper placement of the log stanchion and mooring bits is the product of poor design. This is known as a latent error, and CHIRP believes that there is a high probability that incidents will continue to occur on the vessel because the mooring bits cannot correctly and safely be used as intended. The likelihood of an incident is further increased because of the proximity of the bulwark brackets which create a trip hazard.

The trip hazard and inability to correctly work the mooring bits are evident, and CHIRP is concerned that these had seemingly not been detected either during commissioning trials, during flag and class inspections, or by the crew themselves. CHIRP is also concerned that other vessels of the same design might also contain the same latent design hazards.

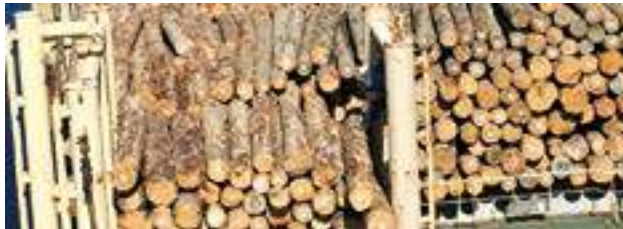
Unsafe access!

The pilot raised the matter with the master and alerted the authorities to these significant safety breaches.

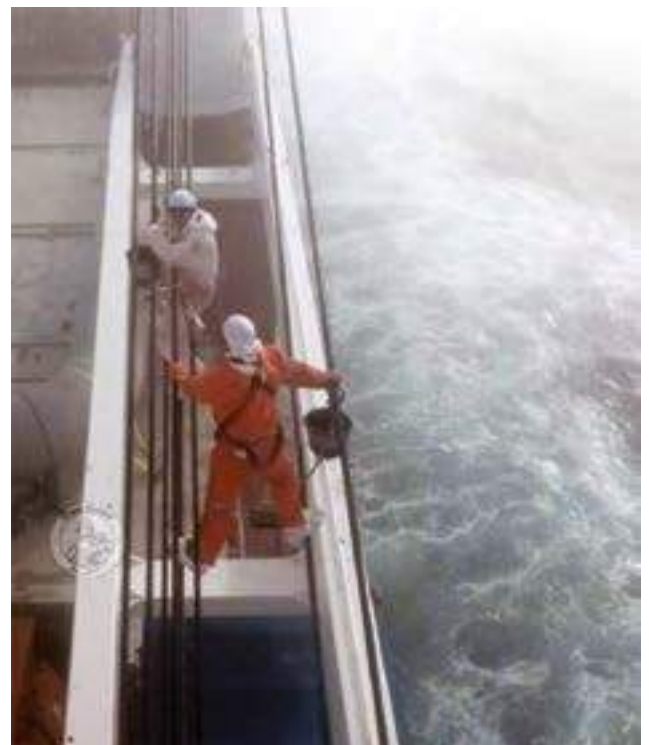
They are not wearing safety helmets or lifejackets despite being close to the edge of the vessel. This activity took place in full view of the bridge team, but they were neither challenged nor stopped.

If you are sent aloft wearing a harness, make sure there is a rescue plan in place. A rescue plan is a pre-planned procedure to safely retrieve someone suspended at height in a harness. It should also be regularly practised to ensure it can be done safely and quickly

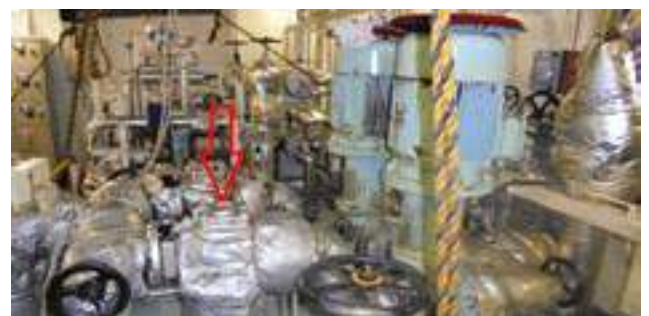
The reporter told us that the chief engineer held the daily meeting at 8 am to discuss the work plan for the day with the senior engineer and the rest of the engine officers and crew. Among others, the inspection and maintenance of the auxiliary boiler’s No1 fuel oil pump filter was discussed. A Toolbox meeting was held regarding the precautions and hazards associated with the maintenance work.

The work commenced after lunch at around 13:40. The senior engineer was about to dismantle and remove the pump’s filter cover when hot fuel and gases suddenly escaped.

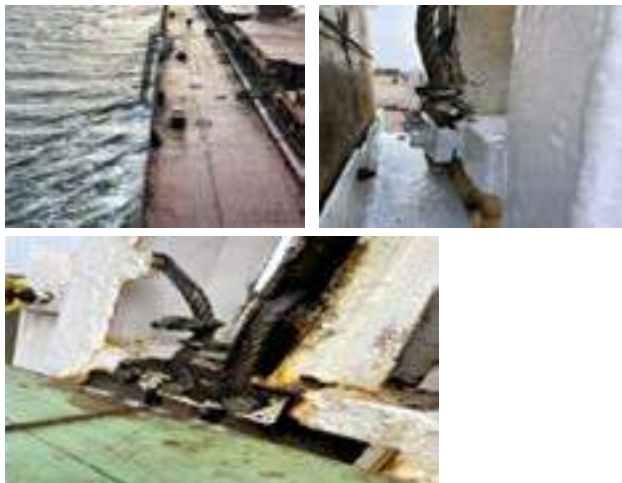
Pilot boarding arrangements are regularly featured in our Maritime FEEDBACK newsletters. However, the accommodation ladder is often perceived by ships' crews to be less of a risk because it is a robust structure and viewed as a part of the hull's structure. Because of these factors, accommodation ladders can be overlooked when undertaking ladder maintenance, especially items such as the hull fixtures to which the wires are affixed. Like the pilot ladder, it is often difficult for a pilot to fully appraise the safety standards of the accommodation ladder's fittings prior to boarding. This incident shows it is also an area of vulnerability and CHIRP wants to highlight this.

The Master undertook remedial action with respect to the accommodation ladder and the fall securing.

Reducing the periodicity for changing the falls to between 18 and 30 months for vessels that have accommodation ladders in these exposed areas should be considered, as should changes to the design for securing the falls. However, thorough maintenance must always be provided to the wires, sheaves and fixtures no matter how difficult the access to the wires may be.

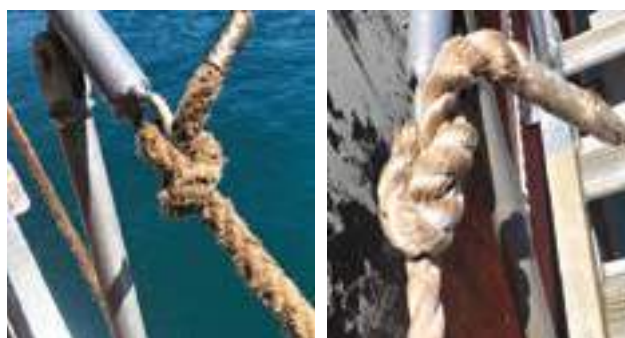
The repeated use of overhand knots in this case indicates that either the officer did not correctly supervise and inspect, or that the crew have become desensitized to a deviance from standard procedures: the local practice on the ship or within the company for securing the pilot ladder rope with an overhand knot had become the accepted norm.

Despite being incorrect there appears to be no culture of challenge by the crew or officers to secure the ropework with the correct knot.

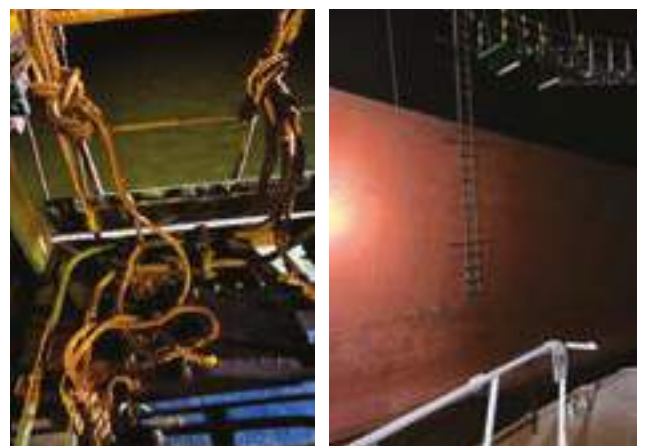
A pilot boarded a tanker at anchor. When they arrived at the top of the ladder, they discovered that it was tied to a rotten railing, there were no suitable hand-holds nearby, and there were many trip hazards on the deck near the embarkation point.

When the pilot raised this with the master, he was told that the ladder was not usually rigged in that position but had instead been moved to accommodate the pilot station's direction to rig a 7m ladder. This was higher than the 5m maximum height at the normal embarkation point, so the ladder had been moved.

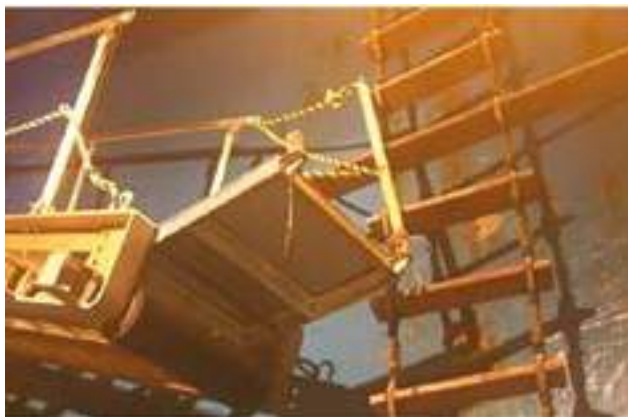
Combination ladders: Trapdoor Type Combination

The pilot who reported this incident had reported the same non-compliant transfer arrangements on this vessel two months earlier. At that time, the master was advised and given drawings of the required modifications. The port state was also informed. On arrival at the port two months later,

nothing had been done to rectify the situation.

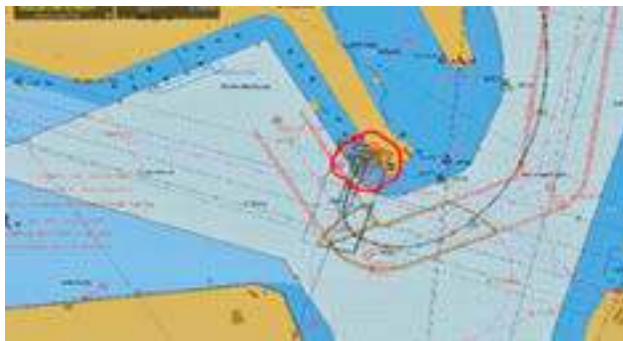
As it passed the mooring dolphin, the vessel turned short round to port, assisted by the tugs. About 5 minutes later the officer at the stern alerted the bridge that the vessel was drifting towards the end of the breakwater. The current was running in an easterly direction during the turn to port, which caused the drift, although the pilot believed that it was running in a westerly direction. The pilot gave several engine orders from dead slow to full ahead to increase the distance from the breakwater, but a noise was heard on the port quarter. Following checks within the engine room to ensure the hull was not breached, the vessel berthed port side alongside at the oil terminal.

An investigation revealed that there were no fatigue issues nor any substance abuse. All equipment was in-class and properly maintained. The passage plan berth to berth was very comprehensive and under-keel clearance (UKC) calculations were prepared and shown to the pilot at the master-pilot exchange. All navigational equipment relevant to this passage plan was being used and accurate. The bridge team members were adequately trained for making proper use of all navigational aids, and for being aware at all times of the vessel's position. The master-pilot exchanged information and pilot card was properly completed and the pilot was fully aware of vessel's particulars and manoeuvring characteristics.

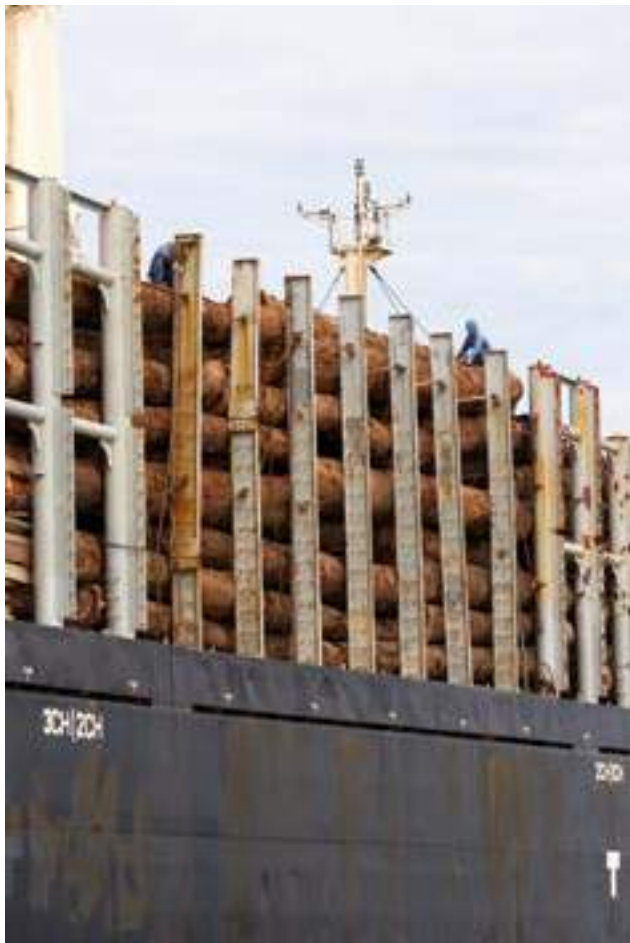
A bulk carrier was loading a timber deck cargo at anchor. While lashing down the timber, an Ordinary Seaman (OS) fell overboard into the sea. Another crew member jumped in to search for them but was unsuccessful, and despite an extensive search over several days, the victim was never found. What caused the OS to fall into the water could not be determined as there were no witnesses. The OS was inexperienced yet had not been trained or briefed on the risks of working on timber. He wore coveralls, gloves, a safety helmet, and studded overshoes. Still, the ship's SMS manual did not mention the rigging of safety lines or wearing safety harnesses when working on top of the timber, nor did it require the crew to wear lifejackets or buoyancy aids.

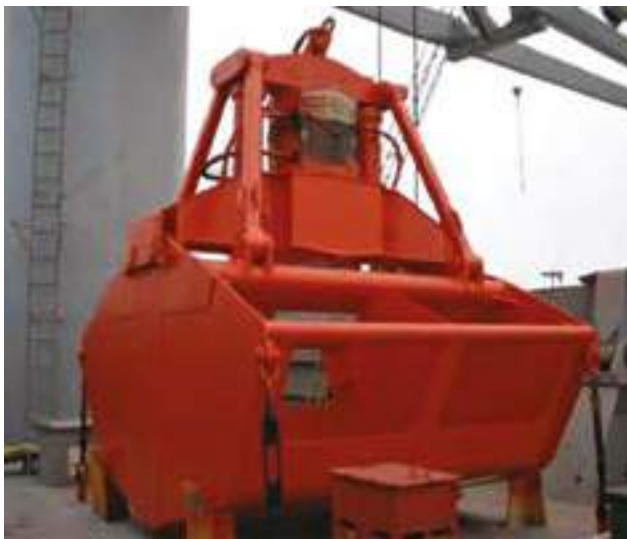
The ship's SMS procedures did not refer to hazards related to access/egress from a worksite at height, and it could not be determined if the risk of going up and down from the grab had been assessed.
