**M/V “EVER GIVEN”**  
**IMO No. 9811000**  
**R-026-2021-DIAM**  
**CASUALTY DATE: March 23<sup>rd</sup>, 2021**

**MARINE SAFETY**  
**INVESTIGATION REPORT**  
**GROUNDING**  
**OF**  
**MV EVER GIVEN**  
**AT**  
**SUEZ CANAL EGYPT**  
**ON**  
**MARCH 23, 2021**

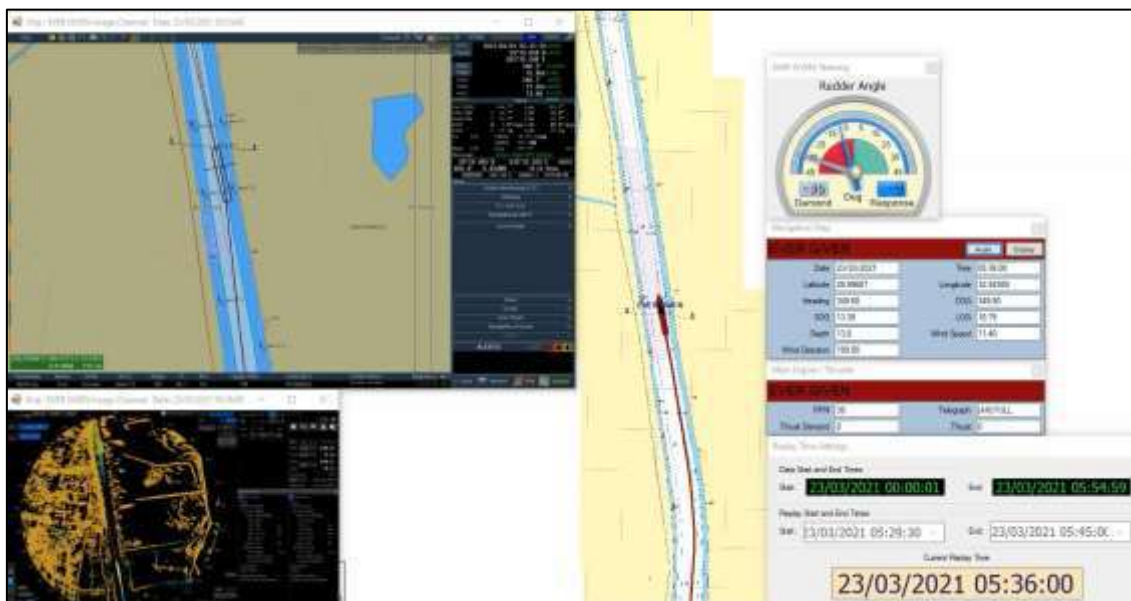
**FIGURE 7: VESSEL POSITION AT 07:36 HRS / LT**  
(Source: Extracted from vessel VDR)

At about **07:36 HRS / LT**, the vessel was positioned on the starboard side of the canal. At about **07:37 HRS / LT** pilot ordered correcting rudder and started to turn back to port, again using large helm order, not course orders.

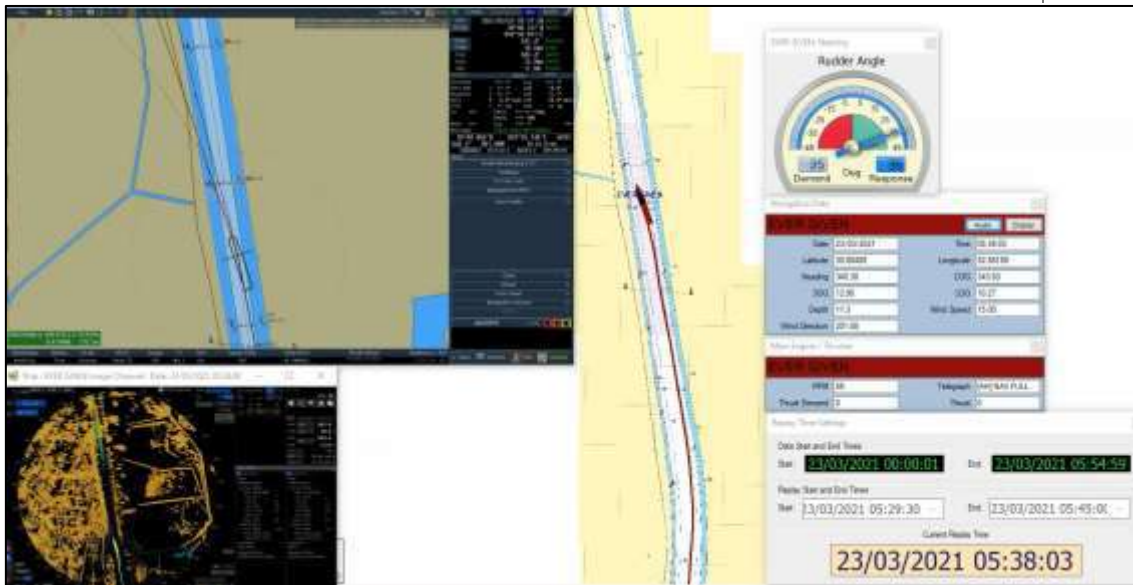
**FIGURE 8: VESSEL POSITION AT 07:38 HRS / LT**  
(Source: Extracted from vessel VDR)

At about **07:38 HRS / LT**, the helmsman reported that the vessel had stopped turning to port and was starting to turn to starboard. At the time, the vessel was close to the port bank of the canal and the speed had increased to about 13 knots over the ground. The vessel then started to turn quickly to starboard, away from the port bank. The pilot initially ordered the rudder to port 20 degrees and then hard to port to stop the vessel from turning. Then the second pilot started shouting at the first pilot in local language, there appeared to be a disagreement between them.

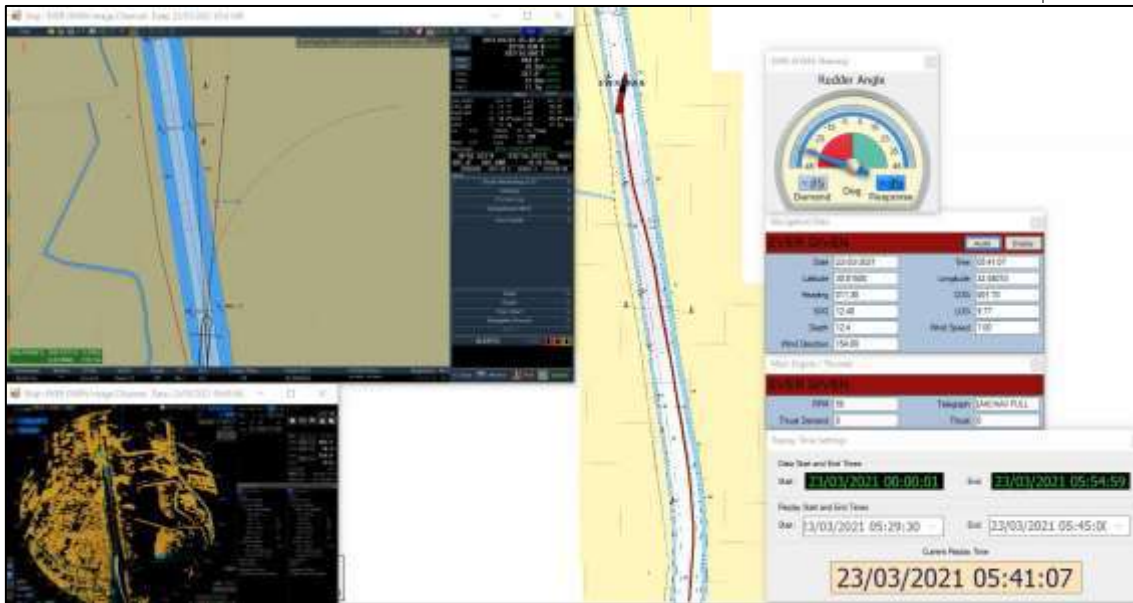
**FIGURE 9: VESSEL POSITION AT 07:41 HRS / LT – GROUNDING**  
(Source: Extracted from vessel VDR)

The first pilot reduced speed to half ahead at **07:39:55 HRS / LT** and the vessel continued to turn to starboard. There was another discussion between the two pilots in local language and the main engine was increased to full ahead again. The vessel continued to turn starboard, towards the starboard canal bank. The pilot again ordered hard to port presumably to try to steady the heading but vessel continued turning to starboard side. The main engine revolutions were increased to Nav full ahead (53 RPM) but still the vessel was swinging heavily starboard. The vessel continued this swinging and grounded at a speed of about 12 knots over the ground on the eastern bank of the canal at **07:41 HRS / LT**, at location 30 01.059 N / 032 34.810E. On grounding the pilot at (**07:43 HRS / LT**) ordered Full Astern and then Crash Astern (**07:44 HRS / LT**), neither orders had any effect. Master also ordered the bow thruster to be started after the grounding, in his first effort to refloat vessel.

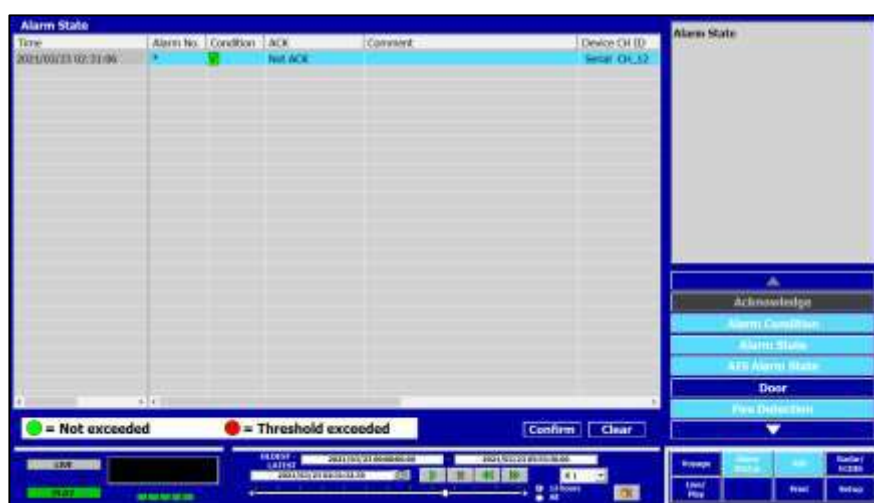
FIGURE 11: Alarm Status - (Source: Extracted from VDR data / Alarm Status)

Vessel’s bridge alarm status reviewed and found that during the period of analysing the VDR Data there were no any error alarms.

**Note:** Bilge alarm was noted at 07:45:54 HR LT, 4 minutes after the grounding, due to the water ingress in the bilge flowing aft (change in trim).

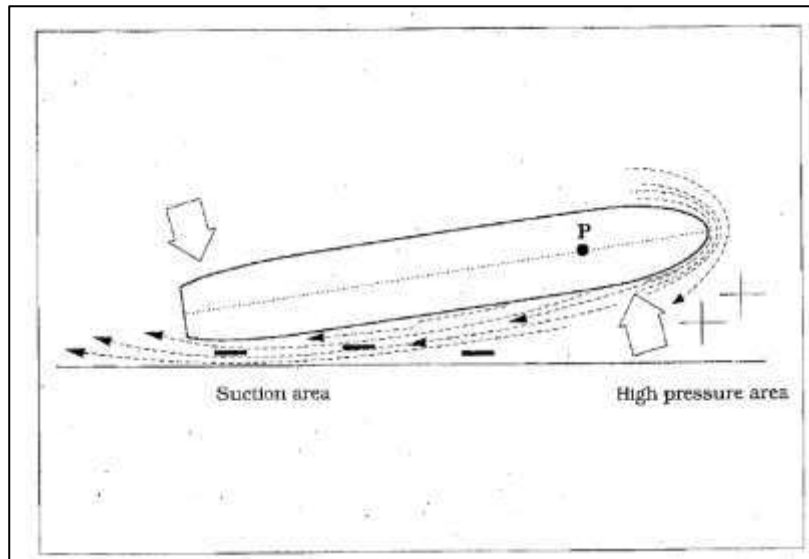
**FIGURE 13: BANK EFFECT**  
(Source: Nautical Institute's "Shiphandler's Guide")

If a vessel moves away from the center-line of a canal towards one of the banks, the flow of water between her side and the nearer bank becomes confined, and therefore lower pressure (greater suction) will occur on that side. This suction will tend to pull the vessel towards the nearer bank. However, it should be noted that these suction forces are not evenly distributed along the length of the hull and their resultant tends to act somewhere aft of amidships. This is equivalent to a force acting aft of the center of gravity which creates a turning moment, deflecting the ship's head away from the nearer bank. In practice this turning moment overrides the bodily suction towards the nearer bank and the vessel will start moving away from it, sometimes so violently that a sheer towards the opposite bank is generated."

Following diagrams from the Nautical Institute's "Shiphandler's Guide" shows that both squat and bank effect has a detrimental effect on steering.

According to the crew statements, master's statement of facts and as illustrated in ECDIS play back and VDR data, M/V **EVER GIVEN**, at about **07:38 HRS / LT**, the helmsman reported that the vessel had stopped turning to port and was starting to turn to starboard. At the time, the vessel was close to the port bank of the canal and the speed had increased to about 13 knots over the ground. The vessel then started to turn quickly to starboard, away from the port bank, that was the time that a combination of squat and bank effect started to heavily effect vessel, due to high speed.
