Report on the investigation of the  
engine room fire and subsequent fatality on board  
the liquefied petroleum gas/ethylene carrier

***Moritz Schulte***

in Antwerp, Belgium

on 4 August 2020

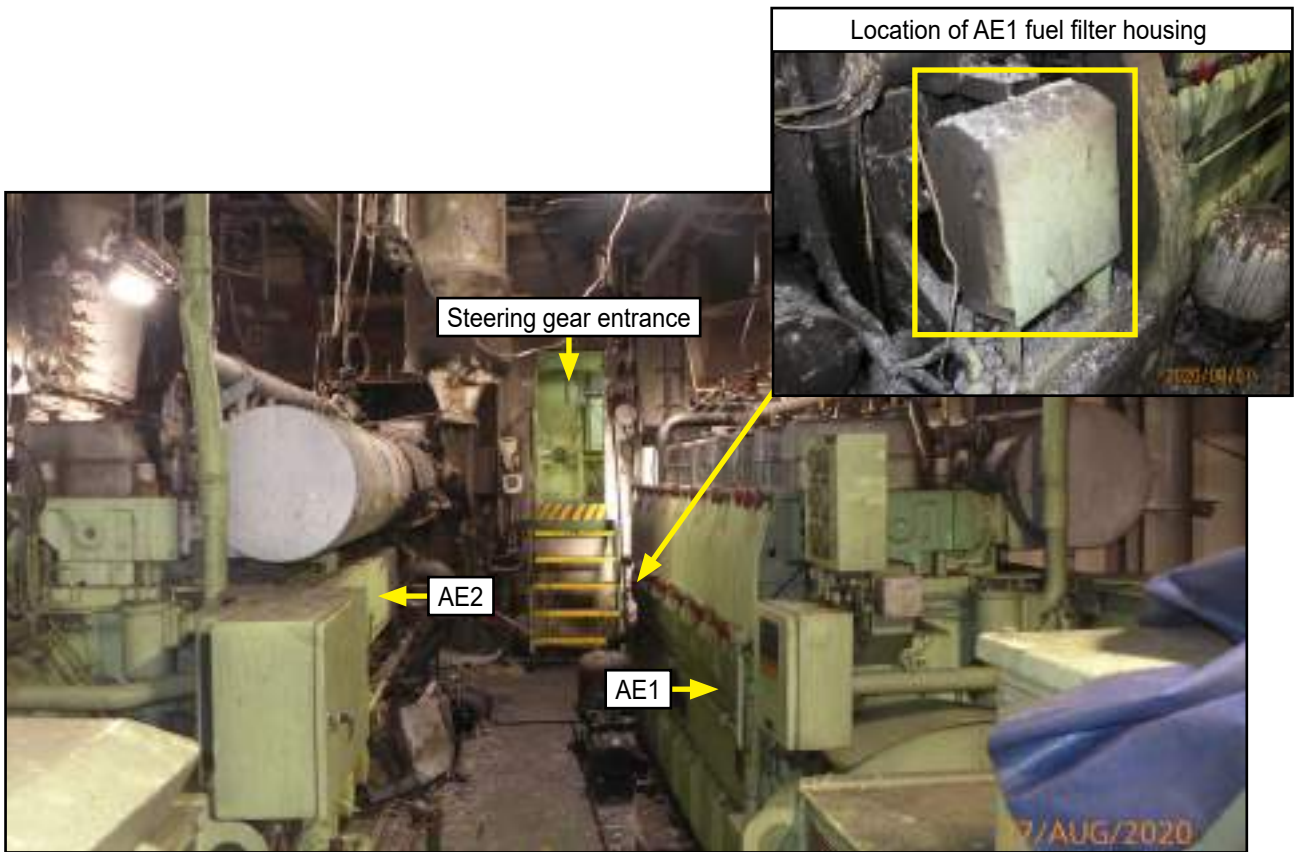
**Figure 2:** View aft between AE1 and AE2 and (inset) the post-fire AE2 fuel filter housing, representing how AE1 would have looked with its splash shield cover in place

door. The AE1 fuel filter housing was under the turbocharger at the aft end of the engine (**Figure 2**), about 1m from AE2's turbocharger (**Figure 3**). The 3/E undid the two locking screws on the splash shield and removed it from the housing to access the duplex fuel filters, placing the cover on the deck (**Figure 4**).

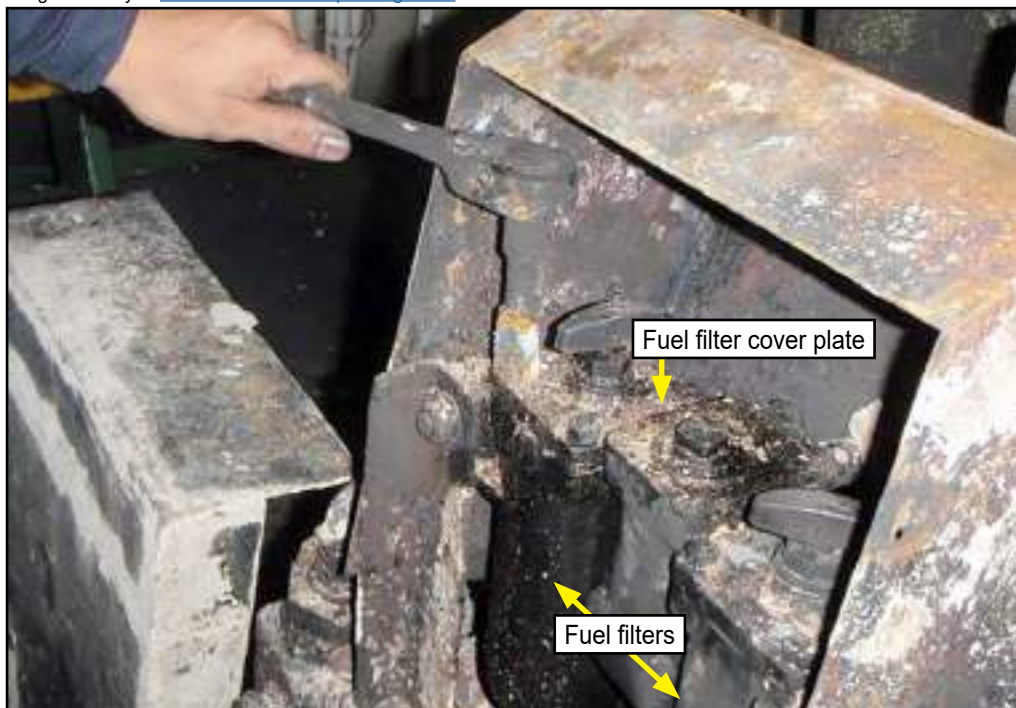
**Figure 5:** Post-fire reconstruction of fuel filter cover plate removal

- The 3/E slackened the rear two nuts and removed the front left-hand nut securing the fuel filter cover plate. As he was undoing the front right-hand nut, the 5.5 bar fuel system pressure lifted the cover and forced the O-ring seal out of its recess, causing it to split (**Figure 6**).
- The marine gas oil (MGO) sprayed out over a large area, covering the 3/E and reaching the running AE2's turbocharger and exhaust pipework insulated cover (**Figure 3**). Soon after, the fuel ignited and thick black smoke began to emanate from the AE2 exhaust insulation.

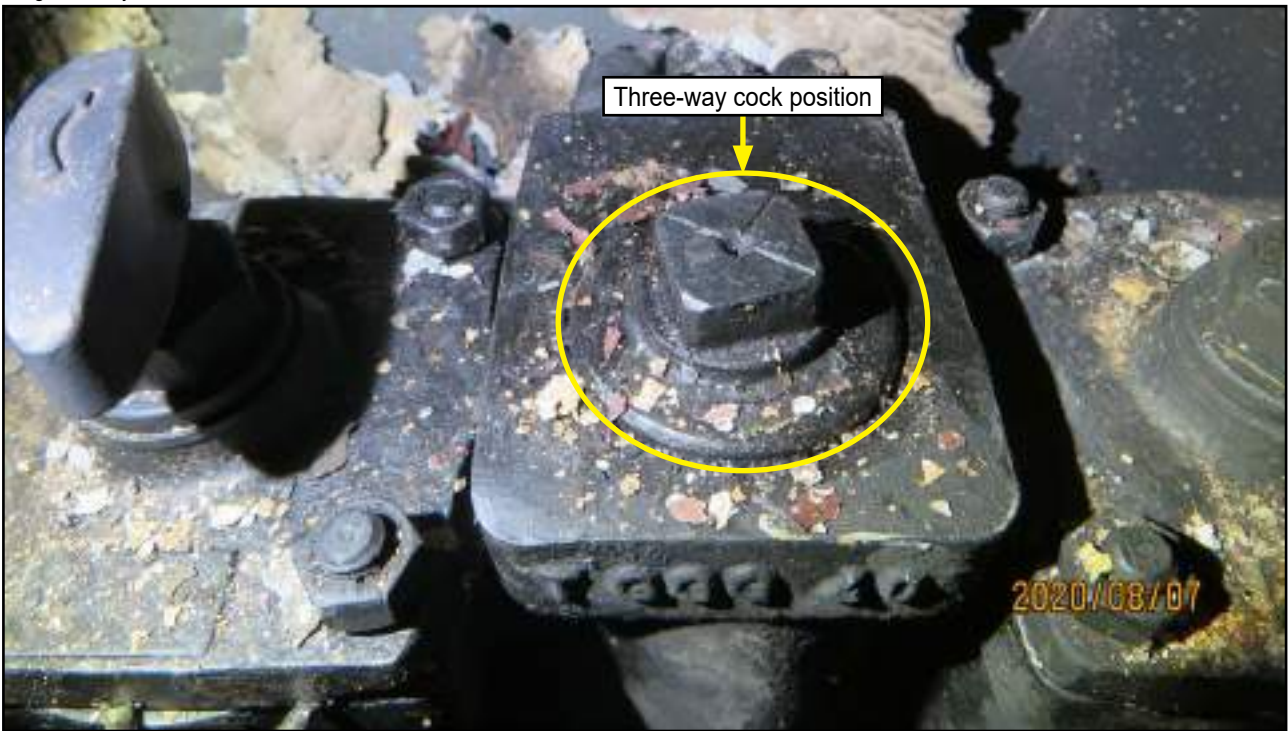
**Figure 14:** AE1 fuel filters, showing three-way cock position as found post-fire

The front section of the splash shield, which enabled access to the filters, had been removed and the three-way cock between the filters was found partially closed (**Figure 14**).

The three-way cock may have been moved to the partially closed position before work started on the filter in an attempt to both complete the intended task and comply with the 2/E's instruction not to isolate the engine. Alternatively, the 3/E may have tried to close it once the fuel spray started. In either event, post-accident testing found that its partially closed position made little difference to the amount of fuel released. However, the three-way cock was designed so each filter could be isolated in turn and, correctly operated, it would have prevented the unintended release of fuel.

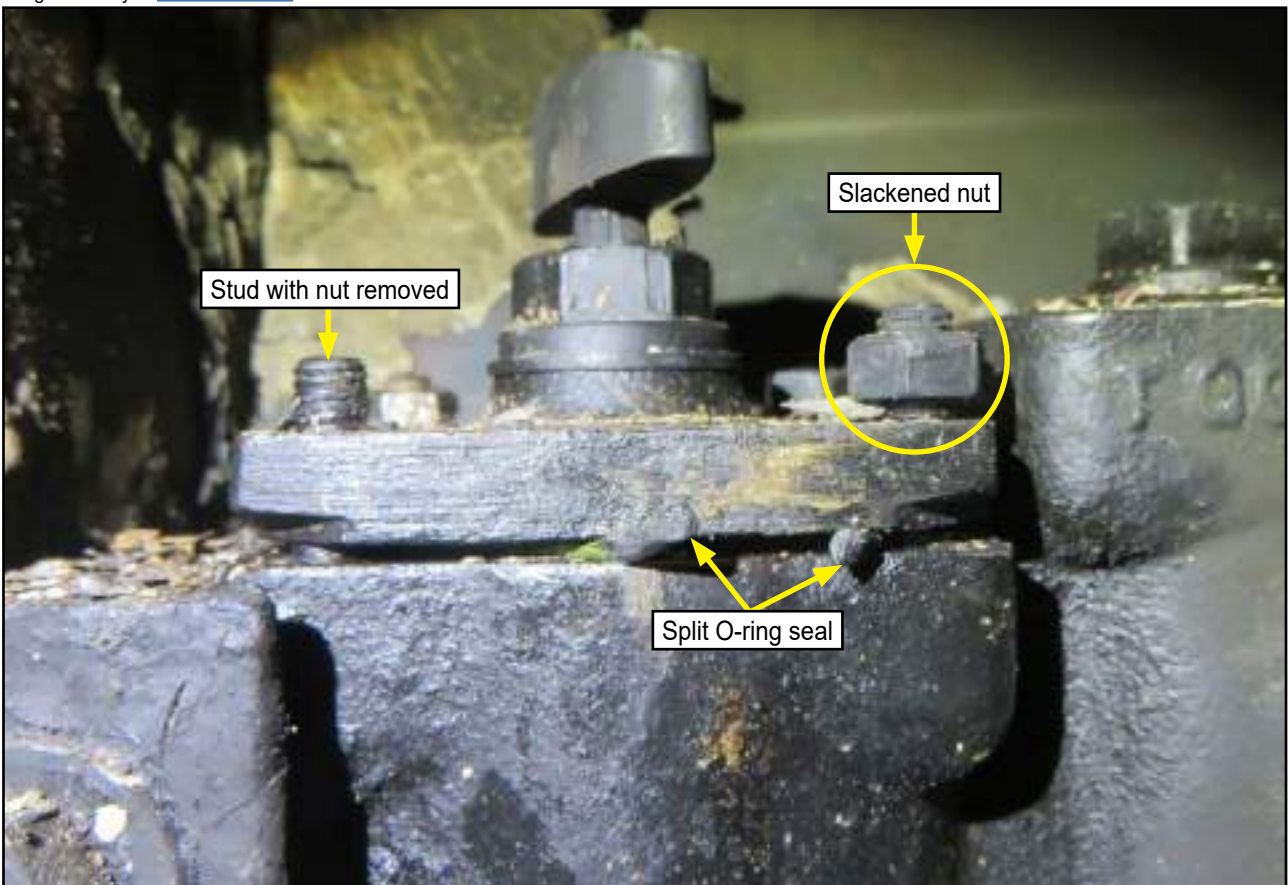
**Figure 15:** AE1 left-hand fuel filter cover and split O-ring seal

The gap between the left-hand filter cover and the filter housing was measured and found to be a maximum of 2.66mm at the front and 1.26mm at the rear. The front right-hand stud was found to be loose.

Both duplex filters were removed from their housings and found to be clean. The inlet and outlet ports within the housing were partially open (**Figure 18**) due to the as found three-way cock position; when tested, the cock could be rotated and the ports closed. The failed O-ring seal was in good condition and, apart from where it had split, was still in position (**Figure 19**).

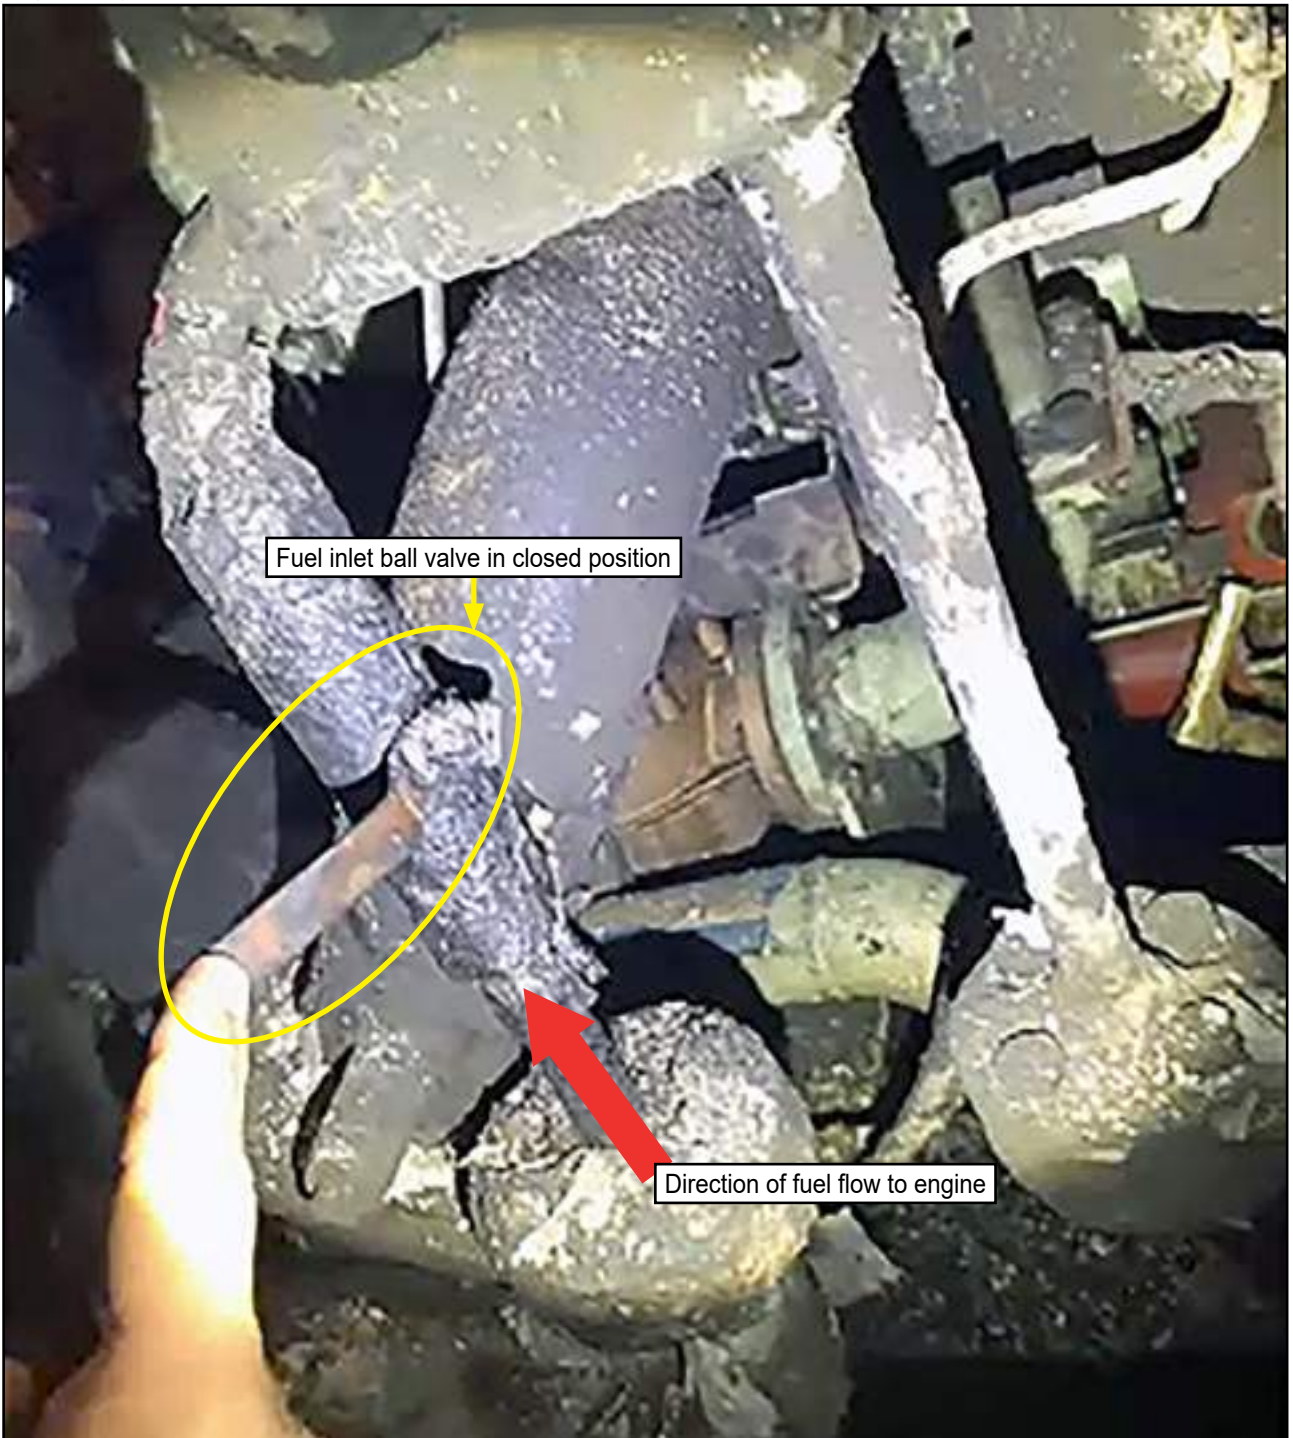
**Figure 16:** AE1 fuel supply isolating ball valve

The fuel supply isolating ball valve was found in the closed position (**Figure 16**). The fuel return isolating ball valve was found in the open position.

The fuel supply isolating ball valve and the non-return valve on the fuel return side of the pipework were pressure tested to 5.5 bar and found to hold pressure without leakage. The return line isolating ball valve was similarly tested and found to not close fully, resulting in a leak. Further examination of this valve identified ball seal damage.

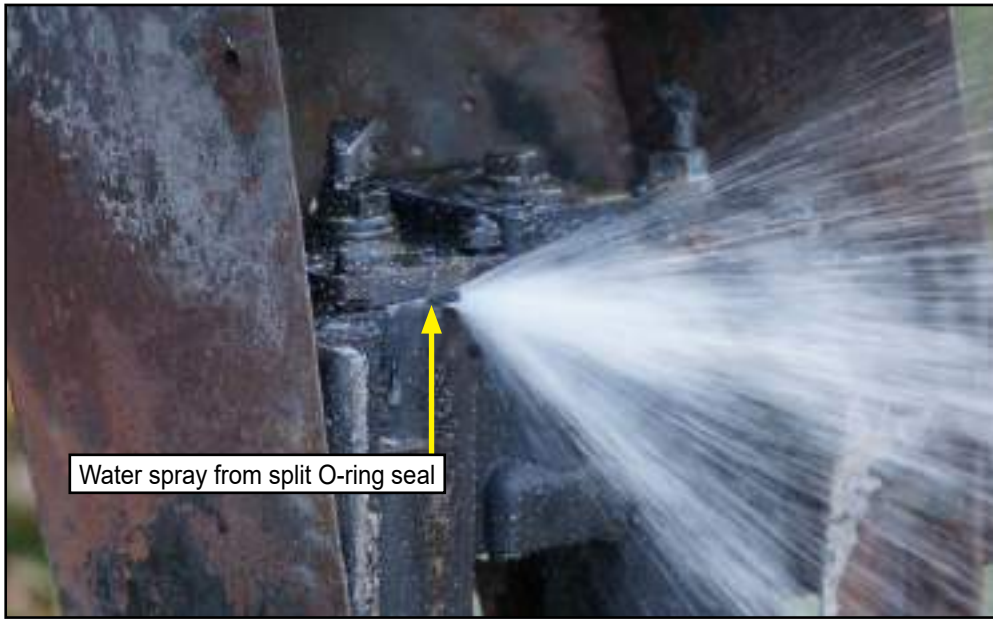
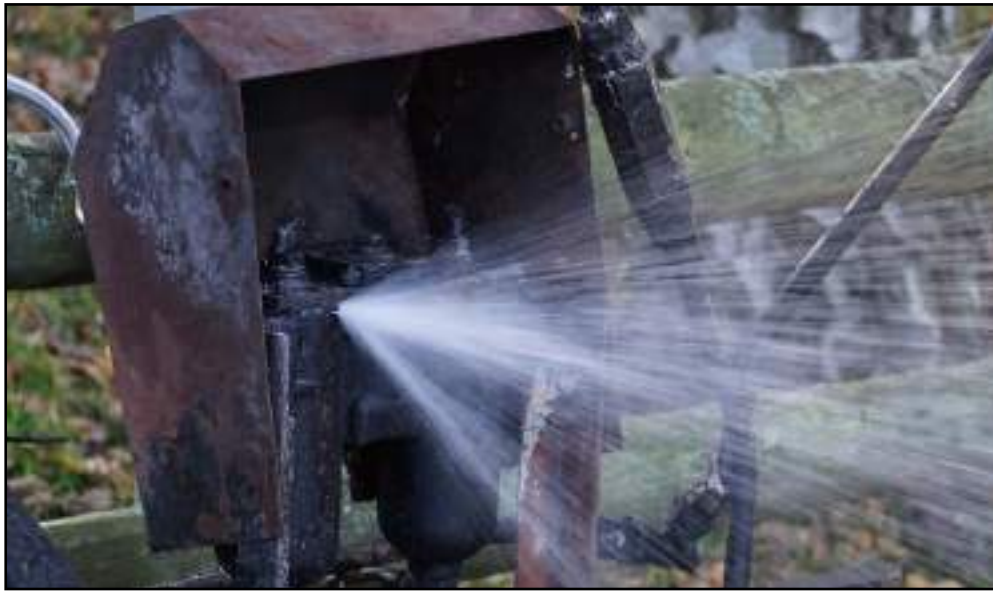
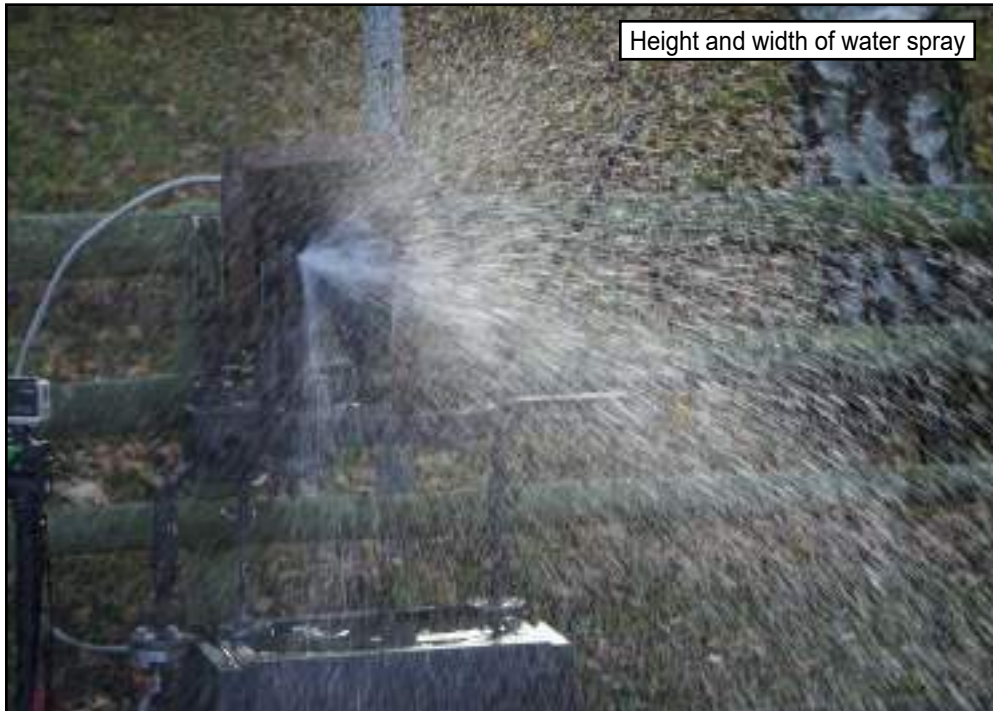
Figure 17: AE1 left-hand fuel filter leakage test

To understand the extent of fuel leakage through the partially removed left-hand filter cover, a 107 litres/minute 20 bar water pump was connected to the supply side pipework. The fuel filter and pipework testing ranged from 2 bar to 7 bar and at 5 bar the water spray reached up to 4m with a height of about 1.6m (**Figure 17**).

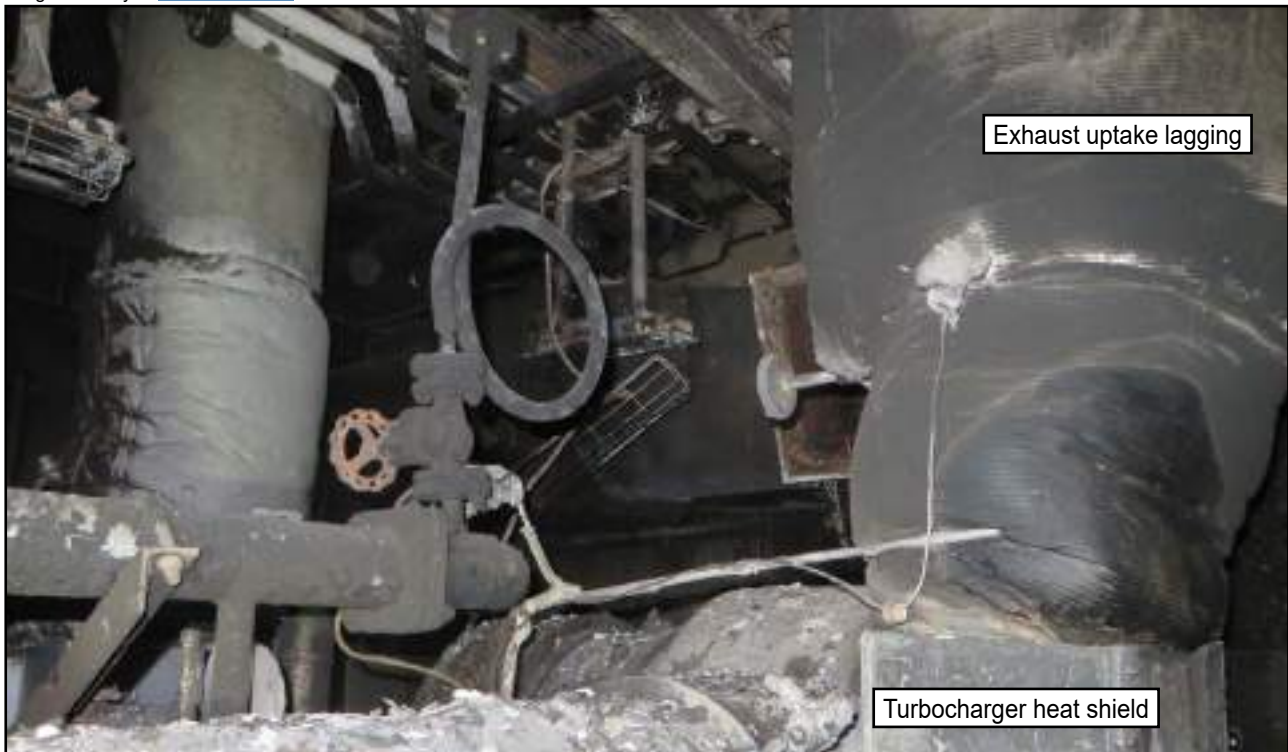
**Figure 20:** AE2 exhaust insulation

The exhaust pipework and turbochargers of the three AEs were protected by lagging insulation, which was covered by a thin galvanised sheet steel heat shield riveted together to form a homogenous barrier. The exhaust uptake pipework above the turbocharger heat shield was lagged (**Figure 20**).

The AE2 exhaust insulation was in generally good condition, although it had some gaps at the junction between the exhaust pipes and the turbocharger and from the turbocharger to the exhaust uptake. It is likely that fuel penetrated through those gaps to the hot pipework, where it ignited. However, given the volume of fuel released in the form of a spray, it is highly likely that ignition would have occurred eventually even with better exhaust protection.

Engine exhaust insulation can degrade due to factors such as maintenance, age and vibration, leading to gaps in coverage. These may not be obvious and are easily missed by simple point measurements. More reliable means of testing for hot spots include the use of TICs.

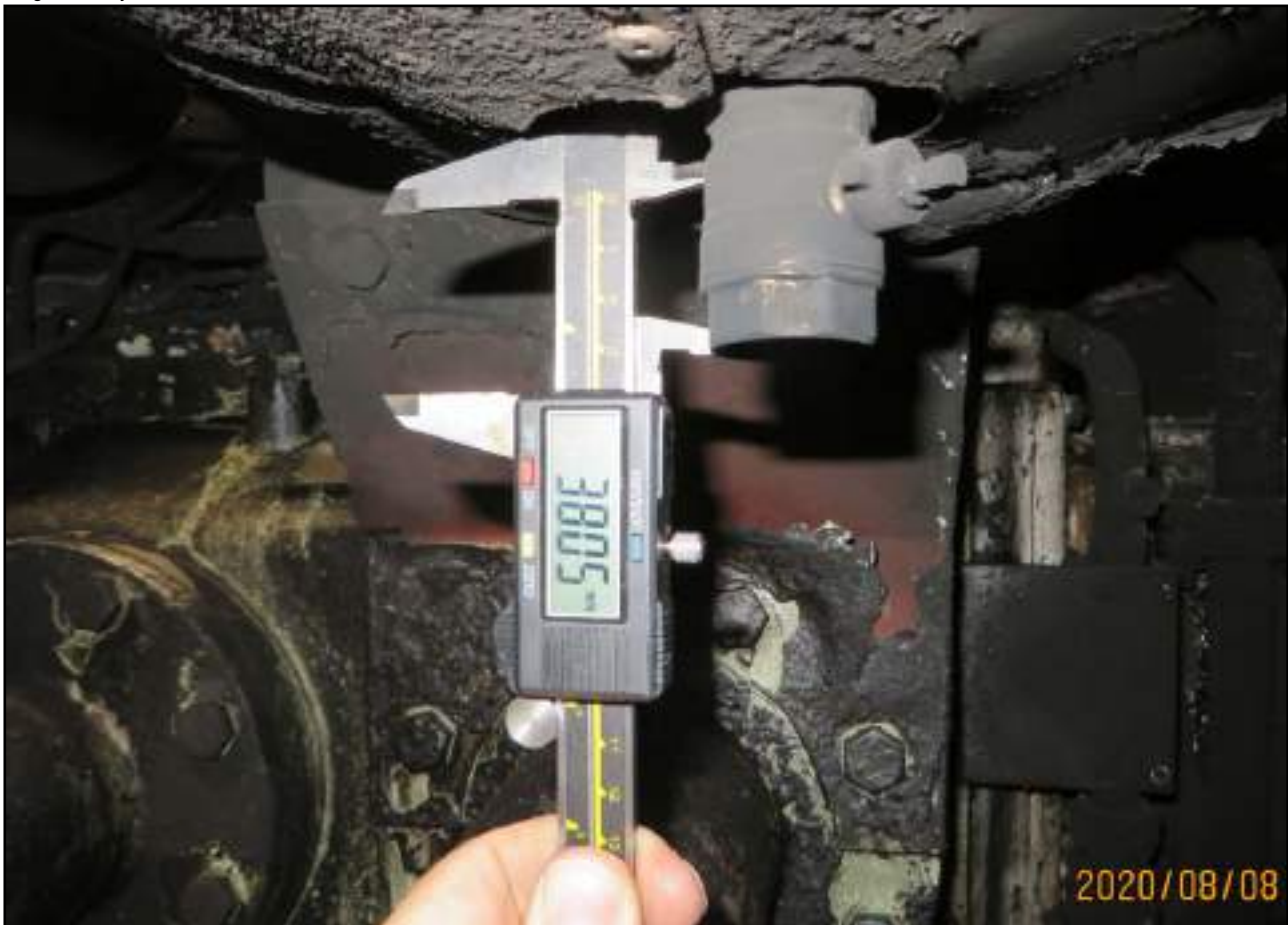
**Figure 22:** AE2 exposed turbocharger water washing drain connection

Additional exposed exhaust components included an unlagged valve on the turbocharger water-washing drain connection at the base of the turbocharger, which protruded almost 40mm beyond the heat shield (**Figure 22**).

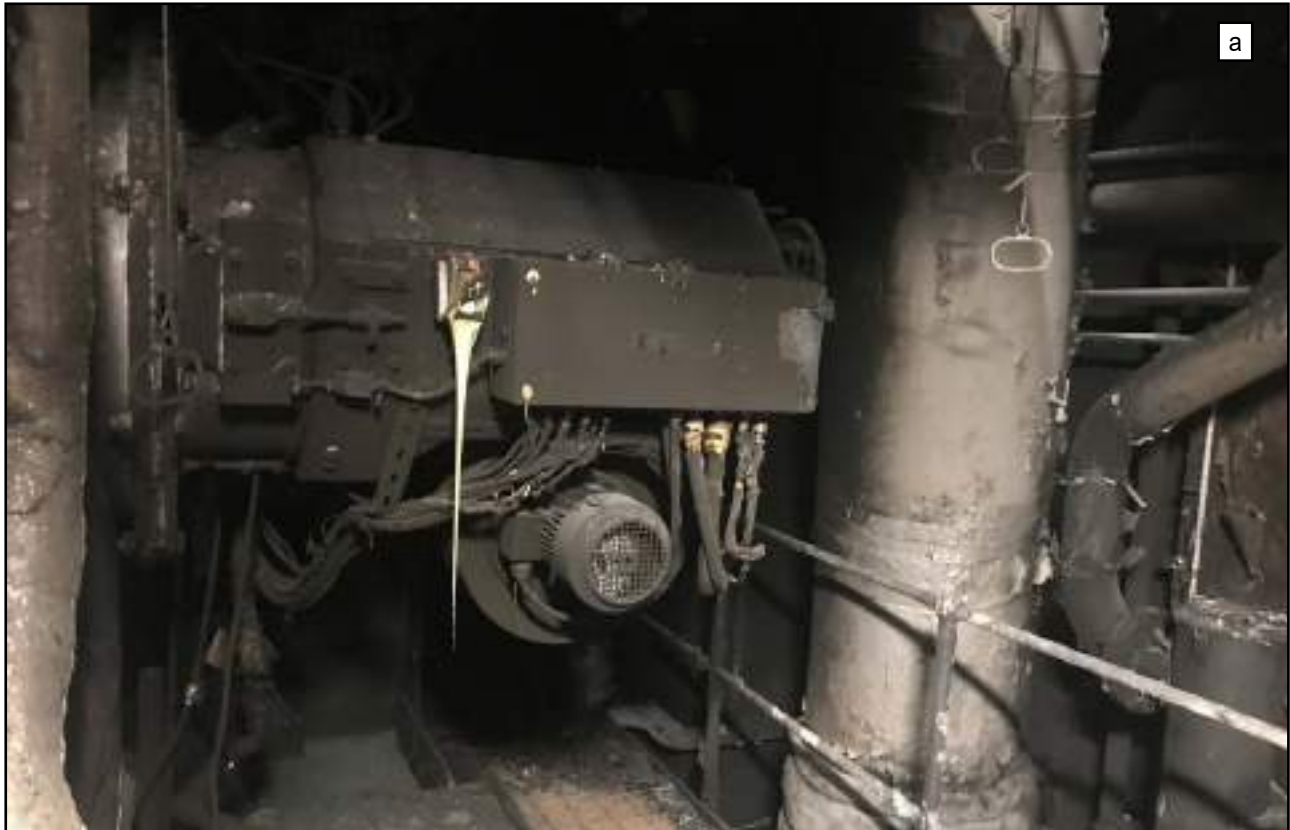
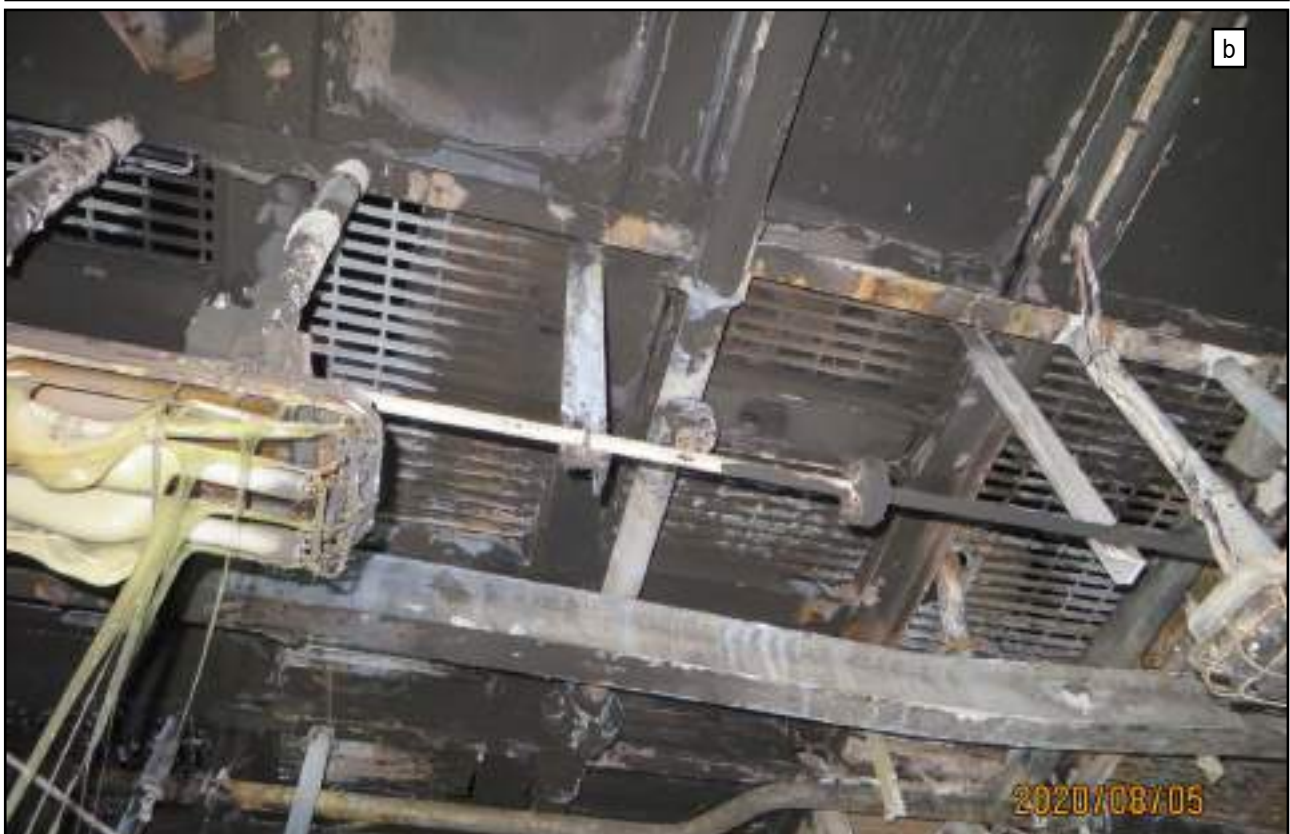
**Figure 23:** Boiler platform fire damage (a) and view up to boiler platform from auxiliary engines (b)

The fire was relatively short in its duration, but intense. It was localised at the aft end of the ER, around the aft end of AE1 and AE2 on A Platform and the entrance to the SG room. The fire had spread upwards, causing heat-related damage to the equipment on the boiler platform above the AEs (**Figures 23a** and **23b**). Heavy smoke damage was prevalent elsewhere.

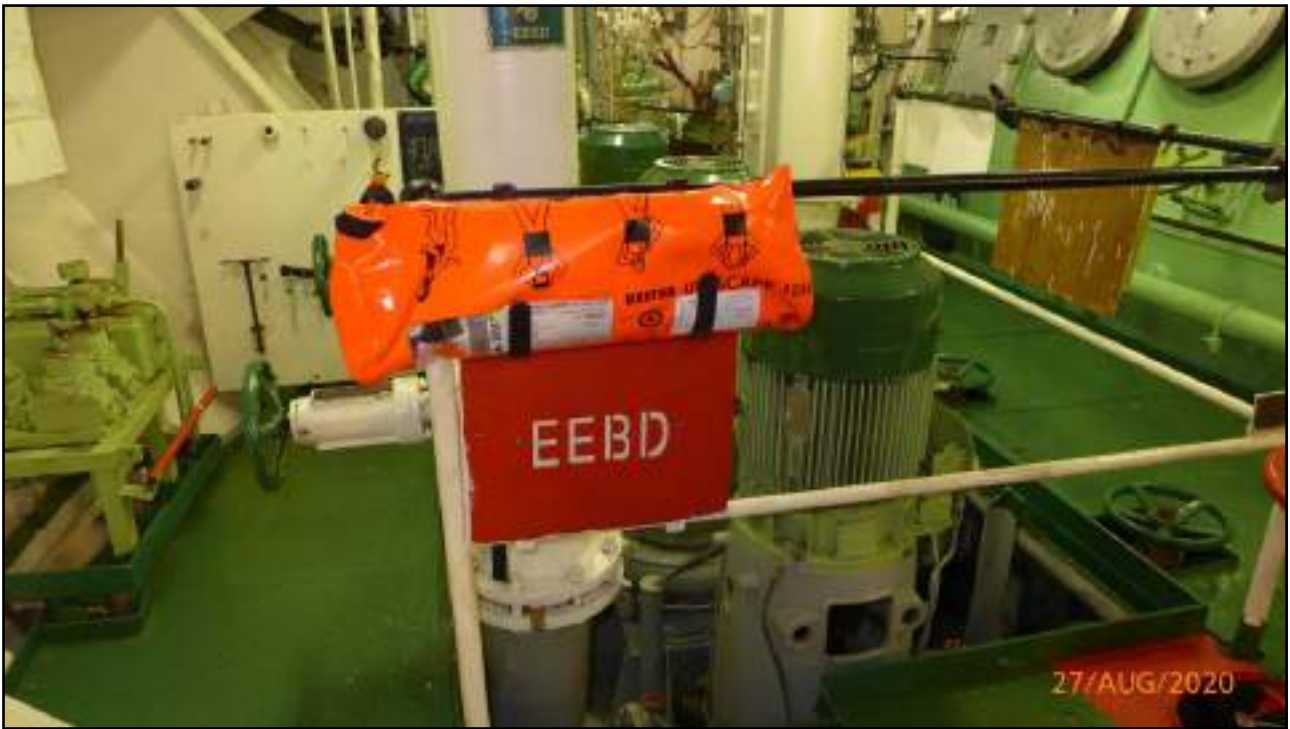
**Figure 24:** EEBD location at the entrance to the bottom deck emergency escape

*Moritz Schulte* was built in 2002 and was equipped with six EEBDs. One each was placed at the entrance doors to the port and starboard emergency escapes on the bottom deck of the engine room (**Figure 24**). Two EEBDs were located in the ECR on A Platform and two in the CCR on the poop deck.

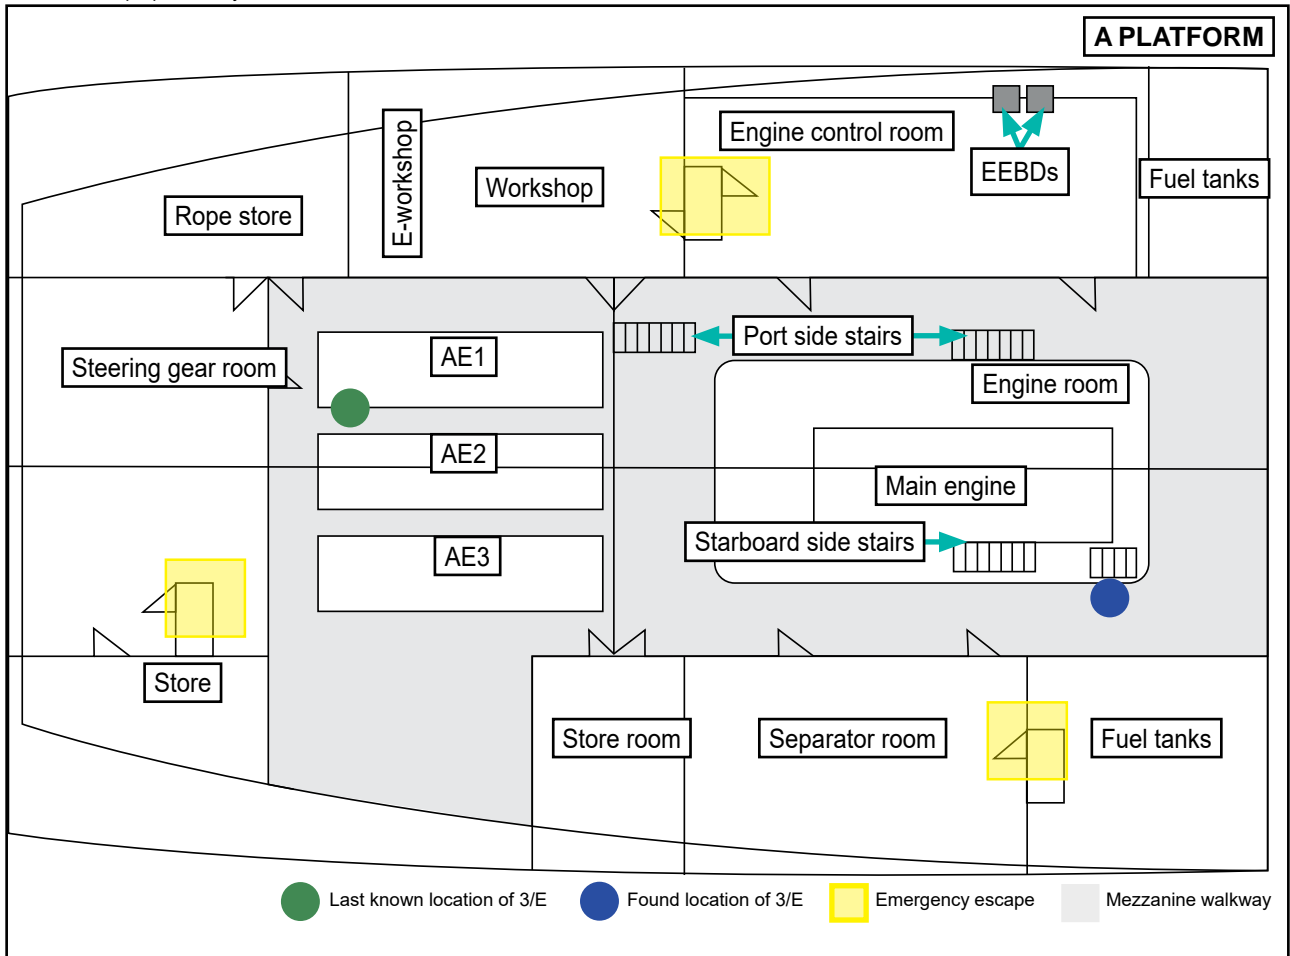
**Figure 25:** A Platform fire control and safety plan

The ER escape routes and locations of the EEBDs were clearly marked on *Moritz Schulte's* fire control and safety plan. When the 4/E and the fitter began their escape from A Platform, their nearest EEBD was in the ECR (**Figure 25**).
