ACCIDENT REPORT

REPORT NO 9/2022

Mooring deck accident on board the cargo vessel *Teal Bay* resulting in one fatality at Kavkaz South anchorage, Russia on 30 August 2021

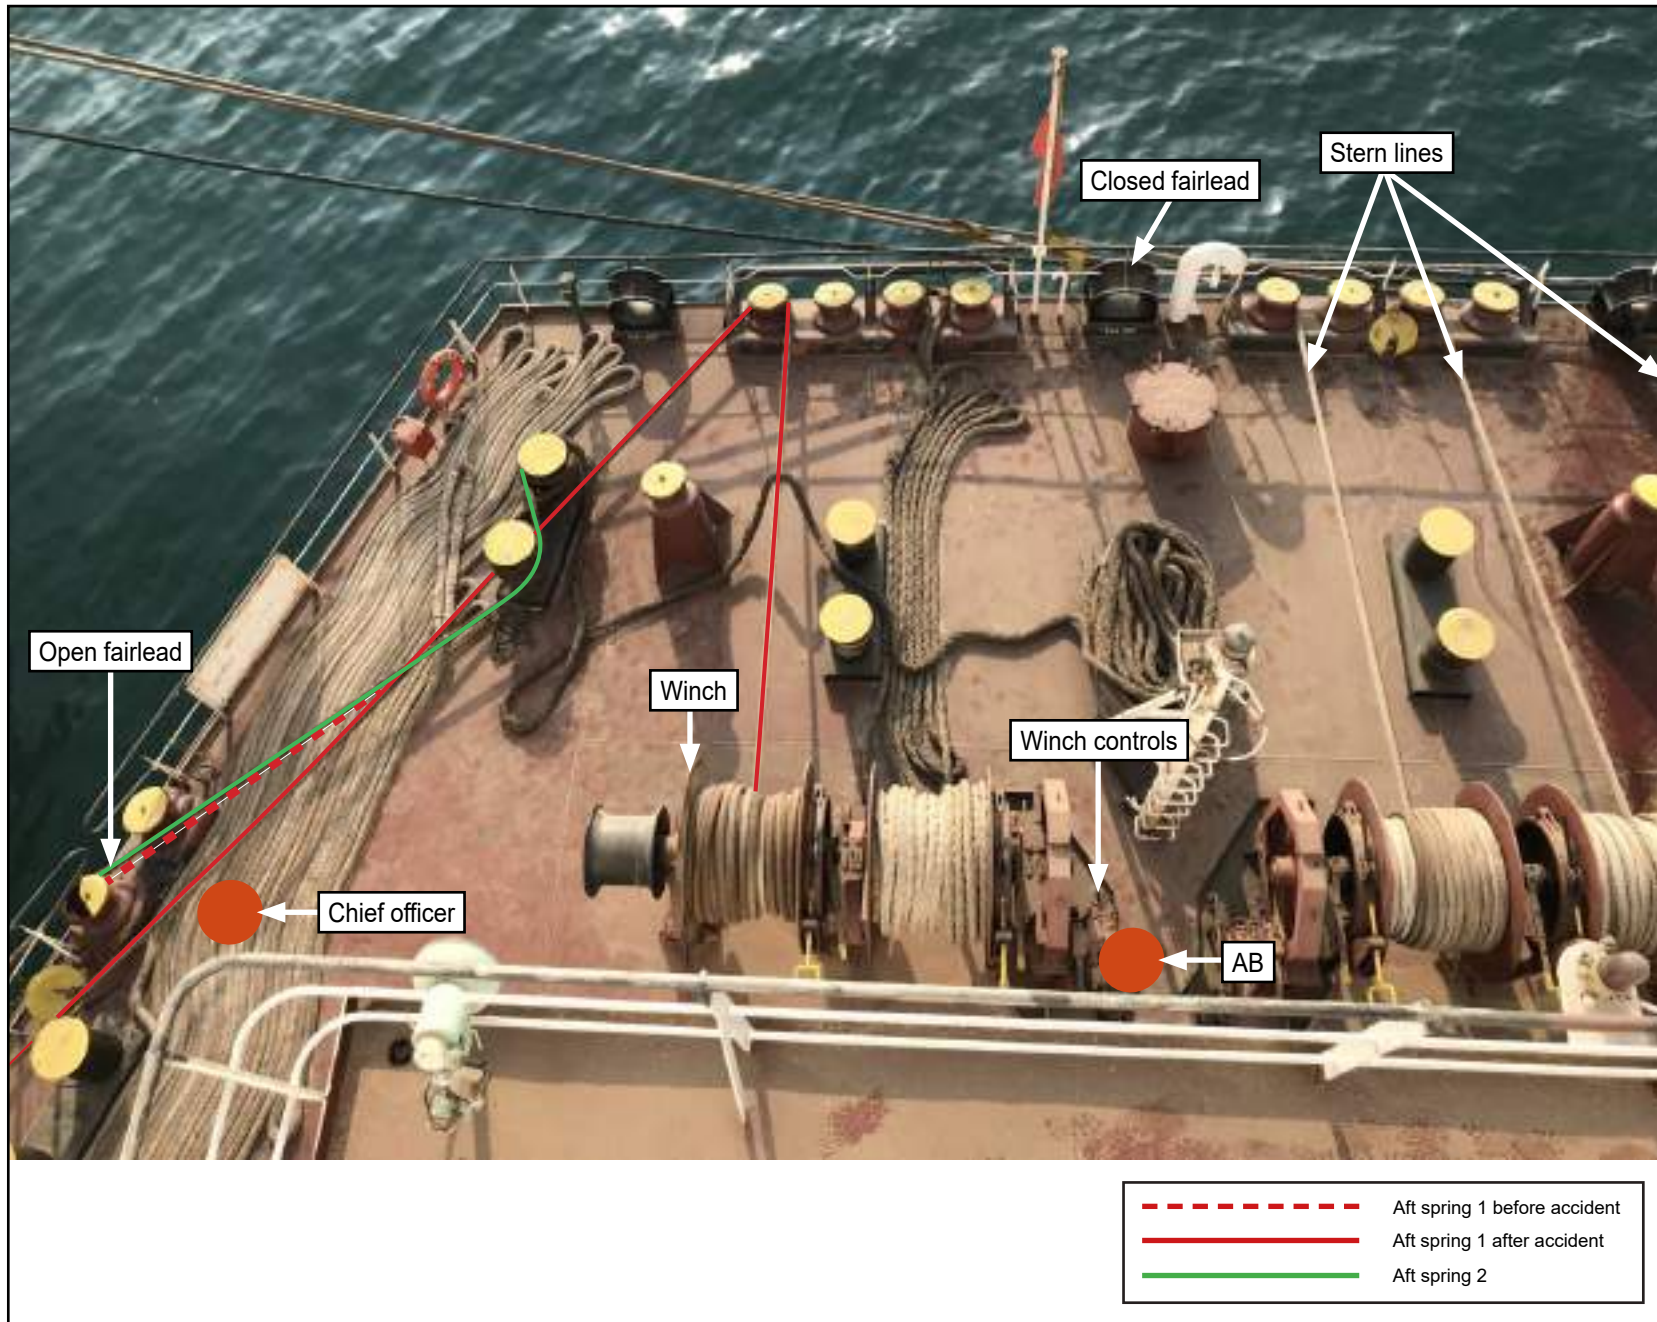
Figure 1: *Teal Bay's* aft mooring arrangement (dotted line indicates position of aft spring 1 before the accident)

The aft spring lines were rigged from the starboard side of the aft mooring deck. One (aft spring 1) was attached to the starboard mooring winch outer drum and led around an open roller fairlead at the stern, back through a set of double bitts and then forward through an open roller fairlead on the outer edge of the mooring deck. The second aft spring (aft spring 2) was secured above aft spring 1 on the double bitts and led forward through the same open roller fairlead (**Figure 1**). Both springs passed through the same closed fairlead on *Kavkaz V's* main deck.

The decision to lead two lines through the same roller fairlead was unsafe and the presence of a second line restricted the available space and limited the fairlead's containment ability, almost certainly contributing to the aft (upper) spring 1 jumping out under tension.

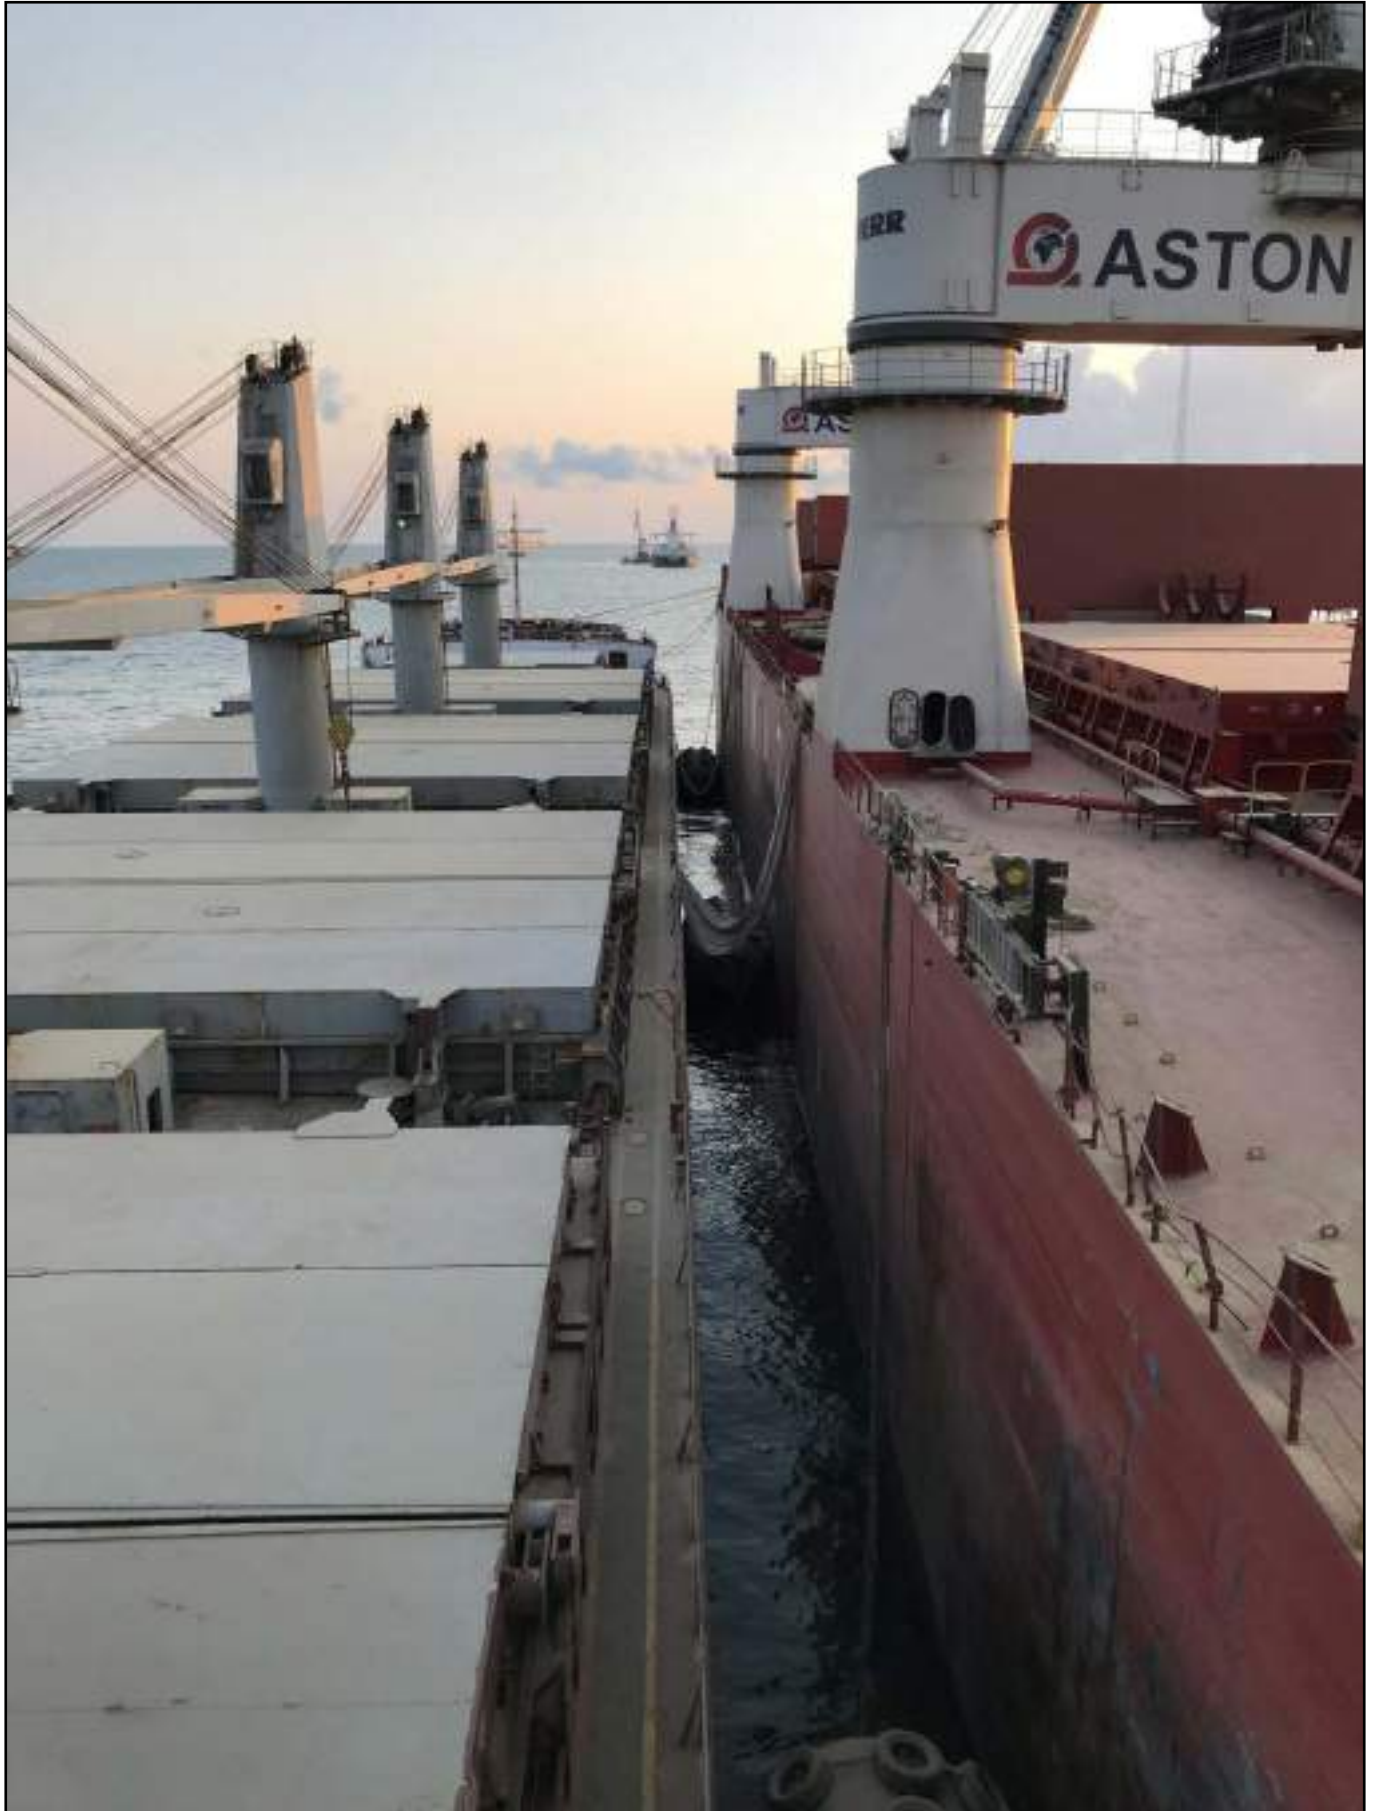
Teal Bay was moored starboard side to alongside *Kavkaz V* (**Figure 2**). The three stern lines were rigged from the port side of the aft mooring deck. Two were attached to the port mooring winch drums and led through open roller fairleads at the stern; the third was secured to a set of double bitts and led through a closed fairlead (**Figure 1**). All three stern lines were led through a single closed fairlead on the port side of *Kavkaz V's* aft mooring deck and placed over bitts.

Figure 2: *Teal Bay* (left) moored alongside *Kavkaz V* (right)

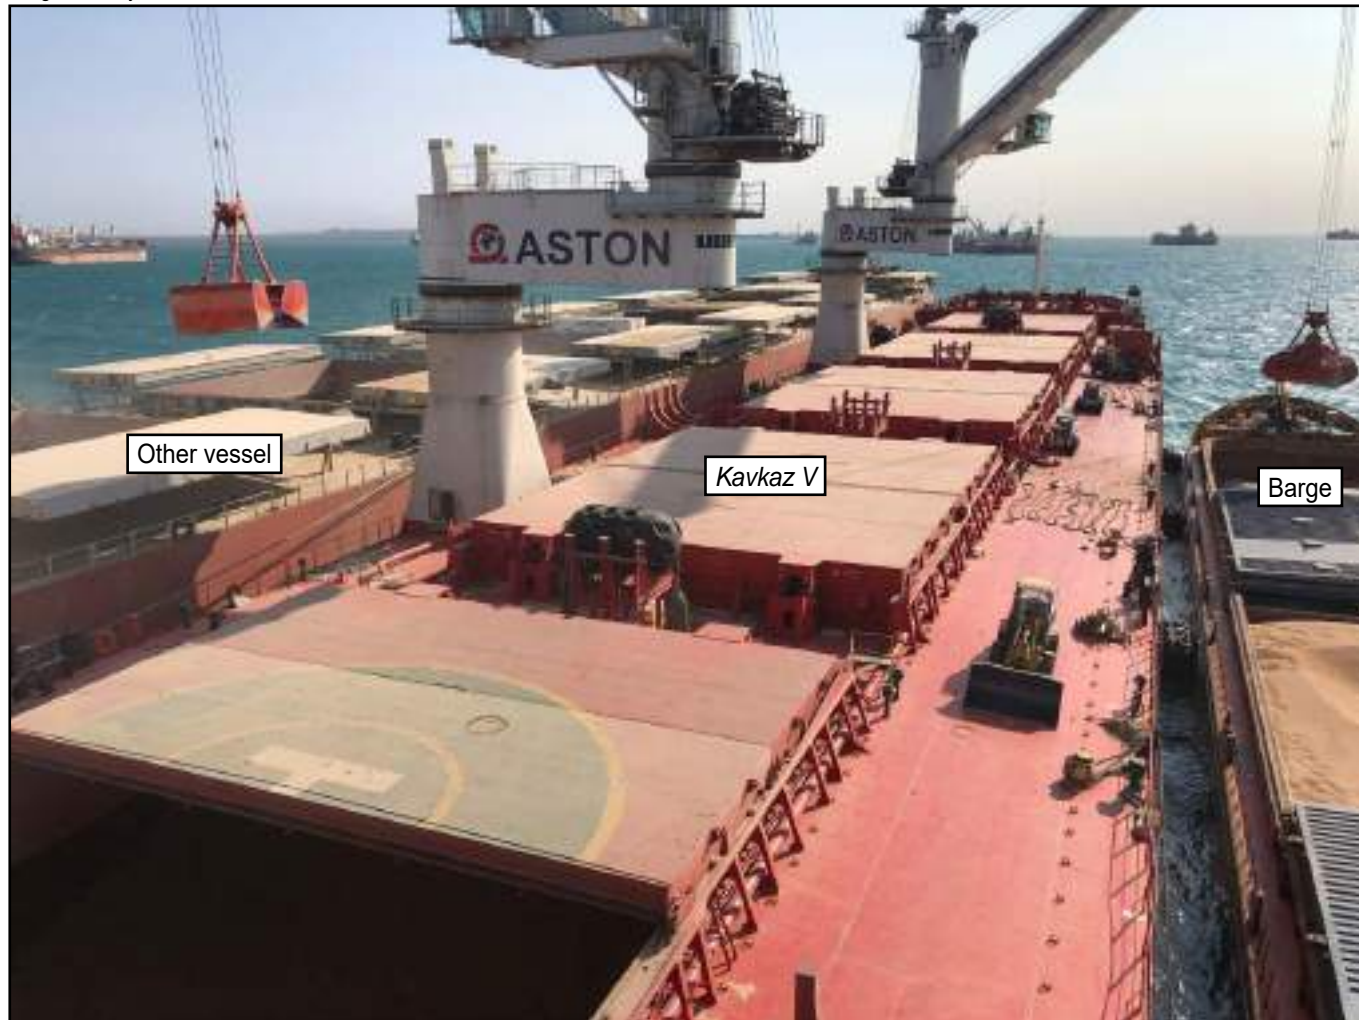
When acting as a storage vessel at anchor, *Kavkaz V*'s cargo holds were loaded with grain from river barges. The grain was then discharged into other vessels moored alongside for onward transport (**Figure 3**). *Teal Bay*'s crew had not loaded cargo in this way before and, until the pilot boarded and informed him of the loading arrangements, the master was expecting to load grain directly from barges while at anchor.

Figure 3: *Kavkaz V* (centre) loading grain from a barge (right) while transferring cargo to another vessel (left)

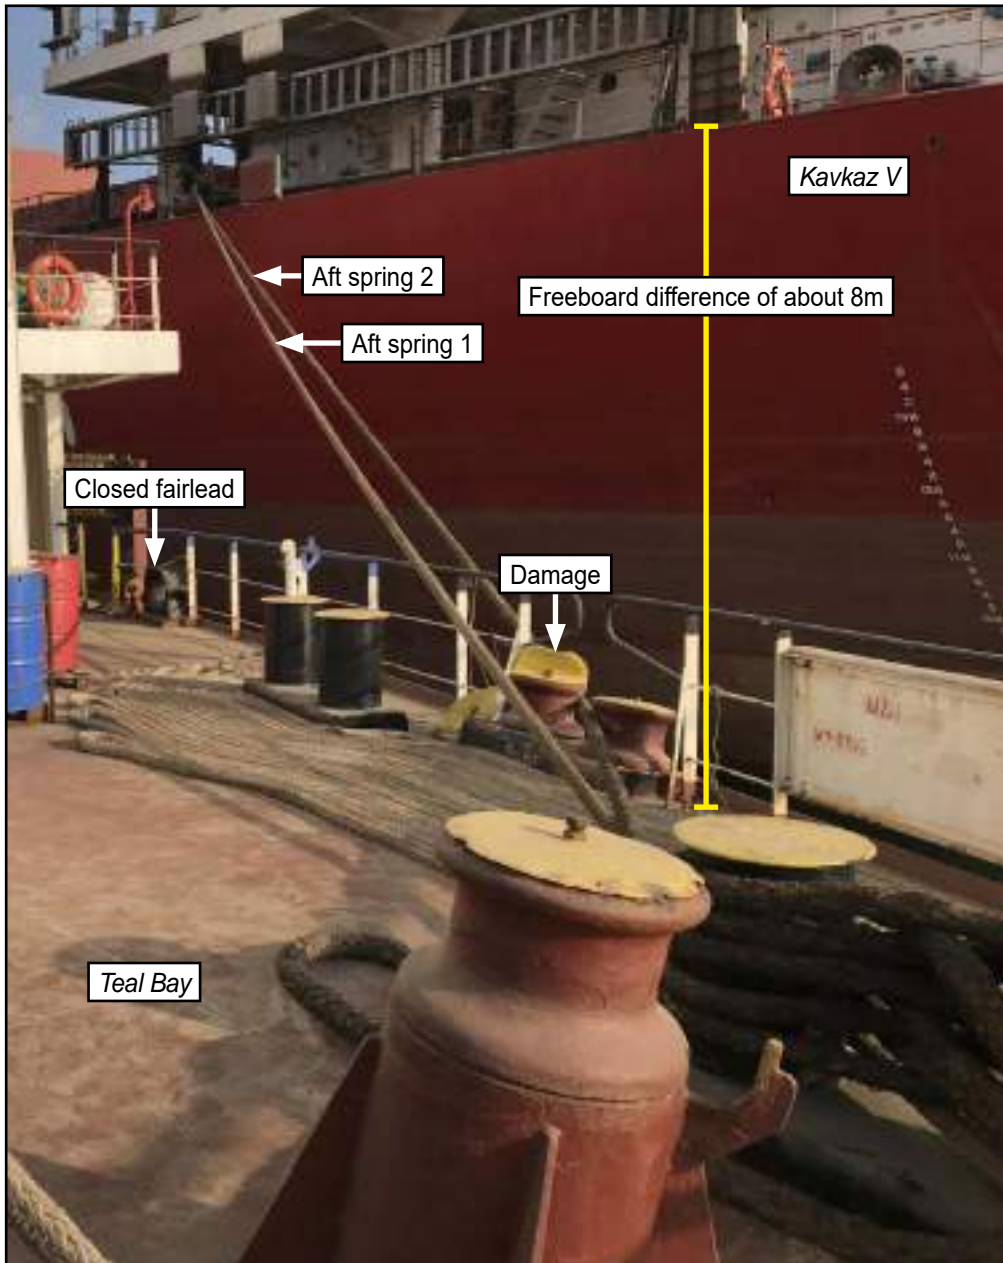
With only a short distance to move, the master's decision to warp *Teal Bay* forward was reasonable; however, it did not consider the hazardous upward lead that the mooring lines had developed because of the freeboard differential between the two vessels. At the start of the loading operation, the freeboards of *Kavkaz V* and *Teal Bay* were similar, but after 22 hours there was a difference of about 8m (**Figure 4**). When tension was applied to the aft spring the upward angle of the line became too great for the open fairlead to contain it and it jumped violently upwards, striking the C/O. As the freeboard difference had arisen gradually, and *Teal Bay's* crew were unfamiliar with situations where their vessel was lower than the object it was moored to, they had not realised the dangerous situation that had developed. Without a risk assessment prior to the forward move, the opportunity to identify the hazard and take steps to minimise the risk to crew was lost.

Figure 4: *Teal Bay's* aft deck, showing the nearest closed fairlead, freeboard difference, damage and location of aft spring after the accident

Although *Teal Bay's* aft deck mooring equipment included several closed fairleads (**Figure 4**) the springs were led through an open one. This was probably because, constrained by the position of mooring equipment on both vessels, *Teal Bay's* crew judged that the open fairlead provided the most suitable arrangement for the aft spring and had not considered the additional hazards introduced by the loading method. This lack of hazard recognition was further demonstrated by the fact that *Teal Bay's* mooring risk assessment did not include reference to STS loading.

- Conducted additional safety training with *Teal Bay's* crew, including modules on safe mooring operations and STS.
- Issued a work instruction setting out a plan to remove open fairleads from the fleet and replace them with a closed type or universal type of fairlead and directed managers to make allowance for this within the dry dock specification for vessels scheduled to dry dock.
