Report on the investigation of the collision
between the general cargo vessel
Scot Carrier
and the split hopper barge
Karin Høj
resulting in the capsizing of the barge with two fatalities
in the Bornholmsgat traffic separation scheme, Sweden
on 13 December 2021

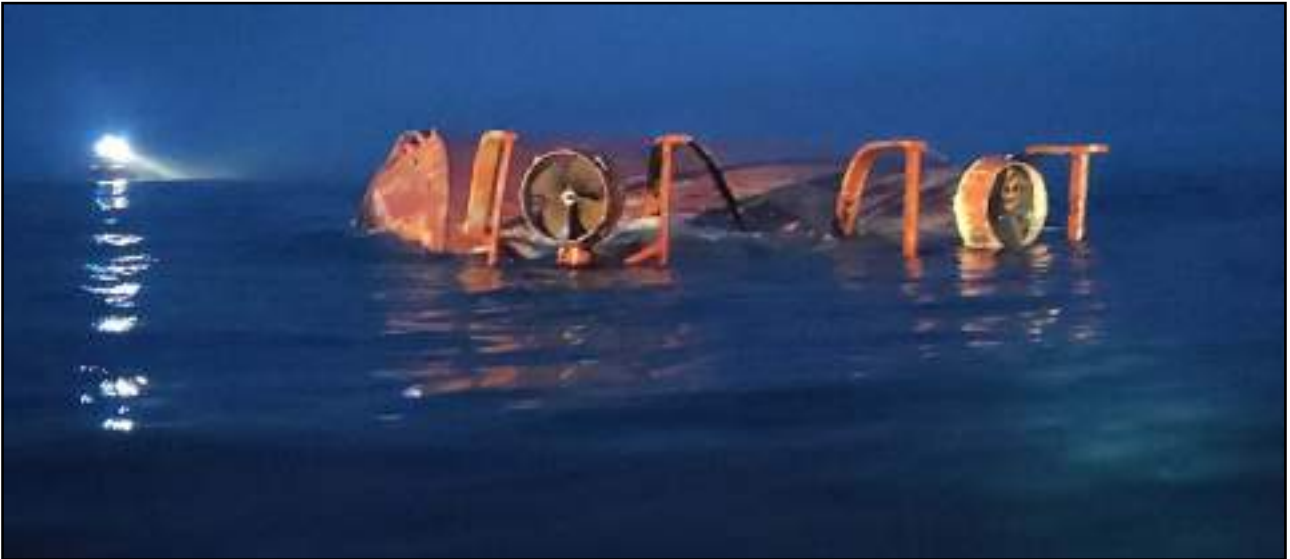
Figure 13: Karin Høj's upturned hull, showing azimuth drive units at the stern

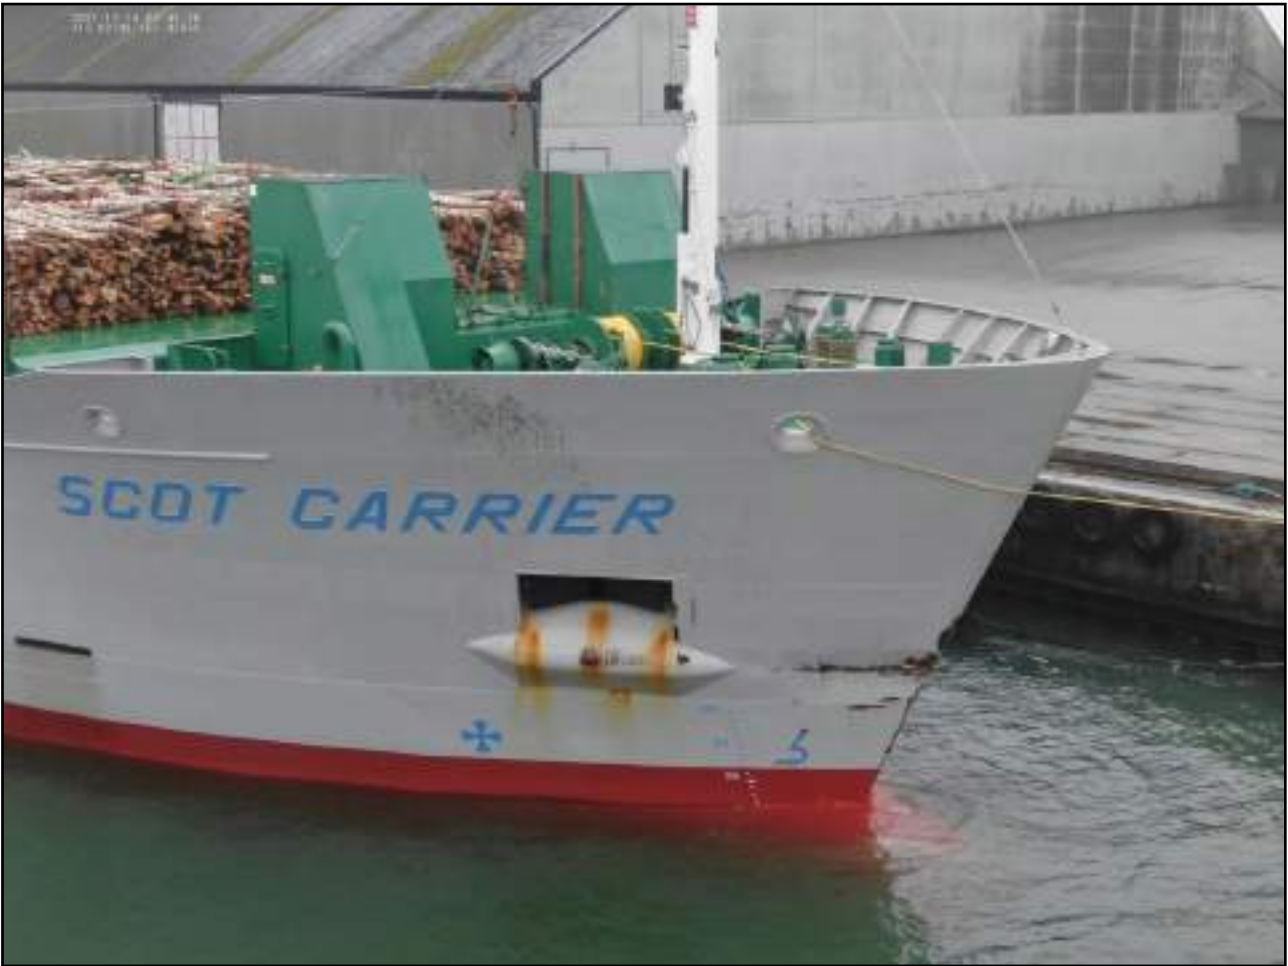
Figure 15: Damage to *Scot Carrier's* bow, showing collision damage on stem and hull, and silt staining above the ship's name

On 14 December, a Lloyd’s Register surveyor attended *Scot Carrier* to assess the damage to the ship’s bow (**Figures 15, 16 and 18**) and noted:

The surveyor issued *Scot Carrier* with a condition of class¹⁰ that required repairs to be completed within 2 months.

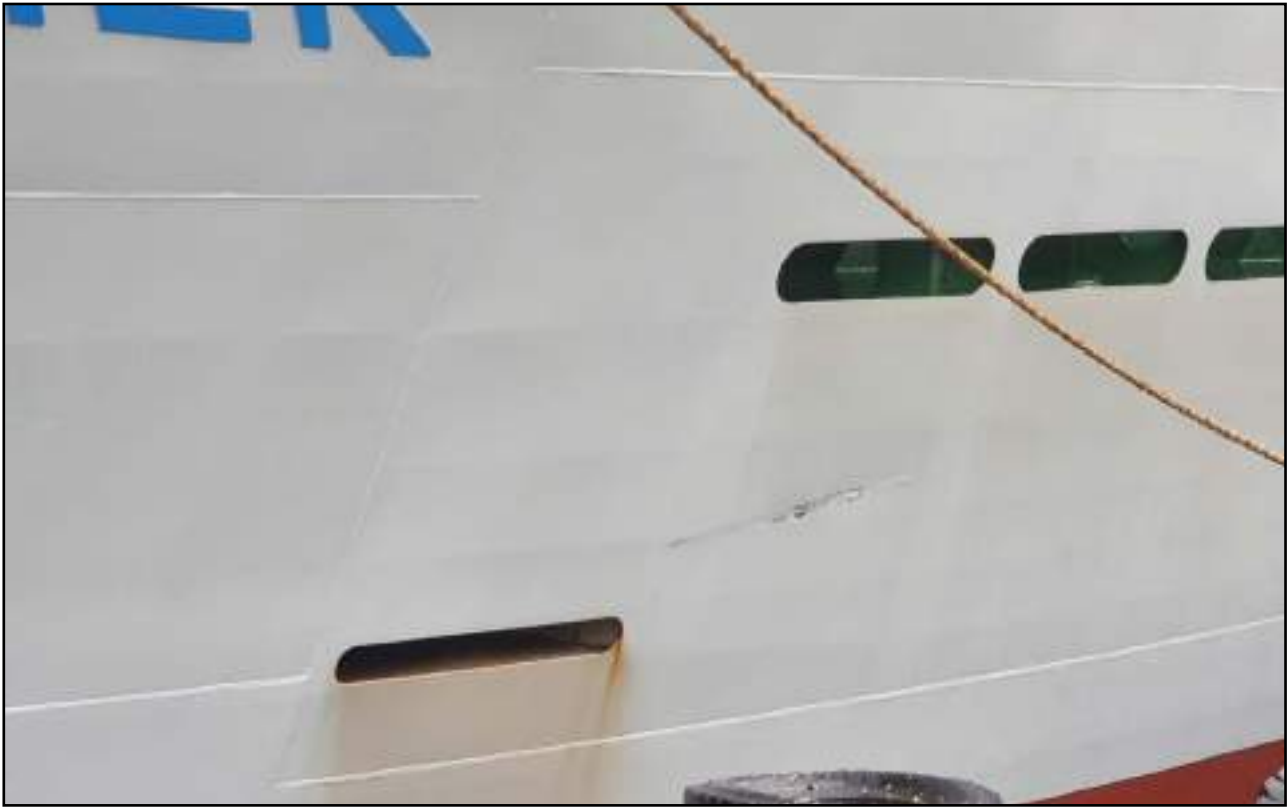
At 1400, Sweden Rescue directed *Scot Carrier* to proceed to the nearby port of Ystad, Sweden. Coastguard officers boarded and inspected the vessel on its arrival. Inspectors from both the MAIB and Danish Marine Accident Investigation Board (DMAIB) attended *Scot Carrier* later the same day, carrying out an immediate inspection of the ship’s hull and taking photographs of the damage to its bow (**Figure 15**). The inspectors noted silt stains above the ship’s name on the starboard side and new damage to the paintwork on its port side (**Figure 16**).

Figure 16: Damage to *Scot Carrier's* paintwork on the ship's port side

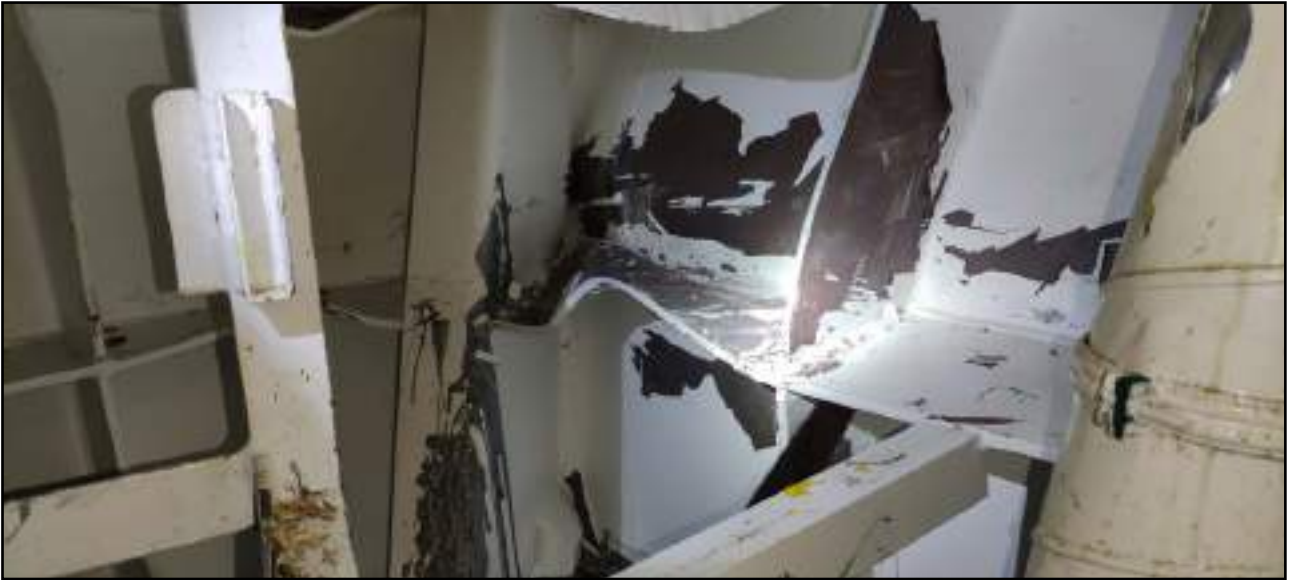
Figure 18: Damage to *Scot Carrier*'s internal bow structure

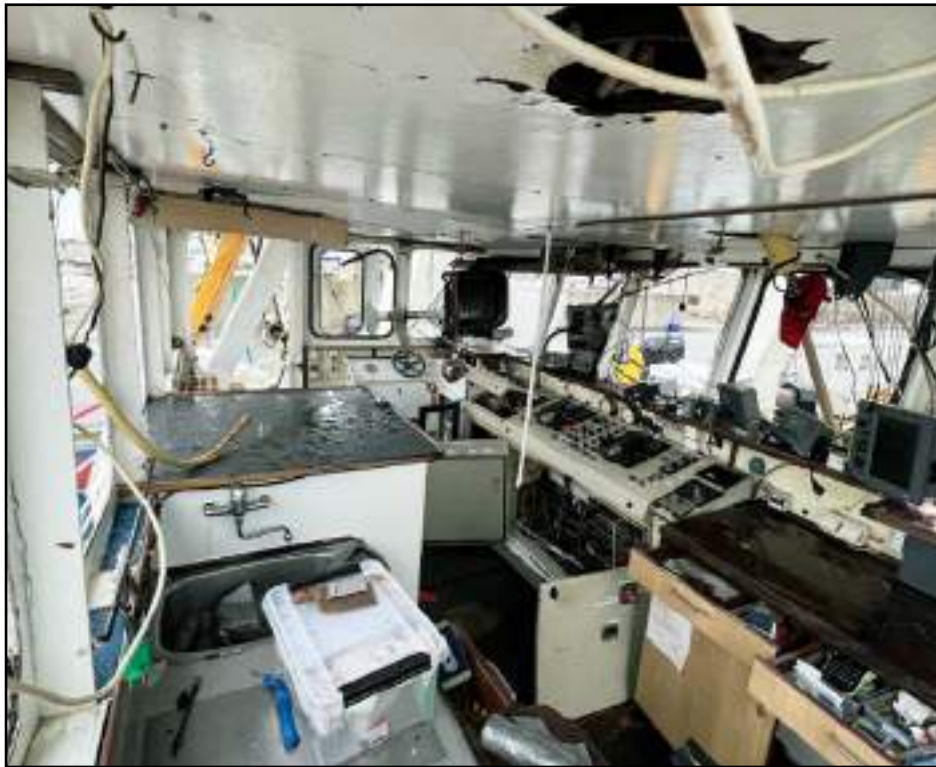
Karin Høj's bridge had sustained extensive damage while the vessel was being towed while inverted and later grounded. All of the window panes were missing and the helm chair and navigational equipment had been torn from their mountings (**Figure 24**). Paper objects such as charts and logbooks were lost. No data was recoverable from the electronic navigation systems.

Figure 24: Karin Høj's bridge, post-salvage

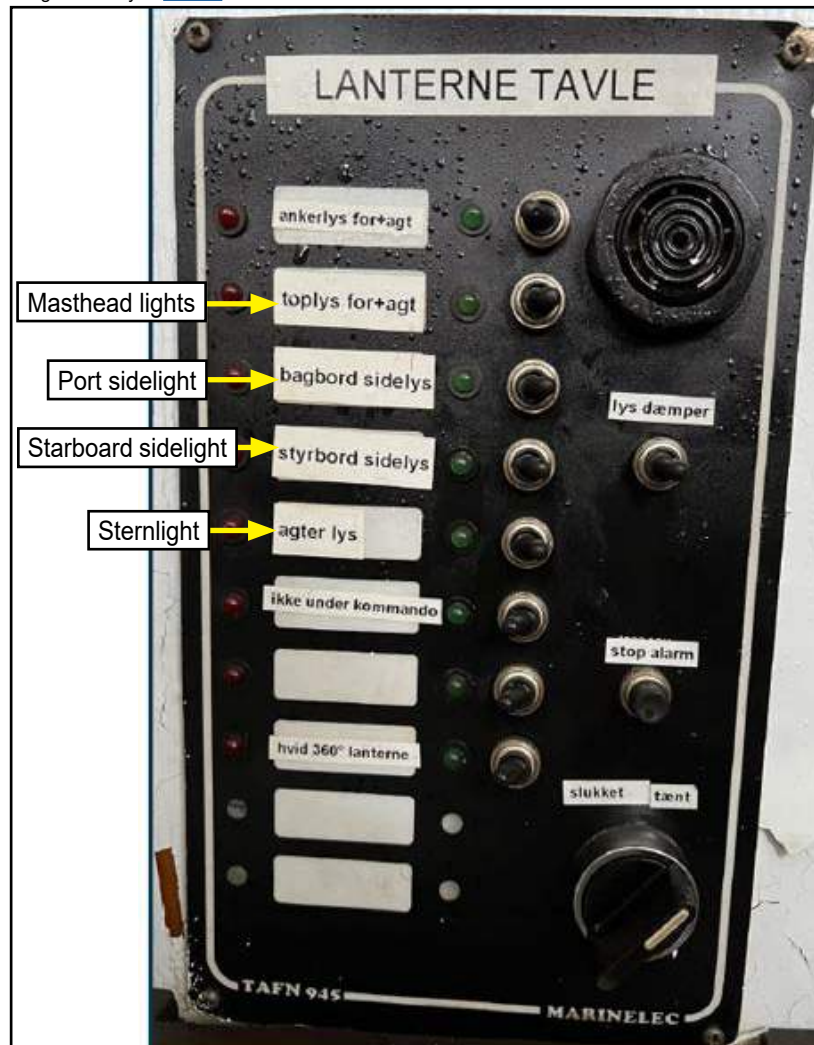
The switches to the masthead lights, port and starboard sidelights and stern light were in the *on* position (**Figure 25**). The key in the BNWAS control panel was in the *on* position (**Figure 26**). It was not possible to determine the BNWAS alarm interval setting selected.

Figure 25: Karin Høj's control panel for navigation lights

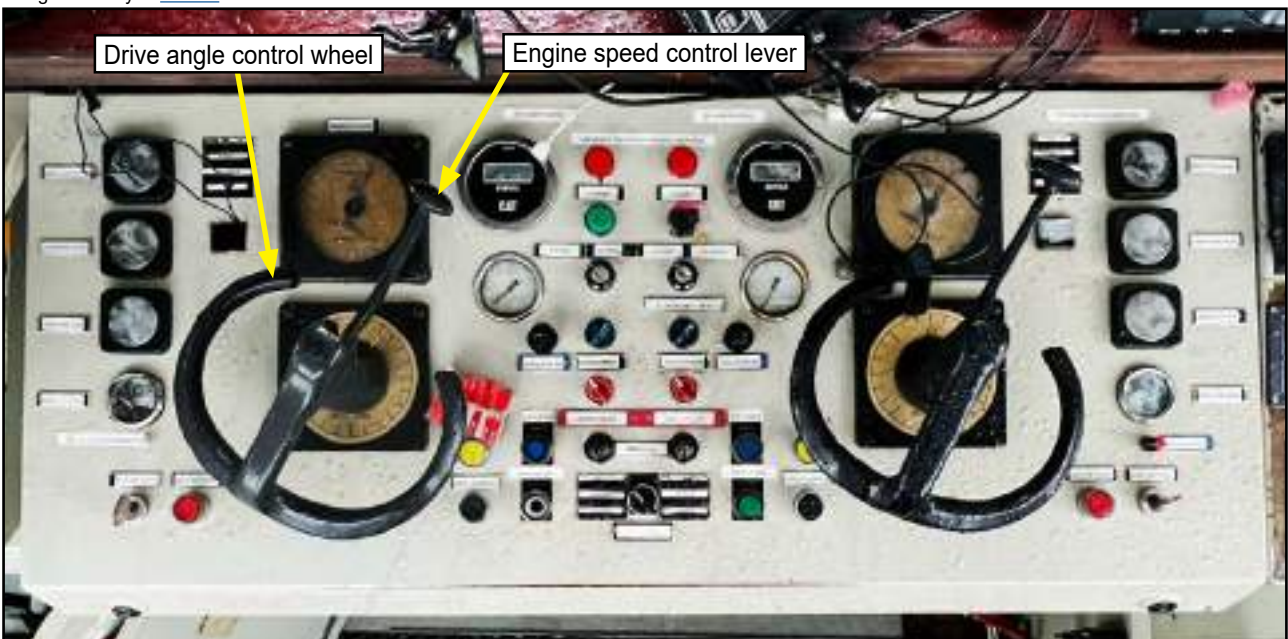
Both bridge azimuth drive angle control wheels were positioned at 30° thrust to port with the speed control lever at full ahead (**Figure 27**). The controls were easily turned, and their position as well as the position of the azimuth drive units might have changed during the salvage operation.

Figure 27: Karin Høj's azimuth drive controllers

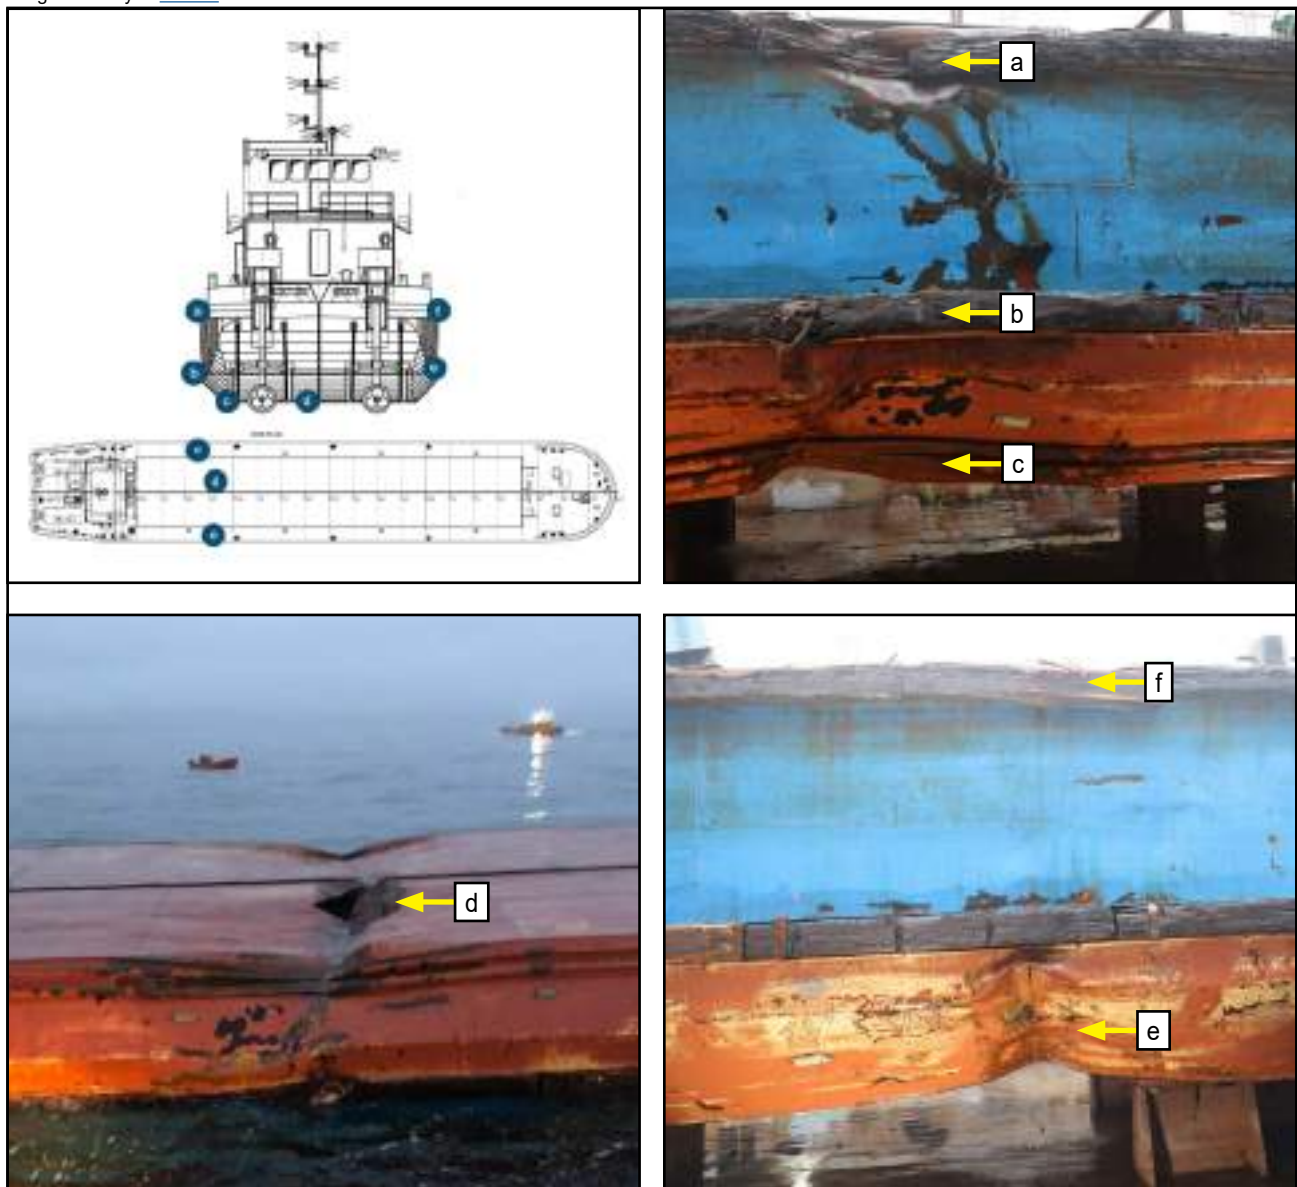
Karin Høj's hull had sustained severe damage forward of the accommodation, between frames 28 and 34 (**Figure 28**), including:

- a) indentation in the side plating at the gunwale and a crushed upper fender;
- b) large indentation in the upper part of the bilge plating;
- c) indentation on the lower part of the bilge plating;
- d) penetration of the hull plating on the port side of the keel;
- e) indentation in the bilge plating; and
- f) a crushed fender.

Figure 28: *Karin Høj's* hull damage

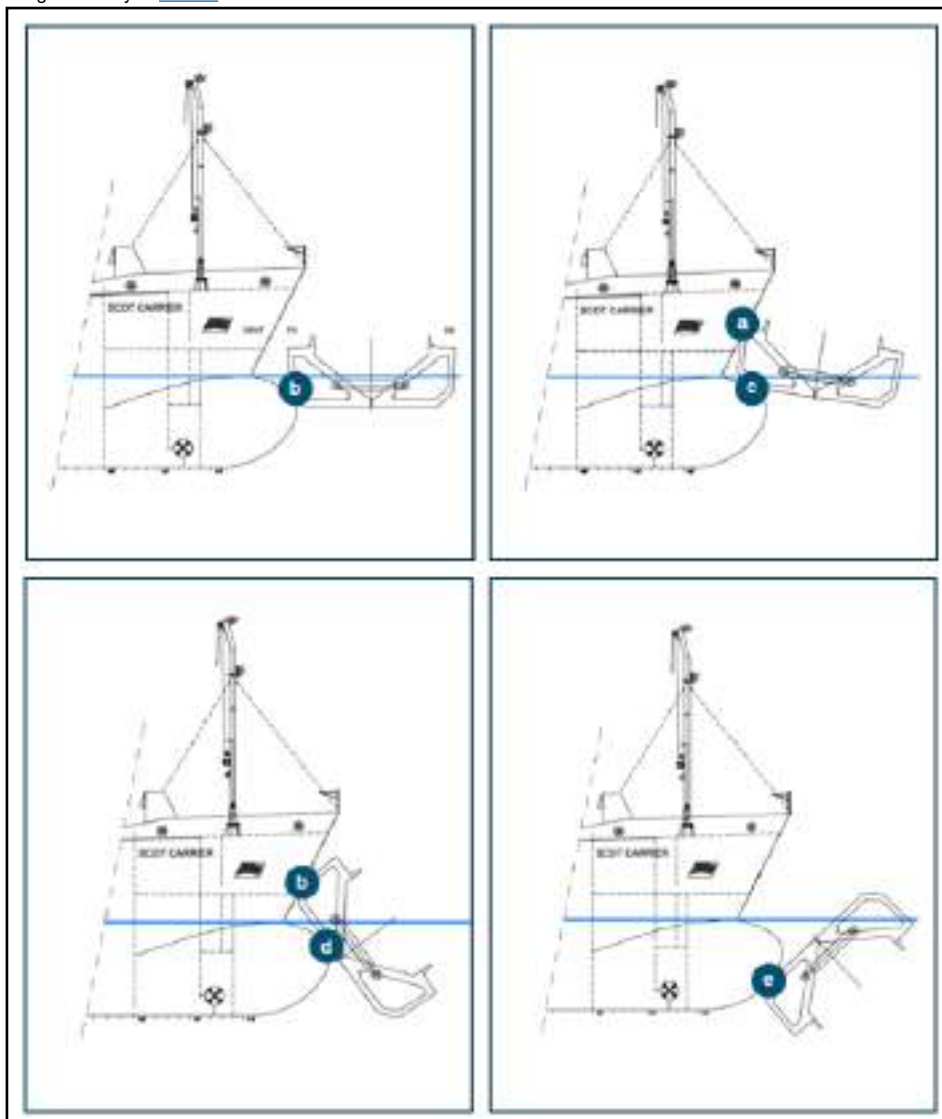
Figure 33: Likely dynamics of collision and *Karin Høj*'s capsizing, showing damage points

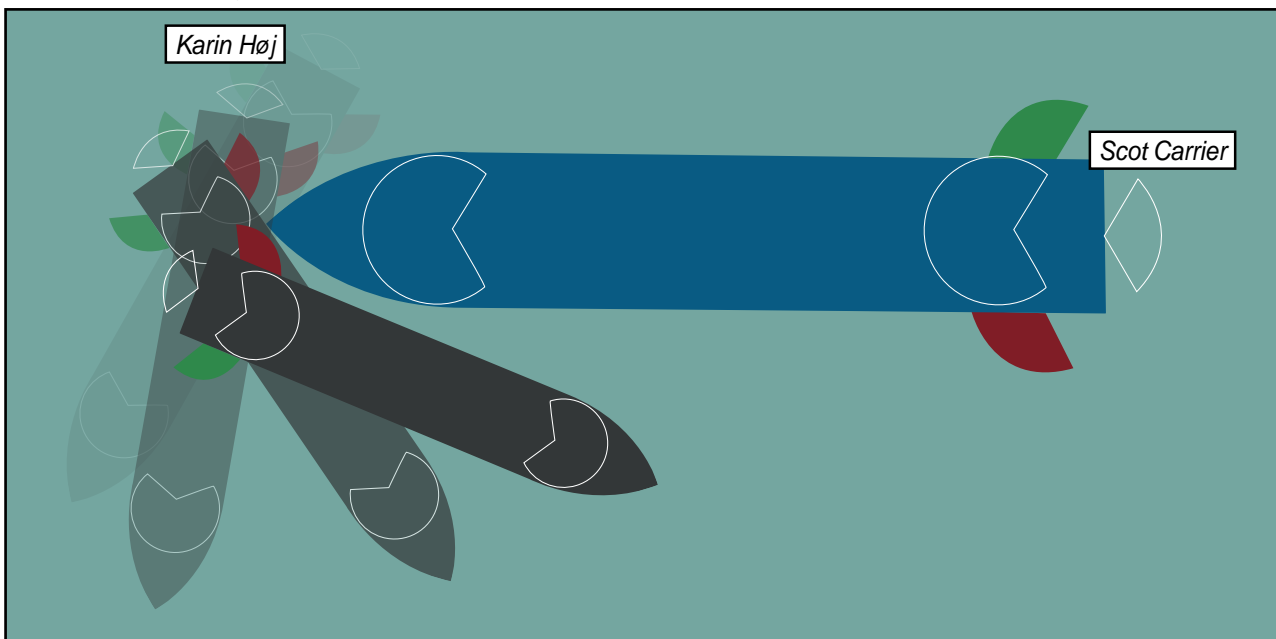
Figure 34: Likely dynamics of collision and the effect on *Karin Høj*
