MIR-23-16

Collision between Cargo Ship *Damgracht* and Cargo Ship *AP Revelin*

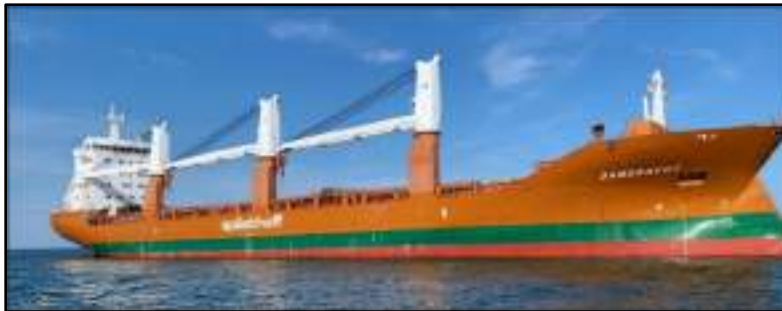
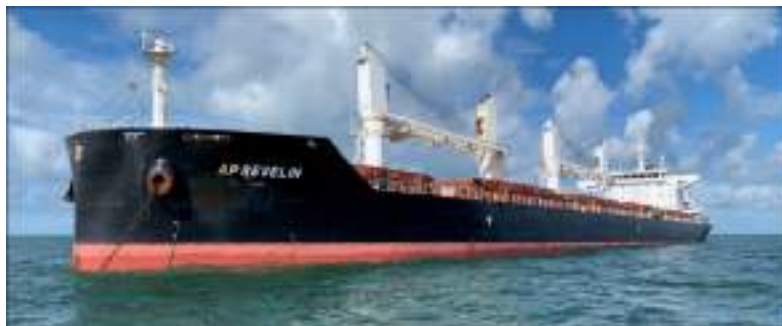
Figure 1. Cargo ships *Damgracht* (above) and *AP Revelin* (below) anchored after the collision.

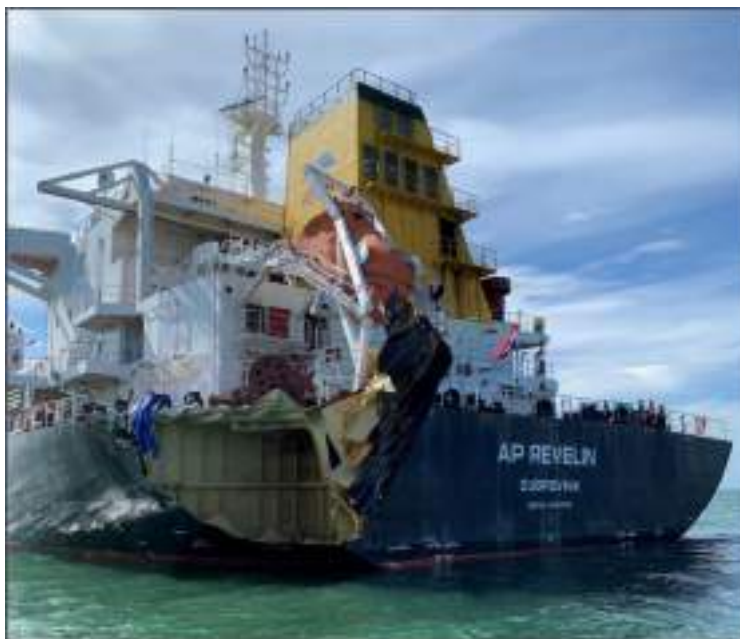
Following the collision, surveyors conducted damage assessments on both vessels. The *AP Revelin* sustained damage on the port, aft section of the stern deck, the freefall lifeboat and its davit structure, engine room store bulkhead, side shell and transom plating, and portside freshwater tank.

Figure 5. Damaged stern area of the *AP Revelin* after the collision.

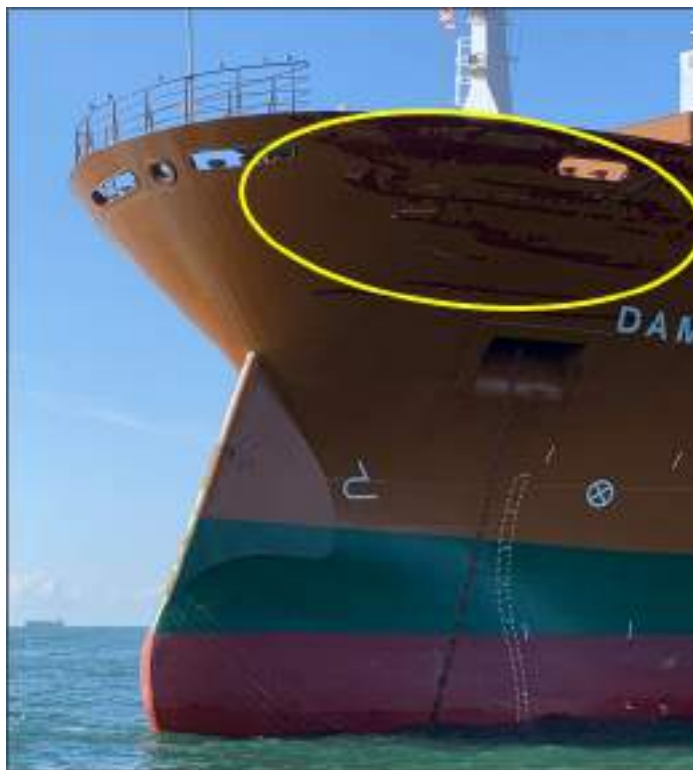
Surveyors inspected the bow of the *Damgracht* and found that the upper port side of the bow above the anchor pocket had indents that were "smooth without sharp knuckles" and that no cracks were revealed. They "evaluated and found acceptable" the damage in the supporting structure.

Figure 6. Port bow of the *Damgracht* after the collision with damage circled in yellow.

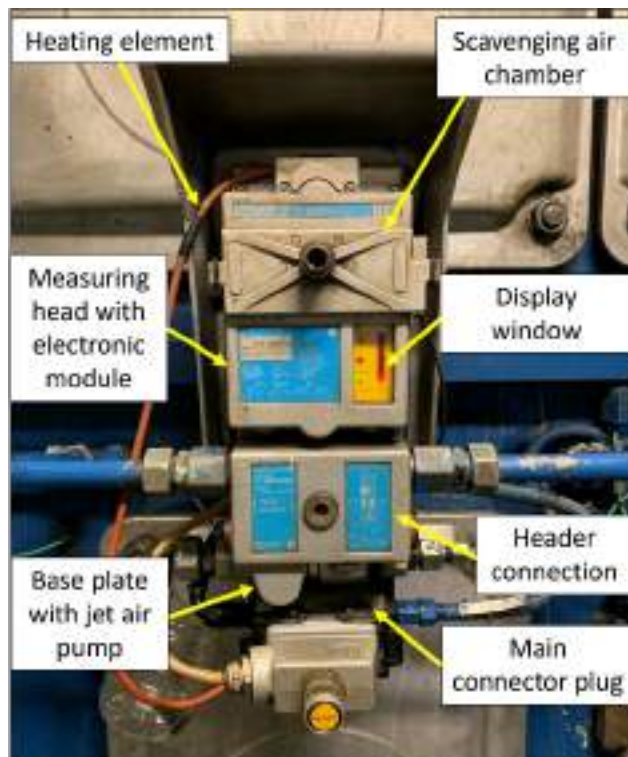
Figure 7. Main engine oil mist detector aboard the *Damgracht*

The OMD was designed to shut down the engine immediately when an oil mist alarm was sensed “in order to minimize immediate or consequential damages.” The OMD aboard the *Damgracht* did not have an override switch that could delay or disable the shutdown function.

According to the manufacturer, condensation of water could “trigger a false high oil mist alarm when small droplets of water were detected by the optical measuring track” and subsequently, the engine would shut down. The manufacturer stated that excessive oil was also a reason for false alarms, especially when oil drops fell through the measuring head across the infrared light beam (the detector reacted to turbidity caused by oil drops).

The National Transportation Safety Board determines that the probable cause of the collision between the cargo vessel *Damgracht* and the cargo vessel *AP Revelin* was the *Damgracht*'s loss of propulsion caused by an automatic shutdown of the main engine due to a false alarm, likely triggered by water vapor sensed by the oil mist detector shortly after engine maintenance was completed to replace a failed cylinder head gasket during high-humidity conditions.

Once anchored after the collision, the *Damgracht*'s engineering crew conducted maintenance on the OMD: they cleaned the unit, replaced the filters, and adjusted the air flow. The chief engineer verified that the air pressure to the OMD air jet had been set within the correct range (60–80 millimeters of water). The engine crew did not find any irregularities nor any evidence that the OMD had malfunctioned or required repairs. The crew also inspected the lube oil purifier after the collision

When certain engine components, such as cylinder head gaskets, fail, cooling water can be introduced into engine lube oil systems. Ambient air conditions, such as high humidity or extreme cold temperatures, can also increase the water content within engine lube oil sumps. The elevated quantity of water in lube oil systems can trigger false alarms in engine crankcase oil mist detectors (and lead to an engine shutdown) due to water droplets passing through the measuring track or the filter glass detecting condensation (mistaking it for oil mist). After an engine's crankcase is opened and exposed to these conditions during maintenance and repair, it is good practice for engine crews to inspect and test the lubricating oil system for water intrusion and ensure lube oil purifying equipment is functioning properly to remove any water or other contamination in the lube oil.
