Fatal fall from the pilot ladder of *Formosabulk Clement*

5 nautical miles east of Caloundra, Queensland on 9 August 2021

ATSB Transport Safety Report

MO-2021-004

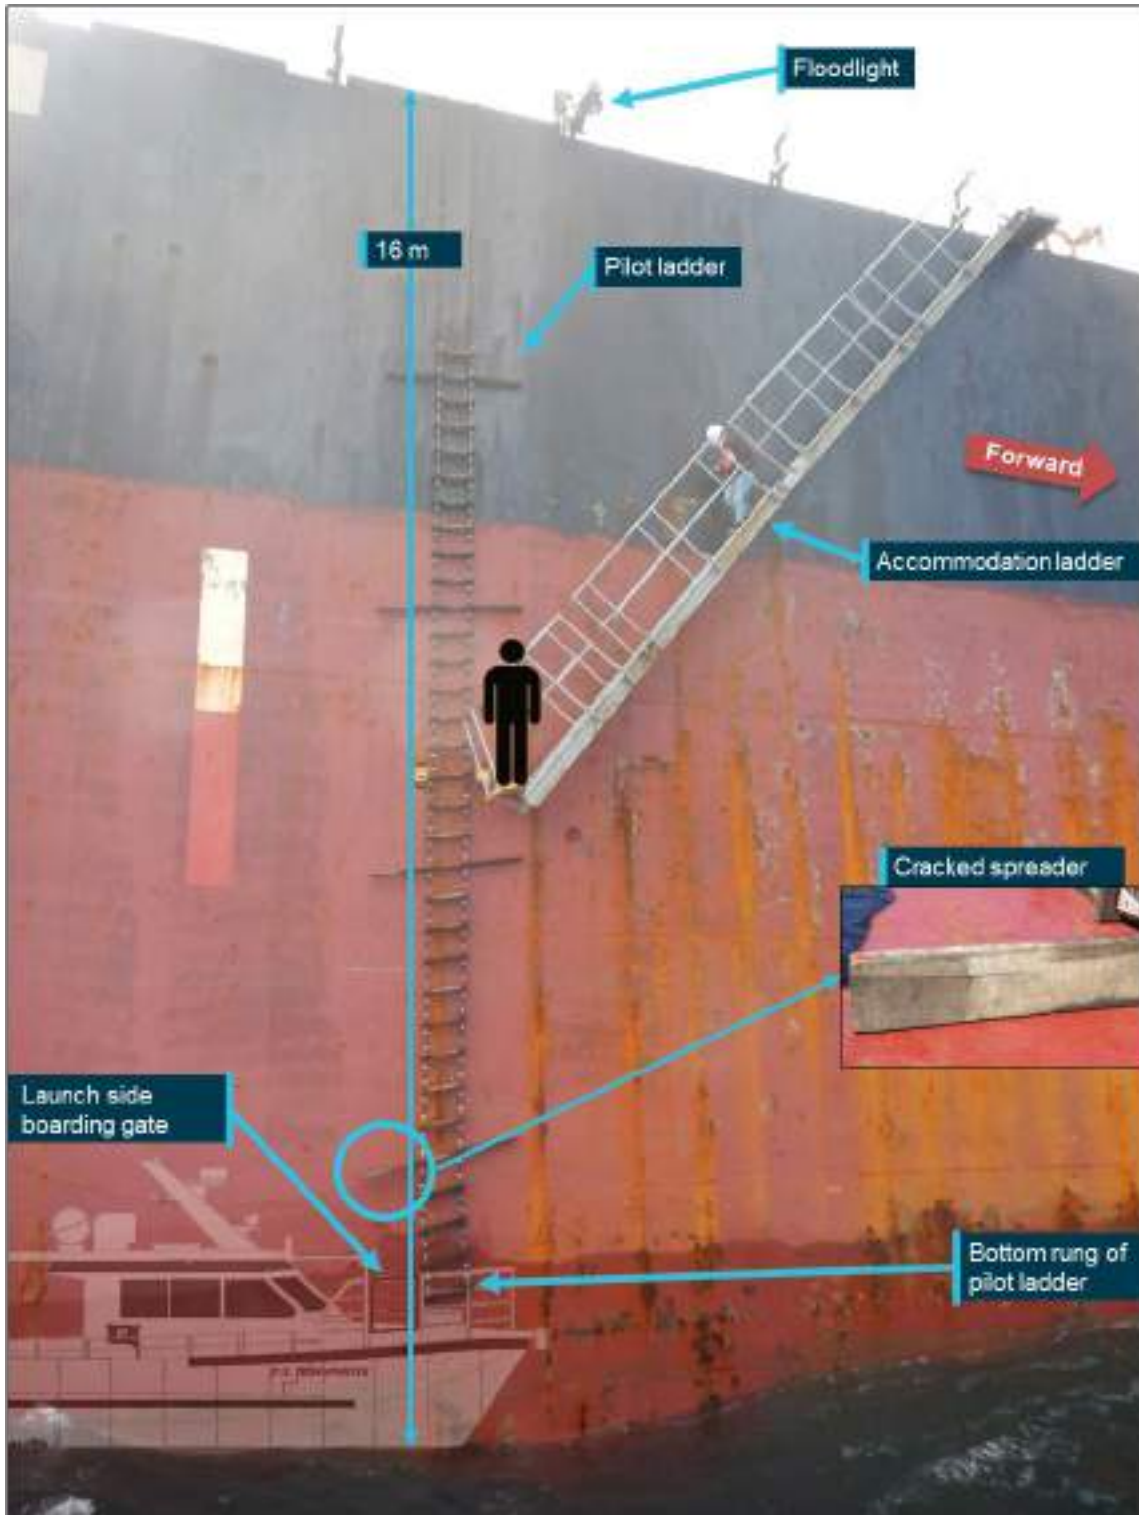
Figure 2: Starboard side boarding site and ladder arrangement

Following the accident, PSC inspection found the pilot ladder defective, as, among other issues, the lower spreader was cracked (possibly due to contact from the launch during the transfer). The ship was detained by AMSA under the *Navigation Act 2012*, in part, due to deficient safe means of access to the vessel. The rope pilot ladder was replaced prior to the ship sailing from Australia and the deficiency was closed.

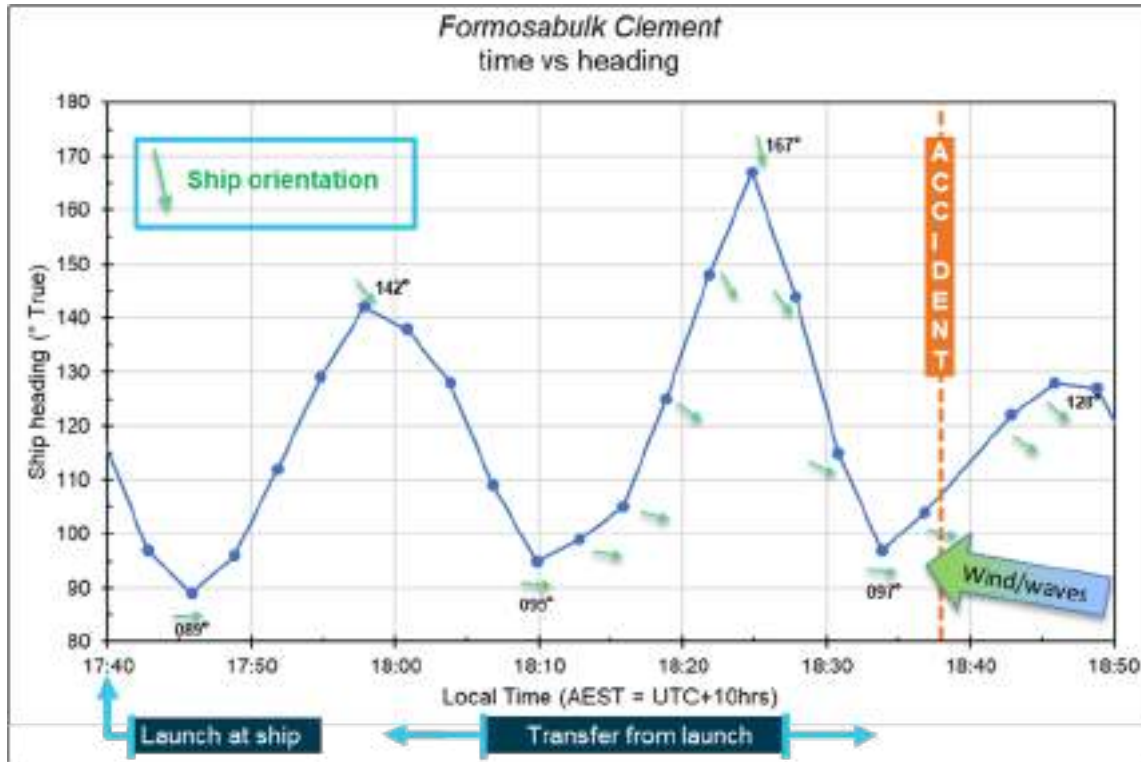
At 1745,⁷ *Formosabulk Clement* was at one extreme of yaw about the anchor with the starboard side exposed to the weather (heading 089° with weather from 100°—Figure 3). The launch skipper recalled there was a little bit of sea from the east-south-east and that it 'wasn't the calmest of conditions' (noting that several of the launch passengers had been sick during the journey). The

Nearing 1800, the ship was at the other extreme yaw angle about the anchor and was on heading 142° with the boarding area sheltered. The master radioed the launch and informed the skipper that the wind was now from the port side and it was suitable to ‘try once again’.

Figure 3: Ship yaw leading up to the accident

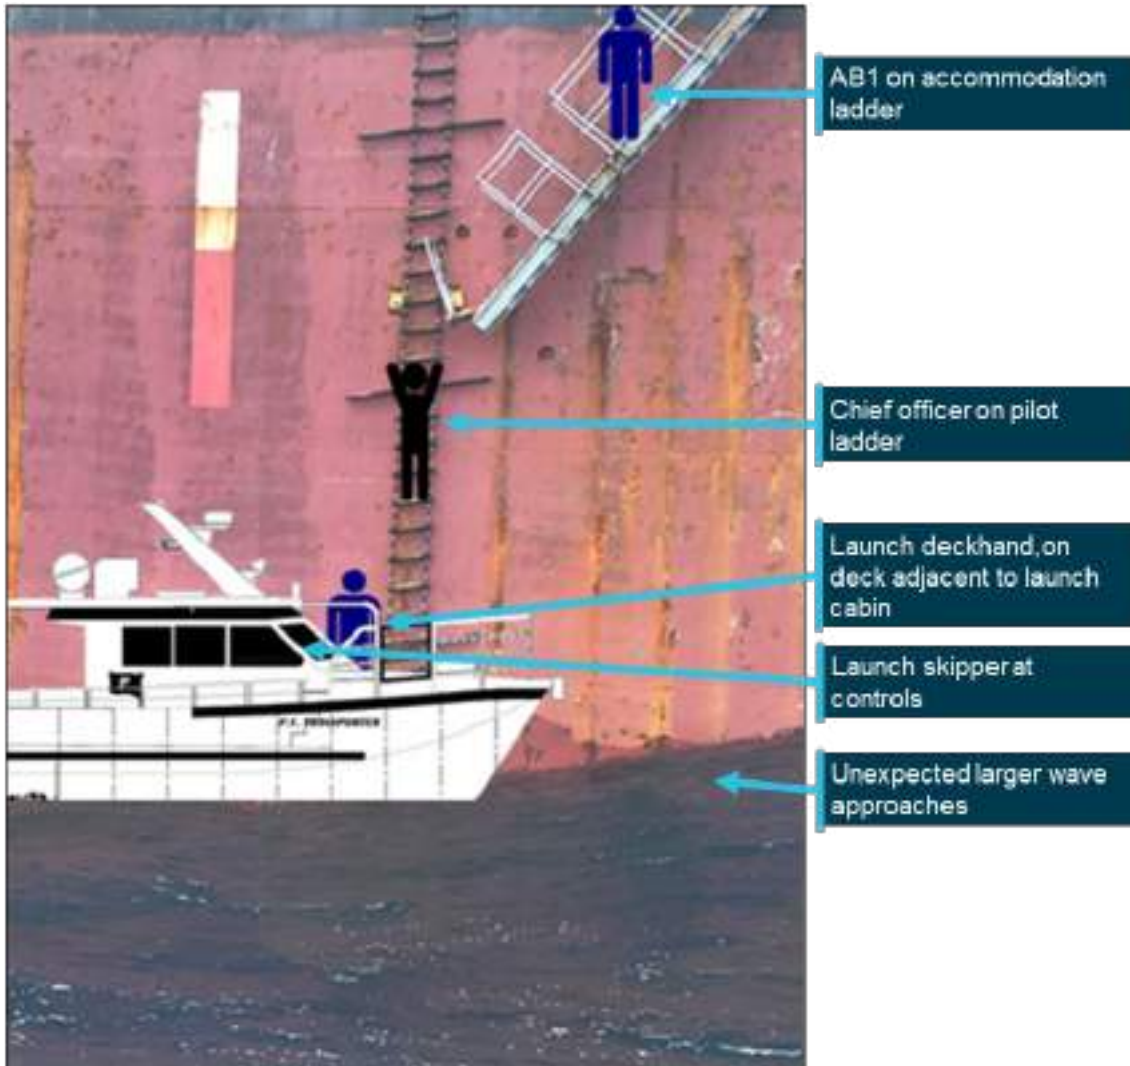
Soon thereafter, the launch came close alongside and the dCM began to descend the pilot ladder a second time. The deckhand felt the conditions were suitable and did not direct the dCM away. The launch skipper was unaware of the presence of the dCM on the pilot ladder or of the interactions between the deckhand and the dCM.

Figure 4: Approximate positioning of the launch and personnel at 1838

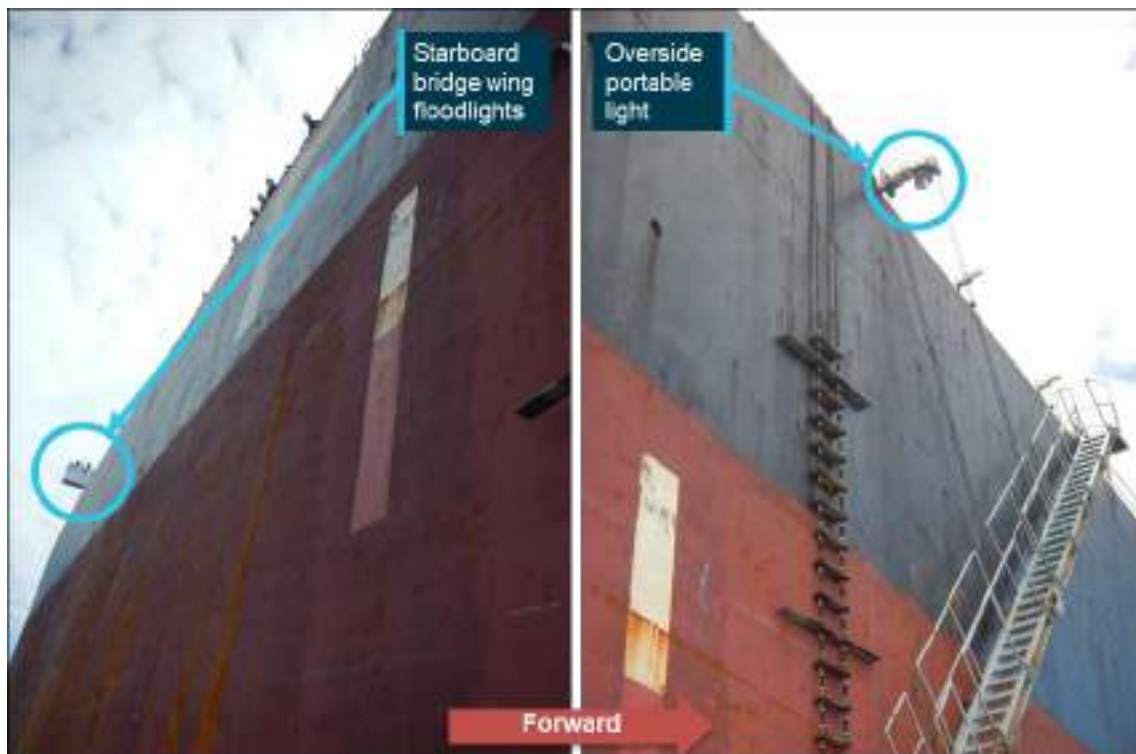
Lighting for the boarding area was provided by a portable floodlight mounted over the side at deck level and floodlights mounted on the ship's starboard bridge wing (Figure 5). Deck lighting was also used to illuminate the work area on deck. Sunset was at 1723, and the ship's crewmembers reported that there was sufficient lighting for the task.

Figure 5: Ship lighting for the starboard boarding area

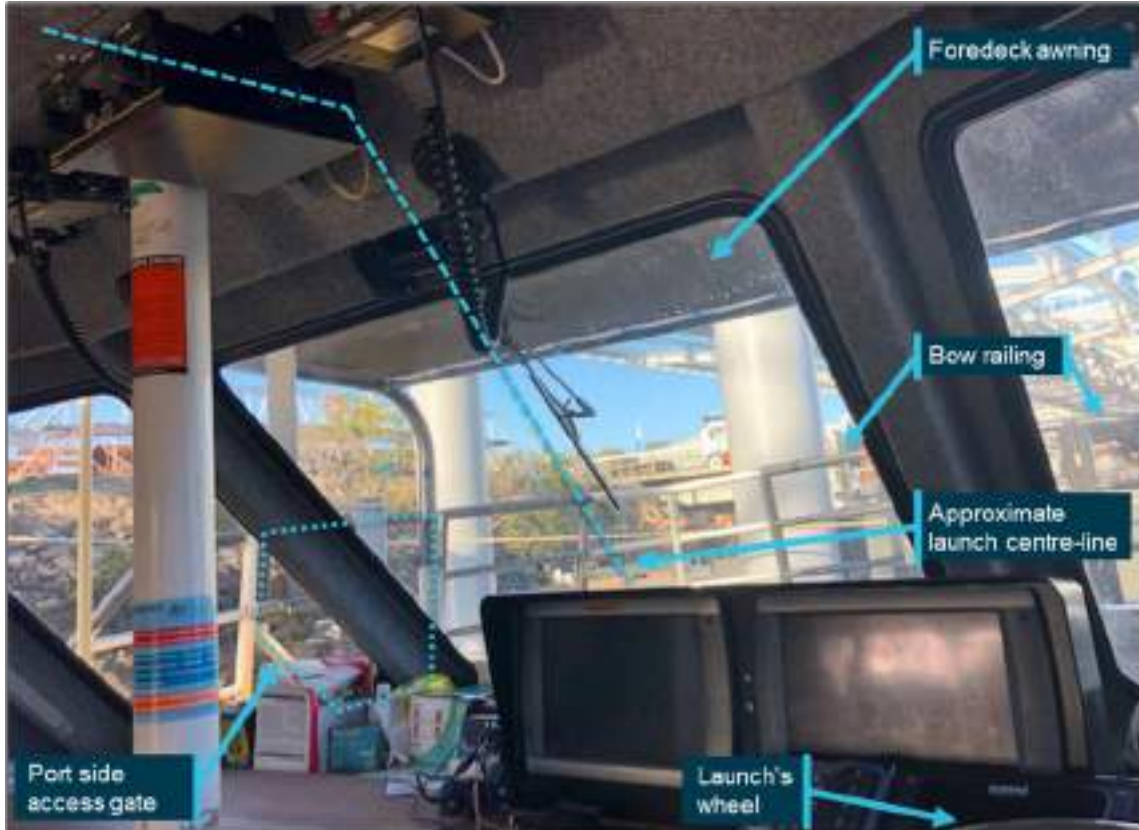
The vessel's helm position was located to starboard of the centreline. The cabin layout combined with the foredeck awning limited the skipper's view upwards, especially in close quarters such as when the launch was alongside the ship (Figure 7).

Figure 7: The view from *PT Transporter*'s skipper's position at the helm
