# SAFETY DIGEST

Lessons from Marine Accident Reports

2/2023

# MARINE ACCIDENT INVESTIGATION BRANCH

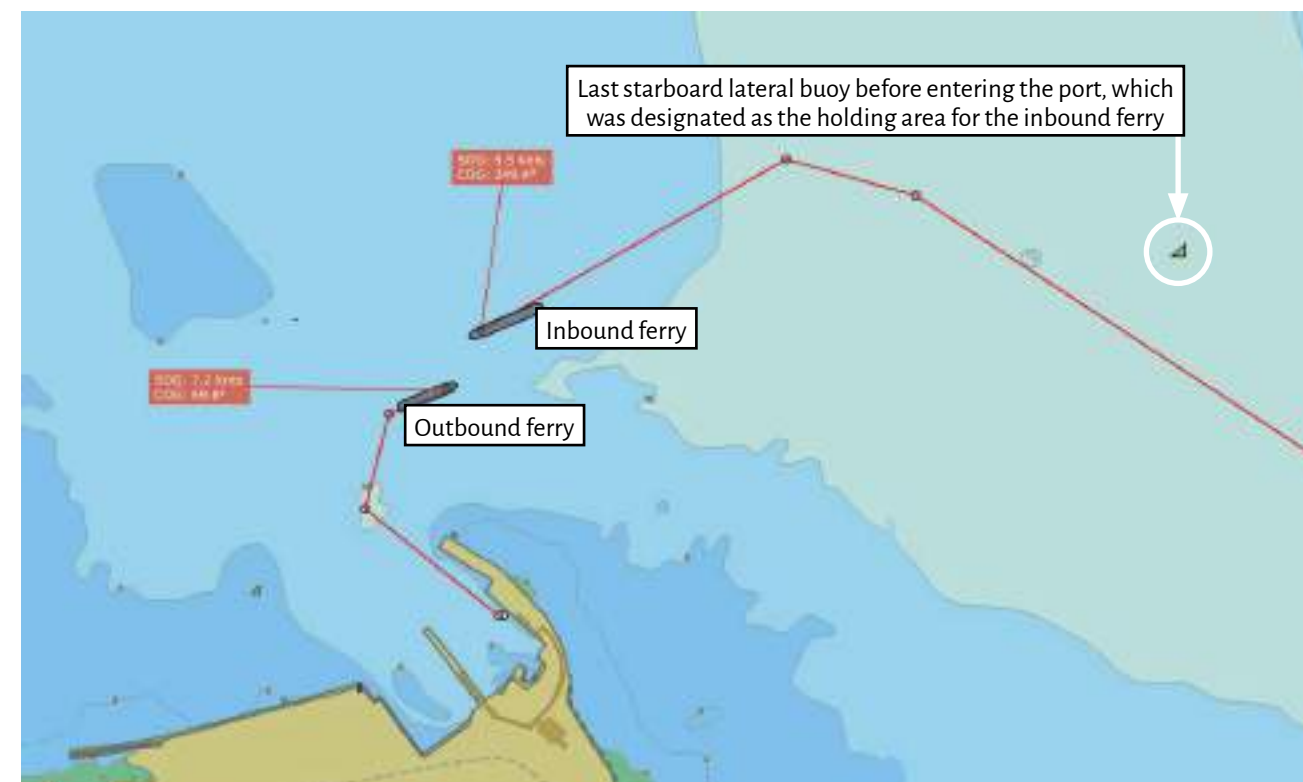
Figure 1: Chart reproduction, showing the tracks of the ferries and the position of the lateral buoy

The outbound ferry's master put the helm hard to starboard and applied full bow thruster power to starboard. The outbound ferry's bow swung clear, but the stern was swinging to port towards the inbound ferry so the master stopped the bow thruster and applied port rudder to avoid collision. The ferries passed one another at about 50m (Figure 2).

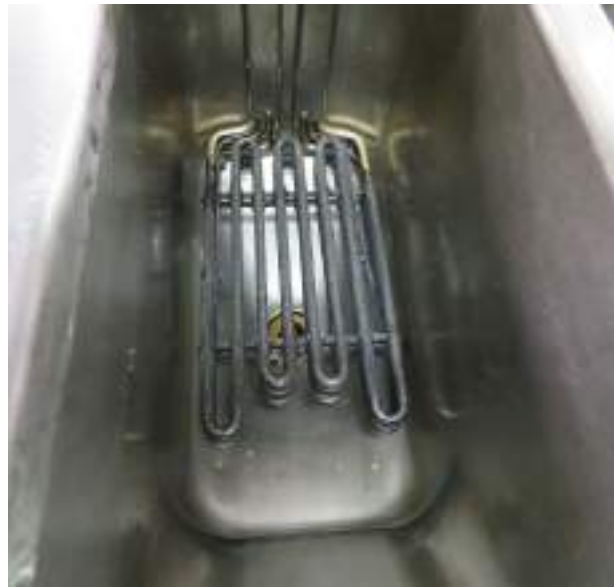
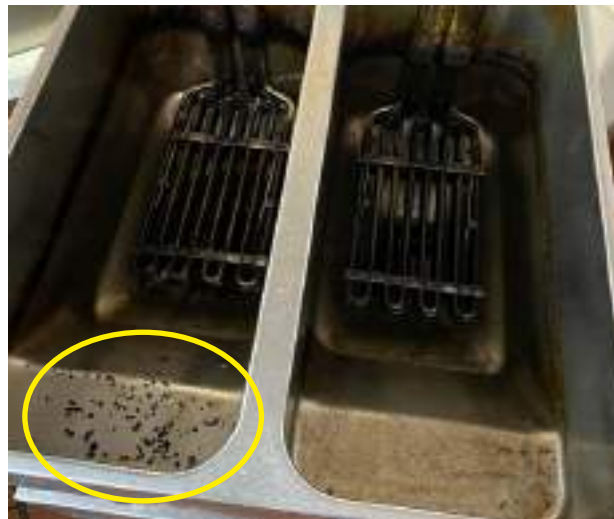
The crew raised the alarm and used a fire blanket to quickly smother the flames. The ship's emergency team mustered, isolated the galley's power and ventilation supplies and confirmed the fire was successfully extinguished. No one was injured in the incident and there was no damage to the ship. The two deep fat fryers had been drained of oil for cleaning and the cause of the fire was found to be residual food scraps saturated with fat that had ignited when the fryers were switched on.

Figure: A clean deep fat fryer (top) and the deep fat fryers with residual food scraps (bottom)

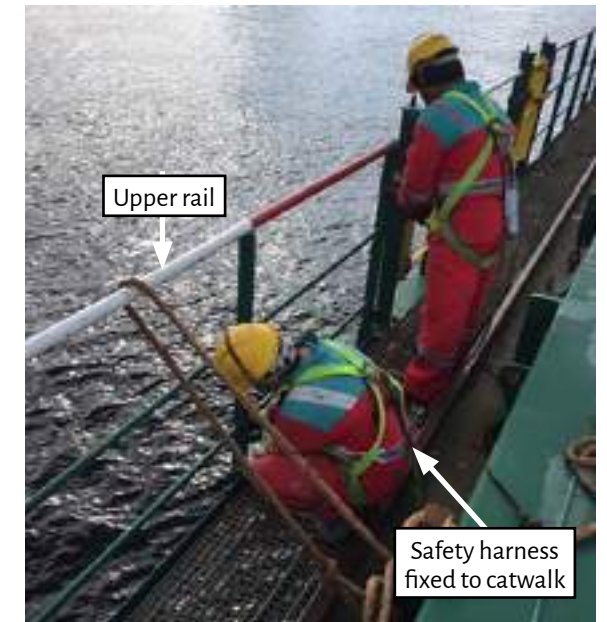
The 2/O was leaning towards the unsecured rail when it suddenly started to fall outboard. The 2/O, who was not wearing a safety harness fixed to the catwalk, lost their balance (Figure 2) and fell about 3.5m to the concrete quay below. The 2/O was in hospital for more than 10 days, having broken both legs in an attempt to land on their feet.

Figure 1: Bolts being removed from a section of upper rail

1. **Procedure** → The shipboard risk assessment for this task required anyone working aloft or over the ship's side to wear a fall arrester. Following safety procedures increases the opportunity to identify hazards and determine what equipment or control measures are needed to mitigate them and keep people safe.
2. **Equipment** → A safety harness and appropriate restraint tether would have prevented the fall. Personal protective equipment (PPE) may be deemed uncomfortable to wear and will likely require adjusting to allow you to work effectively, but it is essential when carrying out high-risk tasks such as working at height.

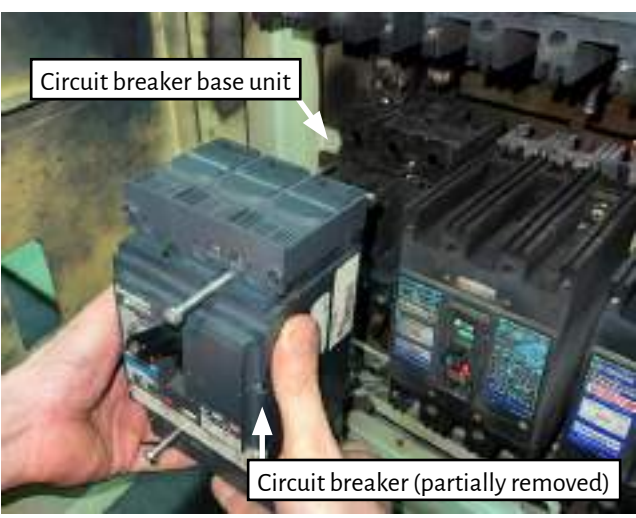
The circuit breaker was designed to be removed without the need to isolate the base unit (Figure 1); however, the electrician was unfamiliar with this arrangement and had loosened one of the live connections on the input to the base unit (Figure 2). The electrician used rubber gloves to insulate themselves from the live 440 volt (V) alternating current terminals when working on the connections.

Figure 1: The circuit breaker arrangement

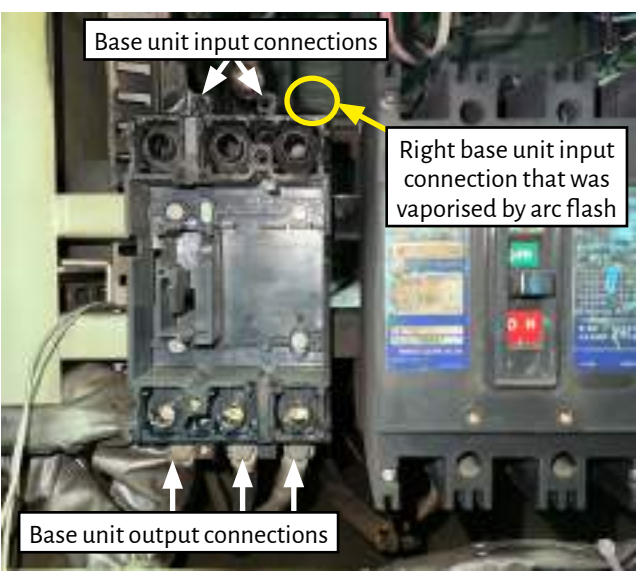
Figure 2: The base unit connections

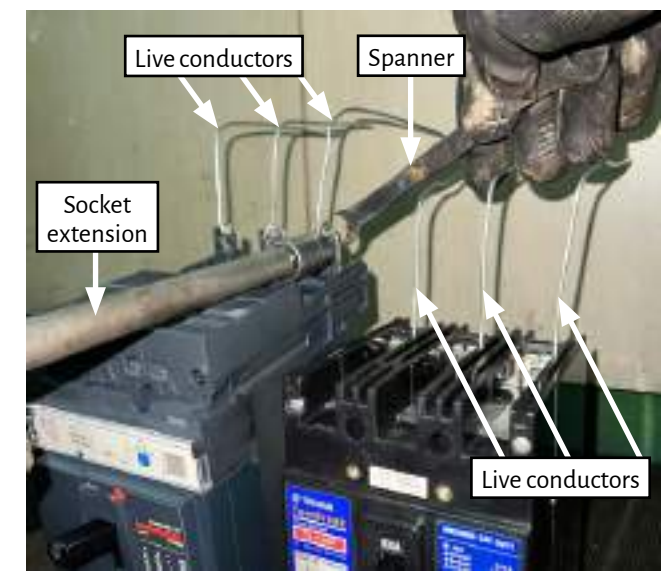
After the C/E left the engine room, the electrician tried to reconnect the cables to the base unit using a socket extension on the head of the bolt and a spanner to hold the nut in position at the rear of the connections. As the electrician tightened the bolt on the live input connection, the nut rotated and the steel spanner touched an uninsulated copper conductor on the adjacent circuit breaker base unit. This caused a short-circuit between two phases of the switchboard (Figure 3).

Figure 3: Reconstruction of the accident

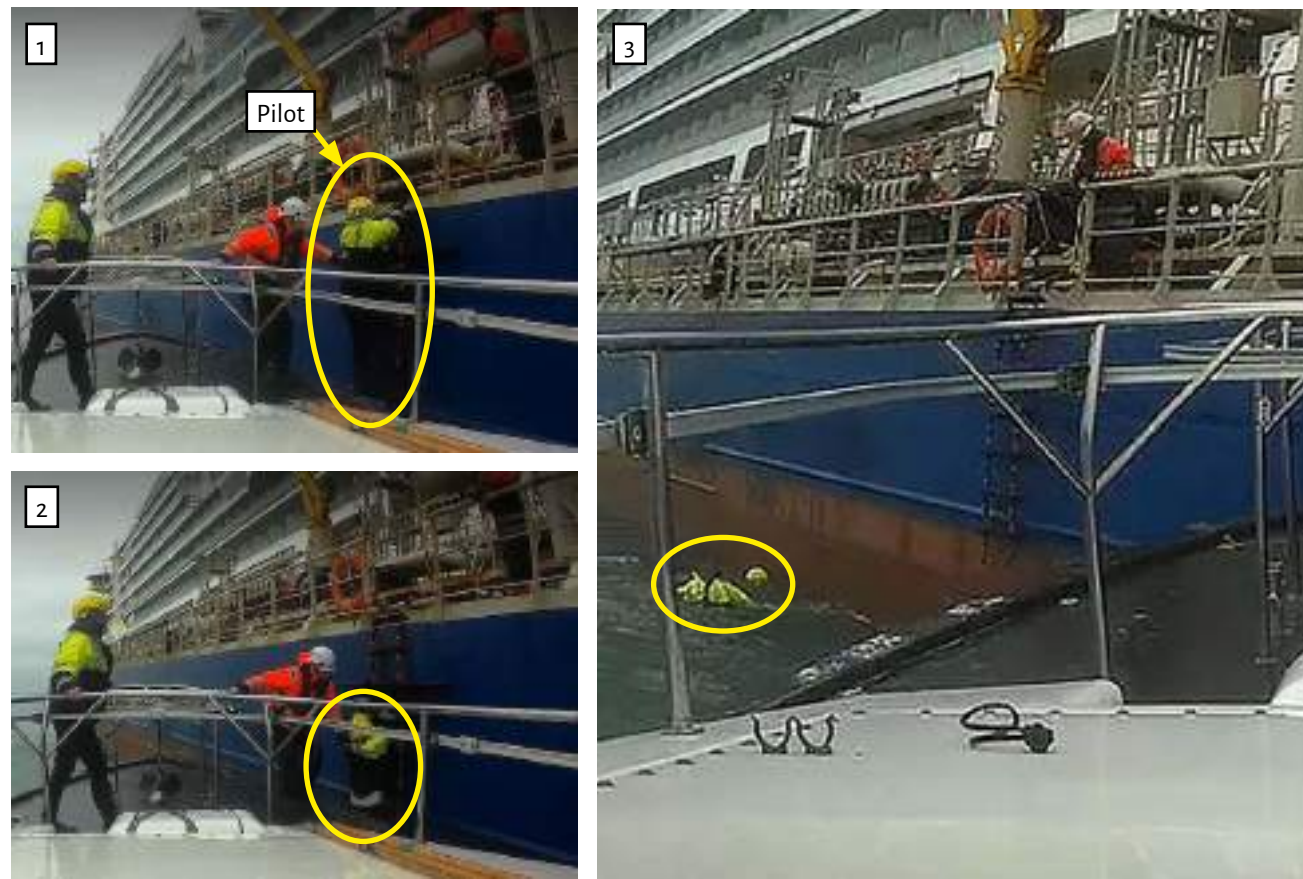
A pilot was embarking a moored bunker tanker via its pilot ladder in calm conditions. Once alongside the tanker, the pilot tested the ladder and then stepped onto it. As the pilot began to climb, the ladder suddenly dropped by over a metre and the pilot fell from it into the water (Figure 1).

Figure 1: The fall sequence

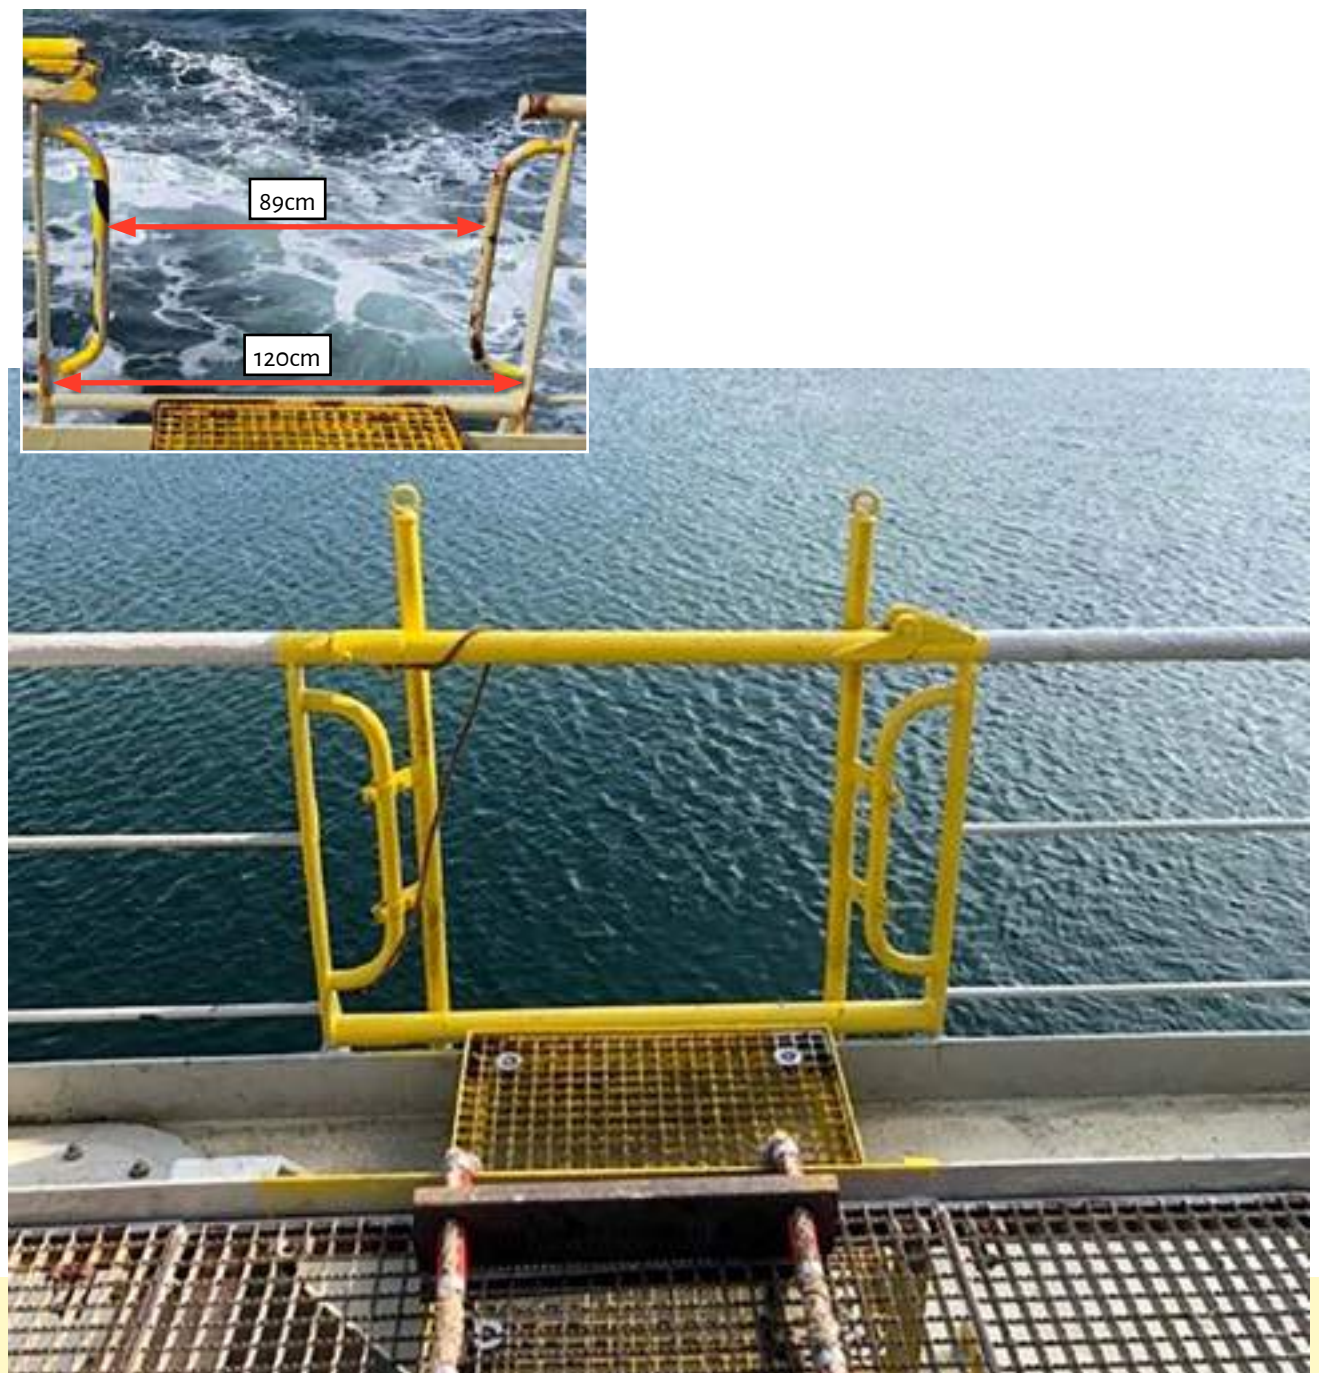
Figure 2: Guard rail gate at the top of the pilot ladder before (inset) and after modification to make it compliant

- Check** → A responsible officer must check that the pilot ladder is correctly rigged and ready for use before the pilot boards. In this case a rung of the pilot ladder had become caught on a deck fitting and when the pilot put their weight on the ladder it unexpectedly dropped, causing them to lose their handhold and fall into the water.
- Equipment** → A post-accident inspection of the tanker's pilot boarding arrangements found that the tanker's guard rail handholds were more than 80cm apart and its boarding arrangements were therefore assessed as noncompliant with SOLAS<sup>1</sup> regulations. Figure 2 shows the arrangements at the time of the accident and after the owner's modifications to provide compliant handholds.

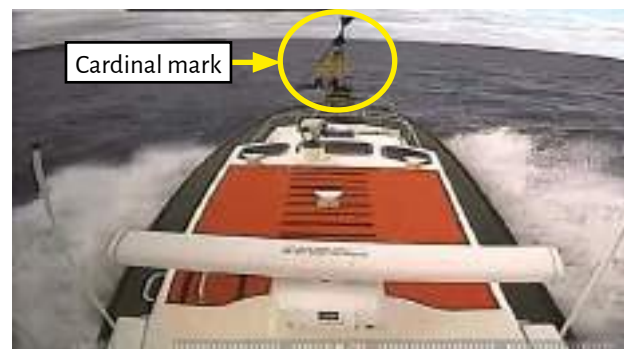
The pilot vessel struggled to maintain 12kts at full throttle on its passage back to the pilot station, which was later found to be due to an issue with the starboard fuel pump that occurred during the collision.

Figure: The pilot vessel colliding with the cardinal mark

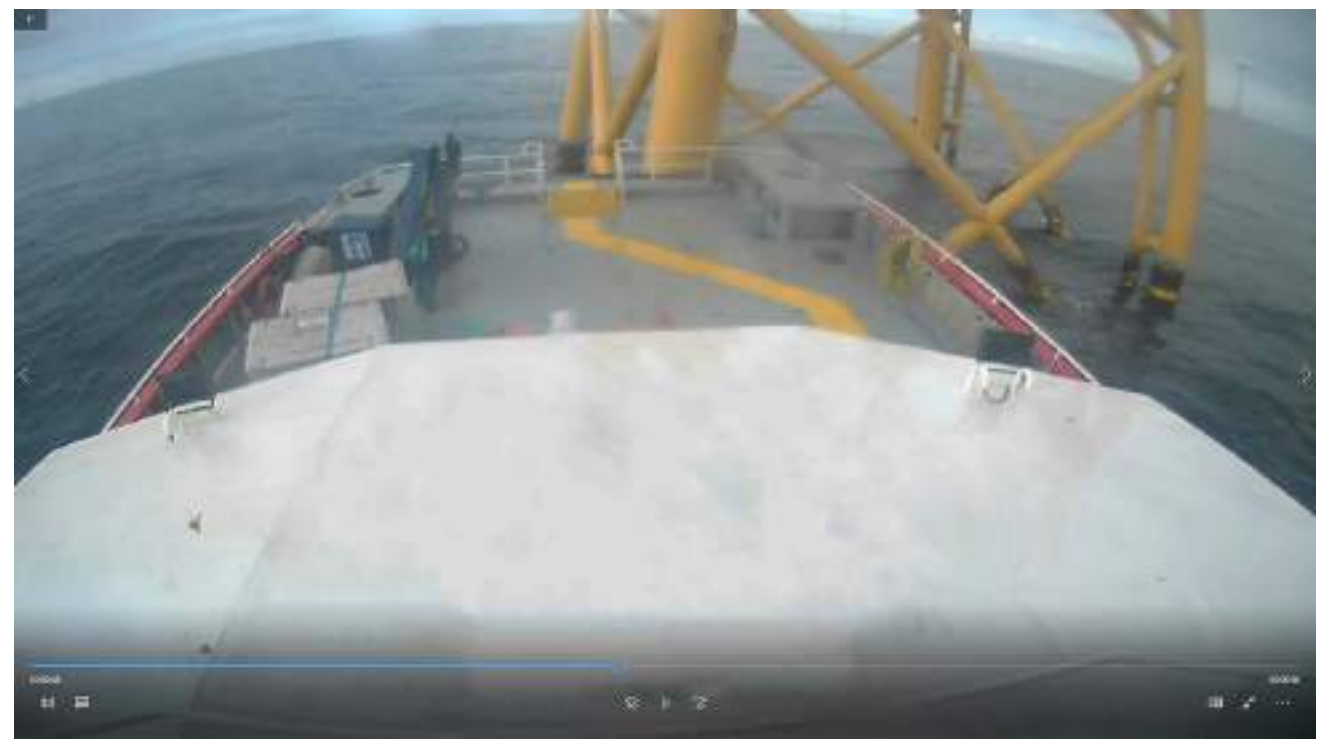
Figure 2: The moment the workboat bow collided with the wind turbine tower platform

The workboat took the brunt of the impact on its off-centre protected bow section (Figure 2) and unsecured items were thrown forward across the deck as the vessel came to a jolting standstill. The crewman was thrown against a shelf and sustained two broken ribs. The master assessed the crewman's injury and the damage to the

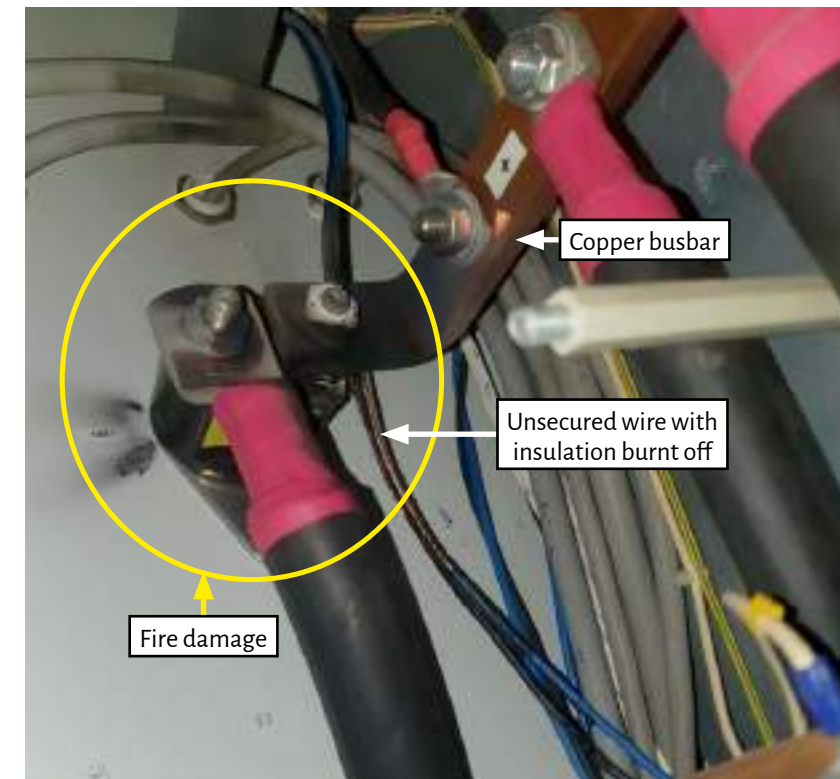
The cause of the fire was traced to an unsecured wire inside the 24V DC control panel, which was touching the copper busbar that supplied starting power to the main engine. Over time, vibration

had caused the insulation surrounding the unsecured wire to wear through until the wire's conductor made contact with the busbar. The powering up of the circuit caused a short-circuit and conducted a massive current. The circuit breaker protecting the system opened and interrupted the circuit when the master pressed the start button, and this was repeated when the engineer reset it and tried to start the engine again. The unsecured wire was not designed to withstand such a high current even for a short time and rapidly heated up, burning away its remaining insulation and starting a small fire (Figure 1).

Figure 1: The burnt wire

The tug owners arranged a check of all control cabinets and any identified loose wires were properly secured.

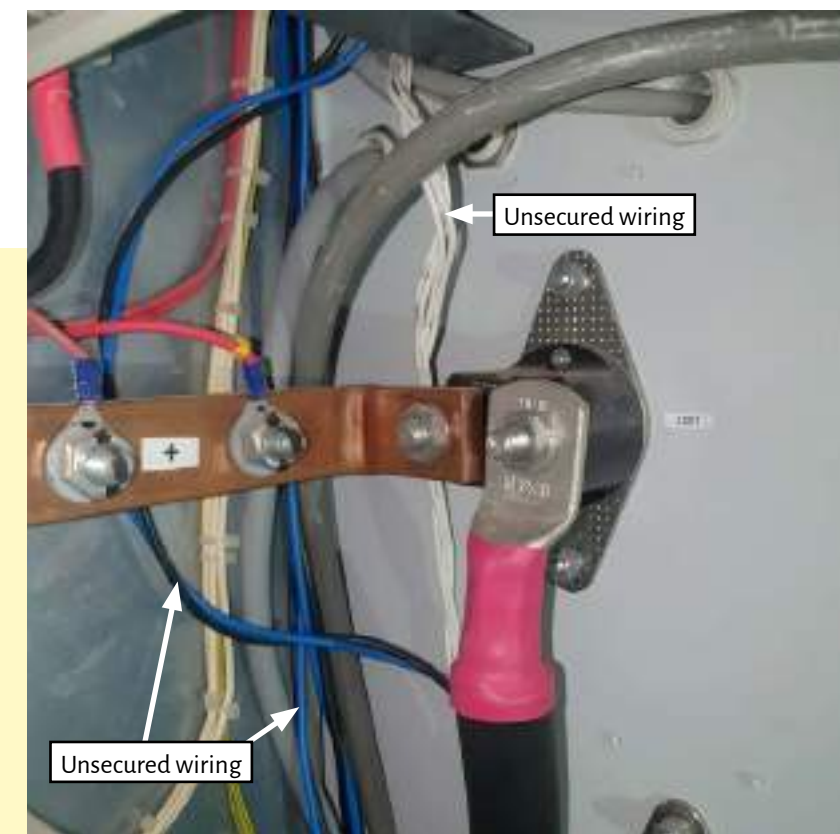
An inspection of the 24V DC control panel found several other unsecured wires (Figure 2), demonstrating that the risk remained for a similar event to happen again.

Figure 2: Unsecured wiring in the electrical control panel

3. **Action** → During inspections of electrical panels engineers should be aware of the risk posed by poorly supported wiring and loose connections and take appropriate action to reduce it to a safe level: find it, isolate it, secure it.

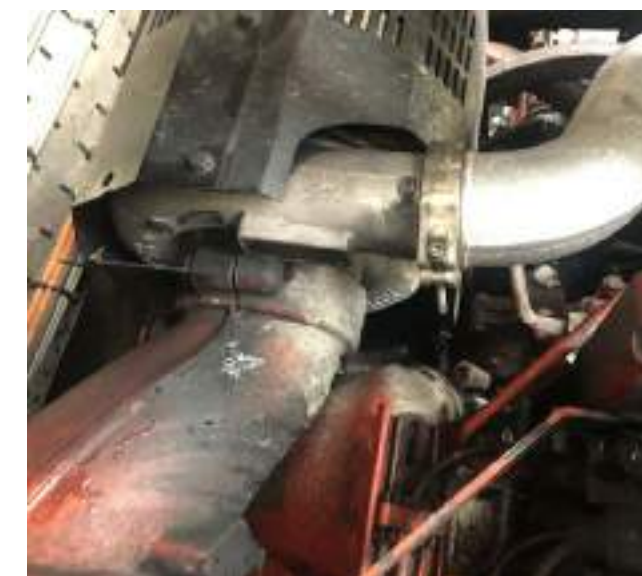
Figure 2: The seat of the fire (glowing orange)

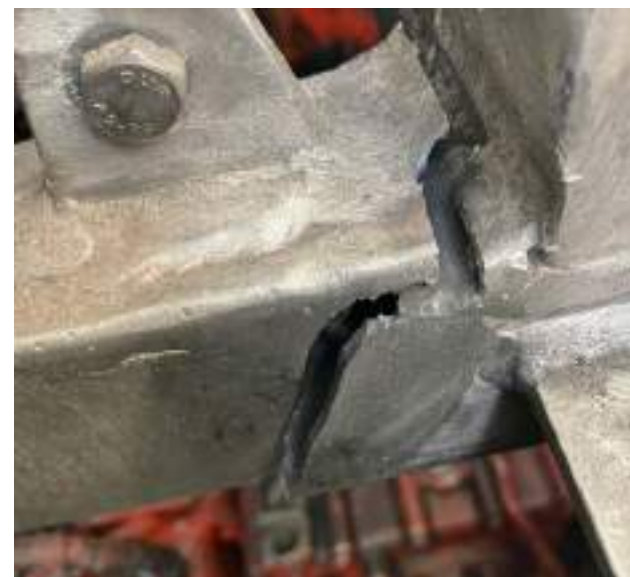
The turbocharger inlet had become fractured by excessive movement of the engine on its mounts. This had happened over time because the engine's fixed stays and some support brackets had sheared off through vibration and stress (Figure 3).

Figure 3: Fractured engine support

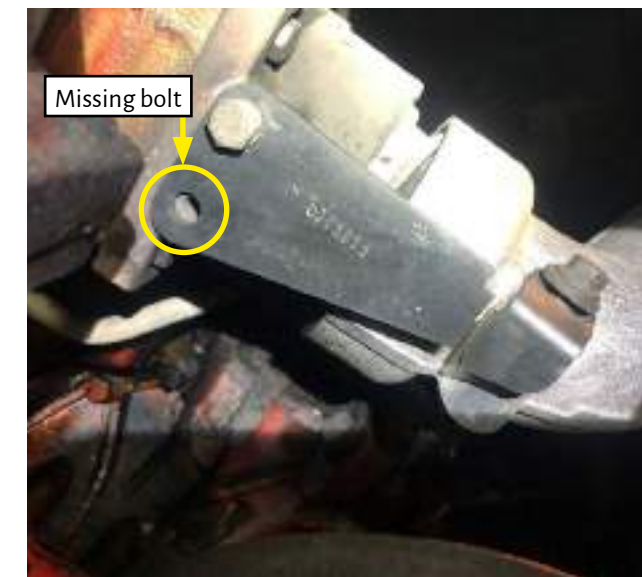
Figure 4: Fractured bracket and missing bolt

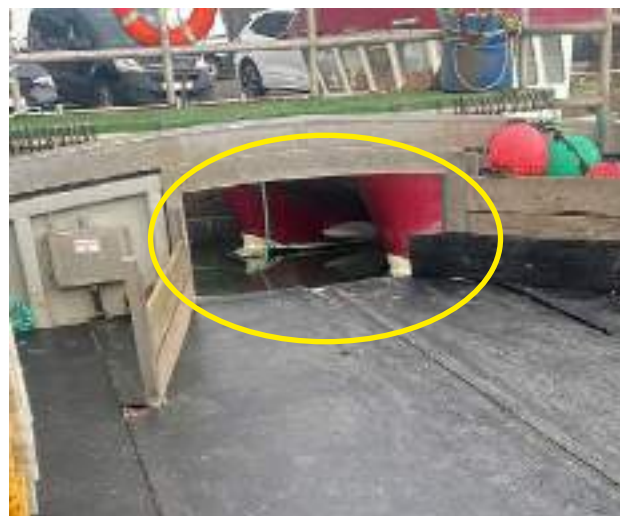
Figure 1: The coverless shooting hatch

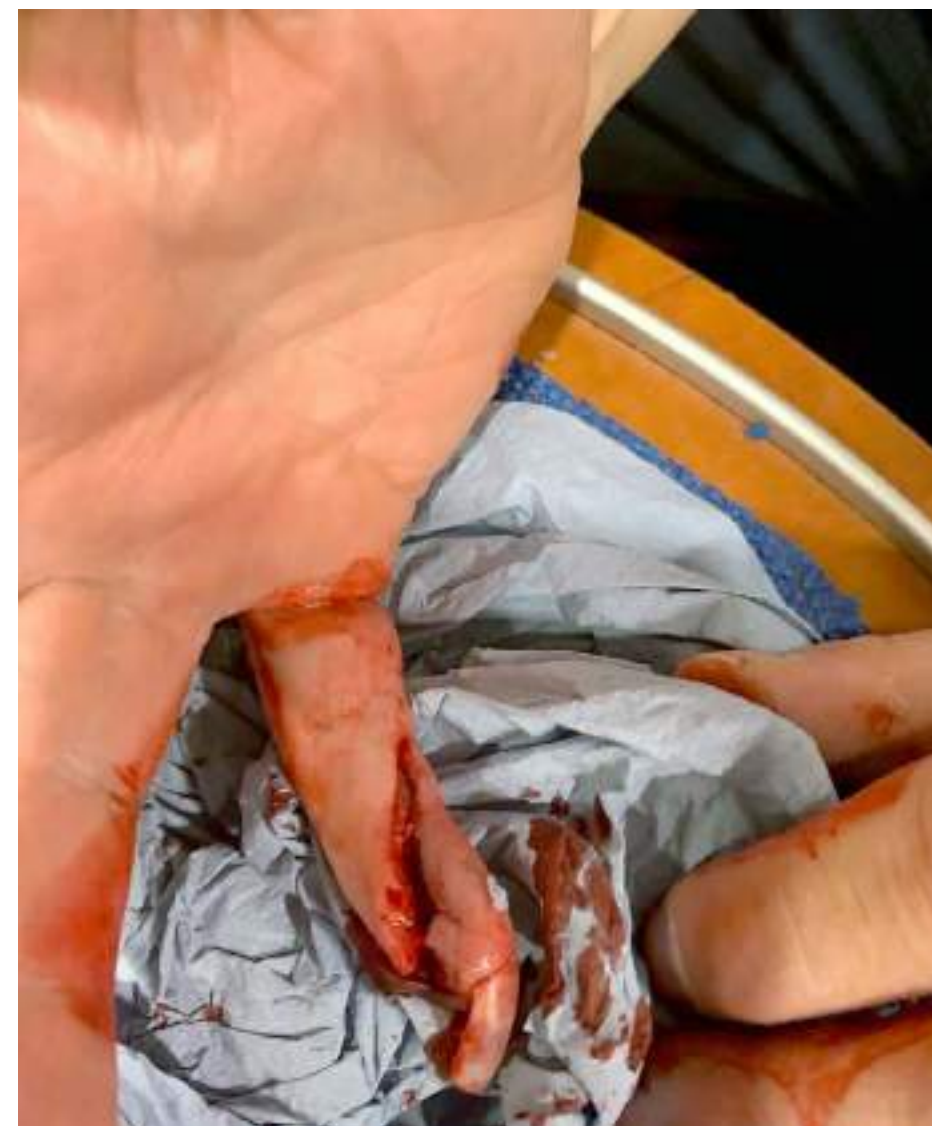
Figure 2: The partially severed little finger

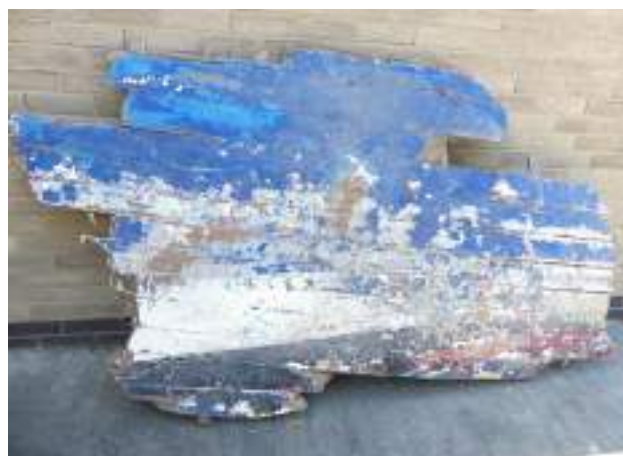
Figure: Recovered hull section

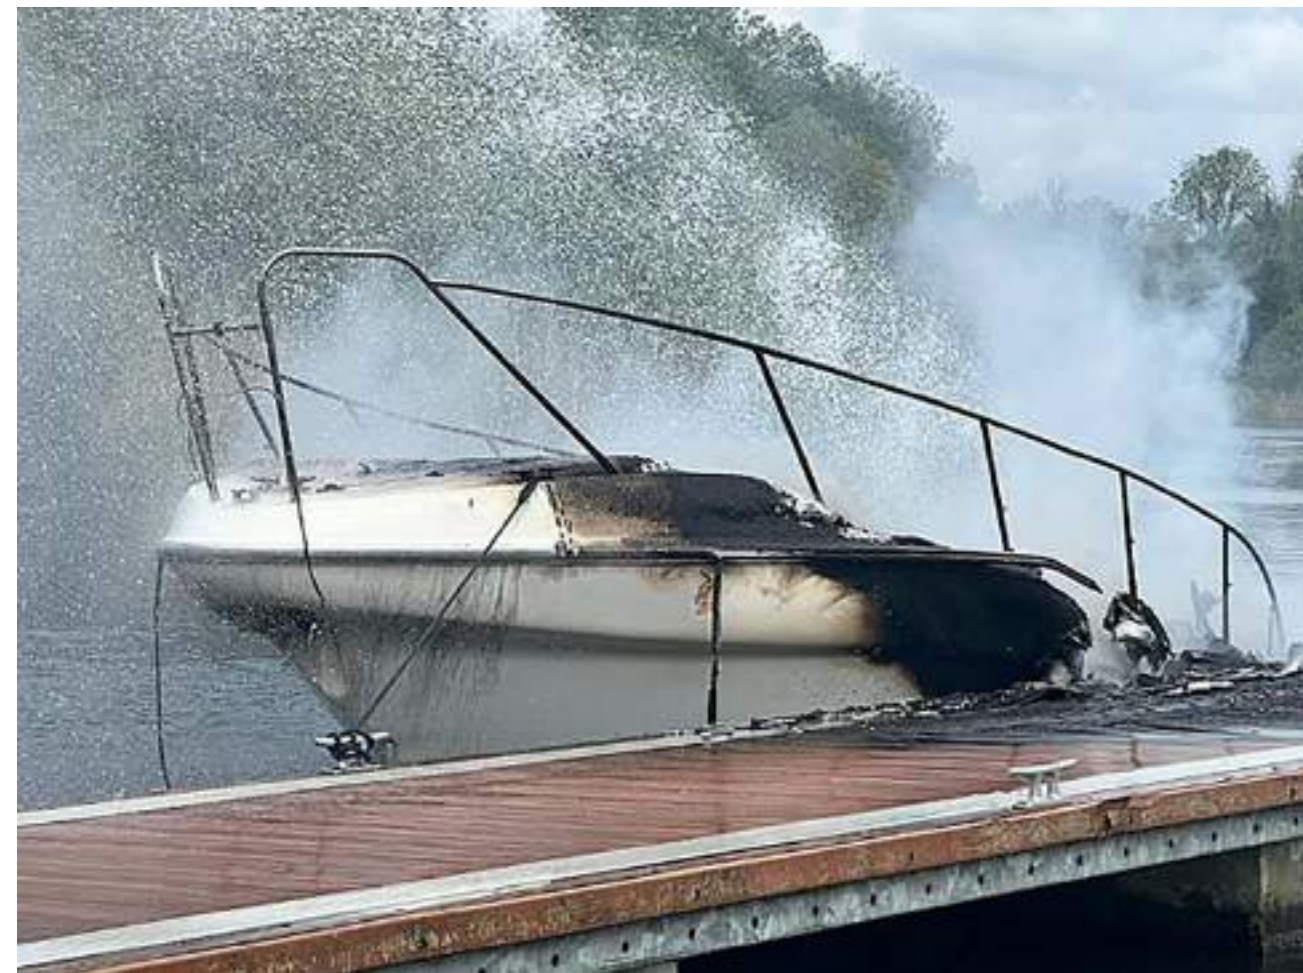
and evacuated to hospital by helicopter, having suffered significant burns from which they were lucky to survive. Tragically, both dogs perished in the accident. The fire-ravaged motor yacht (Figure 2) later sank to the bottom of the loch.

Figure 2: The burned-out motor yacht just before it sank

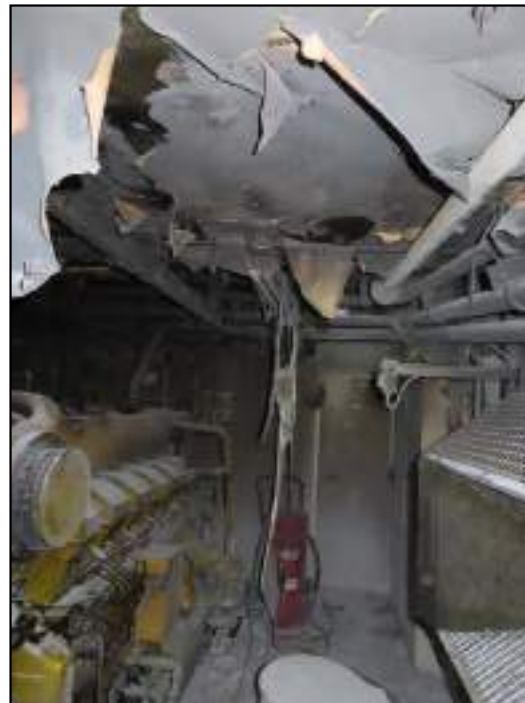
*Finnmaster's* fire-damaged compartment

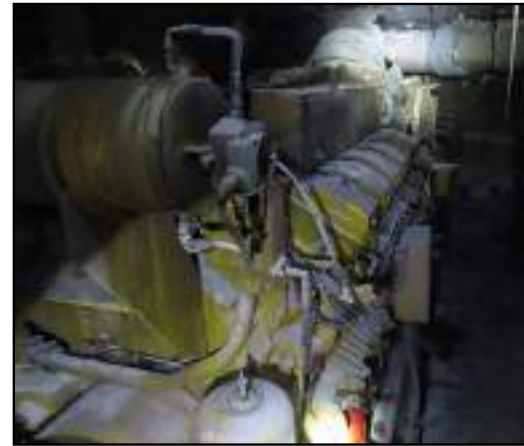
**Figure 1:** Damage sustained to auxiliary engine room

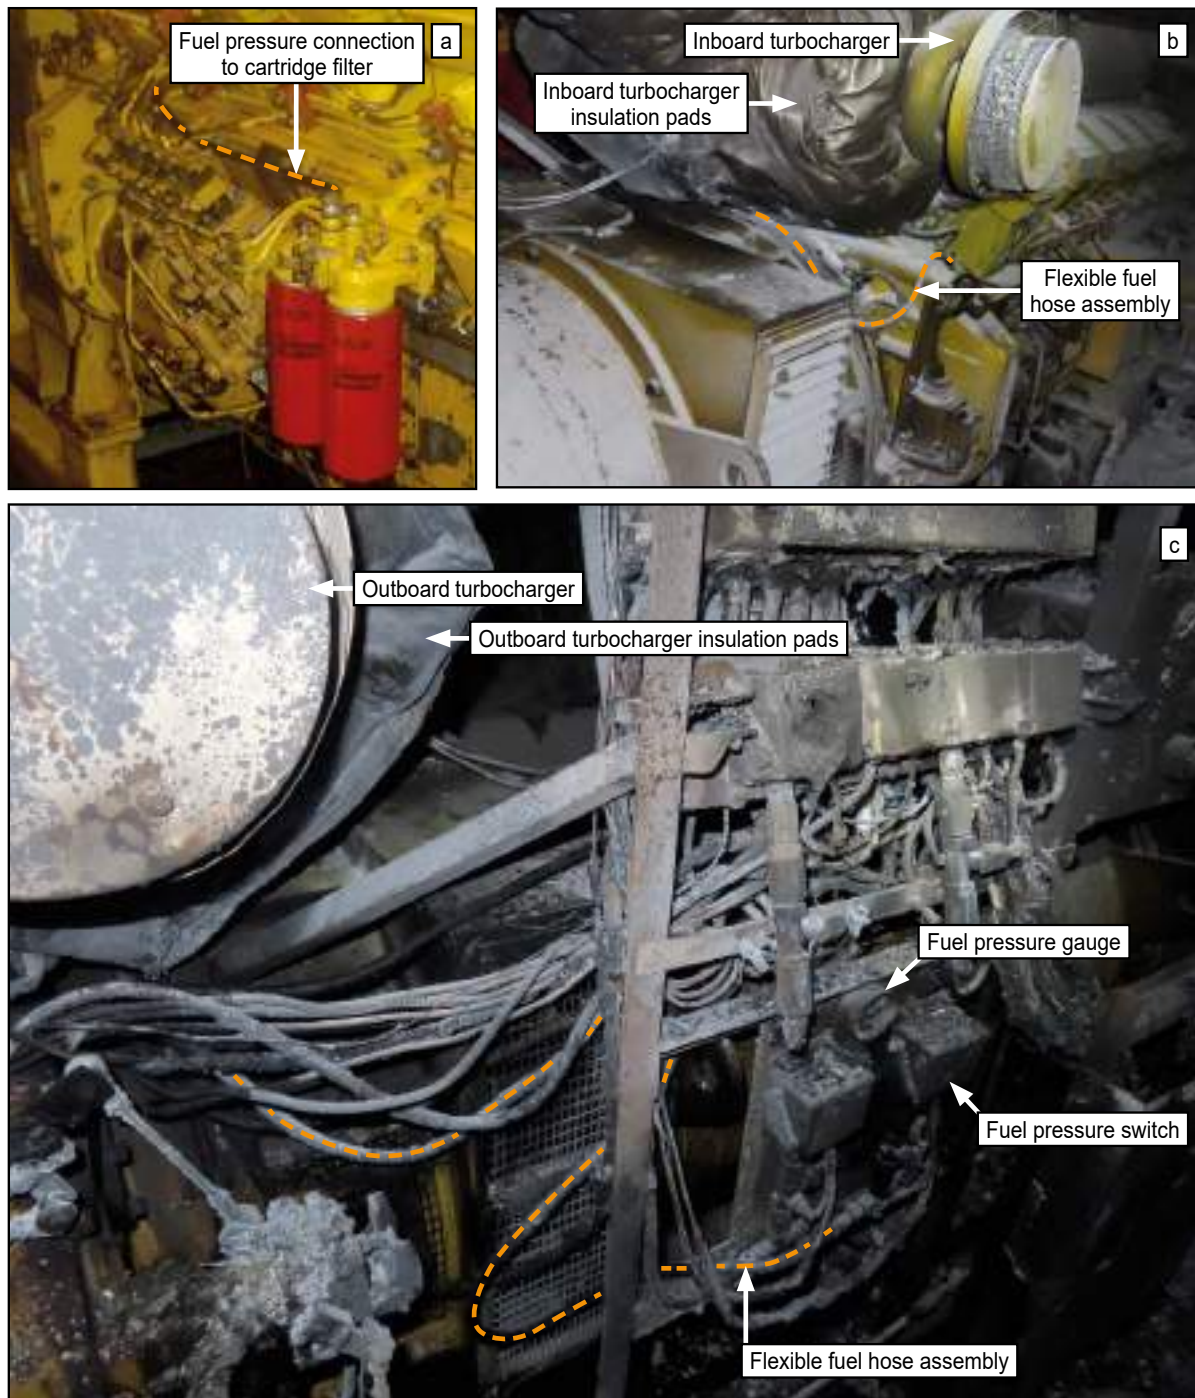
The IMO guidance on flexible hose installations, including the limitation of length, were incorporated into the rules of the two classification societies that provided oversight of *Finnmaster* during the period that the flexible hoses were in place on the vessel.

**Figure 3:** Small-bore flexible fuel hose assembly on AE2, as indicated by dashed orange line

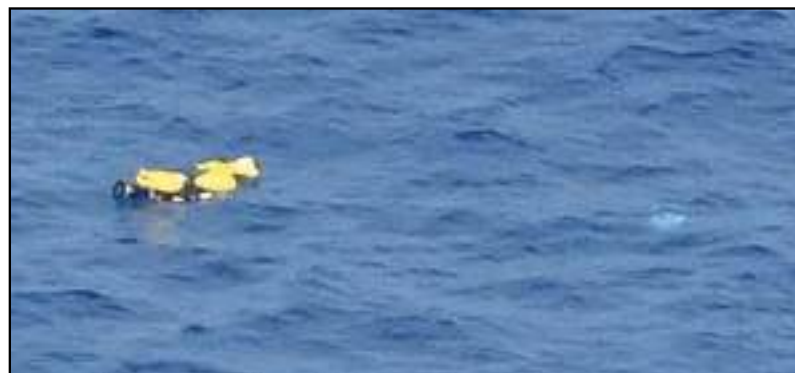
It was not possible to determine the cause of the port liferaft's failure to deploy correctly, as it was not recovered after the accident. It was last observed drifting in an inverted orientation, having apparently released from its canister and partially inflated (**Figure 1**).

**Figure 1:** The port liferaft, floating inverted and partially inflated

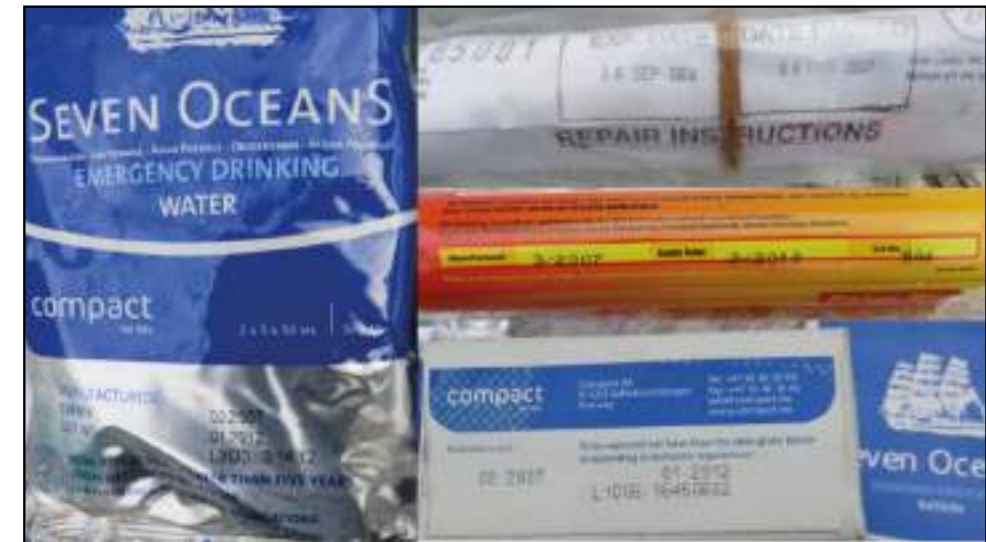
- the torch batteries had expired in January 2010;
- all of the pyrotechnics had expired in March 2010; and
- all of the food and water supplies had expired in January 2012.

**Figure 2:** Examples of the expired consumable items in *Piedras*'s starboard liferaft
