Report on the investigation of the falling of  
a lifeboat into the sea during  
a launching exercise on board the  
polar research vessel

***RRS Sir David Attenborough***

on Loch Buie, Isle of Mull, Scotland

on 4 March 2021

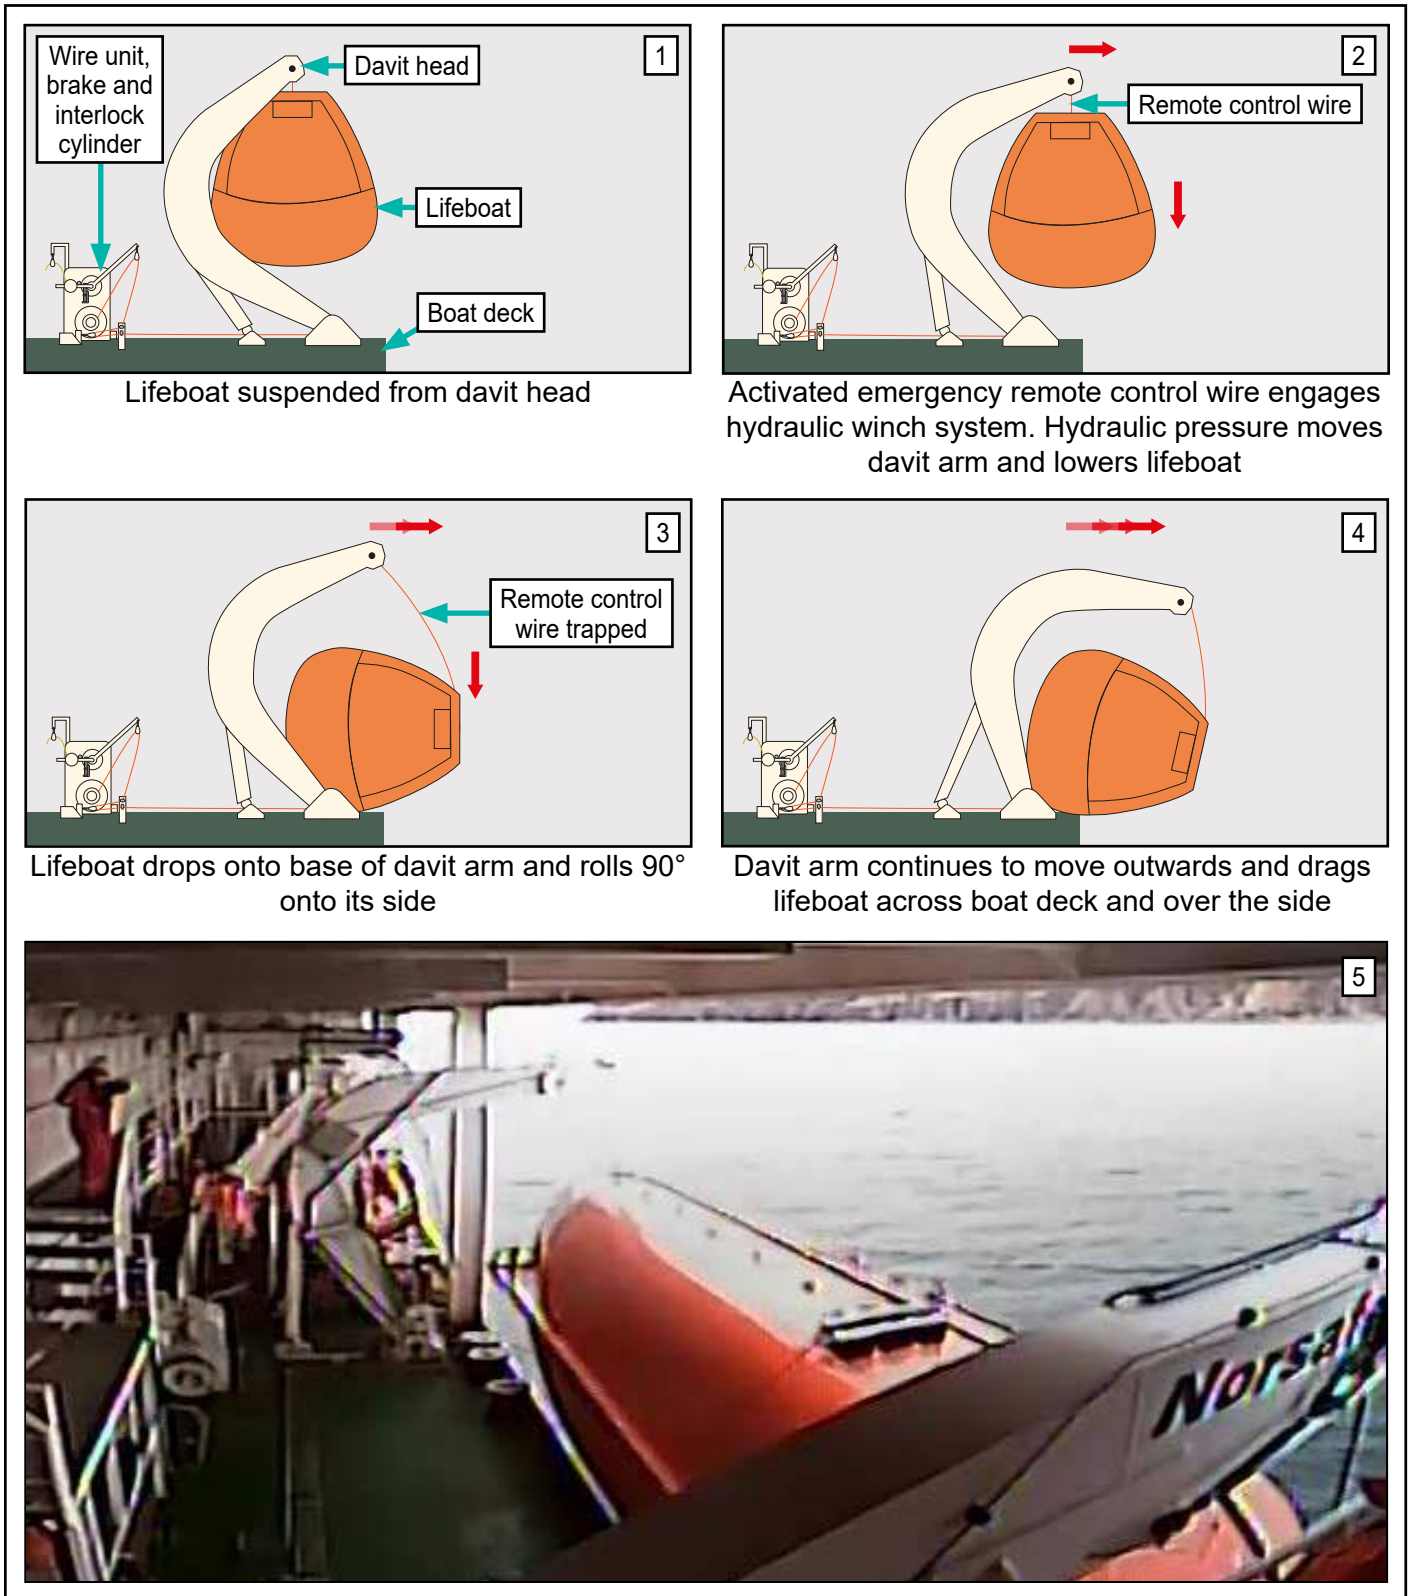
**Figure 3:** Sequence of lifeboat being dragged over the side

The C/O decided to test the remote control launching system from within the lifeboat and so three crew entered the lifeboat from the embarkation platform on the davit and sat in their assigned positions: the third officer (3/O) was in charge of the lifeboat, at the helm; the seaman grade one (SG1) was next to the 3/O; and the science bosun was in the bow. The 3/O instructed the crew to fasten their seatbelts and prepare for launching. Realising that the remote control wire was not fed through the gland into the lifeboat, he released his seatbelt, stood up, opened the hatch and fed the remote control wire into the lifeboat. He then closed the hatch and sat back down on the seat, but did not fasten his seatbelt again. He then attempted to start the lifeboat launch by pulling the lifeboat remote control wire, which was adjacent to his seat. However, the lifeboat did not launch so the SG1 unfastened his seatbelt, stood up and pulled the remote control wire again, which activated the launch system. At the same time as the davit arms started to move, the winch system released the lifeboat falls.

The lifeboat dropped from the davit head, landed on the base of the davit arms and rolled 90° onto its side on the deck. The SG1 let go of the remote control wire and was thrown towards the helmsman's seat. On the boat deck, the bosun's mate activated the hydraulic system pump's emergency stop but the davit arms continued to move outwards. The lifeboat was dragged across the deck and momentarily balanced on the deck edge before being pulled over the side (**Figure 3**). The forward hook released the falls suspension ring followed by the suspension ring being released from the aft hook. The lifeboat, with its bow pointing downwards, fell towards the sea. The aft falls suspension ring ripped the aft hatch off as the lifeboat dropped bow first into the water. The 3/O and the bosun inside the lifeboat remained in their seats but the SG1 fell to the bow. The lifeboat became completely submerged and water started to flood through the aft hatch opening before the lifeboat righted itself and came to rest, floating on an even keel.

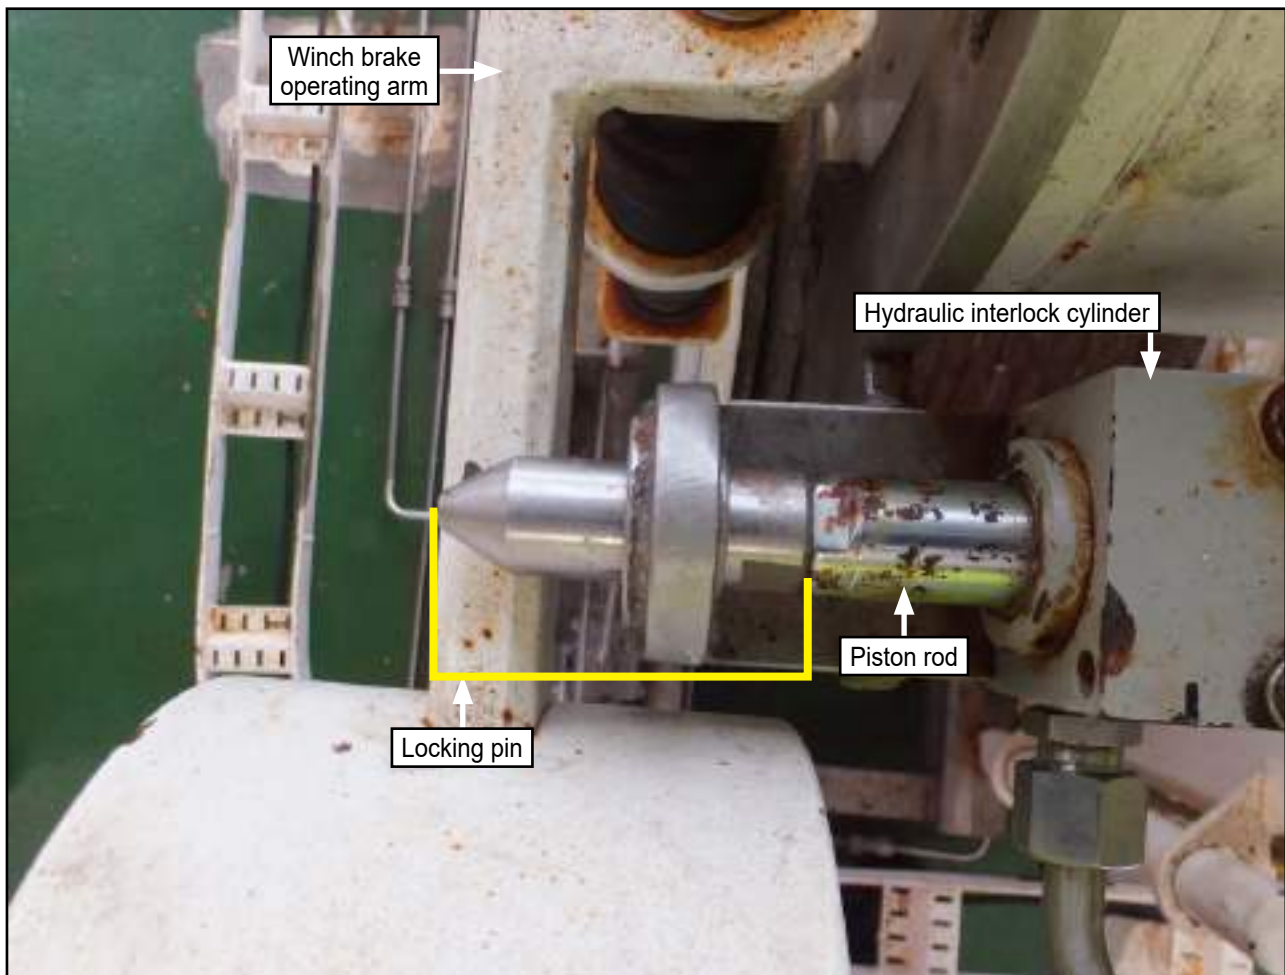
**Figure 5:** The hydraulic interlock cylinder as fitted to davit

The interlock cylinder piston rod was retracted by applying hydraulic pressure through the hydraulic oil inlet port that acted against a piston, the other side of which was vented to atmosphere via a sintered bronze filter. When hydraulic pressure was removed the piston rod and its locking pin were extended outwards by means of a return spring (**Figure 6**).

The piston rod was manufactured from hardened chrome alloy steel designed to resist wear but not, specifically, to resist corrosion in a marine environment.

It is likely that corrosion caused the interlock cylinder piston rod to seize in the retracted position after the initial unmanned lifeboat launches. The interlock cylinder piston rod was vulnerable to the effects of the marine environment because it had not been designed to operate in a salt-laden atmosphere. The piston rod was manufactured from chrome steel to produce a uniform hardened finish that would resist wear and maintain unrestricted movement of the rod through its cylinder. RRS *Sir David Attenborough* was built and outfitted outside and the davit equipment had been installed during the vessel's build, 16 months before the accident, and the interlock cylinder had not been maintained in accordance with VLSE instructions since its installation. The interlock cylinder's piston rod had corroded due to its prolonged exposure to the elements and the surface finish had degraded sufficiently over time to cause it to seize in its housing. As a result, the interlock cylinder's spring could not overcome the resistance of the corrosion and return the piston rod to its extended position once the hydraulic pressure had been released.

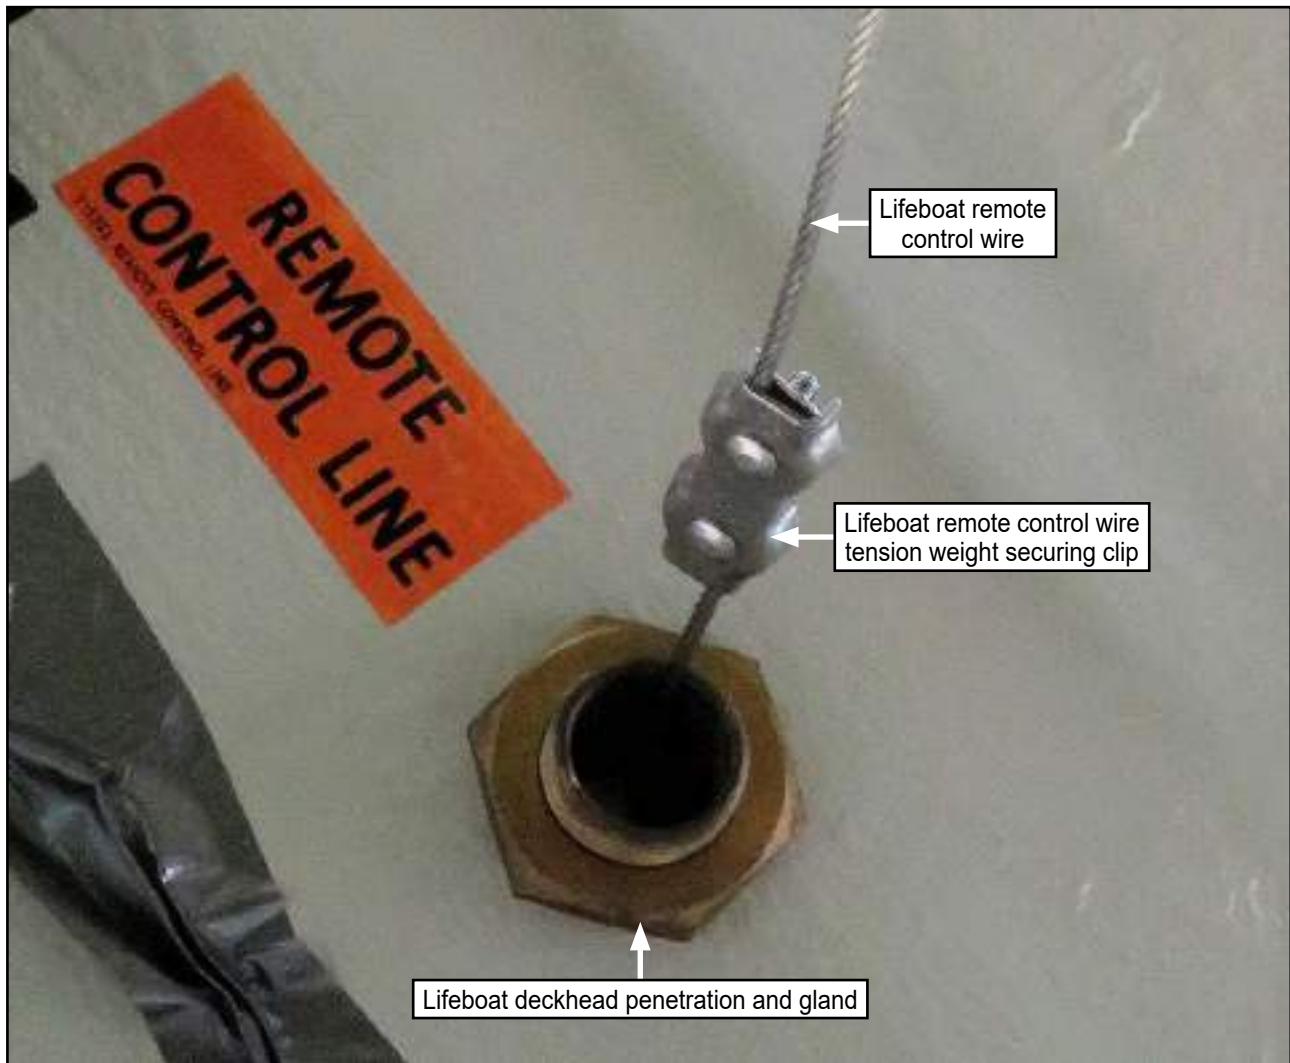
**Figure 7:** Lifeboat remote control wire tension weight securing clip

During the commissioning process for the lifeboat it was found that the remote control wire tension weight securing clip (**Figure 7**) was too big to pass through the deck gland fitted to the lifeboat canopy deckhead. To overcome this the VLSE service engineer enlarged the deckhead aperture and fitted a larger gland. In February 2020, the load testing of the davits and winches was signed off as completed, having been witnessed by an LR surveyor, Cammell Laird staff and VLSE service engineers. In July 2020, following basin trials of the lifeboats, BAS staff signed a document to accept that all lifesaving equipment and lifeboats had been installed and commissioned and were functional.

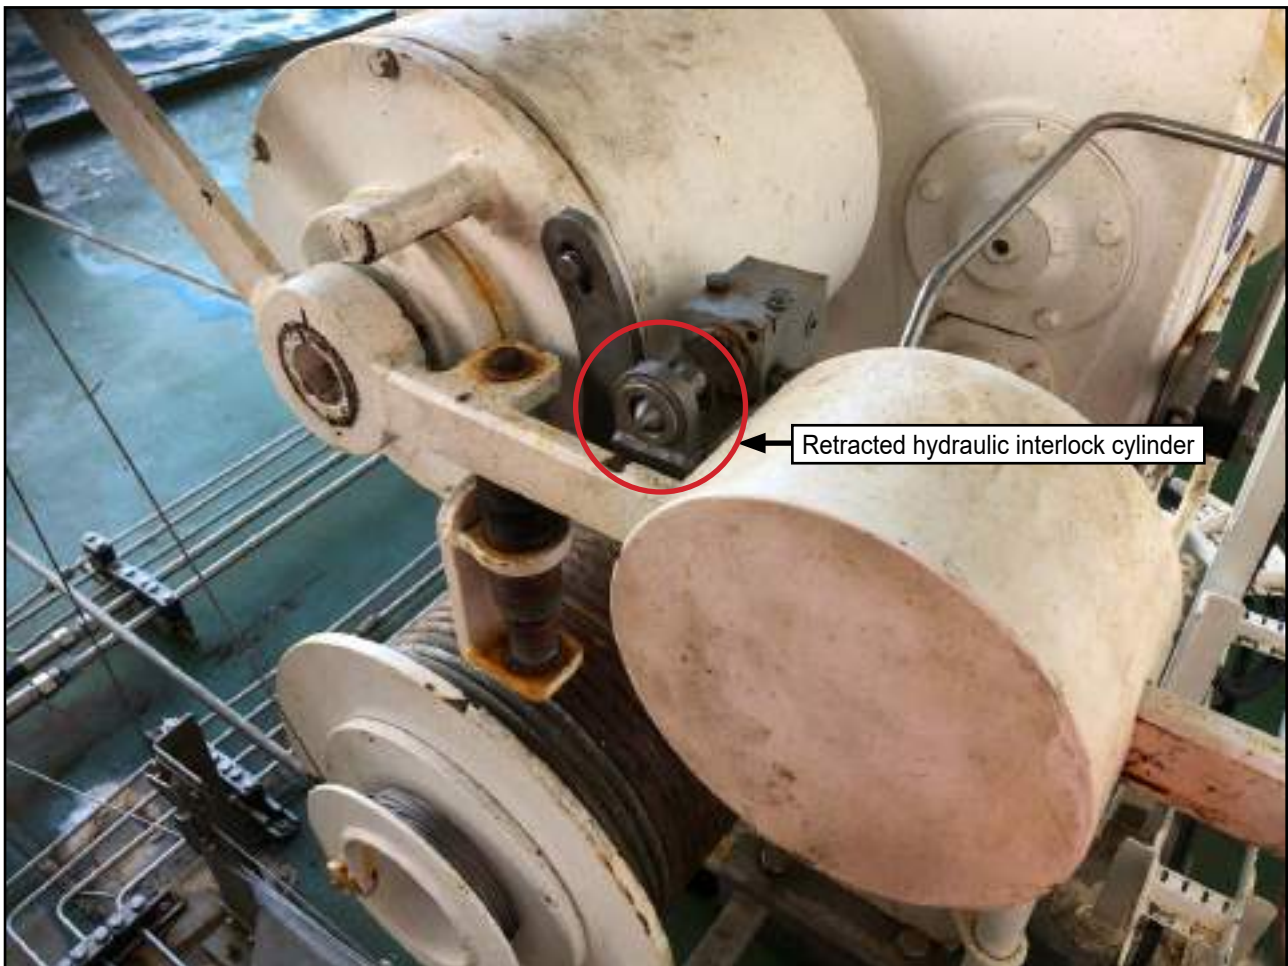
**Figure 8:** Retracted hydraulic interlock cylinder

The hydraulic system was powered up and a series of simulated davit lifeboat launch sequences were carried out. It was found that hydraulic pressure was applied to the interlock cylinder at the correct point in the sequence, retracting the interlock cylinder rod and releasing the winch brake operating arm. When the hydraulic pressure was released the interlock cylinder rod did not return to the extended position over the winch brake operating arm (**Figure 8**). This sequence was repeated several more times with similar results.

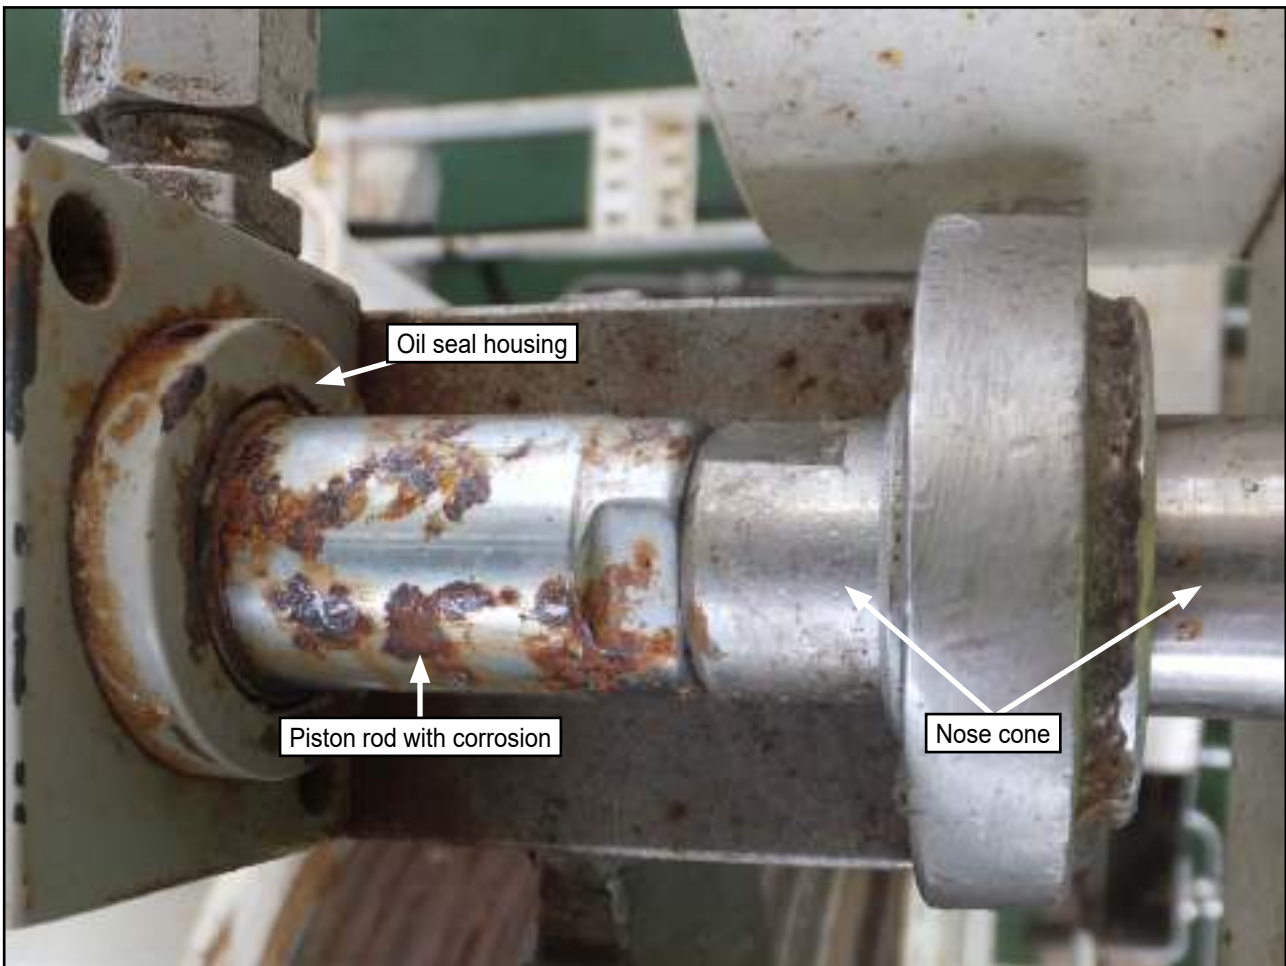
**Figure 9:** Corrosion on hydraulic interlock cylinder piston rod

The winch brake arm hydraulic interlock cylinder was removed from the davit system and sent to a specialist hydraulic engineering company for examination and testing. The initial test showed that the interlock cylinder piston rod did not return to its extended position when the hydraulic pressure was released. The examination determined that the internal components of the interlock cylinder, including the return spring, were in good working order with no defects. The oil seals exhibited no signs of wear. The interlock cylinder piston rod had corroded around its circumference, leading to pitting and a rough finish to the surface area (**Figure 9**); it was demonstrated that this degradation prevented the rod from moving linearly over the surface of the hydraulic oil seal and so held the rod in the retracted position. It was also noted that the sintered bronze filter in the vent port for the interlock cylinder rod return spring space had been painted over.

The interlock cylinder piston rod was cleaned to remove the corrosion and to give the surface a more consistent finish before being retested several times. In each test the interlock cylinder rod returned to its fully extended position when the hydraulic pressure was released.

Cammell Laird did not carry out any routine maintenance to the RRS *Sir David Attenborough* davit system after its installation in November 2019. Consequently, the exposed surface of the interlock cylinder piston rod would have started to corrode during the time leading up to the accident.

The lack of maintenance and inspection of the interlock cylinder meant that the corrosion went unnoticed and so the interlock cylinder was not replaced in accordance with the instructions in the manufacturer's manual.

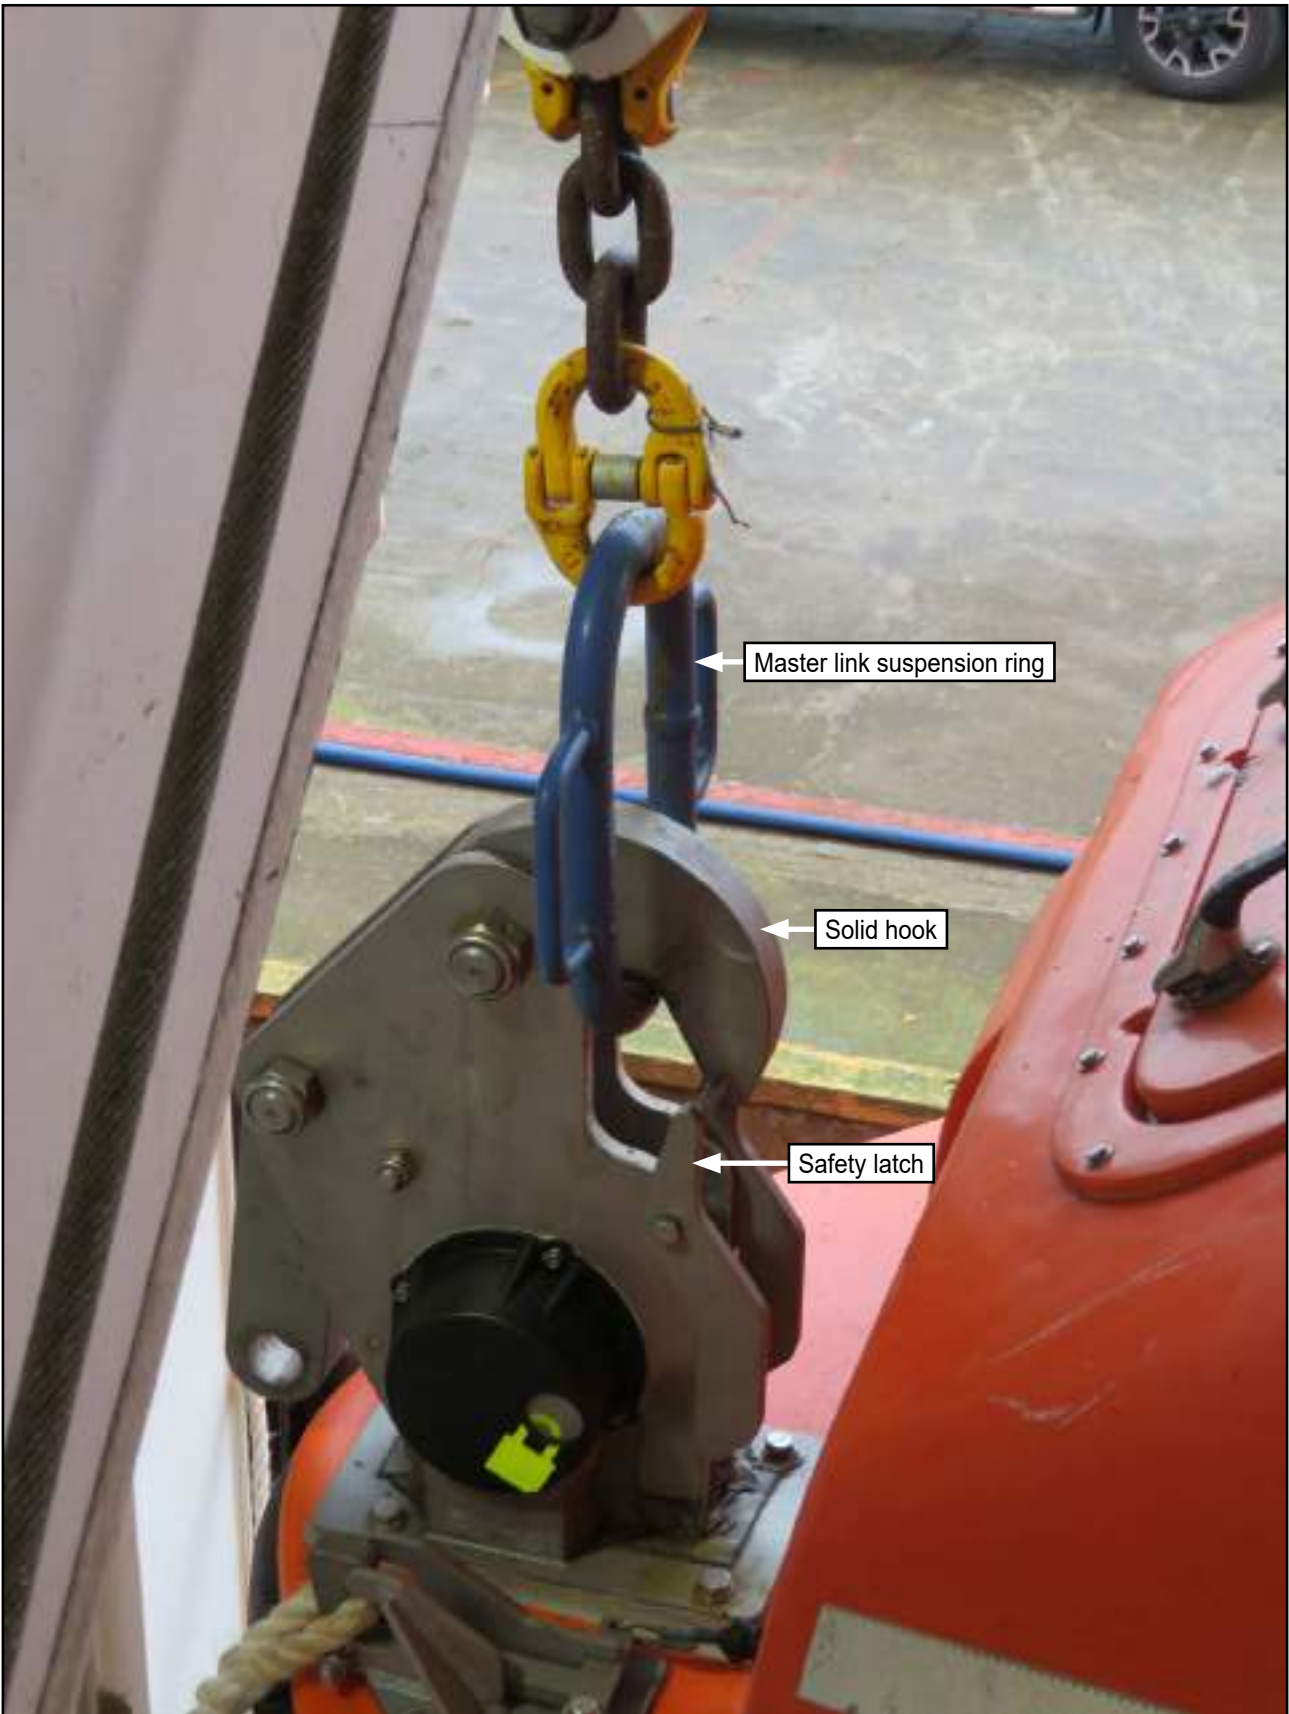
**Figure 10:** Lifeboat hook and master link suspension ring

The safety latches of both lifeboat hooks sustained damage when the master link suspension rings<sup>9</sup> on the davit falls (**Figure 10**) disengaged from the hooks as the lifeboat rolled onto its side and fell to the water. The damaged safety latches were replaced after the accident and the lifeboat hooks were load tested.

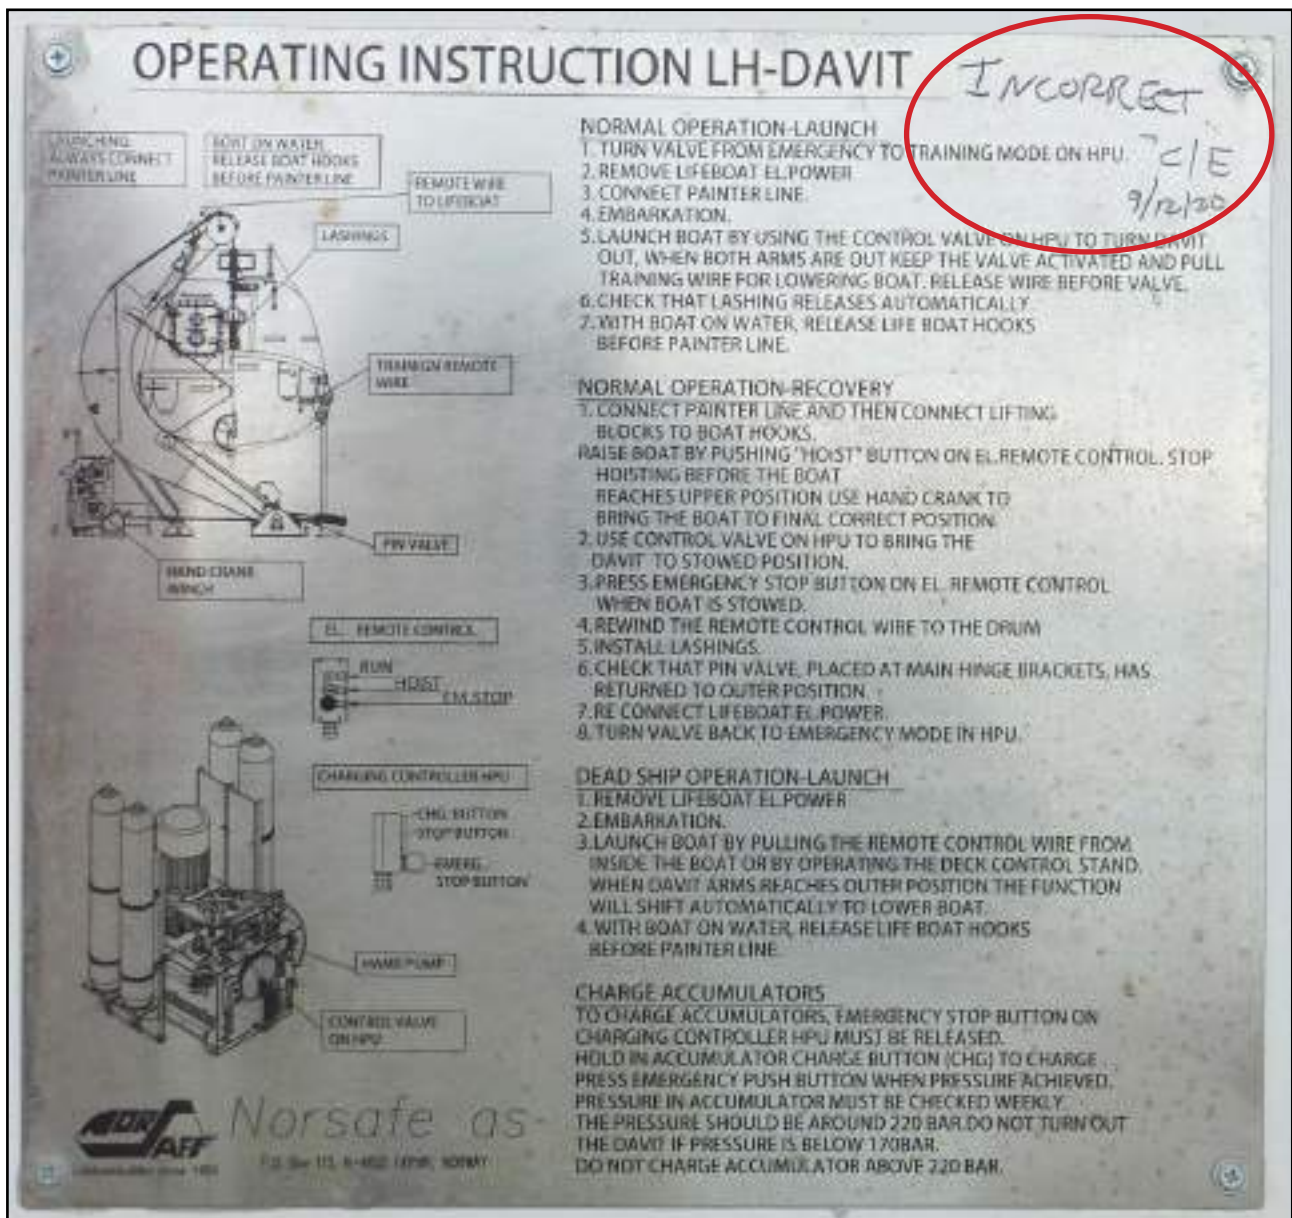
**Figure 11:** Instruction plates fitted adjacent to lifeboat davits, showing the handwritten statement

The description for the training mode procedure deviated from that stated in the Norsafe operation and maintenance manual and included a note that, *This process needs to be confirmed once onboard* [sic]. General information about the davit highlighted the function of the interlock cylinder and the winch brake operating arm. There was no reference to the safety checks that were to be conducted after the davit operation.
