MIR-23-23

Fire aboard Tank Vessel *S-Trust*

On November 13, 2022, about 1530 local time, a fire started on the bridge of the oil tanker *S-Trust* while the vessel was docked at the Genesis Port Allen Terminal in Baton Rouge, Louisiana.¹ Fire teams from the vessel's crew extinguished the fire about 1550. There were no injuries, and no pollution was reported. The damage to the vessel was estimated at \$3 million.

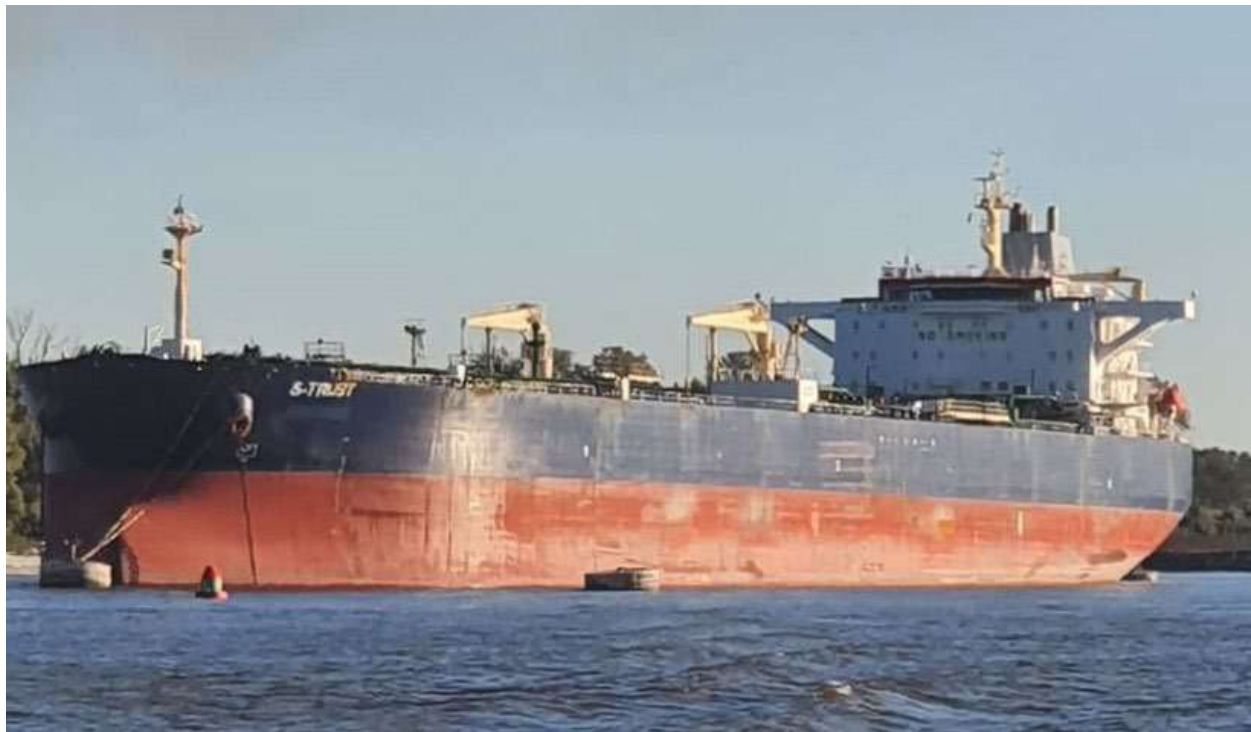
Figure 1. *S-Trust* at anchor following the casualty. (Source: US Coast Guard)

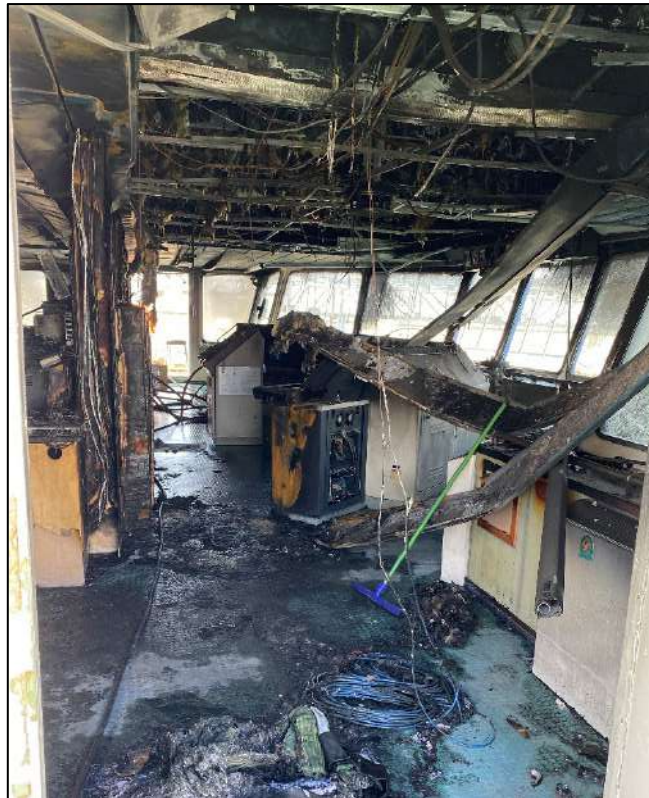
Investigators from the Coast Guard and the Bureau of Alcohol, Tobacco, Firearms and Explosives (ATF) discovered extensive damage throughout the bridge, including significant smoke and thermal damage. There was no damage noted to any of the lower decks in the superstructure. The navigation systems, communication systems, and alarm systems were damaged beyond repair.

Figure 3. The damage to the bridge. (Source: Coast Guard)

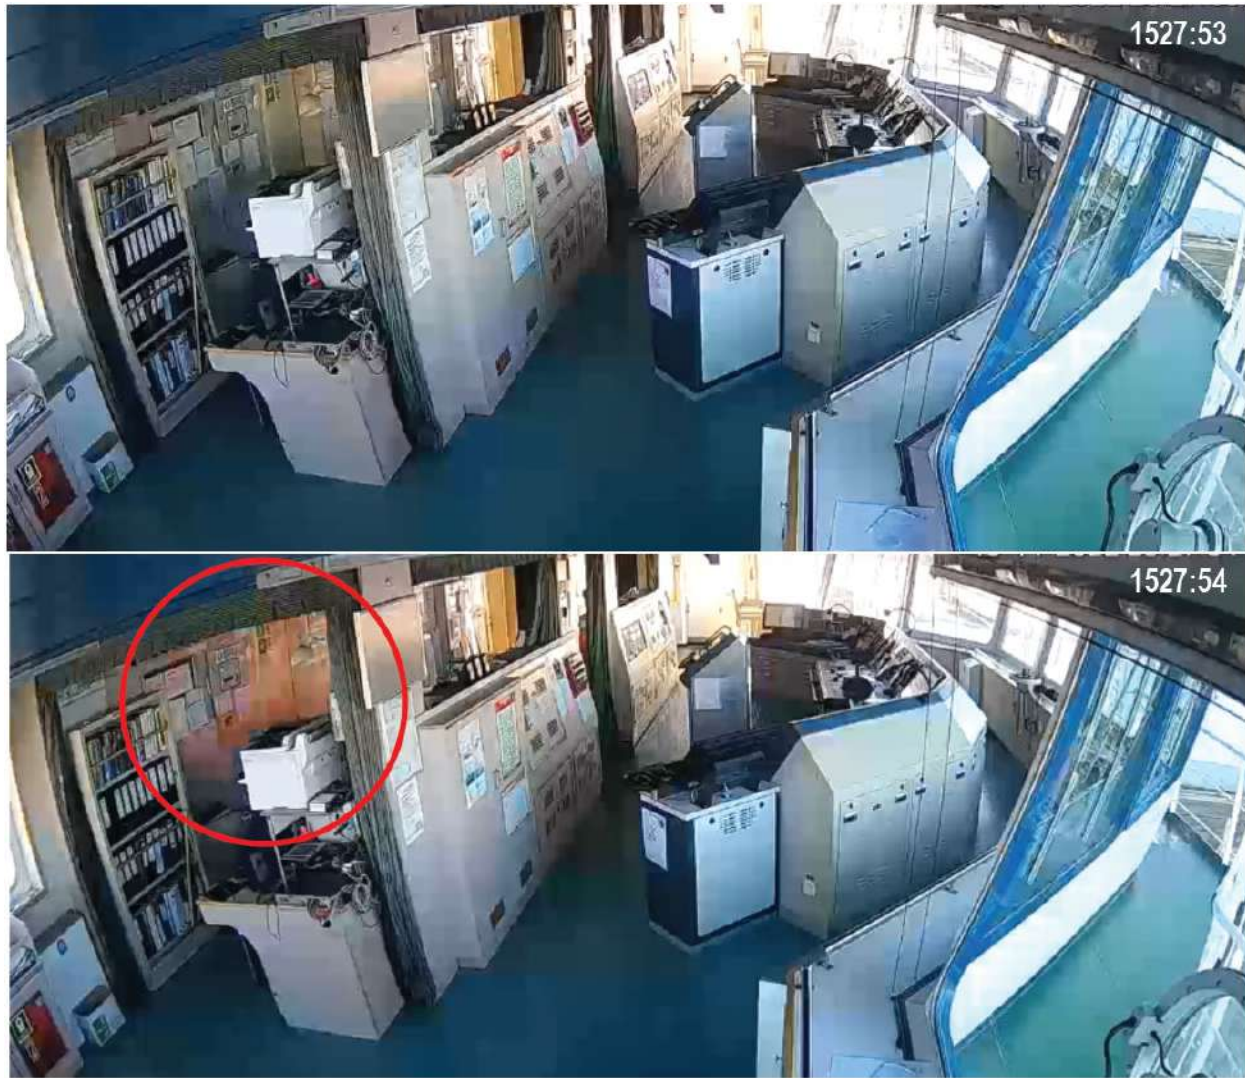
At 1527:54 local time, the footage showed an orange flash immediately followed by a puff of smoke by the communications table. Following the initial flash, the video showed smoke rising up and increasing in volume and thickness.

Figure 4. The bridge closed-circuit camera footage showing the bridge before the initial flash (top), and the flash and smoke, circled in red, at the communications table (bottom). (Background source: Stalwart Management Ltd)

The closed-circuit camera on the bridge captured an orange flash immediately followed by a puff of smoke in the area of the communications table where batteries and chargers for hand-held radios assigned to the bridge were located. Following the flash, smoke and flames were seen growing and expanding as combustible material was consumed by the fire. The ATF concluded that the fire was caused by one of the lithium-ion battery cells on the communications table exploding. The video and other evidence support the ATF findings.

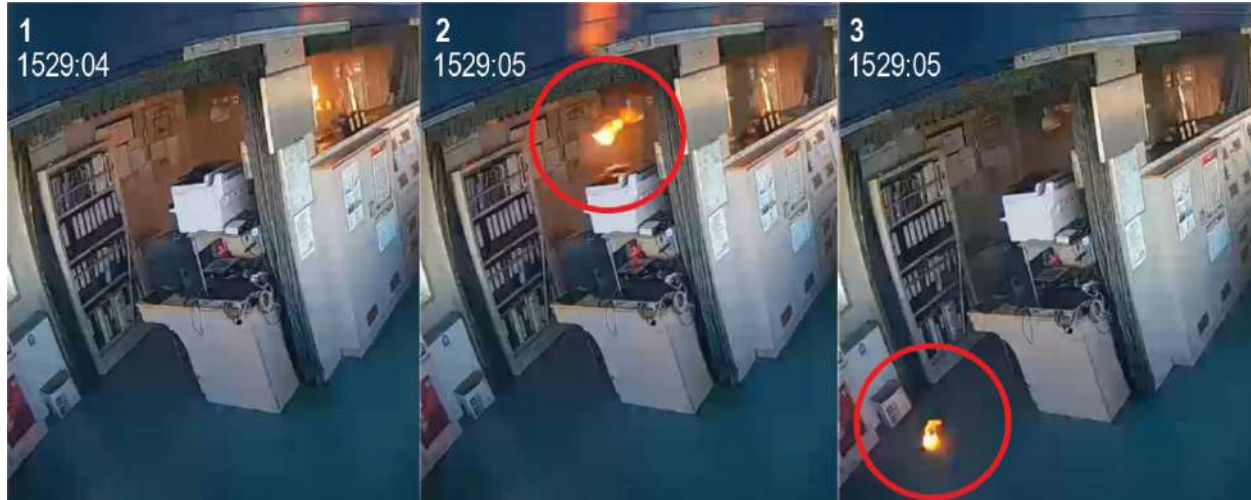
At 1529:04, the footage showed another orange flash in the same area as the first one, followed by an object on fire, which flew from the area of the flash to the starboard side of the bridge, where it landed on the deck in front of the lifejacket locker and continued to burn.

Figure 5. Photos from the bridge closed-circuit camera showing (1) a second explosion, (2) an object on fire propelled into the air (circled in red), and (3) the object, still on fire, landing on the floor (circled in red). (Background source: Stalwart Management Ltd)

video captured a second flash, followed by a flaming object being propelled from the fire and landing on the deck of the bridge, where it continued to burn. This was most likely the other missing lithium-ion cell from the same battery. Based on the video, investigators determined that the second missing lithium-ion cell also experienced a thermal runaway, most likely initiated from the heat of the fire started by the initial battery cell thermal runaway.

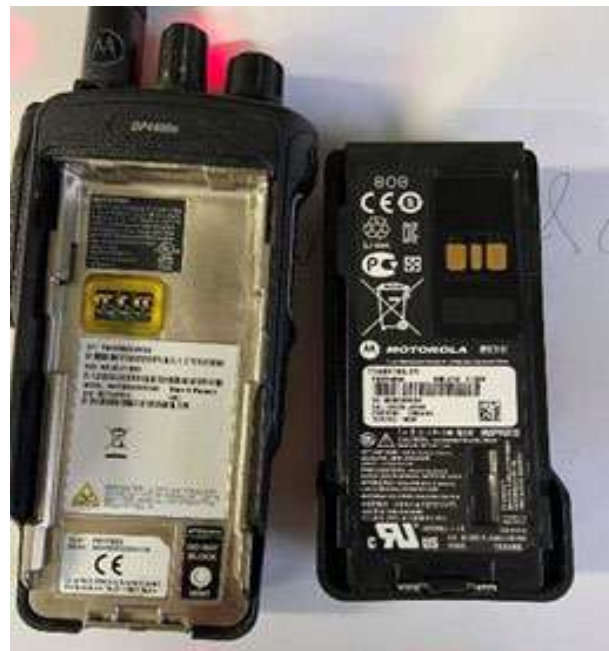
Figure 6. A Motorola DP4400e radio and lithium-ion battery used on the bridge of the *S-Trust*.

The two radios assigned to the bridge were a Motorola DP4400e radio, which used a lithium-ion battery, and a Motorola GP328 radio, which used a nickel-metal hydride battery. A crewmember informed investigators he believed that the batteries for those radios were not charging the day of the fire.

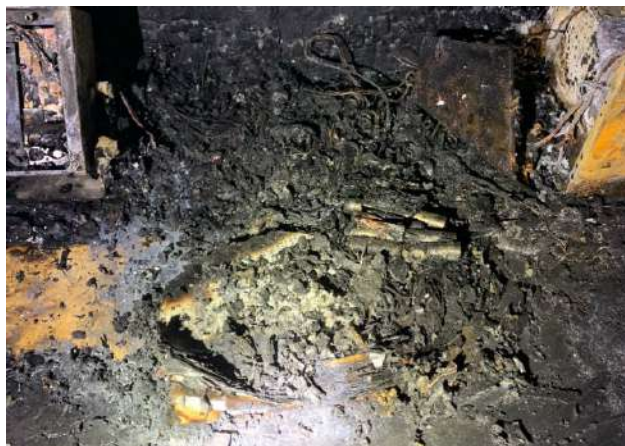
When investigators examined the area around the communications table on the bridge where the video showed the orange flash, smoke, and fire, they found the remains of a lithium-ion battery charger and a nickel-metal hydride battery charger. A closer examination found the remains of three batteries among the charger remains— one nickel-metal hydride battery (which contained six cells) and two lithium-ion batteries (which each contained two cells).

Figure 7. The remains of the lithium-ion and nickel-metal hydride battery chargers on the communications table. (Source: ATF)

The ATF origin and cause report for the fire stated that “the cause of this fire was determined to be an energetic event [explosion] involving a lithium ion battery located on the navigation [communication] desk.” The report detailed the examination of the other electronic devices, including a computer and a radio, on the communications table as well as all six electrical outlets that provided power to the desk. While all of the electronic devices and the outlets sustained fire damage, the ATF report ruled them out as potential sources of the fire. The ATF report also noted that there was a second explosion from within the ensuing fire on the communications table.

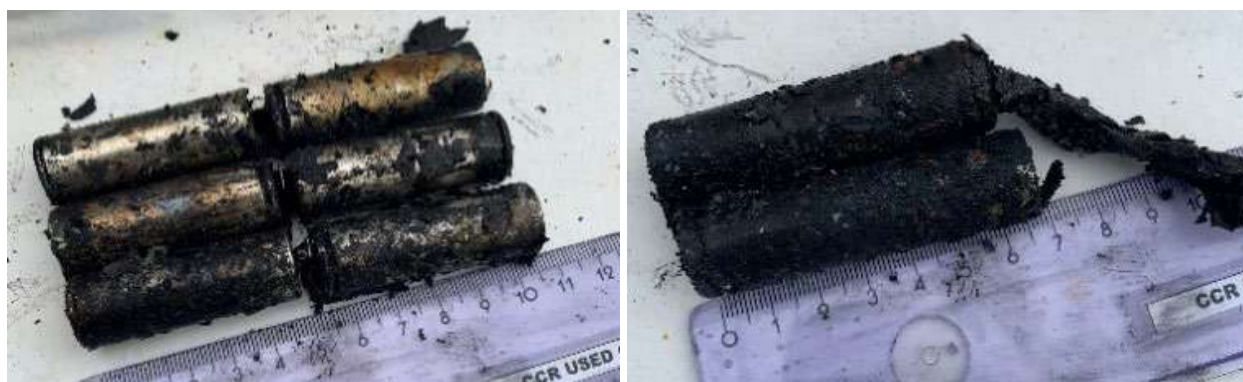
All six of the nickel-metal hydride battery cells were found among the charger remains and exhibited fire damage. Of the remains of the two lithium-ion batteries on the communications table, two cells from the same battery were found among the charger remains and had sustained fire damage. Although investigators found components of the second lithium-ion battery among the charger remains, its two cells were not found.

Figure 8. The nickel-metal hydride battery's cells (*left*) and remains of the lithium-ion battery cells and components (*right*) found on the communications table. (Source: ATF)

Investigators found the remains of three batteries (one nickel-metal hydride and two lithium-ion) on the communications table. The single nickel-metal hydride battery (all of its six cells) was intact; one of the lithium-ion batteries (both cells) was found intact in the remains of the chargers (one nickel-metal hydride charger and one lithium-ion charger). Investigators only found components of the second lithium-ion battery (a two-cell battery). Lithium-ion battery cell explosions are typically caused by a thermal runaway; as such, the initial orange flash and puff of smoke on the video feed was likely the result of one of the missing lithium-ion cells exploding due to a thermal runaway.
