NATIONAL TRANSPORTATION SAFETY BOARD

2022

SAFER SEAS Digest

Lessons Learned from
Marine Investigations

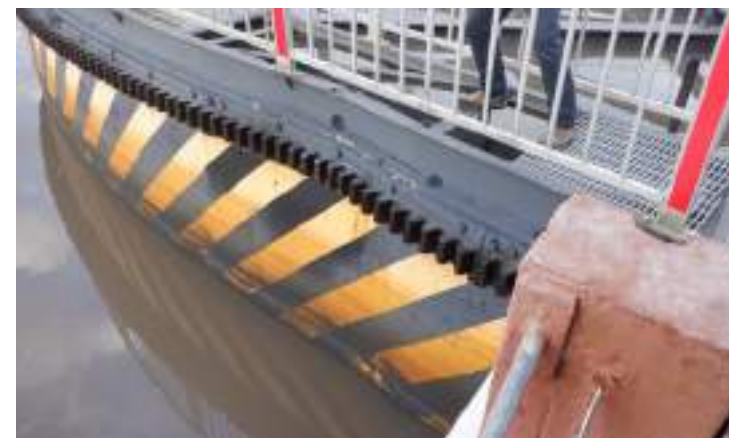
Figure 37. Left: Simplified illustration of Leland Bowman Lock western gates showing the point of contact by barge *HFL 439*, as indicated by the red X.

Figure 38. Below: Damaged steel plating and rack on gate.

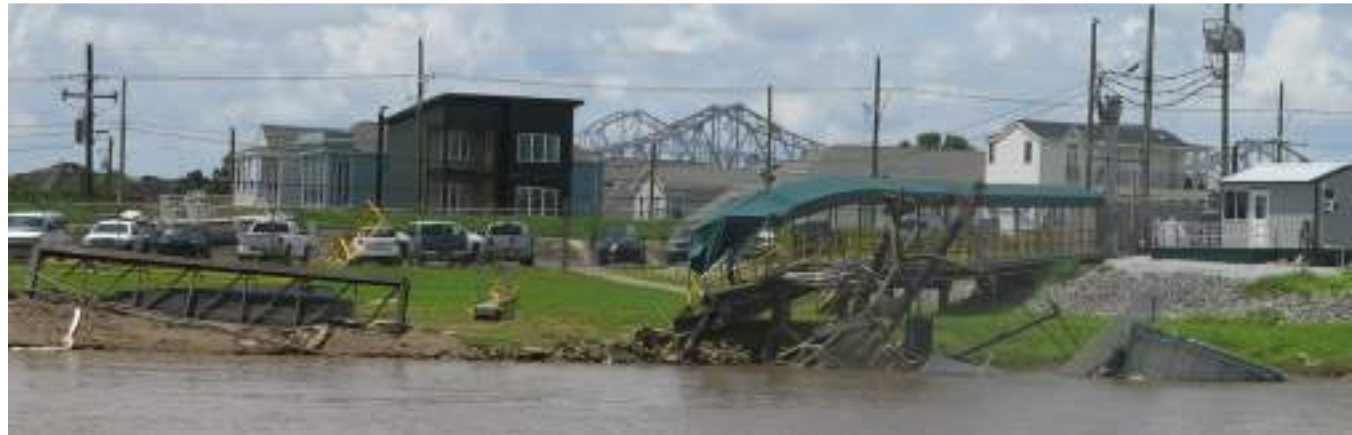
Figure 45. Postcasualty damage to office barge moorings, catwalks, and gangways.

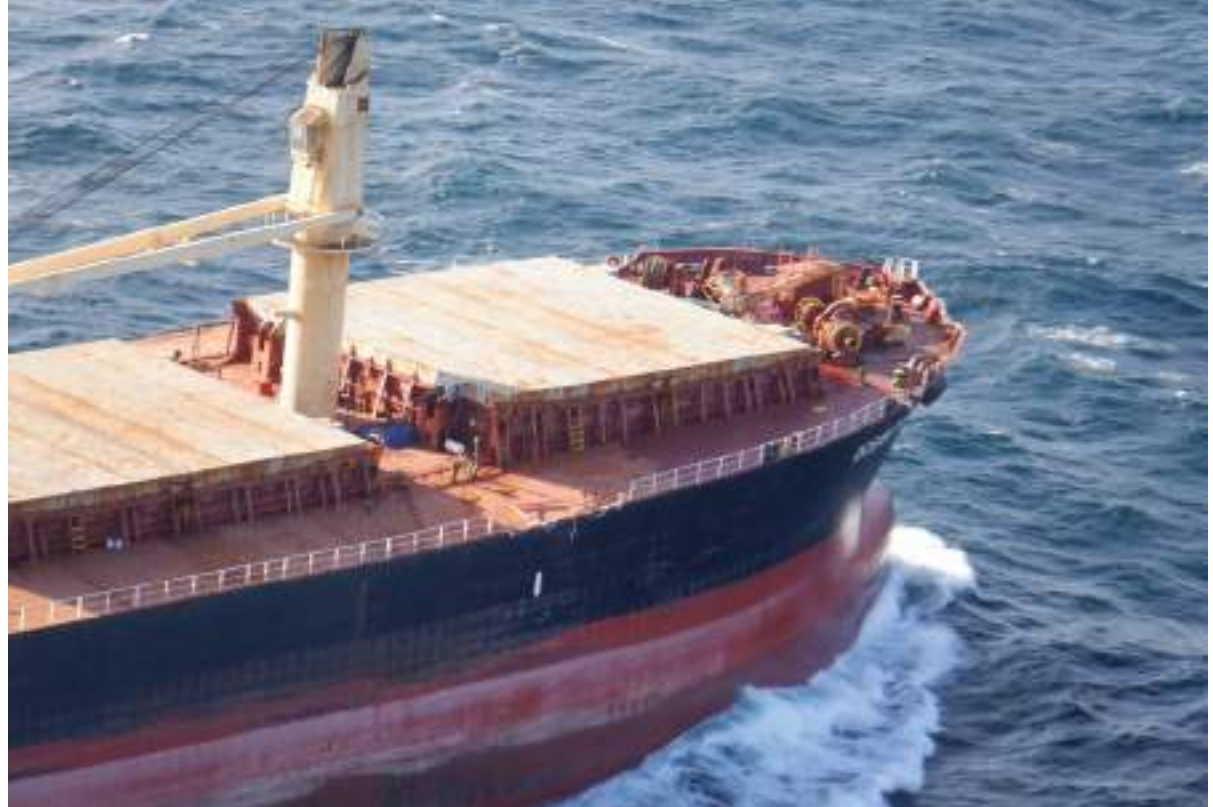
Figure 54. Knocked down mast and damaged bulwark, anchor windlass, and handrails on the *Ocean Princess* following the casualty. SOURCE: BUREAU OF SAFETY AND ENVIRONMENTAL ENFORCEMENT

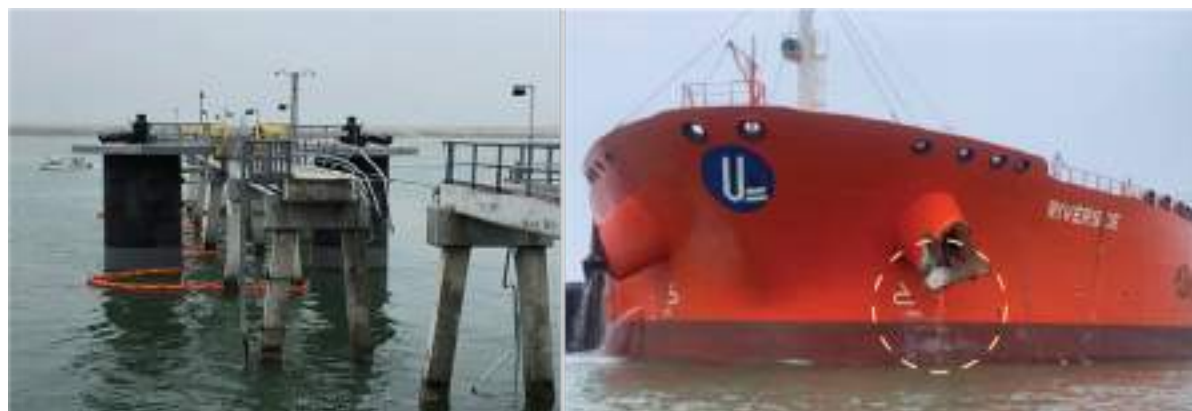
Figure 58. Damage to the no. 4 Moda dock catwalk (left) and the *Riverside* (right, circled). SOURCE: COAST GUARD

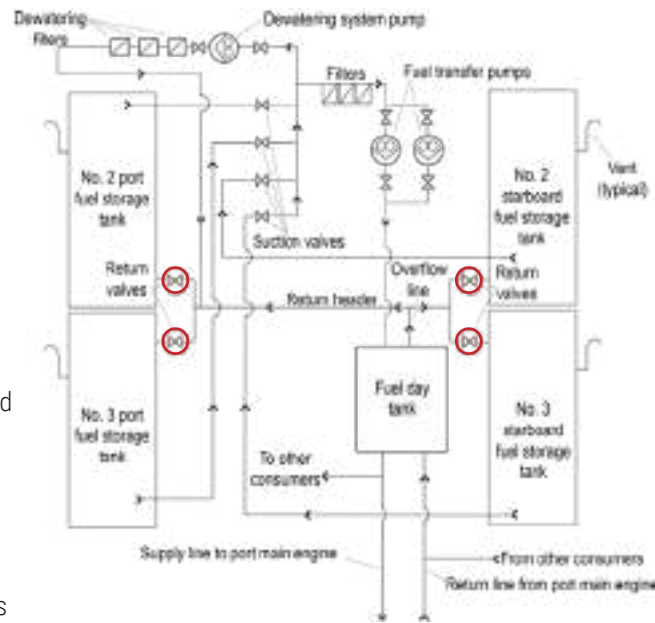
Figure 84. Fuel piping diagram for the *Mary Lynn*. Fuel return valves, circled in red, were inadvertently left closed when a fuel transfer pump was started and the no. 3 starboard suction valve was opened.

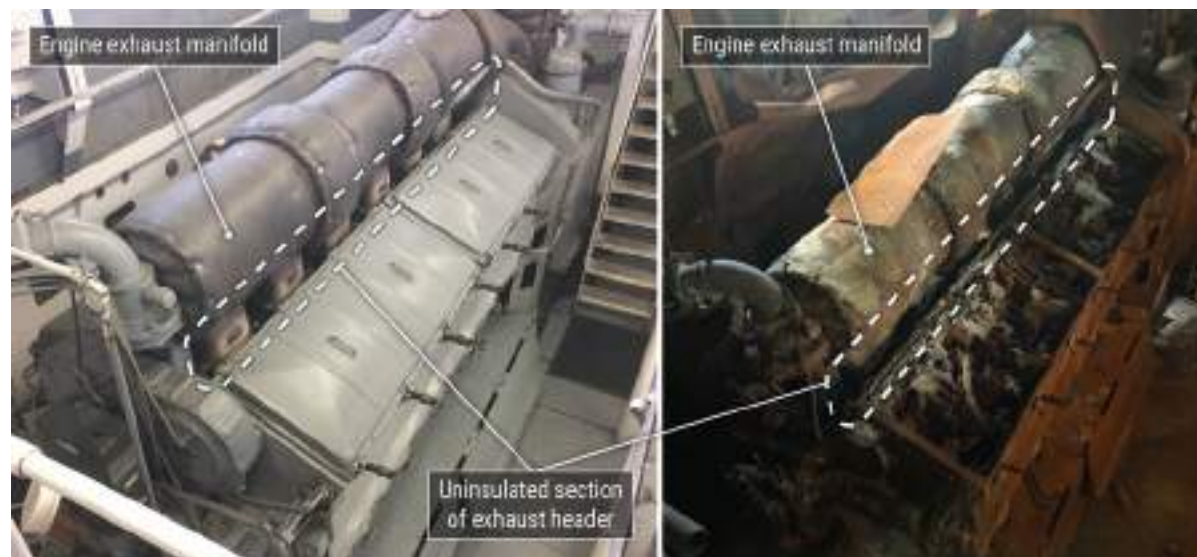
THE PROBABLE CAUSE of the engine room fire aboard the towing vessel *Miss Dorothy* was the ignition of spraying diesel fuel from a main engine's fuel system onto an uninsulated section of the engine's exhaust system. Contributing to the severity of the fire and damage to the vessel was the inability to effectively secure ventilation to the space and fuel to the affected engine.

Figure 91. Starboard main engine before (left) and after (right) the fire, with the uninsulated section of exhaust header indicated. BACKGROUND SOURCE: WESTERN RIVERS BOAT MANAGEMENT INC.

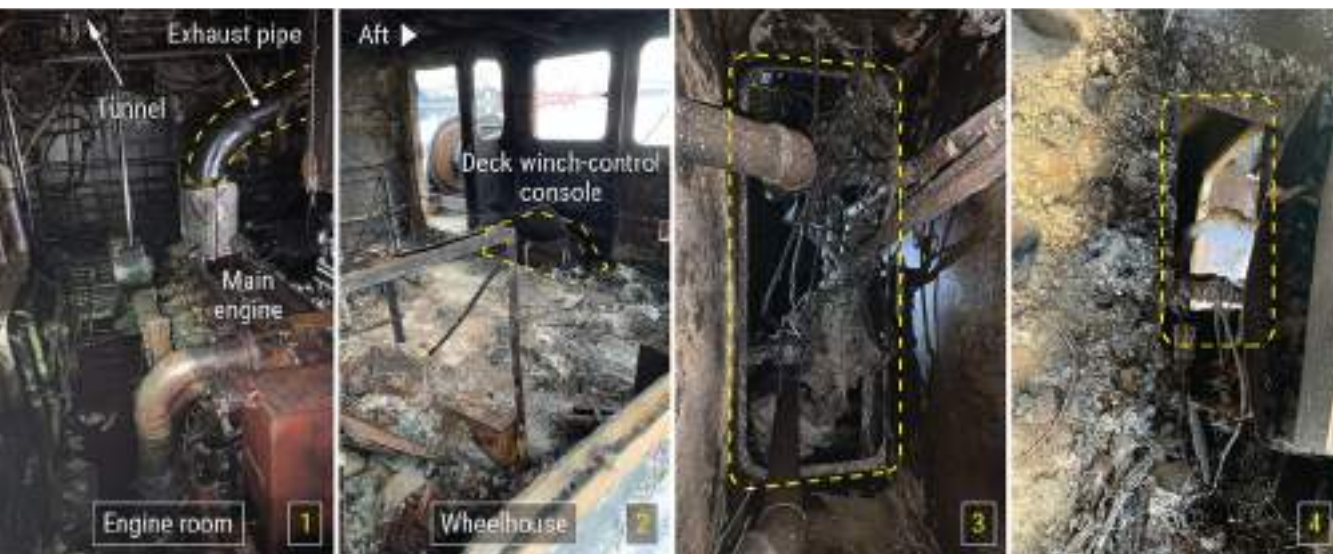
Figure 94. Left to right: Post-fire damage of (1) the engine room, where the crew removed the lagging from the exhaust pipe, as indicated by the dashed line; and (2) the wheelhouse, where the captain observed black smoke emanating from under the deck winch-control console. Damaged pipe/hose tunnel, as identified by dashed rectangles, looking up from the engine room (3), and down onto the deck winch-control console location (4).

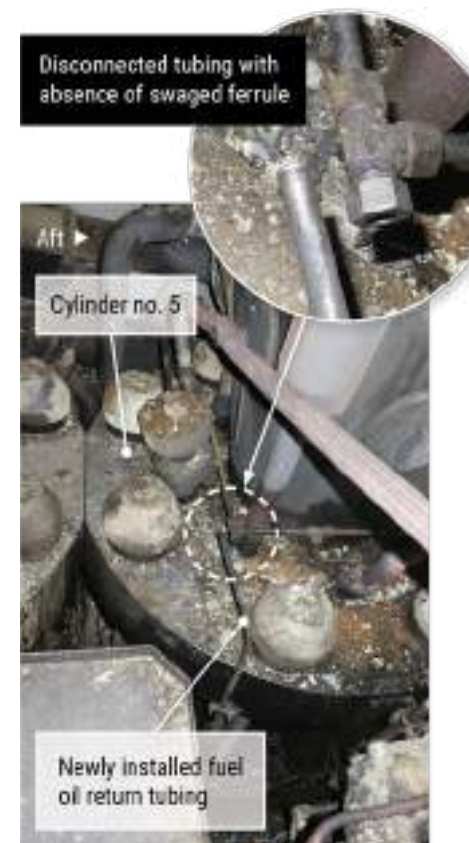
Figure 98. Cylinder no. 5 and the disconnected, newly installed fuel oil return tubing (inset).

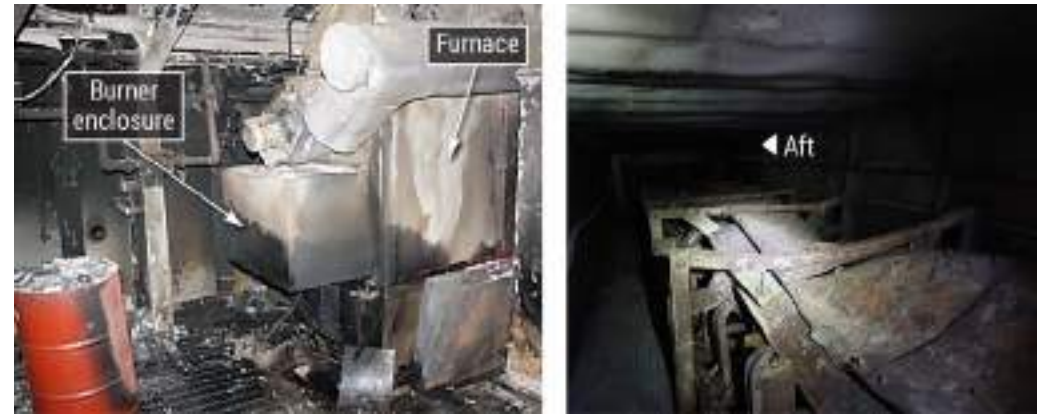
Figure 104. Left to right: Fire-damaged furnace and conveyor belt within the conveyor belt trunk above the furnace. SOURCE: COAST GUARD

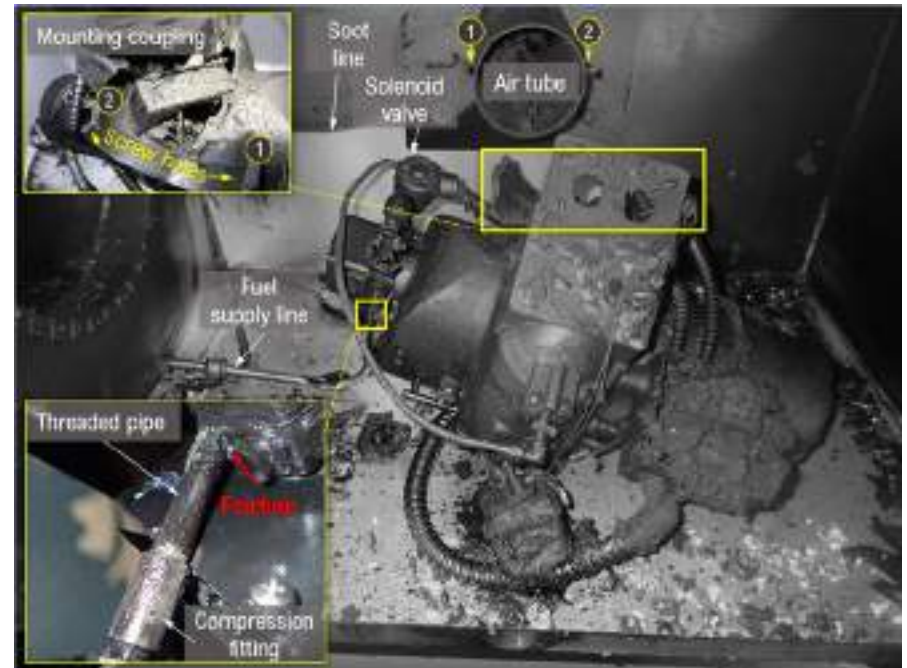
Figure 105. The fire-damaged burner detached from the air tube, lying on the bottom of the enclosure. Photo shows the fractured mounting coupling (top inset, interior view) and the fracture point where the fuel supply pipe threaded into the burner assembly (bottom inset). SOURCE: COAST GUARD

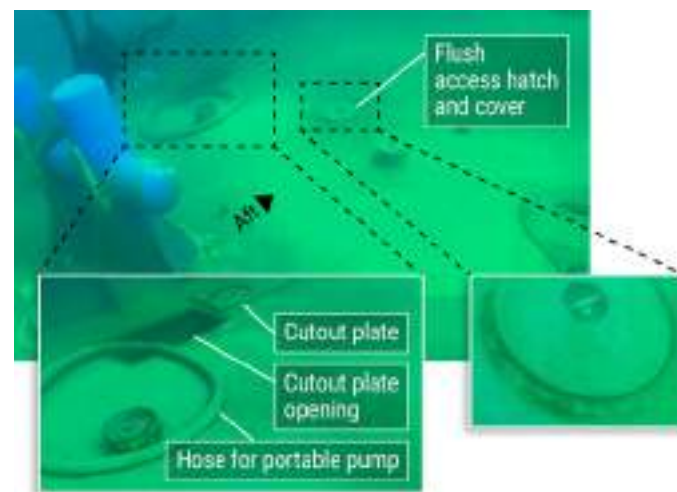
Figure 111. Starboard-side cutout plate with missing quick-acting flush access hatch cover (left close-up) and unseated center quick-acting flush access hatch cover to flanking rudder compartment (right close-up).

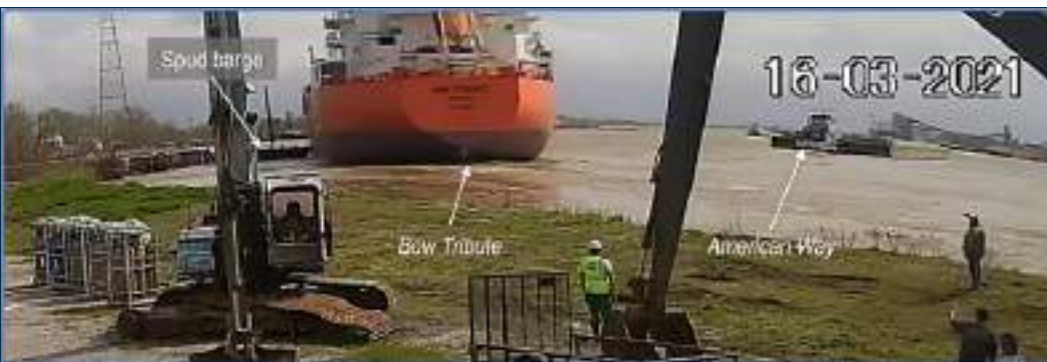
Figure 118. Left to right: Damage to the river intake fender systems: arrow shows damage to the spud barge at New River; damaged catwalk and dolphin piles at Oak Street.

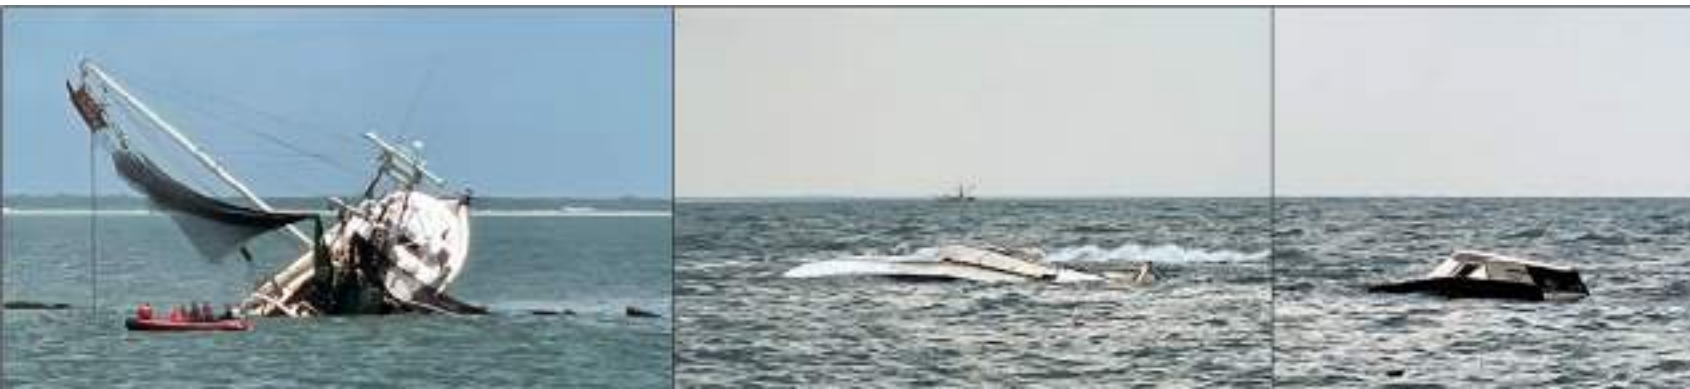
Figure 129. Left to right: *Sage Catherine Lane* following the grounding on the jetty, and after being broken apart on the jetty 3 days later.

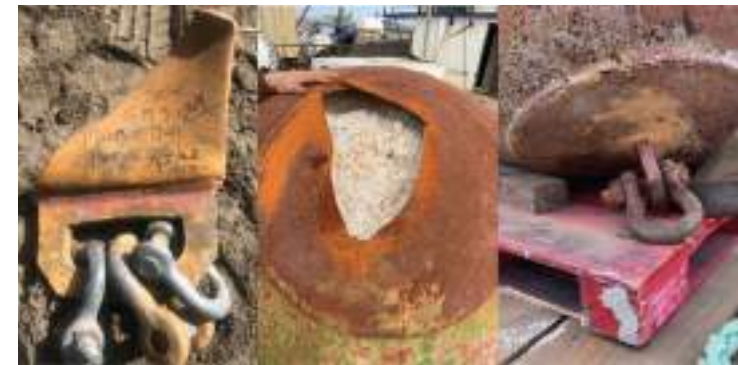
Figure 134. Left to right: *SM-3* mooring buoy: failed weld (with three shackles) that separated from buoy; damaged top with padeye missing; and undamaged bottom padeye. SOURCES ALASKA MARINE SURVEYORS AND NORTHLINE SEAFOODS
