# STENA SCANDICA

Marine accident report on fire

29 AUGUST 2022

**MARINE ACCIDENT REPORT ON FIRE ON BOARD STENA SCANDICA  
ON 29 AUGUST 2023**

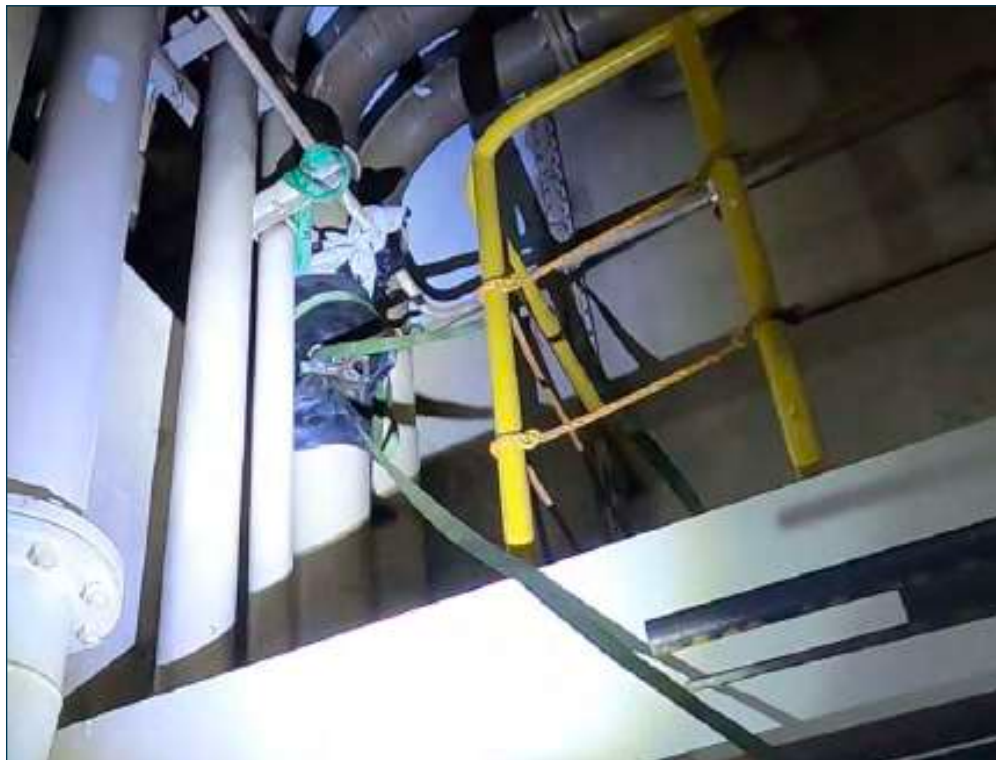
1311 ○ At 1311, the chief engineer informed the master that a drencher pipe had perforated and was leaking. The drencher pipe was located above one of the main engines and had to be repaired to avoid damage to the main engine. The master got the impression that the drenchers was stopped while repair was ongoing and thought they were now without drenchers. However, in the engine room the engine team worked on sealing off the pipe while the drencher system was pressurised.

At 1324, the master received information that the engine team had managed to seal the leaking pipe above the main engine with jackets and belts (Figure 9).

Figure 9: Sealed off drencher pipe leakage.  
Source: DMAIB

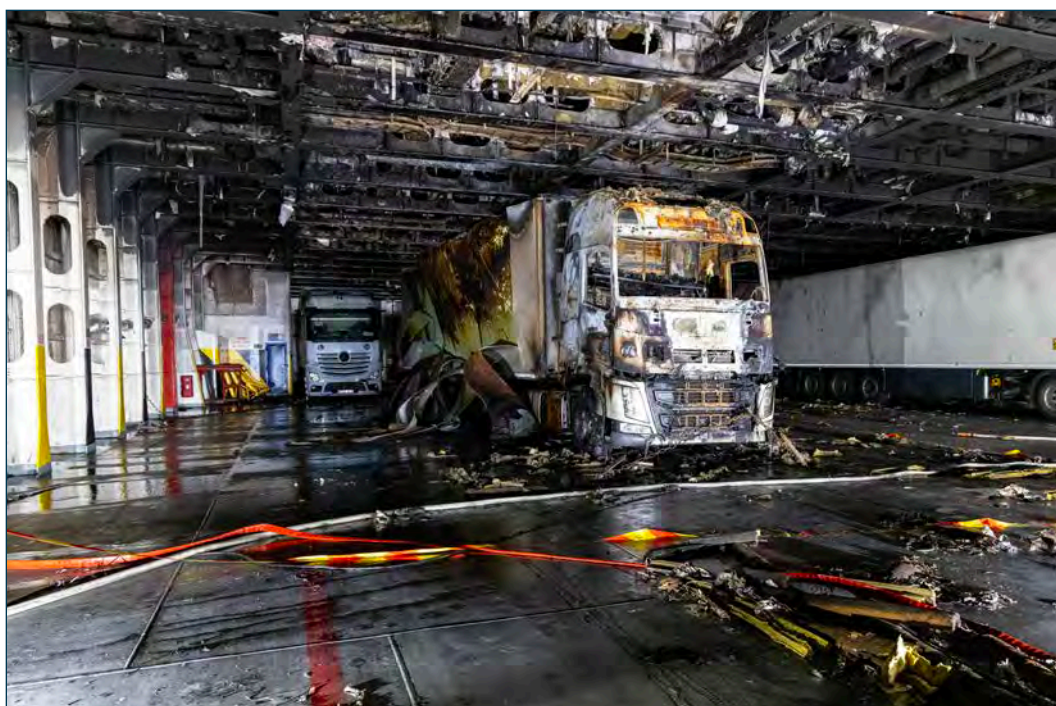
DMAIB requested the crew of STENA SCANDICA not to remove items or vehicles from vehicle Deck 4 upon the ship's arrival. When DMAIB arrived at the site of the fire, it was cordoned off while the site was examined and documented (Figure 12).

Figure 12: Fire scene on Deck 4.  
Source: DMAIB

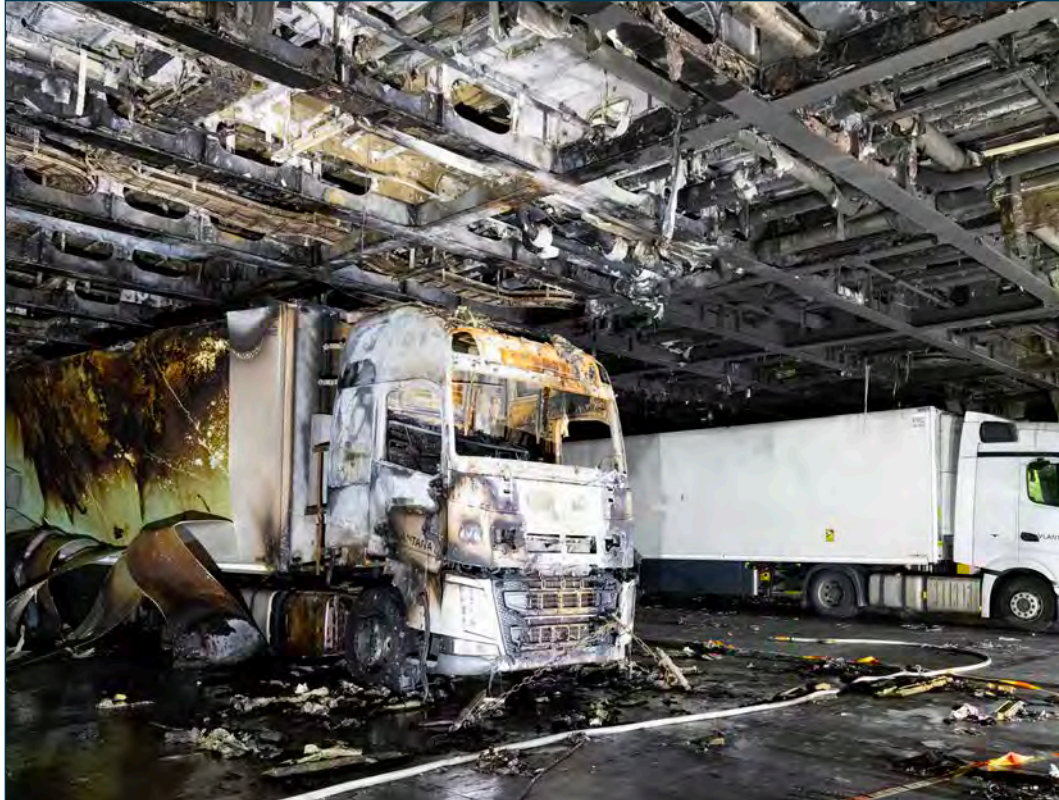
When entering Deck 4, the forward sheltered part was fire-damaged. Fireproof insulation had fallen from the deckhead onto the deck, and debris from burning material lay scattered on the deck. Some of the debris had melted onto the deck or caused superficial heat damage, but otherwise the deck structure was intact. The deckhead and upper part of the bulkhead were covered in soot, and melted plastic was hanging from fluorescent light fixtures (Figure 14).

Figure 14: Deckhead above truck burnt clean from paint and soot.  
Source: DMAIB

On the port side, localised extensive fire damage was observed on the deckhead. Steel had burned clean of soot and paint, and cables fitted in cable trays on the deckhead were laid bare as the insulation had burned away. This indicated that the area had been impacted by high temperatures from radiation heat or direct exposure to a flame plume. Below this area, a truck was located with extensive fire damage on the cab and trailer.

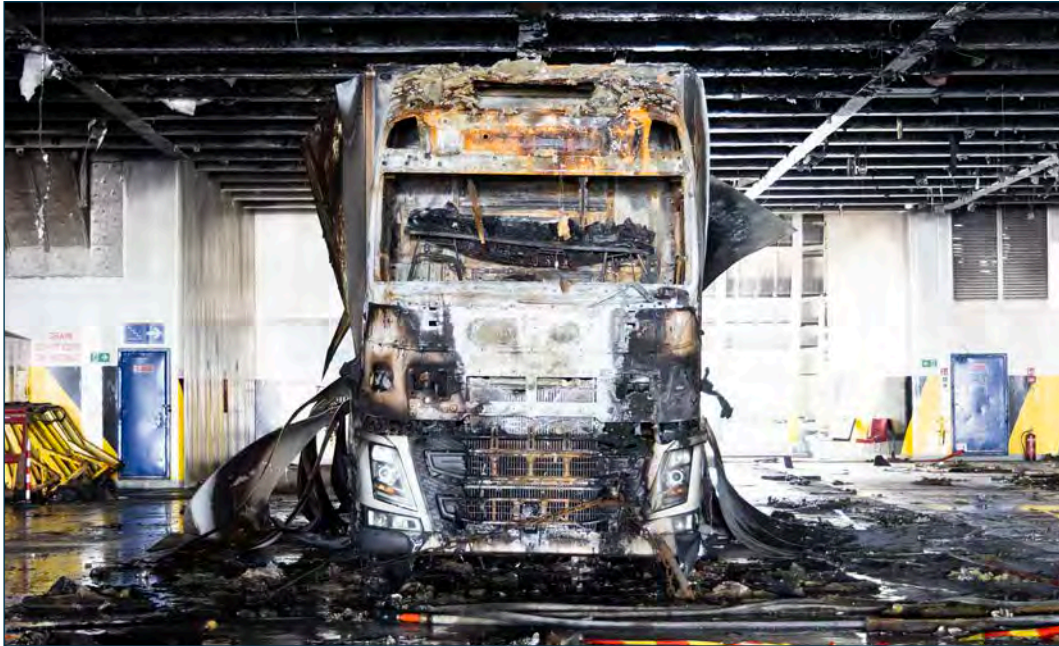
Examination of the truck showed that the truck's cab had been gutted by the fire. The fire damage centred on the front bumper, leaving the sides of the grille and the headlights intact. On the bonnet and the engine bay, the centre had burnt clean from paint and soot, while the corners of the bonnet were burnt clean from paint, but not soot. The cab's windows were missing and were found in misshapen pieces on the deck below. All combustible interior within the cab had burnt away. Both front tyres were intact (Figure 17).

Figure 17: Fire damages on truck front.  
Source: DMAIB

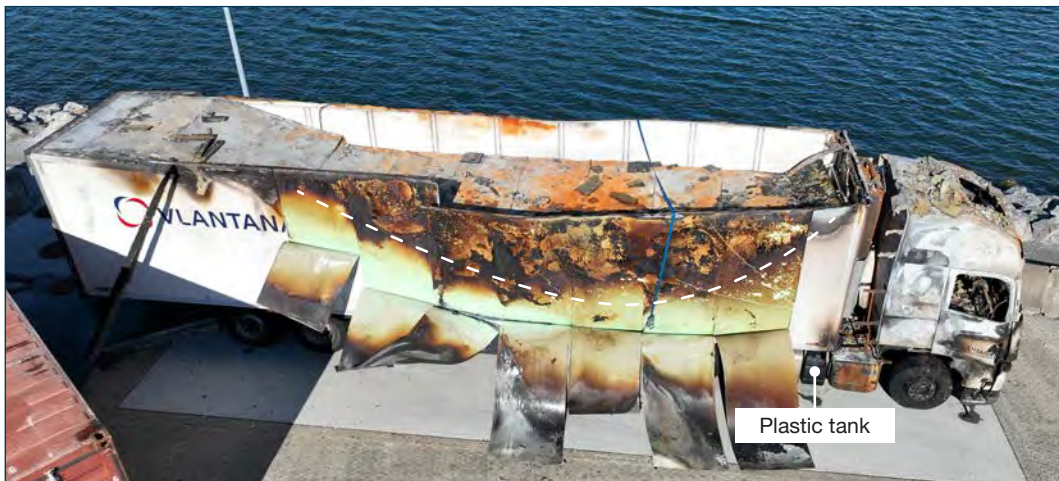
On the trailer's right-hand side (looking from behind), the top bracket had melted and was no longer holding the outer aluminium plating, and the roof had partly collapsed (Figure 18). The inner plating displayed a semi-circular burn pattern covering 2/3 of the trailer's side, starting from its top front corner. In this area, the metal had blackened and oxidised and had been deformed by the heat impact. Below the bottom front corner of the trailer, a black plastic tank was installed on the outside of the truck's chassis. The plastic tank had minor heat damages, but was otherwise intact. This indicated that the heat impact had been limited in this area.

Figure 18: Fire pattern on the truck's right side.  
Source: DMAIB

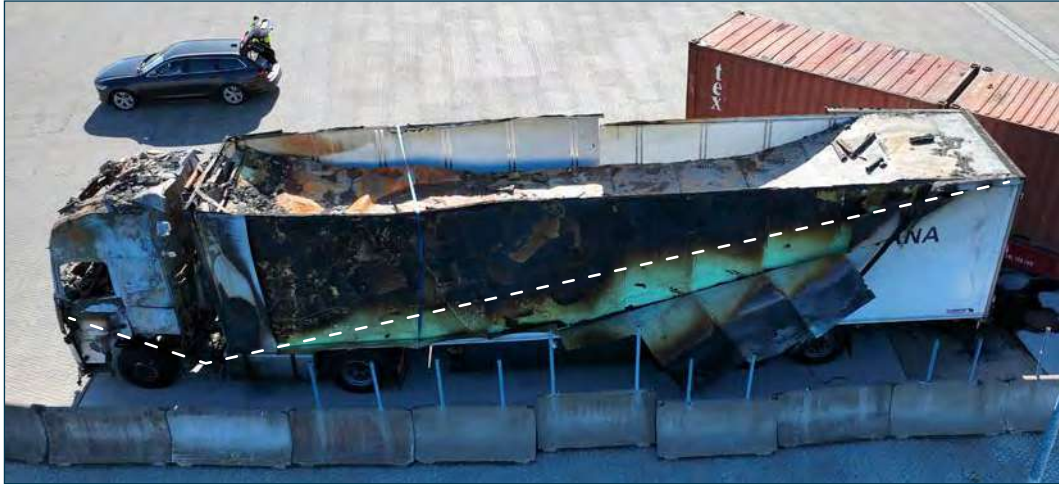
On the left-hand side of the trailer, the outer aluminium plating had similarly loosened from the collapsed top brackets (Figure 19). The inner plating was marked by a burn pattern differing significantly from the other side of trailer. The burn pattern on the trailer's left side started from the bottom front corner and fanned diagonally upwards to the rear top corner.

The fire pattern on the truck's cab and the diagonal fire pattern on the trailer's left side formed a V pattern rooted at the truck's chassis in the gap between cab and trailer. The V pattern indicated that fire had been present in the gap and spread up and out, possibly indicating the fire's point of origin. Therefore, this area was excavated from the burned debris and examined further.

Figure 19: Fire pattern on the truck's left side.  
Source: DMAIB

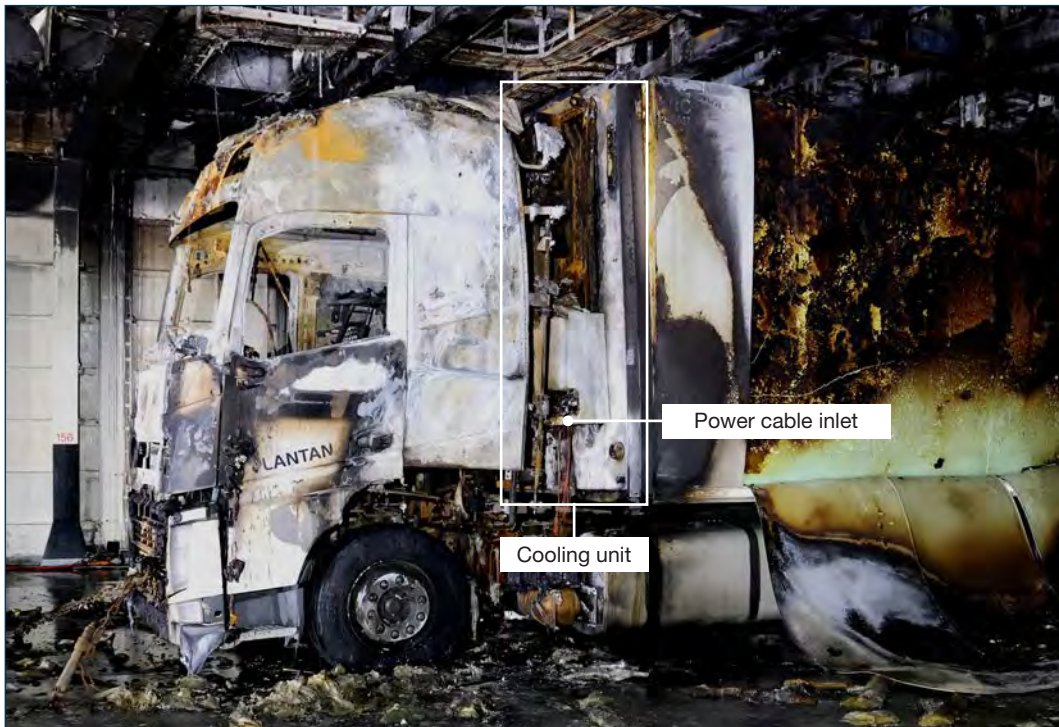
On the front of the trailer, the engine for the trailer's cooling unit was located. The inlet for the ship's power supply cable was located at the bottom of the cooling unit casing. All combustible material on the cooling unit was burned away, melted or deformed (figure 20). The part of the ship's power cable connected to the cooling unit was found melted and burned (figure 21).

Figure 20: Fire damaged cooling unit.  
Source: DMAIB

A mechanical failure in the cooling unit could develop heat and ignite surrounding flammable material. During the investigation, DMAIB did not observe any indications of a violent mechanical malfunction. However, the unit was severely damaged by the fire that it could not be ruled out that a malfunction had occurred which caused ignited material to burn through the cooling unit's casing and fall on top of the truck's battery casing igniting oil and grease residues.

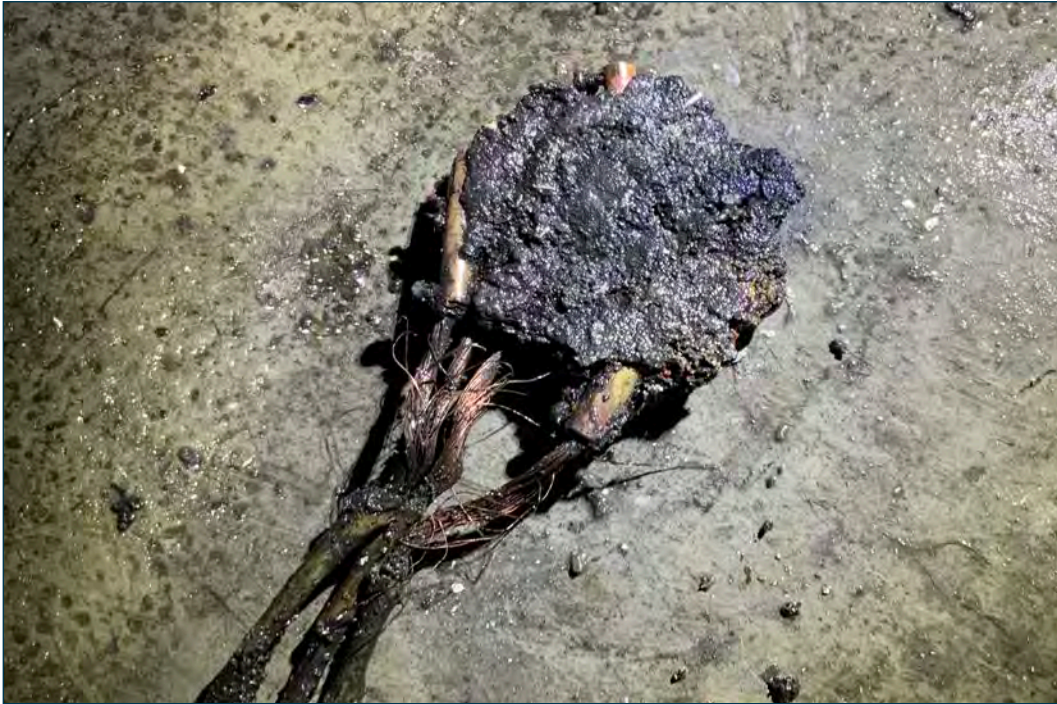
Figure 21: Melted power cable inlet.  
Source: DMAIB

The power cables from the ship to the cooling unit could short circuit and the arc could ignite surrounding flammable material. DMAIB found that the sockets connecting the ship's and cooling unit's power cables were melted. The cables were handed over to the Swedish Police for further forensic examination. Swedish Police did not find evidence of short circuit on the cables. Volvo subsequently carried out a fire investigation on the truck and trailer and found metallic spray resembling copper in the area of the power connection to the cooling unit. Such copper spray could indicate failure on one of the power cables. It has not been possible for DMAIB to verify the observations made by Swedish Police and Volvo. It hence remains unknown to DMAIB whether an electric fault had occurred on the power cables.

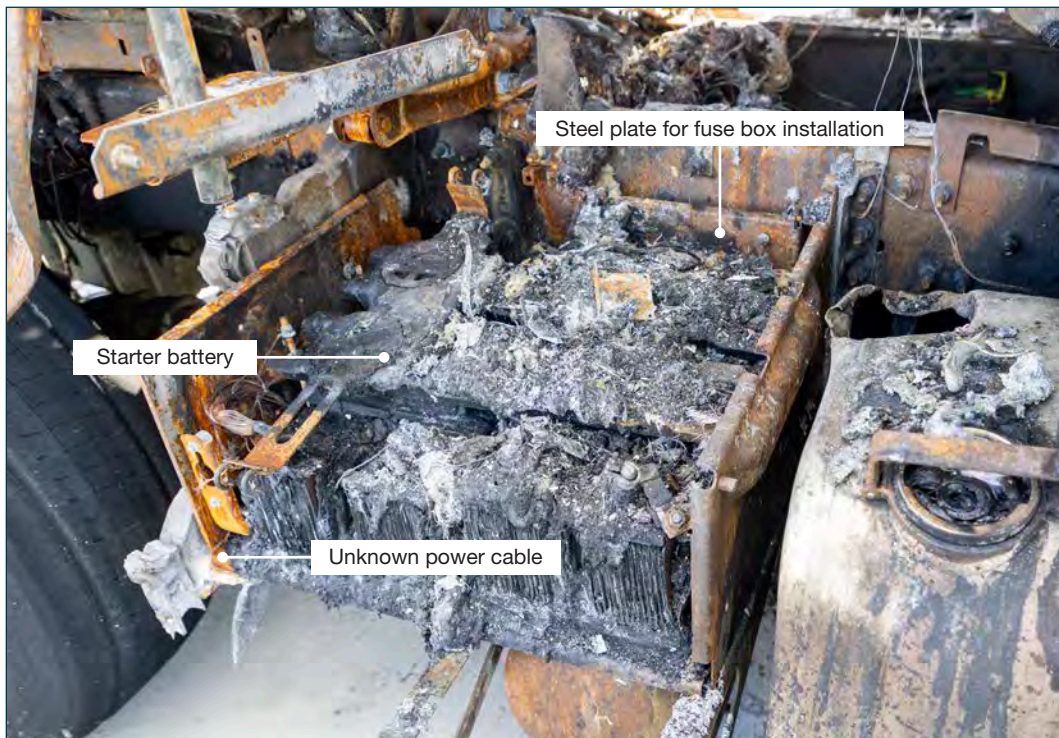
In the area between the cab and the trailer, below the cooling unit, the starter battery for the truck was mounted on a steel platform on the left-hand frame of the chassis. A power cable of unknown origin was found stuck on the left side under the batteries. Behind the battery, a steel plate was mounted on the frame on which a fuse box had been installed (Figure 22).

Figure 22: Starter battery mounted on the chassis.  
Source: DMAIB

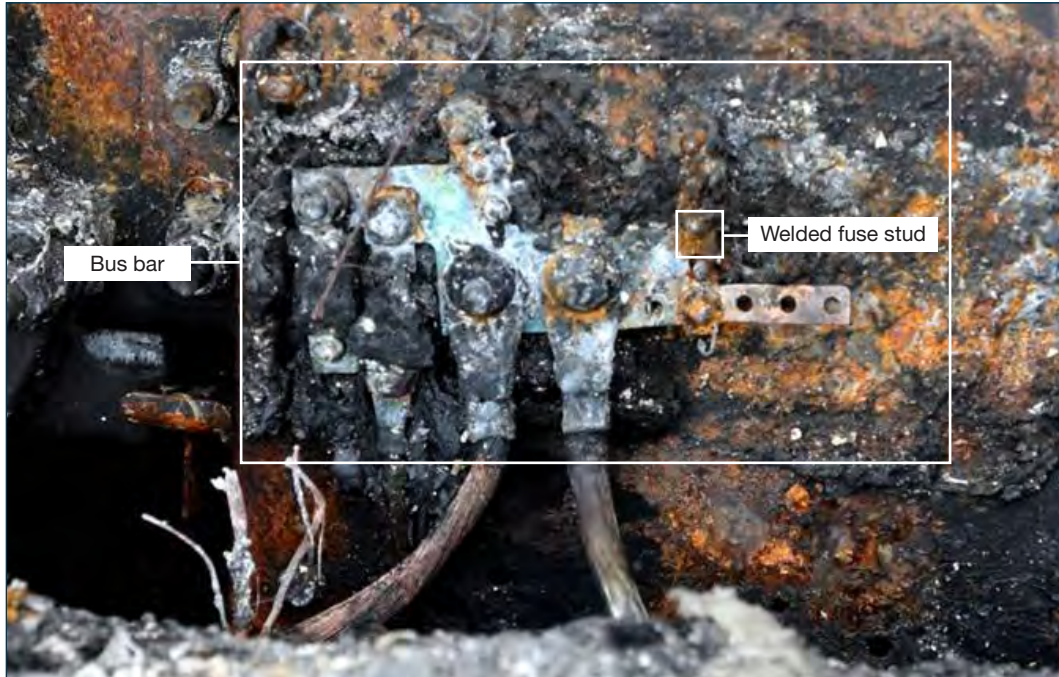
The starter battery and the fuse box installation behind on the left side of the chassis had been exposed to high heat intensity and were entirely burnt out. All plastic covers, boxes and insulation on the cables had burned away. The fuse box bus bar was found behind the battery. It was observed that one fuse stud was found welded to the steel plate, which the fuse box had been mounted on (Figure 23 and 24). In order for steel to weld, temperatures of a minimum of 1,538°C are required. A fire plume normally has a maximum temperature of 1,400°C, whereas electrical faults can result in much higher temperatures. Therefore, DMAIB determined that a short circuit had occurred in the fuse box.

Figure 23: Remains of fuse box bus-bar.  
Source: DMAIB

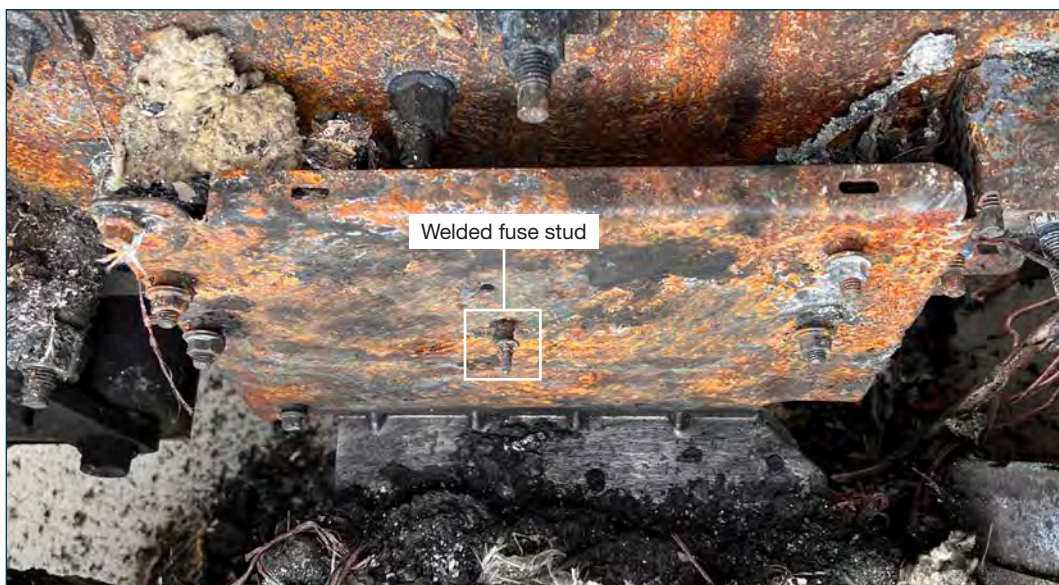
Figure 24: Fuse stud welded to steel plating.  
Source: DMAIB

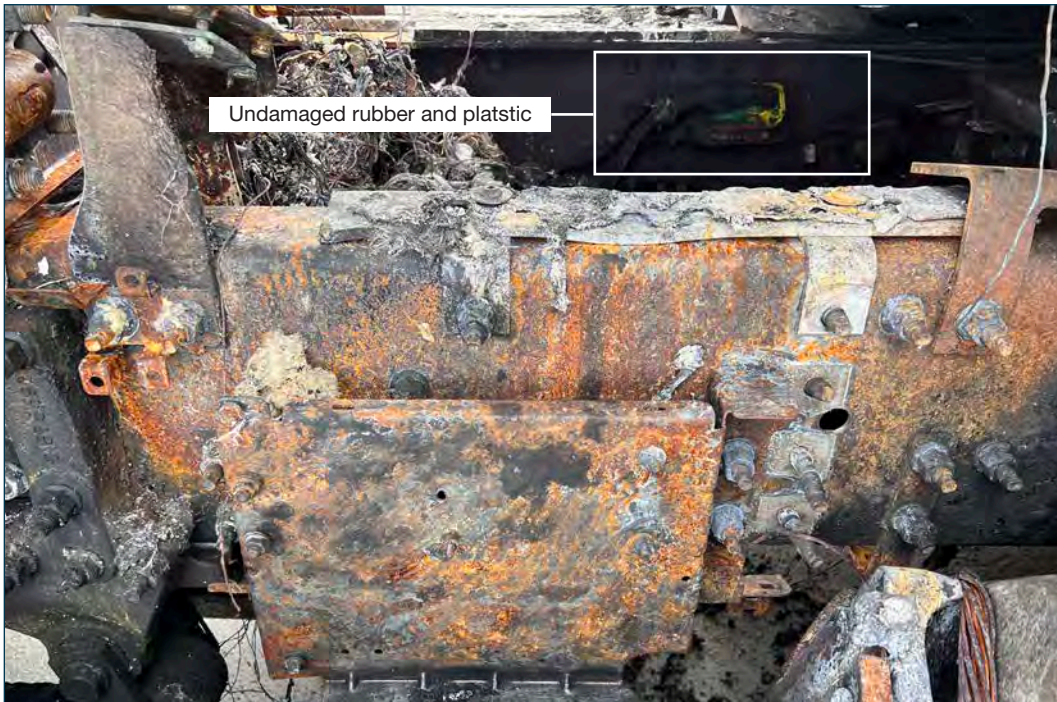
On the right-hand side of the chassis, insulation on the cables remained intact (Figure 25).

Figure 25: Undamaged plastic and rubber components on right-side chassis.  
Source: DMAIB

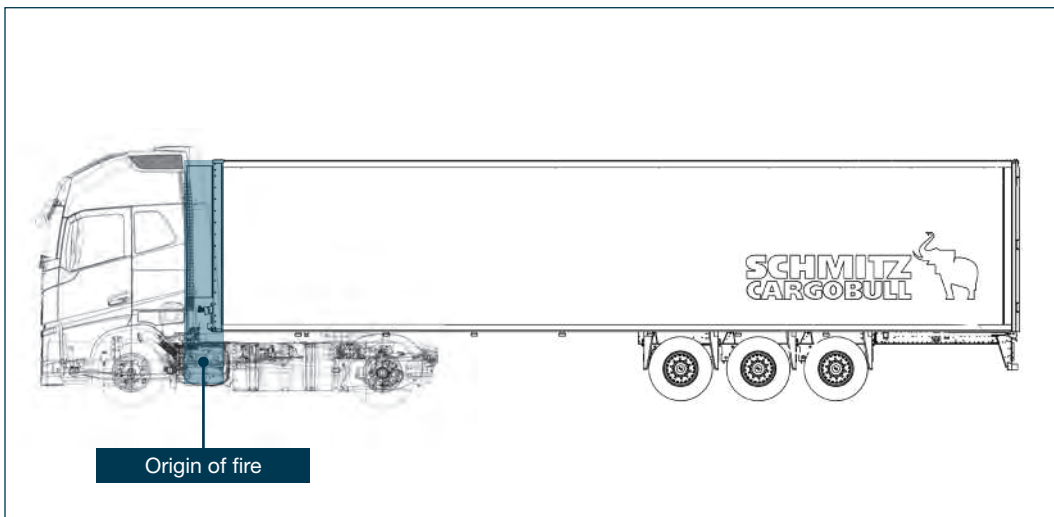
The damage and the fire pattern in the gap between the cab and the trailer showed that the highest temperatures and fire load had been present locally on the left side of the chassis by the starter battery, and that the fire had spread up and out from this point.

Consequently, the gap between the truck and trailer was the origin of fire (figure 26).

Figure 26: Origin of fire.  
Source: VOLVO Denmark/Schmitz Cargobull, modified by DMAIB

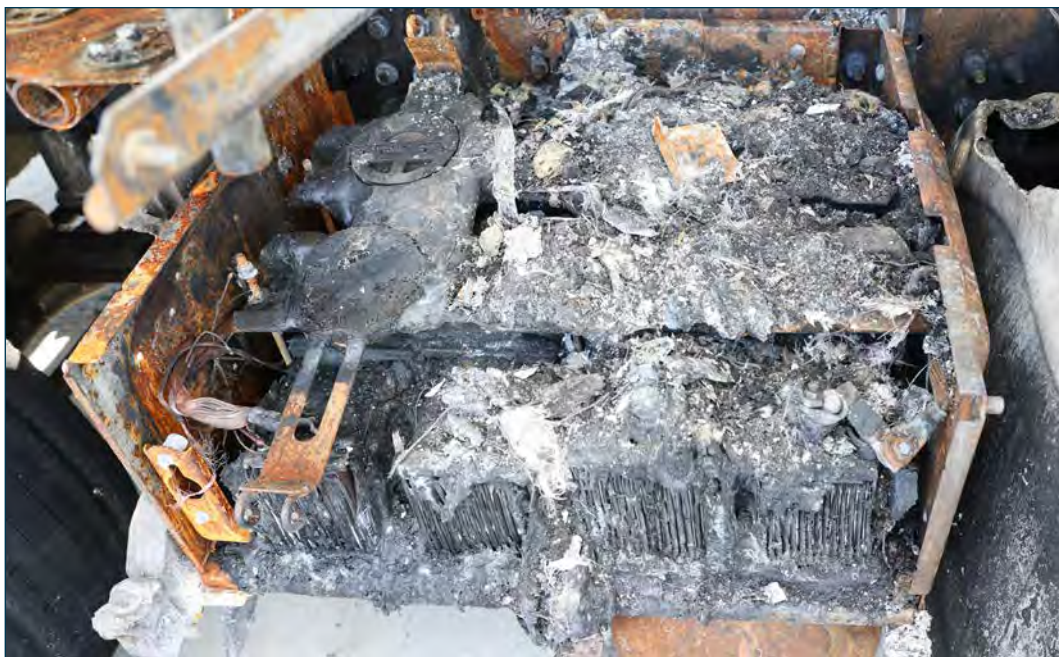
The truck's starter battery could malfunction and develop hydrogen and heat which could ignite surrounding flammable material. However, the battery was destroyed by the fire and a failure stemming from before the fire could not be observed (figure 27).

Figure 27: Damaged starter battery.  
Source: DMAIB

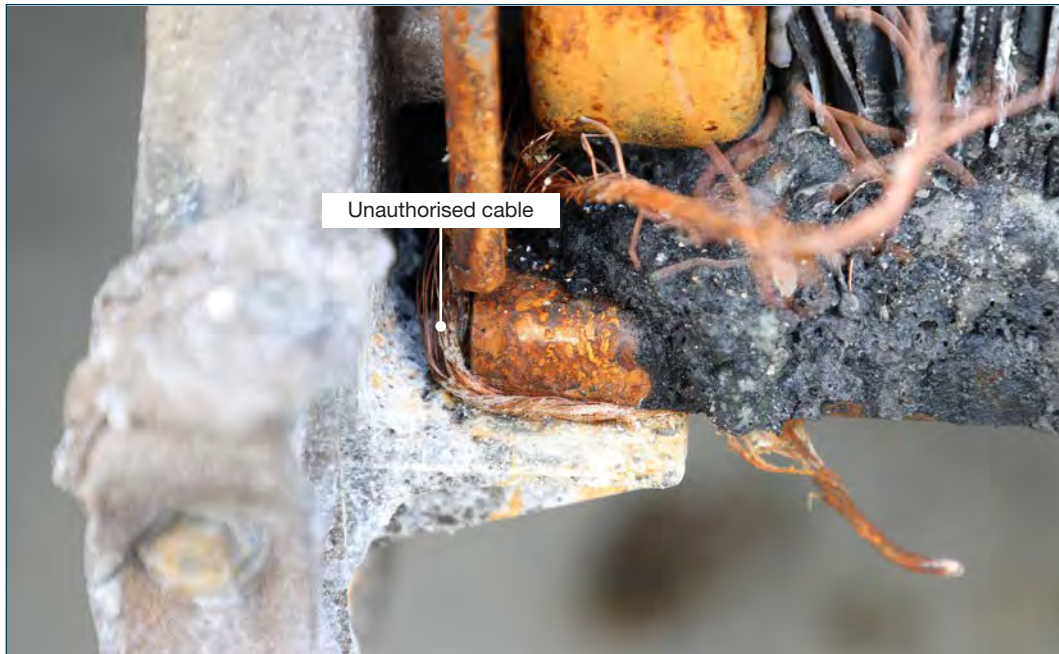
The cable of unknown origin found stuck under the battery frame indicated that an unauthorised installation had been made. The nature of such an installation could not be determined due to the extensive damage caused by the fire. No indications of a short circuit related to the fire were observed (Figure 28).

Figure 28: Unauthorised power installation.

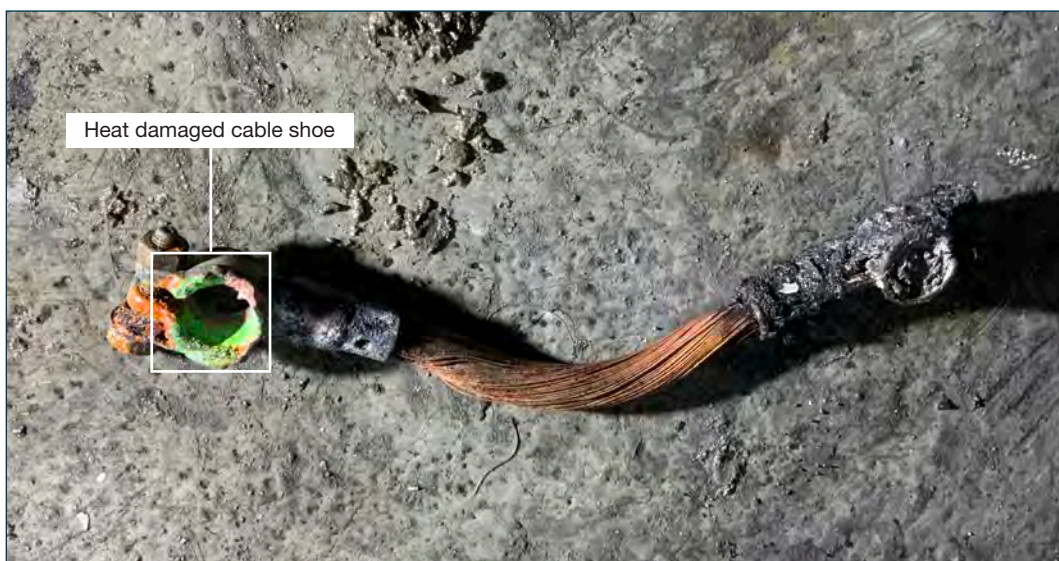
The starter battery consisted of two 12V batteries connected in series. A cable shoe on the cable joining the two batteries was affected by high temperature which could indicate a fault on the wire connection. However, it could not be determined whether this failure occurred as the primary ignition or was secondary. (Figure 29).

Figure 29: Heat damaged cable shoe on battery wire connection.

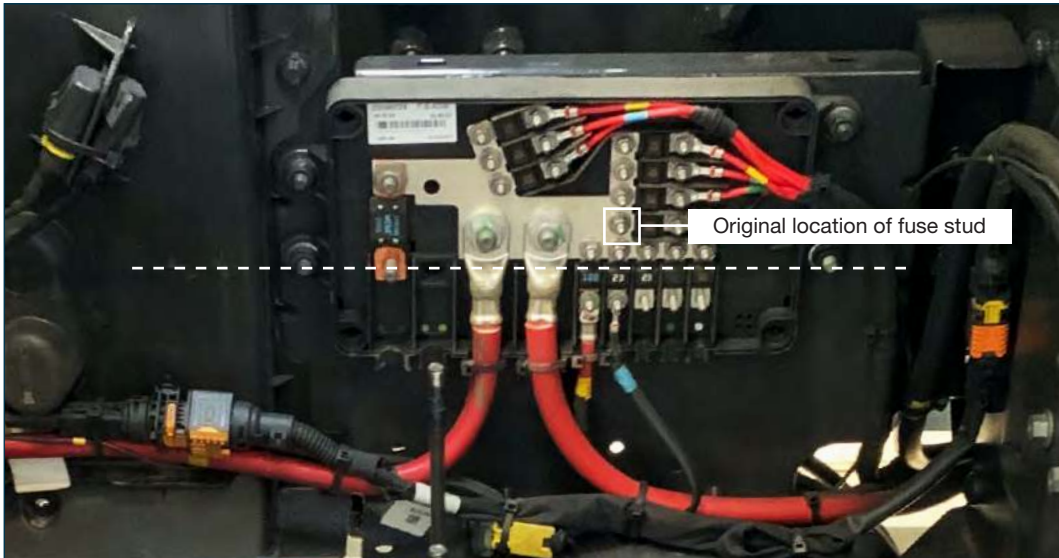
The plastic casing ensured that the conductor charged from the battery's positive terminal was isolated from the negative grounded chassis. If a breach occurred on the casing, a short-circuit electric arc could occur. As one of the fuse studs was found welded to the chassis, DMAIB found it that an arc flash had occurred due to failed insulation on the fuse box. However, it was found that the fuse stud was not welded in its original place indicating that the fuse box had been deformed by the fire and shifted its position before fuse stud welded to the steel plating (Figure 30 and 31). This means that the short circuit in the fuse box most likely was secondary.

Figure 30: Location of fuse stud  
Source: DMAIB

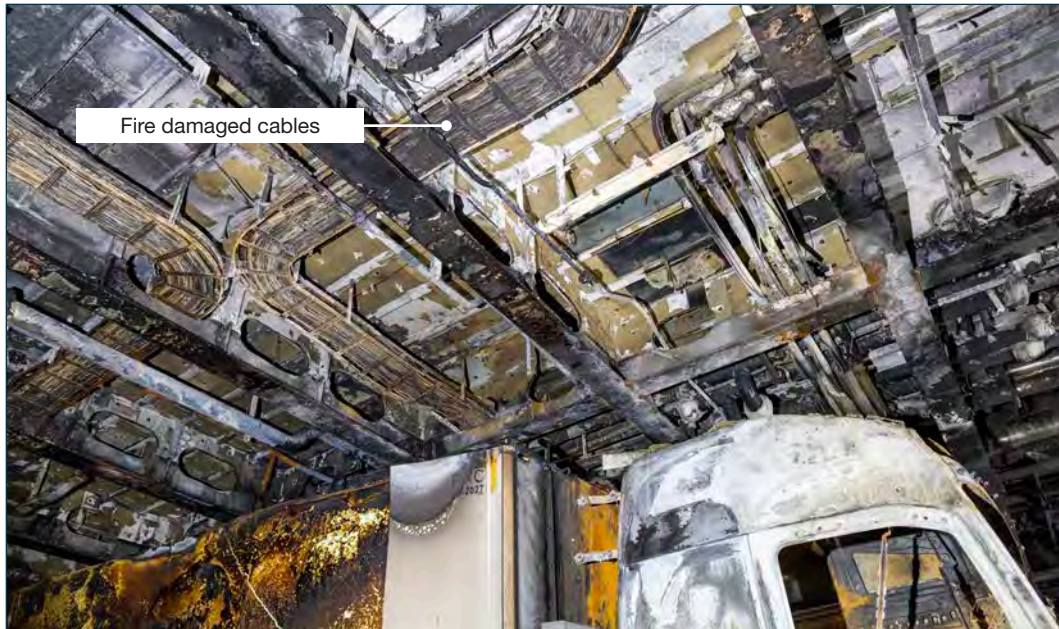
In the area above the opening between cab and trailer, soot was burned away, indicating that the deckhead was subjected to high temperatures which damaged the insulation on the cables installed in trays on the deckhead (Figure 36).

Figure 36: Fire damages to the deck head above the burning truck.  
Source: DMAIB

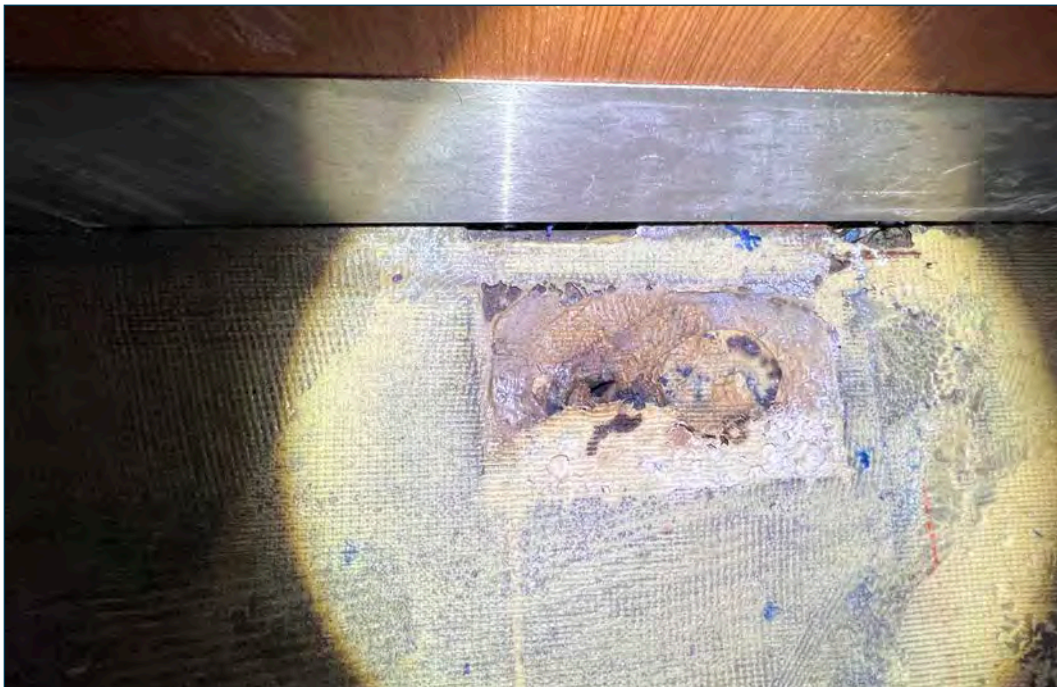
Figure 38: Heat damage to the adhesive.  
Source: DMAIB

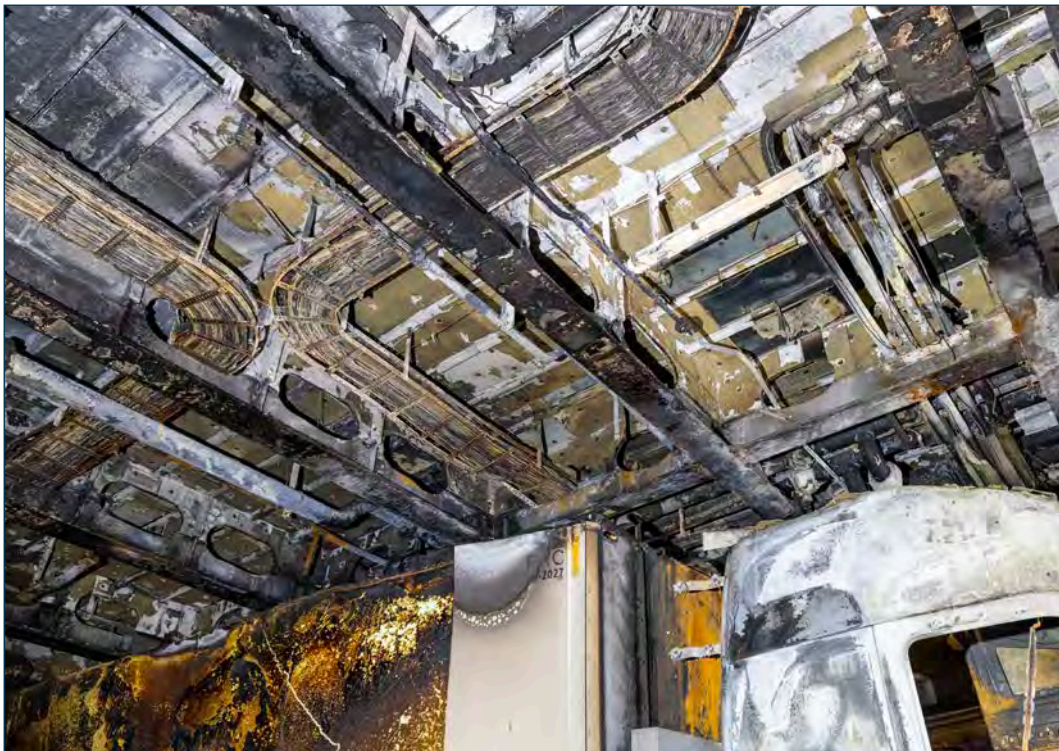
Figure 42: Burnt cable trays visible directly above the truck.  
Source: DMAIB

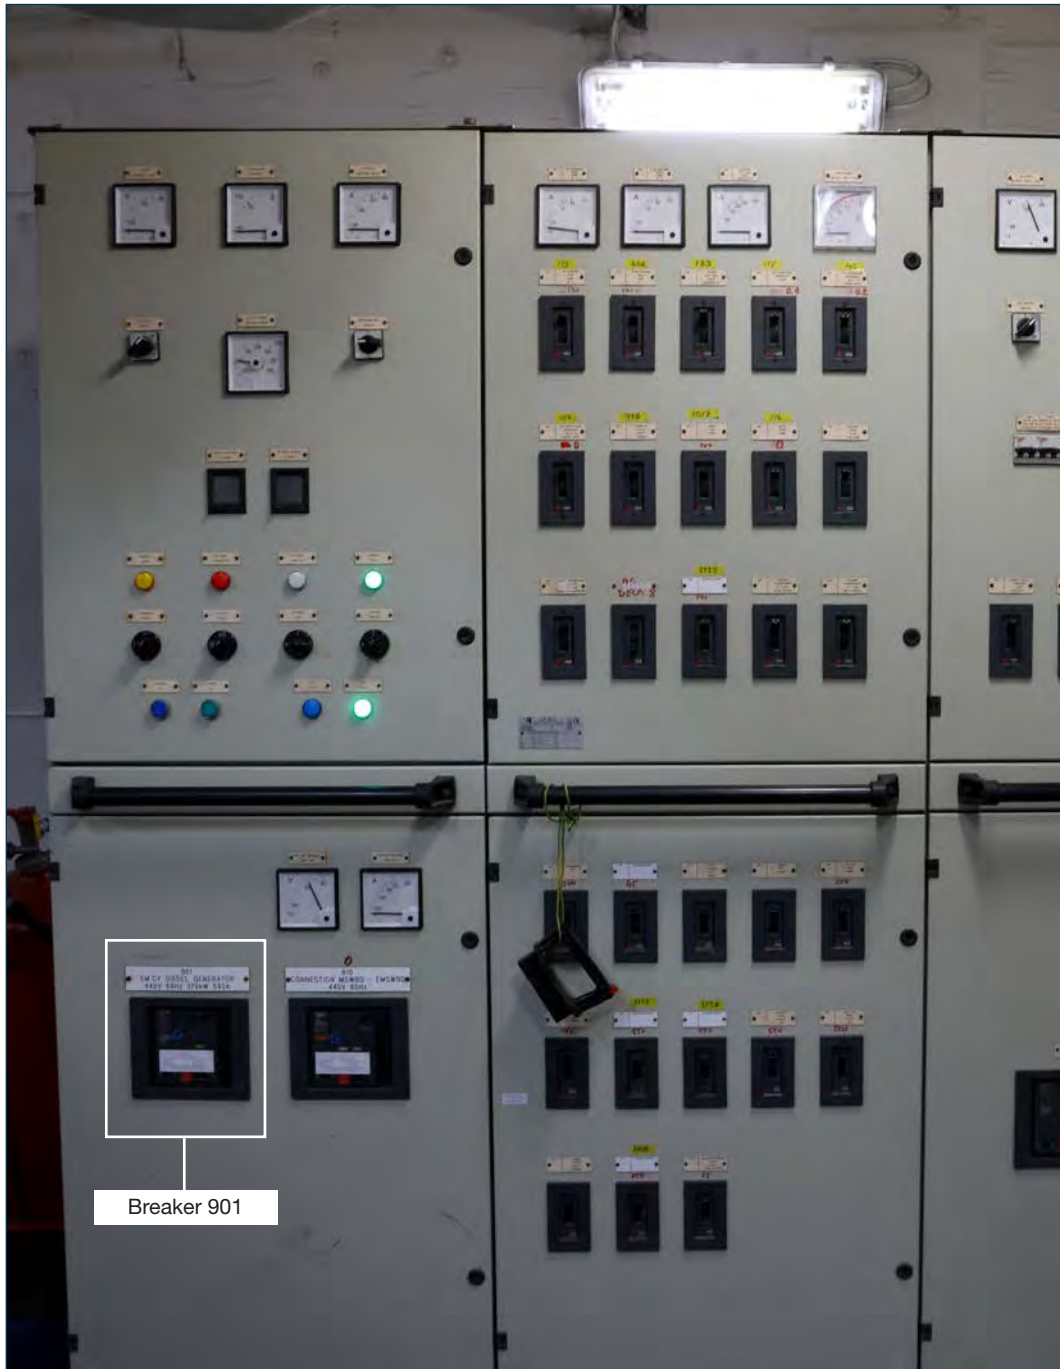
Meanwhile, the ETO had reached the emergency generator room on Deck 8. He observed that the emergency generator was running, but the breaker connecting the emergency generator to the emergency switchboard had not closed as it was supposed to and was therefore not supplying the emergency switchboard. This explained why the 24V UPS batteries were discharging. The ETO made several attempts to close the breaker, but each time the breaker tripped. While operating the breaker, he was informed on the UHF radio that sparks were coming from the cables on the deckhead on Deck 4. He rushed back to the ECR to isolate additional services and to discuss the issue of the tripping breaker with the chief engineer.

Figure 49: Breaker 901 on the emergency switchboard for emergency diesel generator.  
Source: DMAIB

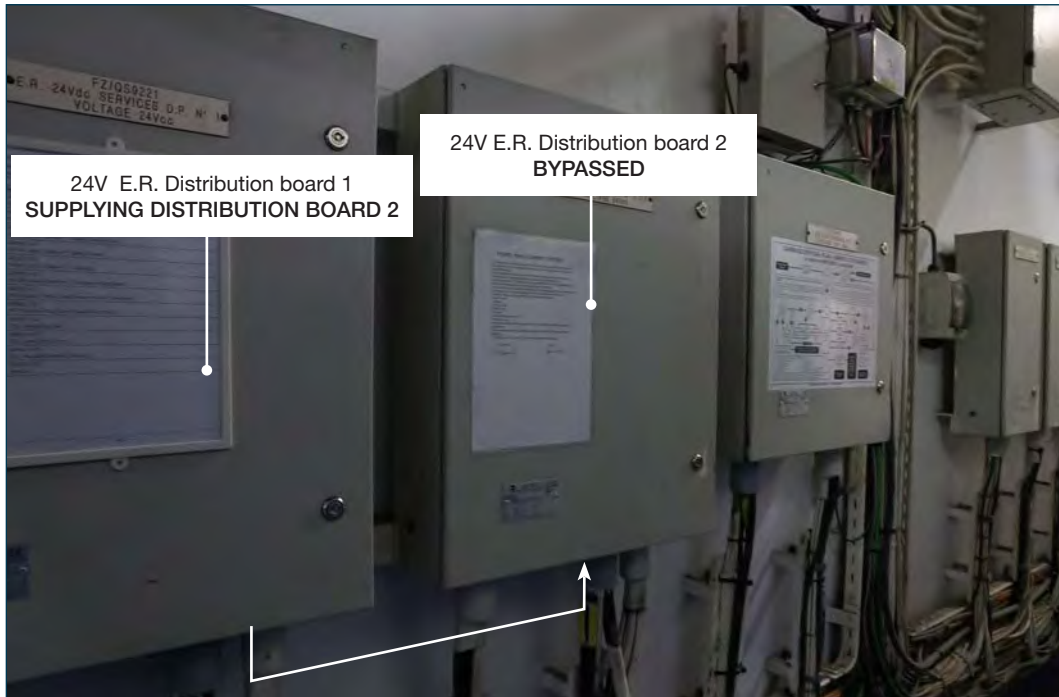
Figure 53: Distribution board for 24 V services in engine room bypassed.  
Source: DMAIB

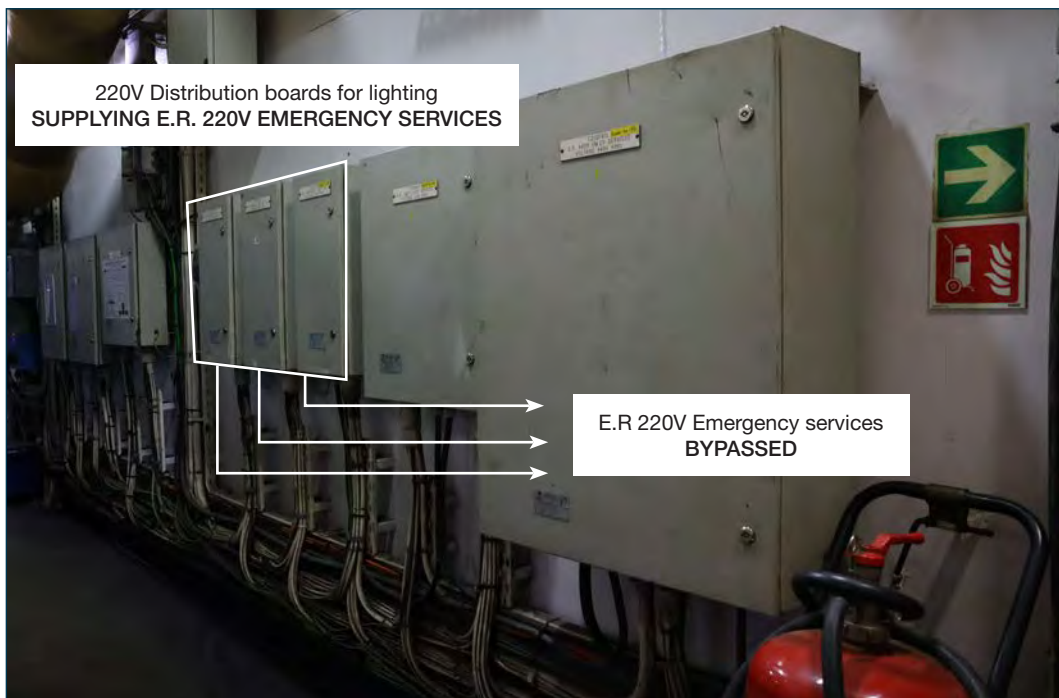
Figure 54: Distribution board for 220V emergency services in engine room bypassed.  
Source: DMAIB
