SAFETY INVESTIGATION REPORT

REPORT NO.: 12/2023

July 2023

MT *SUNNY ISLES* **Fatal injuries to a crew member** **in the steering gear room,** **in position 21° 46' N 059° 58' E** **18 July 2022**

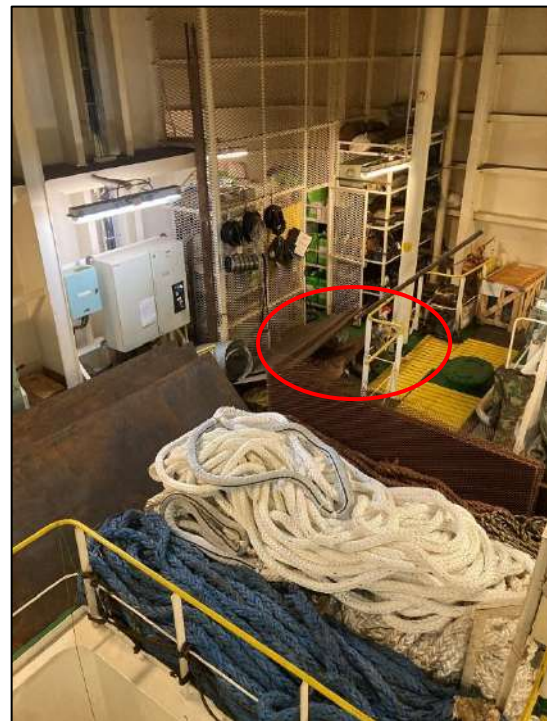
The fitter and MM 1 did not find the appropriate pipes for the task, and as they were leaving the steering gear room, MM 1 noticed a stack of spare steel plates resting against the guard rails at the starboard side of the steering gear. As he moved closer, he saw the second engineer trapped between the stack of plates and the guard rails (Figures 3 and 4)⁵.

Figure 3: Simulated photograph of the location at which the second engineer was found (red circle)

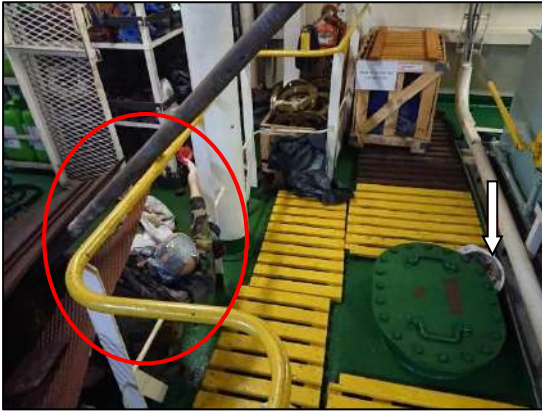
Figure 4: Simulation of how the second engineer was found (red circle); the second engineer's safety helmet can be seen near the manhole, to the left (white arrow)

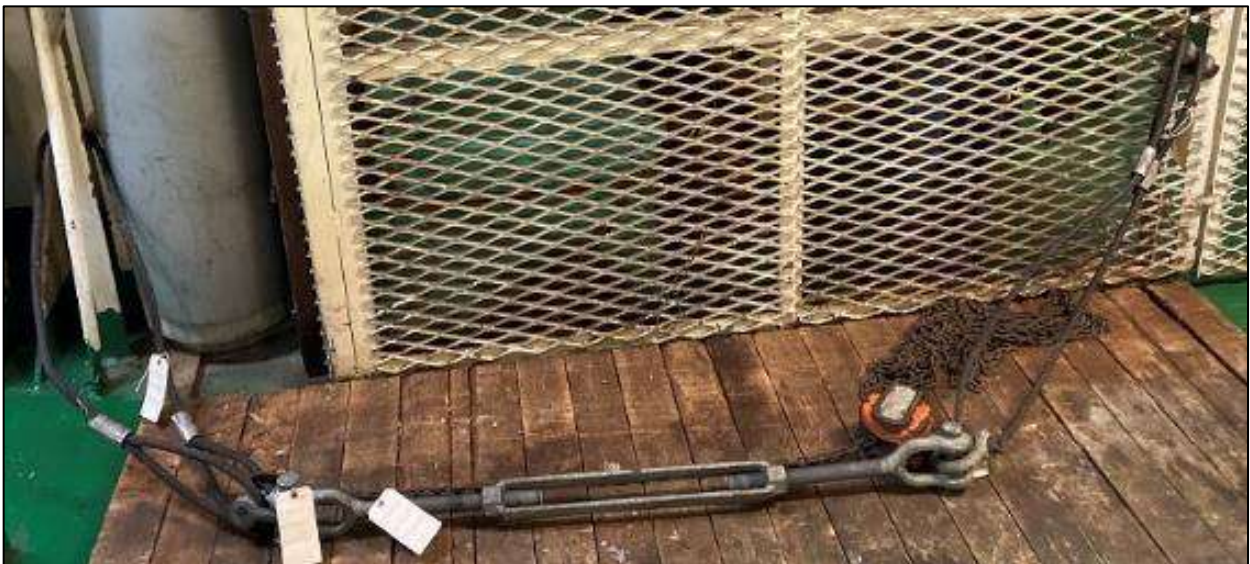
The arrangement (**Figures 5 and 6**) consisted of two wire slings, secured to the vessel's fittings, and connected by a turnbuckle across the face of the plates. A chain block was also connected to the wire slings, across the face of the steel plates.

Figure 5: Simulated photograph of the securing arrangement

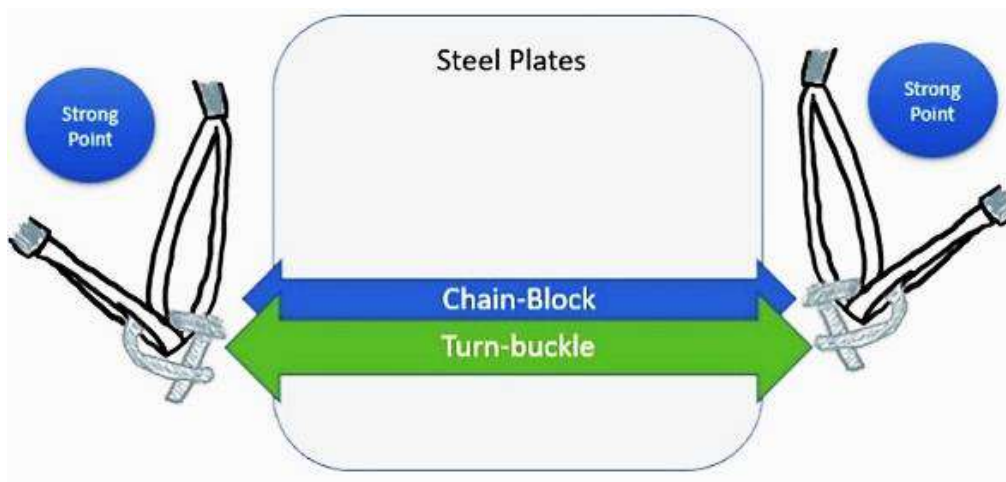
Figure 6: Sketch of the securing arrangement

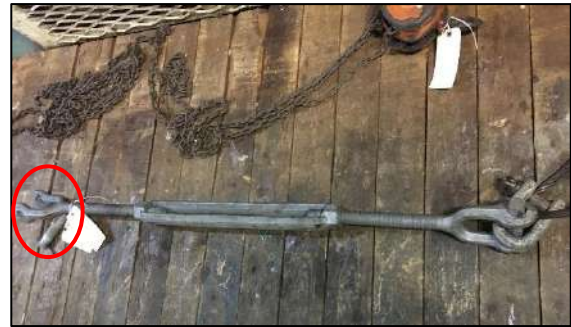
The crew members stated that, after the removal of all steel plates from the accident site, they found the turnbuckle and the hook at the running end of the chain block, released. They further found the pin at the released end of the turnbuckle not in place (**Figures 7 and 8**). The split pin⁷ (red arrow in **Figure 8**), which was designed to prevent the turnbuckle pin from slipping out, was found in the vicinity, intact but not in its place. No damages were observed on any part of the securing arrangement.

Figure 7: Photograph of the turnbuckle with the securing pin out of place at one end (red circle)

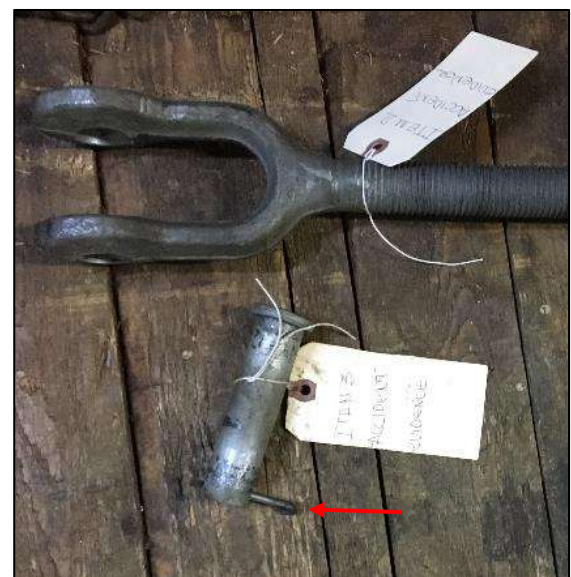
Figure 8: Close-up photograph of the turnbuckle with the securing pin (red arrow: split pin in place)

The crew members stated that they had found the split pin lying in the vicinity⁹, and its ends were found pressed together, thus suggesting that the split pin may have either been removed by the second engineer or slipped out at some point.
