**The Bahamas**  
Maritime Authority

# Marine Safety Investigation Report

into a fumigant poisoning fatality on board mv  
Jupiter on 17 May 2022

Date of Issue: 25 May 2023  
Bahamas Maritime Authority  
120 Old Broad Street  
LONDON  
EC2N 1AR  
United Kingdom

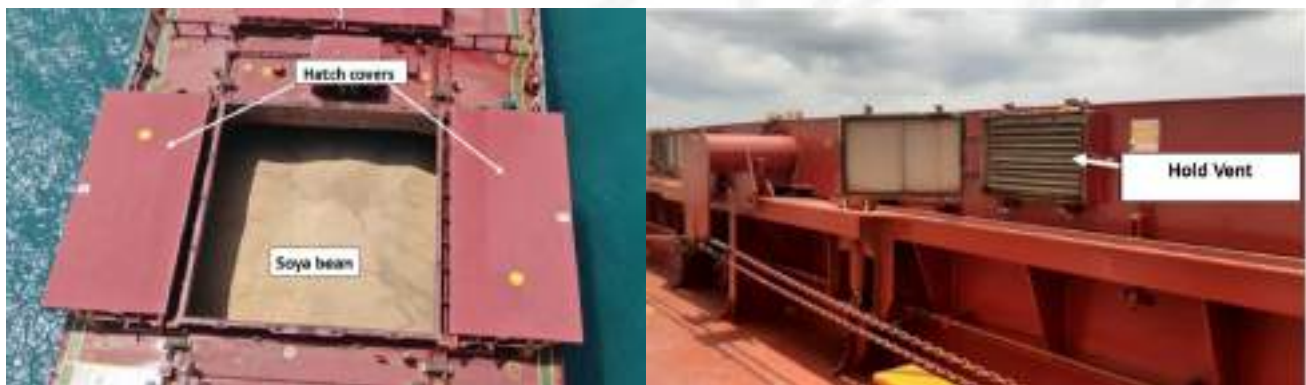
On completion of the fumigant application to all seven cargo holds, the hatch covers were secured for sea, danger signs affixed to the side of the hatches and the hold vents closed and covered over with plastic to prevent water ingress whilst on passage. All holds were to remain sealed for ten days, before the hold vents could be opened to start the ventilation and aeration process. (Figures 1&2).

Figure 1. Aerial view of No.6 cargo hold and hold vent

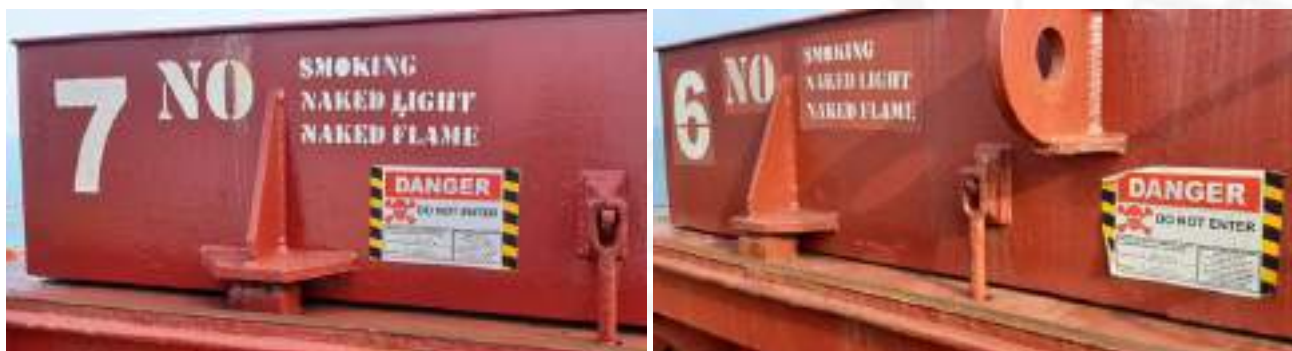
Figure 2. Danger signs affixed to sides of cargo hatches

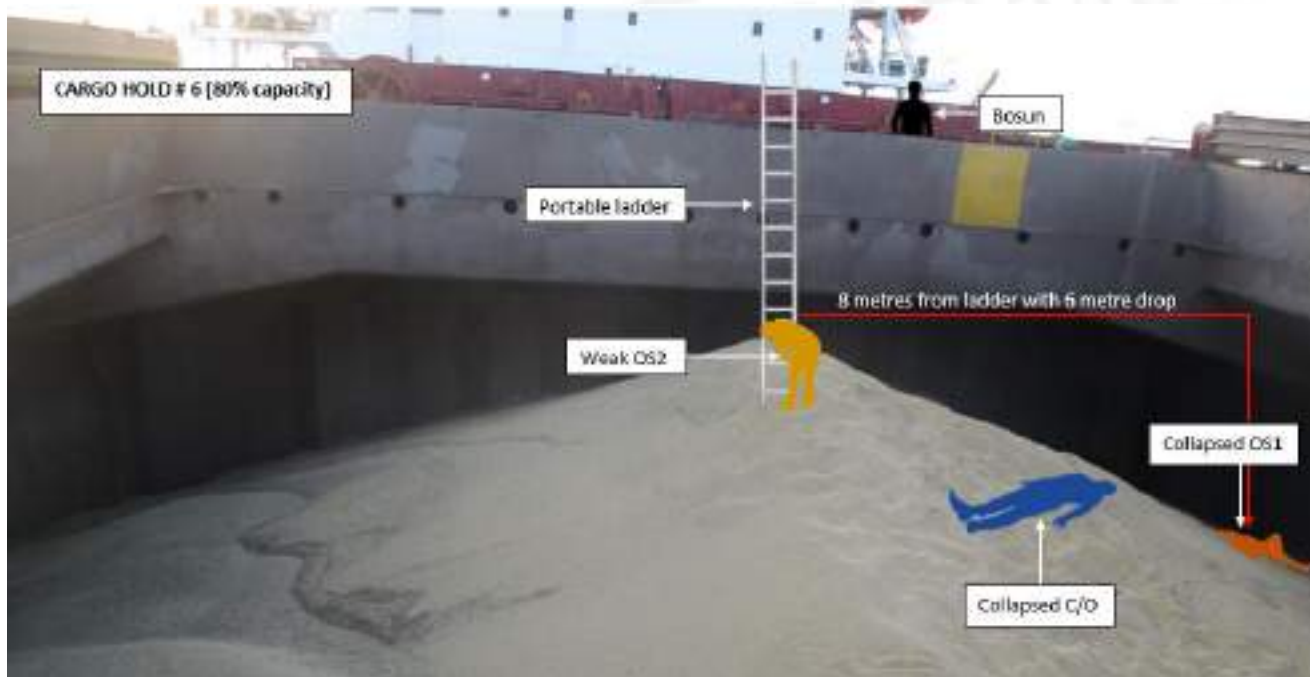
During this time OS1 fetched a portable ladder as hold 6 was only 80% full and therefore access could only be gained with the use of a ladder, when placed inside the hold resting it on the highest point of the soya bean and positioning it against the coaming of the hold (Figure 3).

**Figure 3. Positioning of crew inside cargo hold 6 at time of casualty**

At 10:45 OS1 made his way into hold 6 and shortly after OS2 arrived at the opening and dropped the two buckets into the hold, one of which rolled down the slope of the soya bean in the hold, before then making his way inside the hold via the ladder to join his colleague. OS1 made his way down to the port side to fetch the bucket that had rolled down and collapsed.

OS2 who had now entered the hold was making his way aft, when he observed that his colleague had collapsed and immediately called for help. OS2 started to feel weak, breathless and nauseous, and made his way back to the base of the ladder. When the chief officer heard OS2's calls for help, he notified the master of the emergency and requested assistance, before then making his way into hold 6, and headed straight to OS1 to help. The master summoned the third officer to gather a rescue team and attend to the emergency.

Shortly after arriving beside OS1, the chief officer struggled to offer assistance or pull OS1 clear to the middle of the cargo hold, and was struggling to breathe, and called out for help from OS2, before managing to make his way back towards the centre of the hold where he collapsed, complaining of chest pains, struggling to breathe and see clearly.

On hearing the calls from the chief officer and OS2, the bosun who was removing the hatch cleats on cargo hold 7 arrived on scene and immediately called for the AB to fetch two sets of breathing apparatus and notify another AB to bring additional crew to help with recovering the crew inside hold 6 (figure 3).

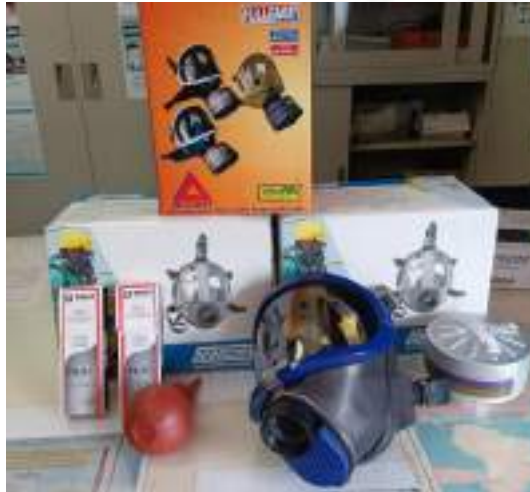
The fumigation contractors identified a TLV of 0.3 parts per million (ppm) and provided safety equipment for detecting phosphine in the accommodation and gas masks for use when crew might be exposed to phosphine (such as when opening the holds for ventilation). The gas detection equipment provided was of the colorimetric tube type: detection tubes had to be opened and inserted into a pump and the air sampled by manually operating the pump to draw air through the tube. Discoloration of the tube indicates the presence of the gas.

The equipment came with a clear message in the safety booklet: **do not enter fumigated holds.**

Figure 4. Safety equipment supplied by the fumigation contractors at Paranagua
