ANNUAL DIGEST

CHIRP

2023

Annual Digest of Reports and Insight Articles 2023-24

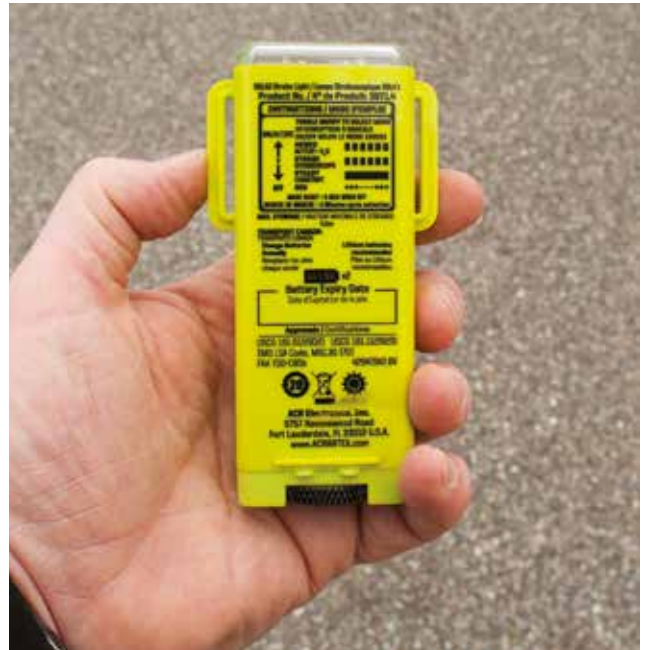
A typical personal locator beacon (PLB)

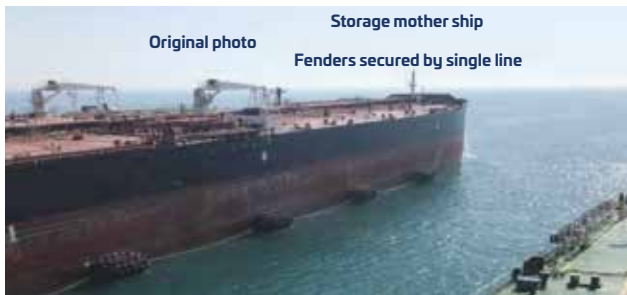
Our reporter sent a photo of a storage ship with incorrectly rigged fenders, noting that a failure of any of the fender's securing lines will lead to a failure of the complete fender protection system.
