SAFETY DIGEST

Lessons from Marine Accident Reports

1/2024

MARINE ACCIDENT INVESTIGATION BRANCH

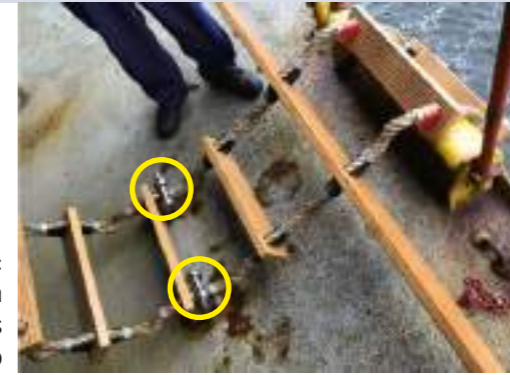
Approximately 50% of all pilot ladder incidents reported to us in 2023 involved the same three deficiencies as those reported during 2022 (Figure 1), the leading deficiency once again being pilot ladders secured using shackles over the side ropes (Figure 2). Also known as 'choke shackles', this arrangement brings the entire weight of the ladder onto one step, which is not designed to take a weight that should be borne by the side ropes. As in 2022, the next most common deficiencies were the ladder being in poor condition or having no or incorrect stanchions (Figures 3 and 4).

Figure 2: A pilot ladder reported in 2023, showing the shackles against the step

- Inspect** → Examine the ladder at regular intervals and before each use to identify damaged or degraded parts and replace it as necessary. Make sure there are sufficient spares of a suitable quality on board.
- Check** → Secure the ladder to strong points using manila rope tails tied in a rolling hitch around both side ropes. Do not use shackles to secure the side ropes.
- Check** → Make sure the stanchions at the top of the climb allow the pilot to gain a firm grip during the transition between deck and ladder.
- Confirm** → Test the ladder to be certain it remains secure when weight is applied. Pilots are not always able to check this themselves, particularly during inclement weather.

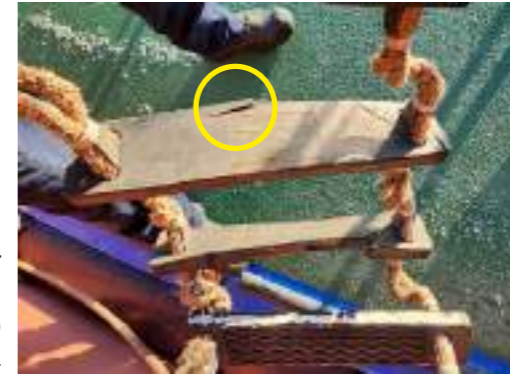
Figure 3: Cracked, warped rubber steps and worn side ropes. The ladder also appears to have been painted

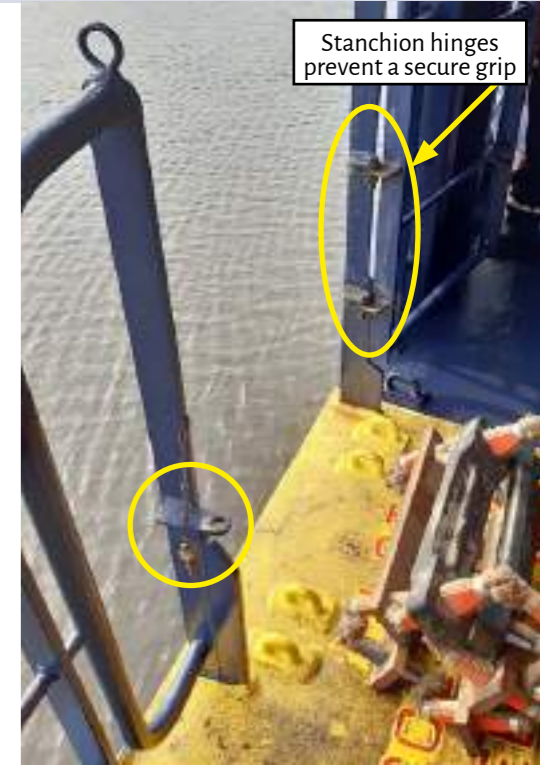
Figure 4: An access gate without suitable stanchions for the pilot to gain a secure grip

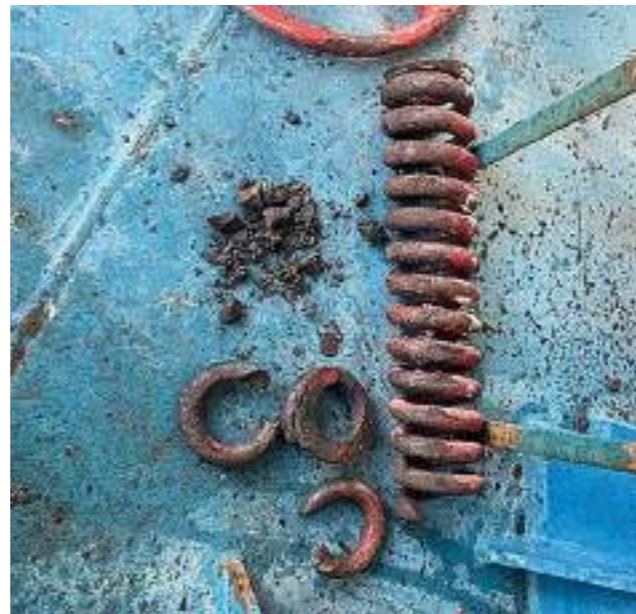
Once the ferry was safely alongside, an examination of the anchor cable brake assembly found that the spring (Figure 2) inside it had fractured in several places and rendered the brake inoperable. The company's technical supervisor was on board at the time and a temporary solution was soon agreed with the classification society and the port authority. The ferry's crew and passengers were uninjured during the incident and there was no other material damage.

Figure 2: The broken anchor cable brake spring

- Equipment** → Corrosion inside the anchor cable brake assembly led to pitting on the spring, which became the initial point of fracture. The routine exposure of equipment to the elements increases its risk of failure and regular checks and maintenance are essential to prevent this.

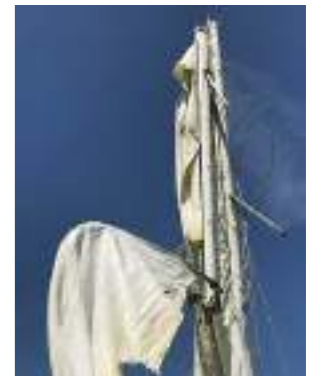
The yacht scraped along the port side of the dredger, damaging its masts and sails as it did so (see figure), but fortunately remained afloat. The dredger's crew rendered assistance before the yacht made its way back to port.

Figure: The damage

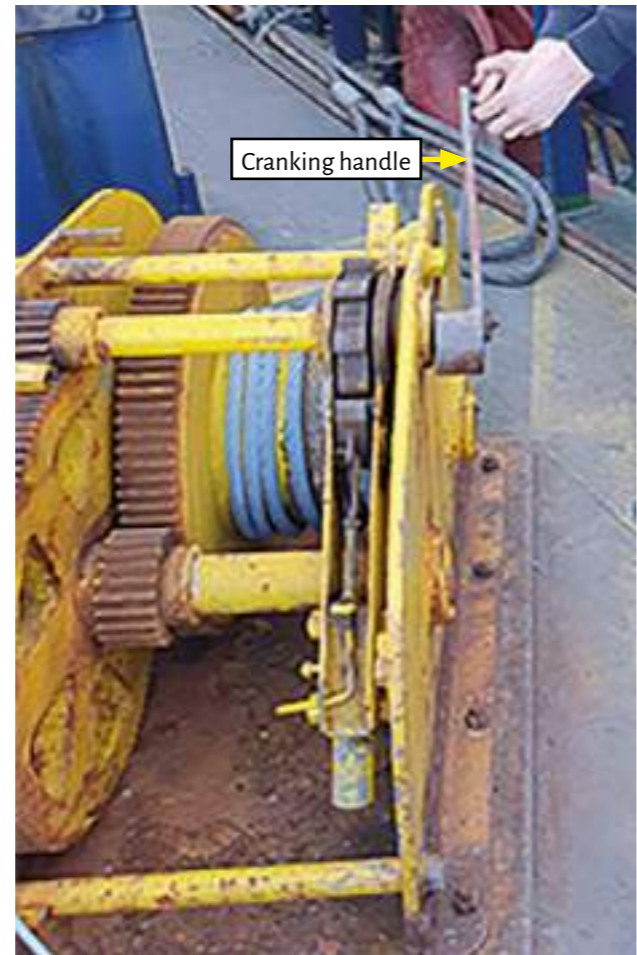
When the winch brake was released the tension in the line connected to the cargo barge caused the winch drum, and still attached cranking handle, to spin uncontrollably. The spinning cranking handle violently struck one of the crew members, fracturing their wrist and inflicting significant pain (Figure 2). The crew member was evacuated from the tug by a Royal National Lifeboat Institution (RNLI) lifeboat and

Figure 1: The coupling winch and removable cranking handle

1. **Risk** → The pusher tug's crew might have identified the risk posed by the hazard of the still attached cranking handle had they collectively taken a moment to undertake a dynamic risk assessment rather than rush to complete the task. Empowering crew to identify hazards, assess the risks involved and report their concerns contributes to a proactive on board safety culture and reduces the likelihood of accidents.
2. **Monitor** → The master could not safely undertake the simultaneous tasks of steering the pusher tug and trying to control the aft deck operations from a position of limited visibility. The use of the closed-circuit television (CCTV) to provide operational oversight from a remote position can help to identify any safety issues and take immediate preventative action.

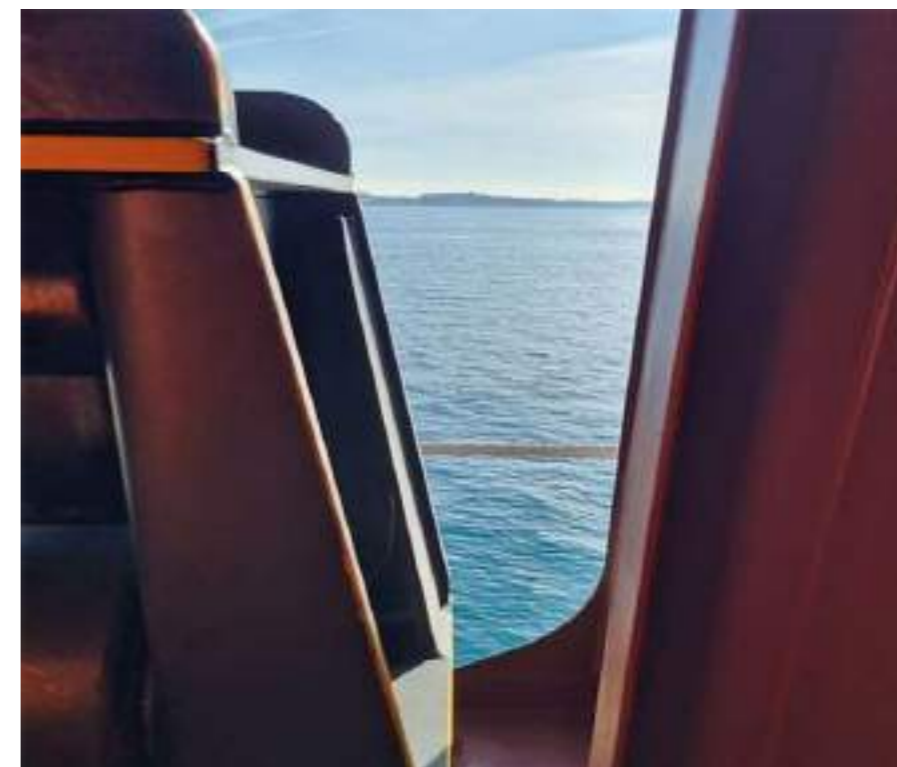
Figure 1: The unguarded opening at the time of the incident

1. **Hazard** → The unguarded opening in way of the mooring line fairlead seemed an obvious hazard after the accident and with the benefit of hindsight. However, it had remained unidentified throughout the ship's design phase, in the course of day-to-day operations, and during surveys and audits. Any work conducted near a vessel's side should include an assessment of the hazard of falling overboard before starting the task.

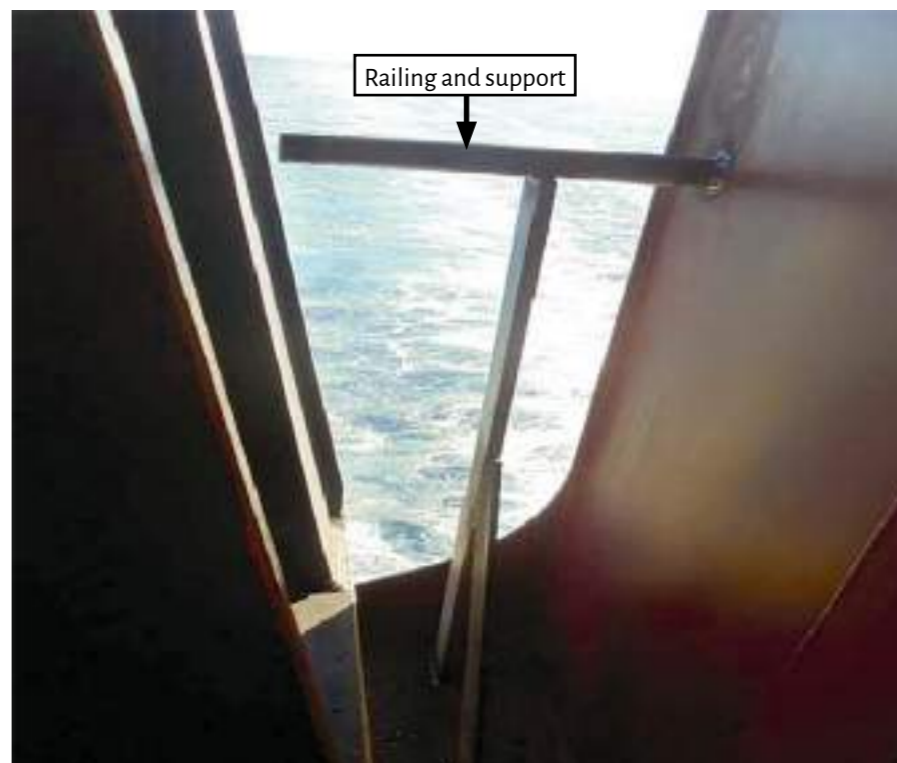
The company's subsequent accident investigation identified the hazard of the unguarded opening and took swift remedial action to fabricate and install a railing and support to mitigate the risk (Figure 2). The company also issued a fleetwide safety bulletin to highlight the accident, and required each vessel to undertake an immediate mooring area hazard assessment to prevent similar incidents in the future.

Figure 2: The guarded opening following remedial action

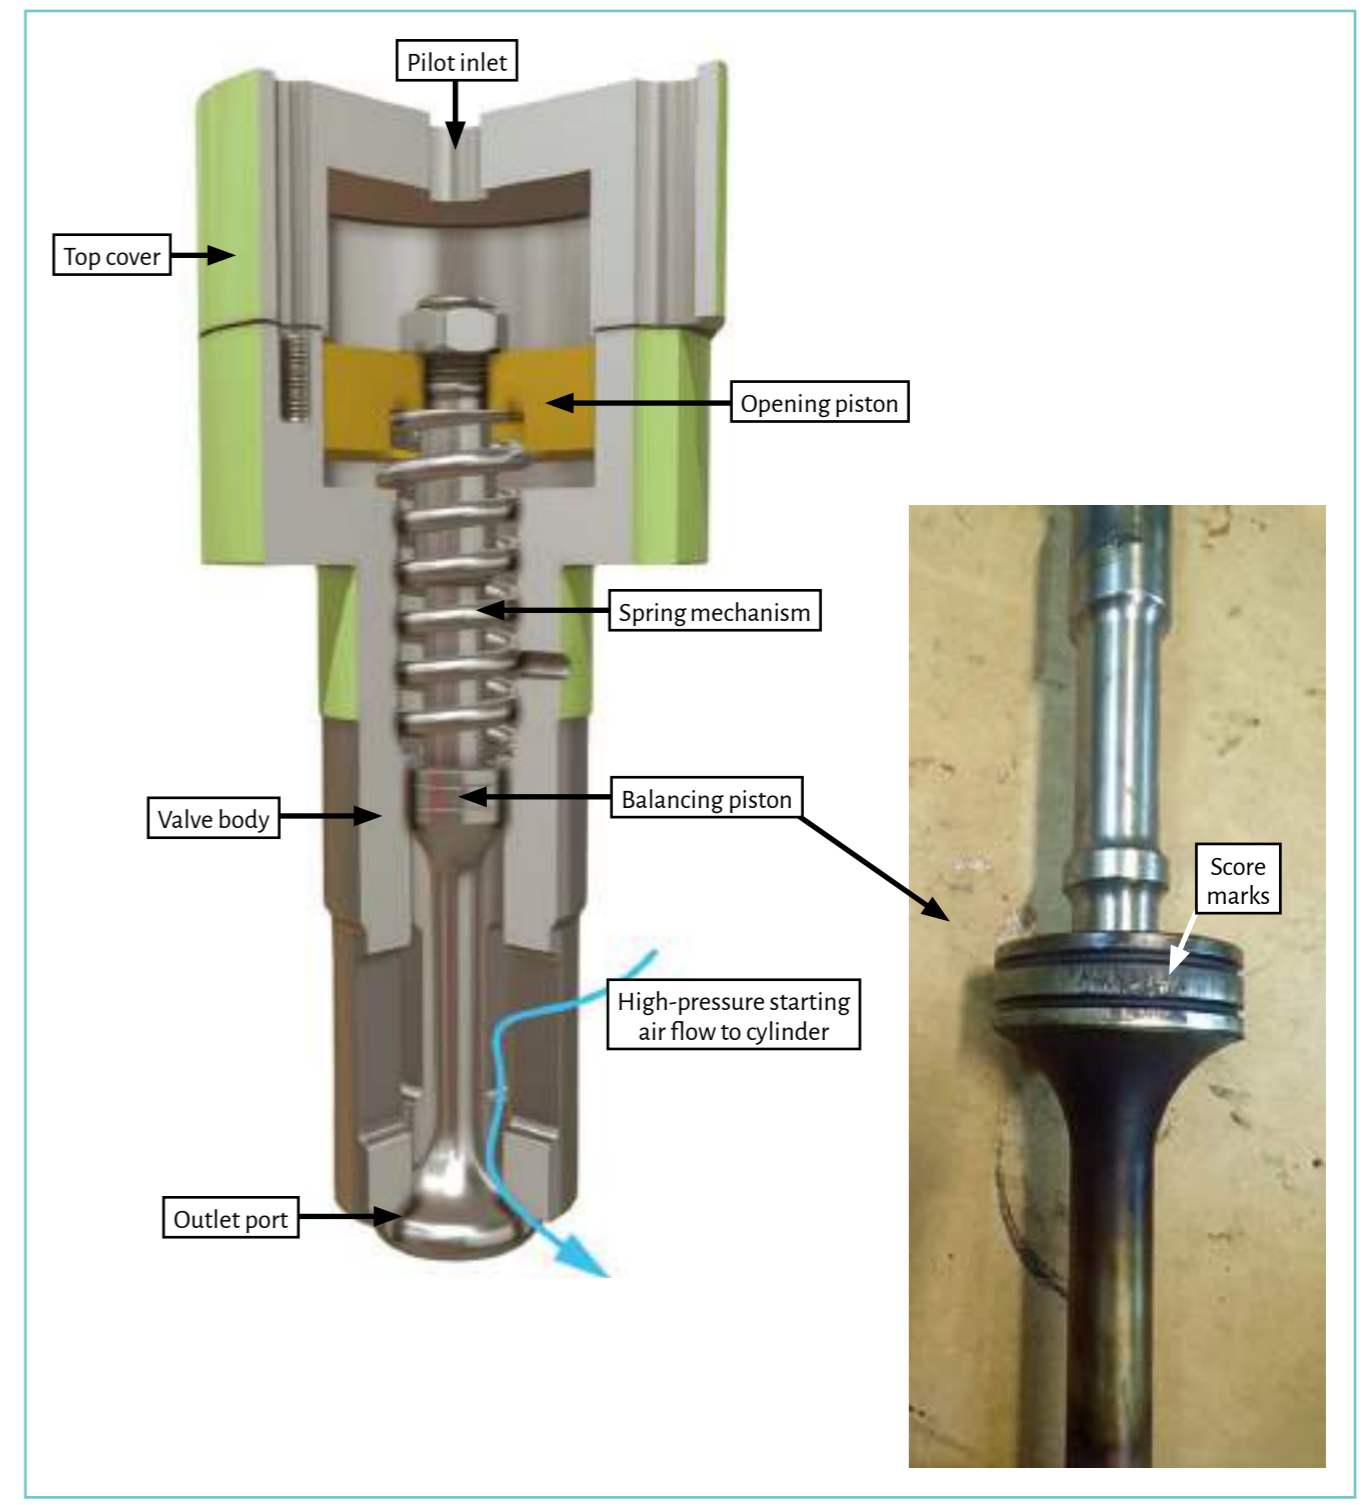
Disassembly of the air start valve found that cylinder combustion gases had leaked into the body of the air start system and scored the balancing piston, causing it to overheat and seize (see figure). The valve was replaced with a spare carried on board, after which the engine was tested and was once more able to run both ahead and astern.

- Hazard** → Air start valve leakage presents a considerable risk. While the failure in this case prevented the engine from starting, leakage of hot combustion gases into the air start system introduced the risk of a starting air system explosion. Early detection and remedy is vital to maintain a safe engine room environment and prevent devastating consequences.

Figure: Cross-section of an air start valve and (inset) the seized balancing piston

- Risk** → The failure of a single component in the air start system led to a significant hazard for the ship. Such failures can have serious consequences, and it is vital to identify potential hazards and implement measures such as checks and proper maintenance to ensure reliability.

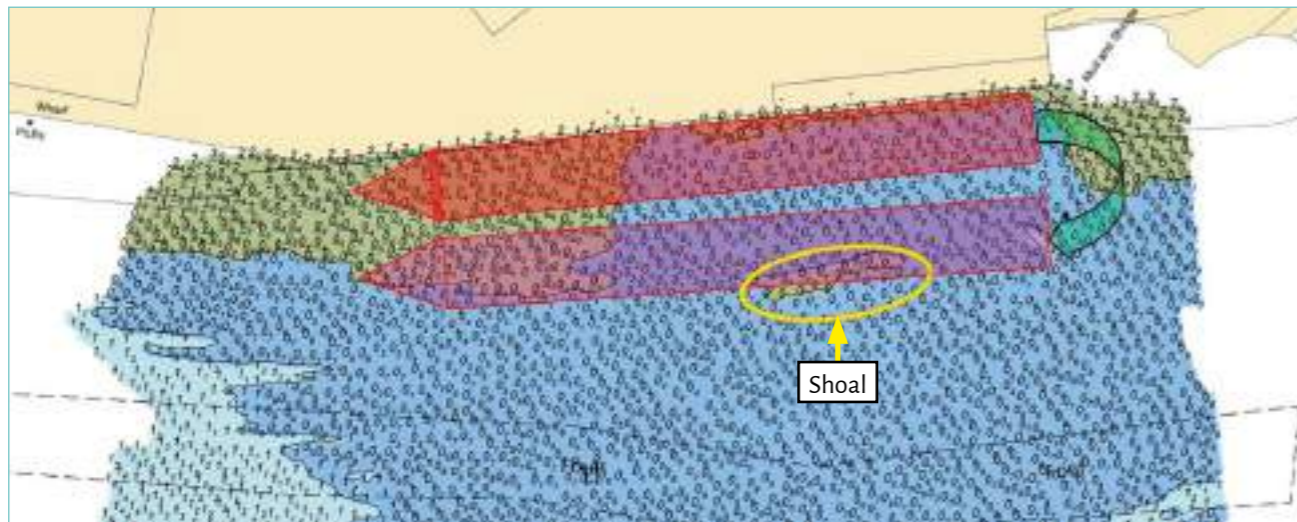
Following some rapid hydrographic survey work it became clear that the slope of the riverbed at the NAABSA berth had changed. The mud was now on an incline and was serving to draw ships away from the quayside. The resulting strain on the mooring lines was too much when the vessel settled aground. On parting, the mooring lines snapped back some 40m at their greatest extent. Dredging quickly resolved the primary cause of this accident by levelling off the riverbed adjacent to the quay.

Figure 1: The cargo vessel resting on the shoal

1. **Monitor** → For a NAABSA berth to be safe to use it needs to be flat and without any significant incline. A riverbed can easily change its profile following heavy rain, extended dry periods or due to significant building works either up or downstream. Regular surveys of the berth area are necessary to determine the profile and depths and whether any debris is present that might cause a hazard. The last survey in this case had been carried out 6 months before the incident but there had been heavy rainfall in the intervening period.

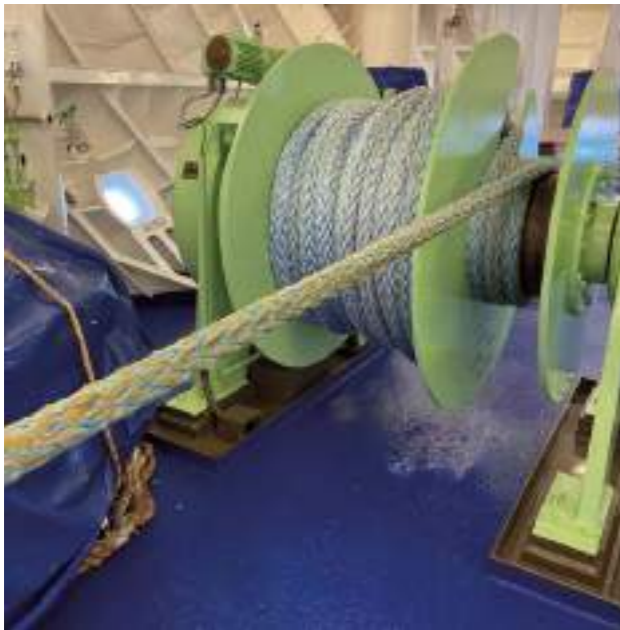
A cruise ship was being prepared for departure from a Caribbean port and an able seaman (AB) was working on the mooring deck, using a messenger line around the mooring rope to guide it onto a winch drum (Figure 1). A deckhand was operating the winch remotely, and with limited visibility of the AB's position near the drum, when the messenger line suddenly snagged under the mooring rope and became wound onto the winch drum itself.

Figure 1: The winch drum

1. **Margin of safety** → Exercise caution around moving machinery. Avoid getting too close to rotating equipment and ensure that loose clothing or any objects that can become caught in it are kept clear. The long messenger line used to guide the mooring rope was able to reach the deck and wrap itself around the AB's leg, leading to the accident. Maintaining a safe distance from the winch drum is essential to prevent such incidents.

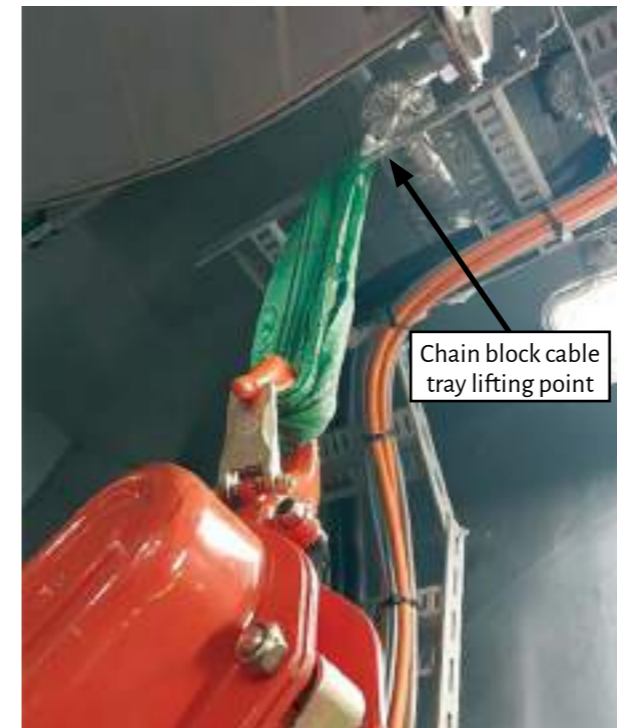
Post-incident examination of the lifting arrangements found that only one of two 980kg working load limit deckhead fixed rings had been used, along with lifting attachment points to a cable tray (Figure 2) and a pipe bracket. Additionally, the chain blocks used for lifting the

Figure 2: The cable tray lifting point

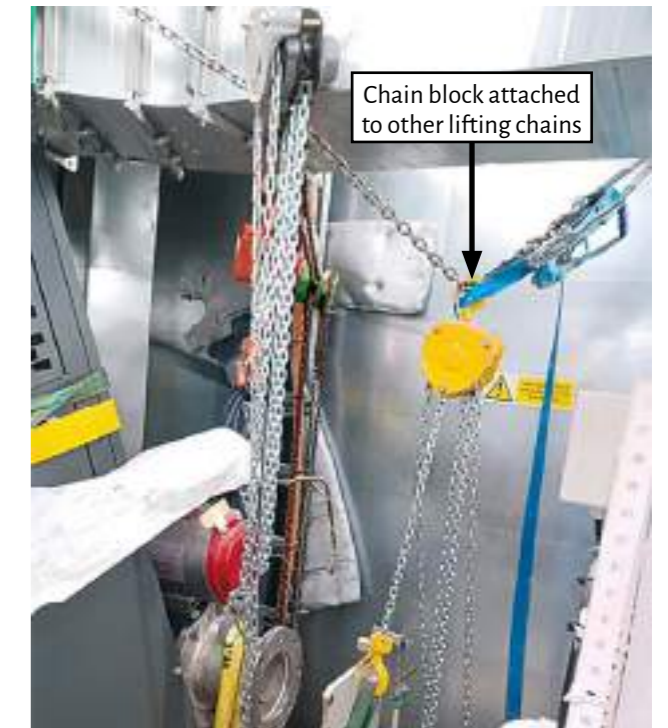
aft end of the compressor were hooked on to the chains of other chain blocks (Figure 3). The steel bars did not have any spreader arrangements and the wide forklift truck 'lifting slots' allowed movement of the bars.

Figure 3: The lifting arrangements

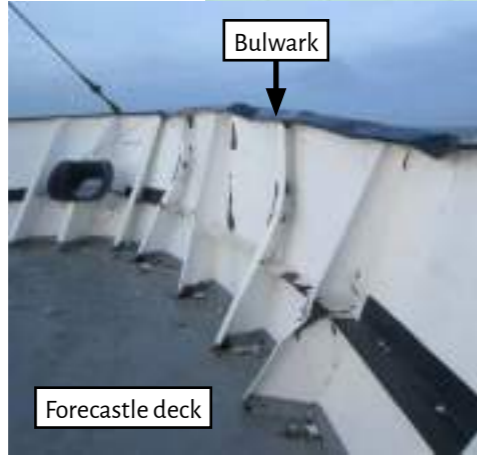
The cargo ship sustained damage to its foredeck bulwarks (Figure 2) and the LNG carrier incurred minor scrapes to the ship's side. Fortunately, only the C/E's pride was hurt.

Figure 2: Damage to the bulwark

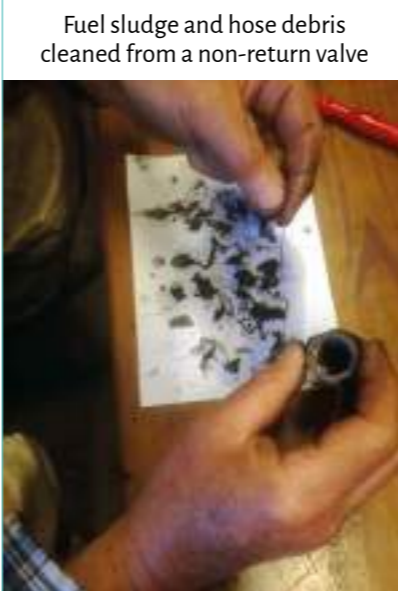
Realising that the vessel was being set towards danger, the skipper called for assistance. The heritage vessel was later towed to a nearby harbour where the main engine and generator were stripped down and examined. Many of the fuel system's flexible hoses were found to have degraded, resulting in flaps of rubber detaching from the internal walls and acting like non-return valves. Fuel sludge had also clogged the pipework throughout the engine and generator systems (see figure).

Fuel sludge and hose debris cleaned from a non-return valve

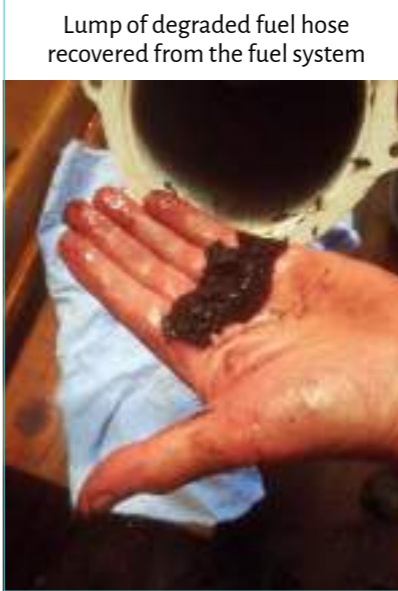
Lump of degraded fuel hose recovered from the fuel system

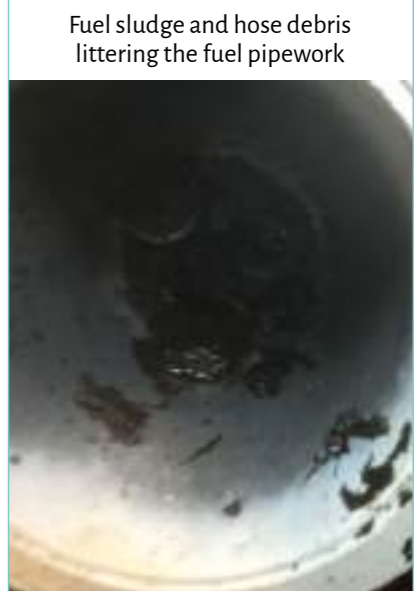
Fuel sludge and hose debris littering the fuel pipework

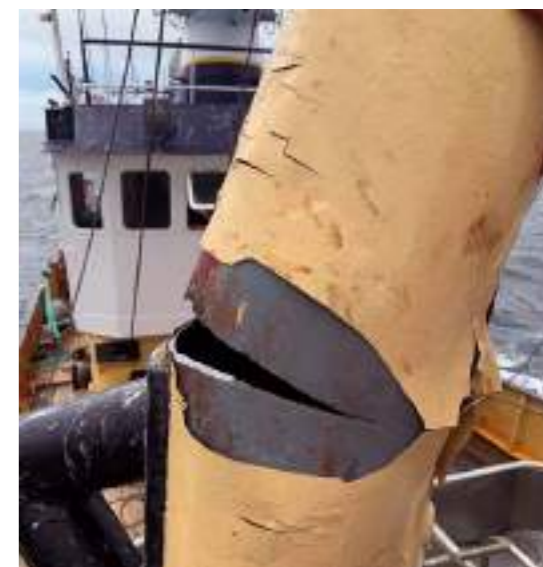
Figure 2: One of the cracks in the derrick posts

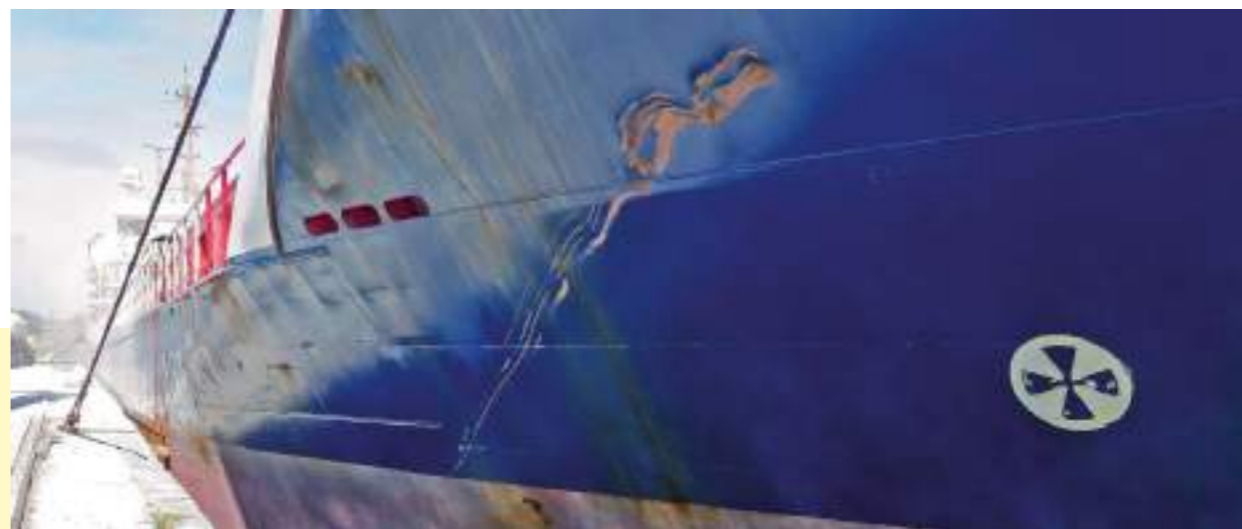
Figure 3: The area of plate damage

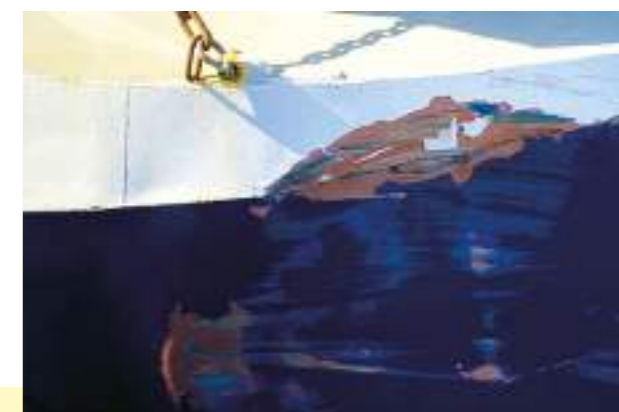
Figure: Damage to the beam trawler's bow

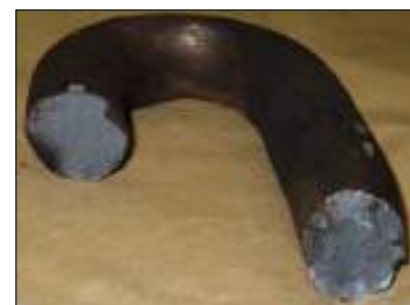
The ongoing MAIB investigation has found that a section of chain in the port dredging gear quick-release assembly failed as the gear was being retrieved. A 32mm chain link, which was led over a static steel pin at the derrick head (**Figure 1**), parted (**Figure 2**) and allowed the towing block, monkey face block and associated gear to fall to the deck below.

Figure 2: Failed chain link on *Honeybourne III*

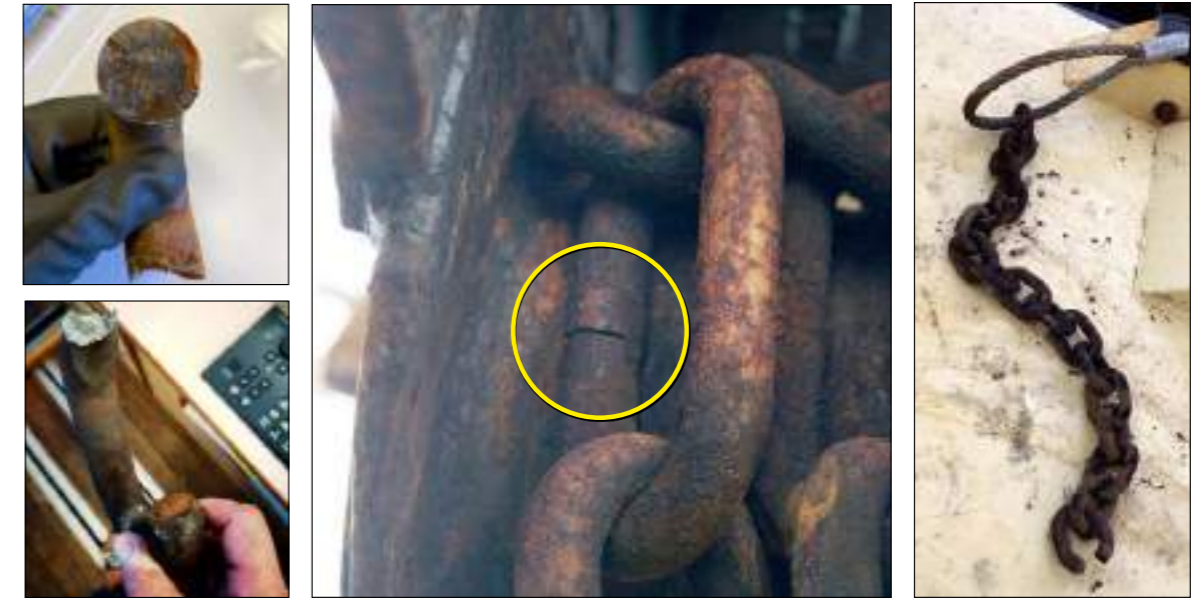
The configuration of a chain led over a static pin as part of a quick-release gear is commonly used on board scallop dredgers and beam trawlers. Such arrangements are known to have failed previously and chain fractures have been identified during routine inspections of quick-release gear (**Figure 3**).

Figure 3: Identified chain defects in static pin arrangements
