Marine Investigation Preliminary Report

Contact of Containership *Dali* with the Francis Scott Key Bridge and Subsequent Bridge Collapse

Location:	Baltimore, Maryland	Accident Number:	DCA24MM031
Date and Time:	March 26, 2024 0129 local time (eastern daylight time)	IMO Number:	9697428
Ship:	<i>Dali</i> (Neo-Panamax containership)	Injuries:	8 (6 fatal)

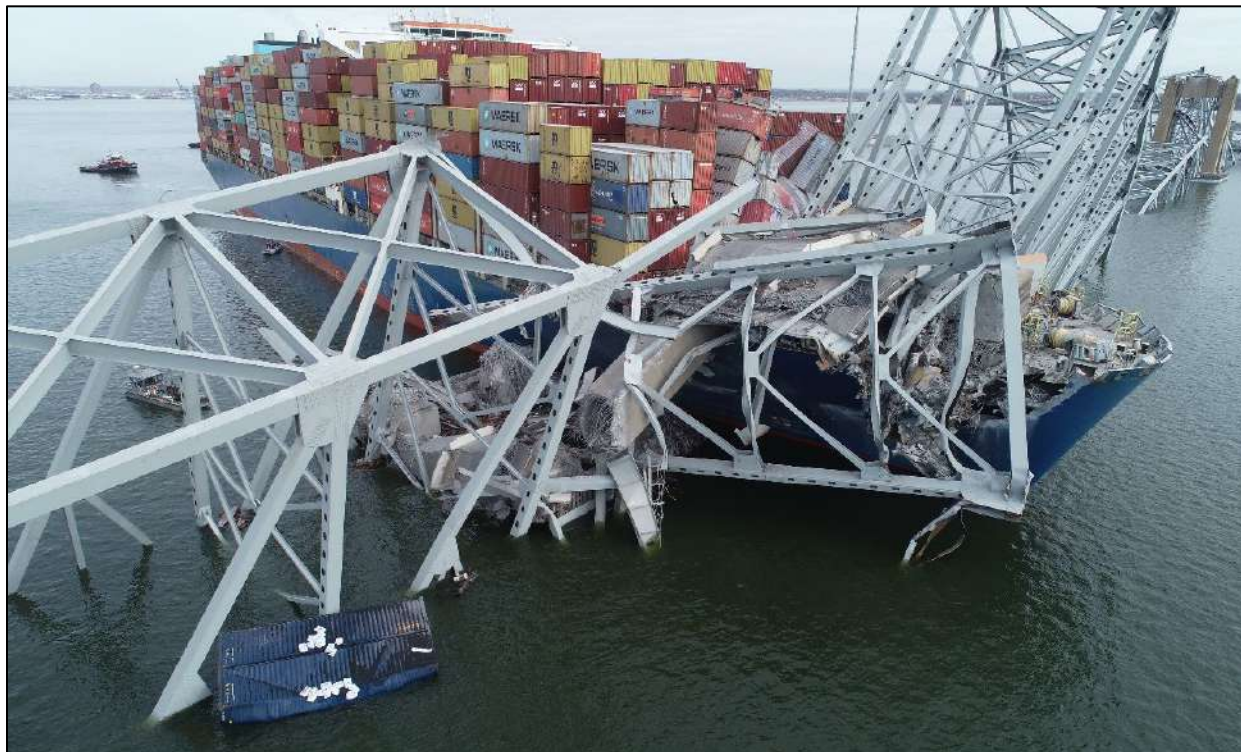
Figure 1. The *Dali*, with portions of the collapsed Key Bridge across its forward deck and in the Patapsco River, on March 28.

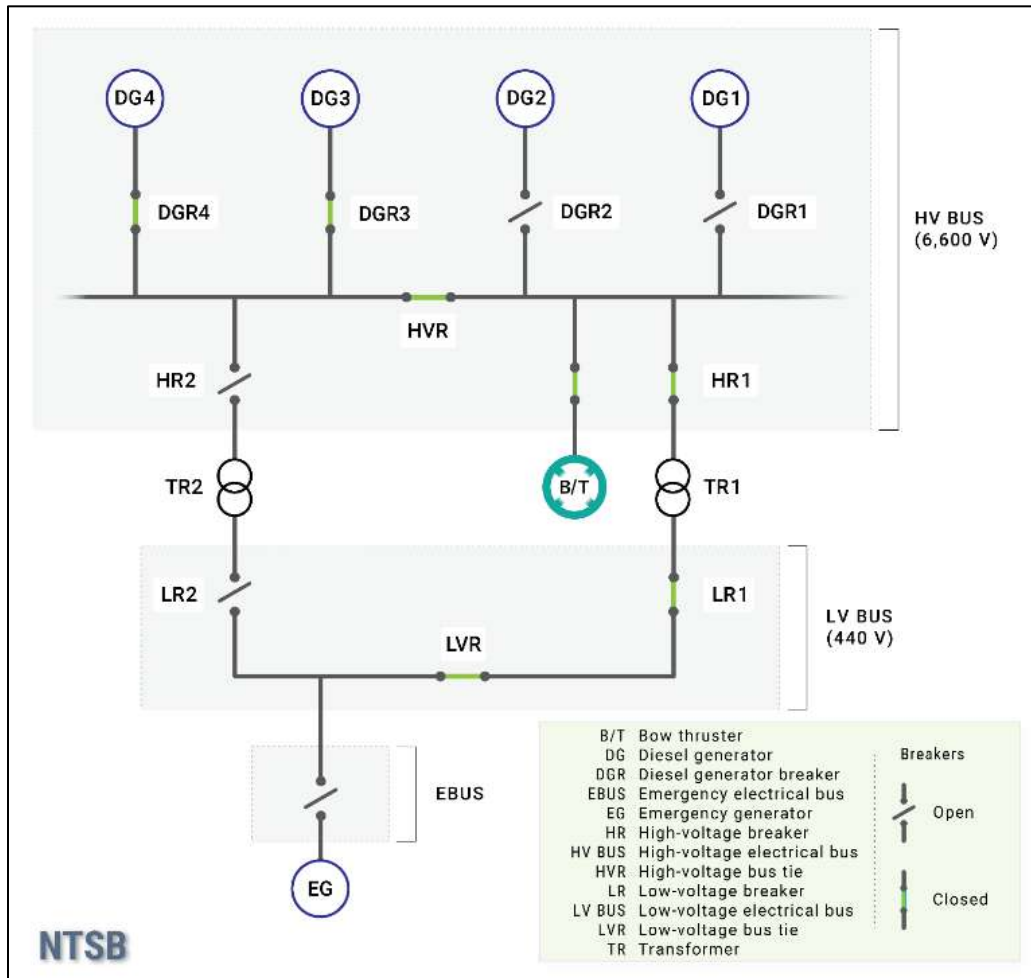
Figure 5. Simplified one-line electrical diagram of the *Dali* electrical power distribution system. Breakers shown reflect their positions at departure on March 26.

About 0125, the *Dali* was 0.6 miles—or three ship lengths—from the Key Bridge when electrical breakers (HR1 and LR1) that fed most of the vessel's equipment and lighting unexpectedly opened (tripped) (see figure 7). This caused the first blackout (loss of electrical power) to all shipboard lighting and most equipment, including the main engine cooling water pumps (which controlled engine cooling water pressure) and steering gear pumps.

- The *Dali* crew was able to restore electrical power to the vessel, but, when the ship was 0.2 miles from the bridge, a second electrical blackout occurred because DGR3 and DGR4, the breakers that connected generator nos. 3 and 4 to the HV bus, opened, causing a total loss of vessel electrical power (HV bus and LV bus). Having connected to the emergency bus by this time, the emergency generator provided electrical power to the emergency equipment continuously through the second electrical blackout.
- Generator no. 2, which had previously started automatically because it was in standby mode, connected and restored power to the HV bus via DGR2.

The first vessel blackout after departure on March 26 occurred when the HR1 and LR1 breakers opened unexpectedly.

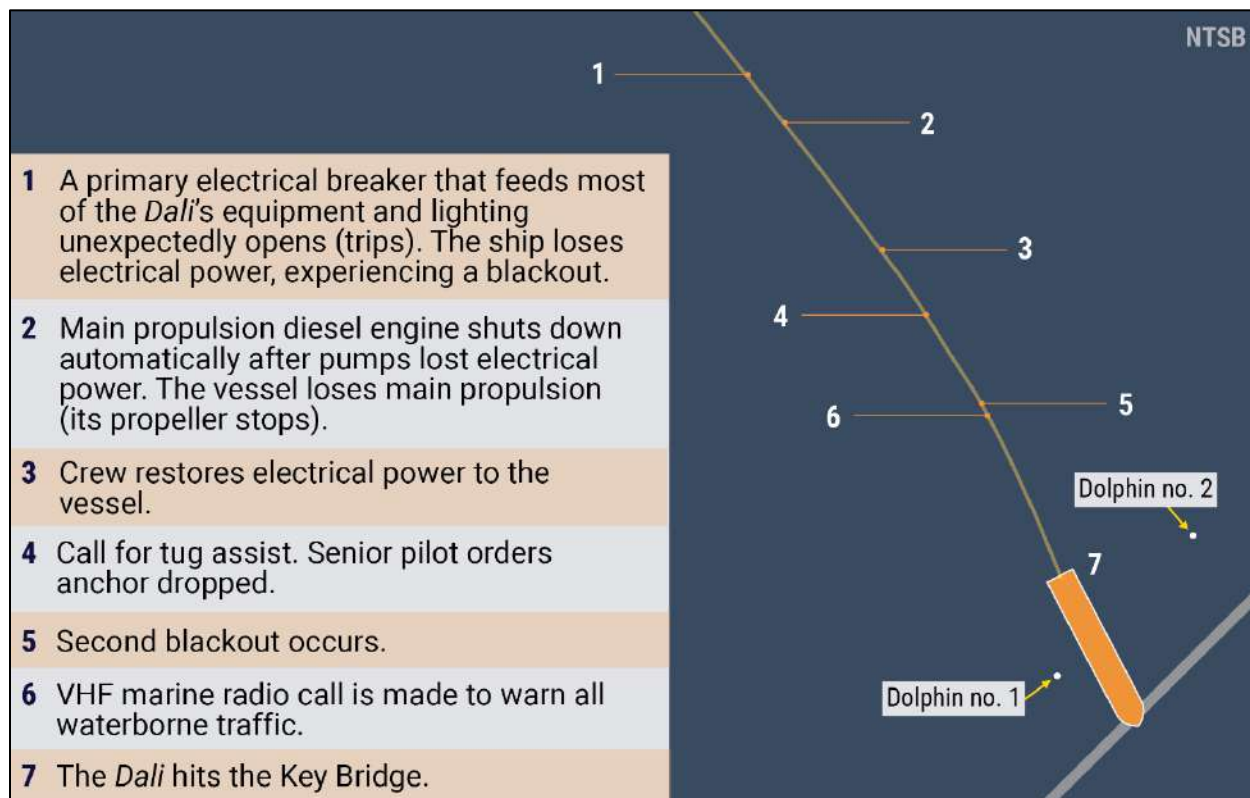
Figure 7. The *Dali*'s route on March 26, between the first blackout, and the *Dali* striking pier no. 17 of the Key Bridge. The location and approximate size of two of the bridge's "dolphins," sheet pile and concrete structures protecting the bridge's piers, are labeled in the lower right.

At 0129:10, the *Dali's* starboard bow struck pier no. 17 of the Key Bridge at 6.5 knots. Six spans of the bridge (the main spans [17, 18, and 19] and spans 20, 21, and 22) subsequently collapsed into the water and across the ship's bow. A *Dali* crewmember, who was on the bow at the time of the accident, told investigators that, as he was releasing the brake on the port anchor, he had to escape from the falling bridge before he was able to reapply the brake. (Due to ongoing salvage efforts, the amount of anchor chain paid out is still unknown.)

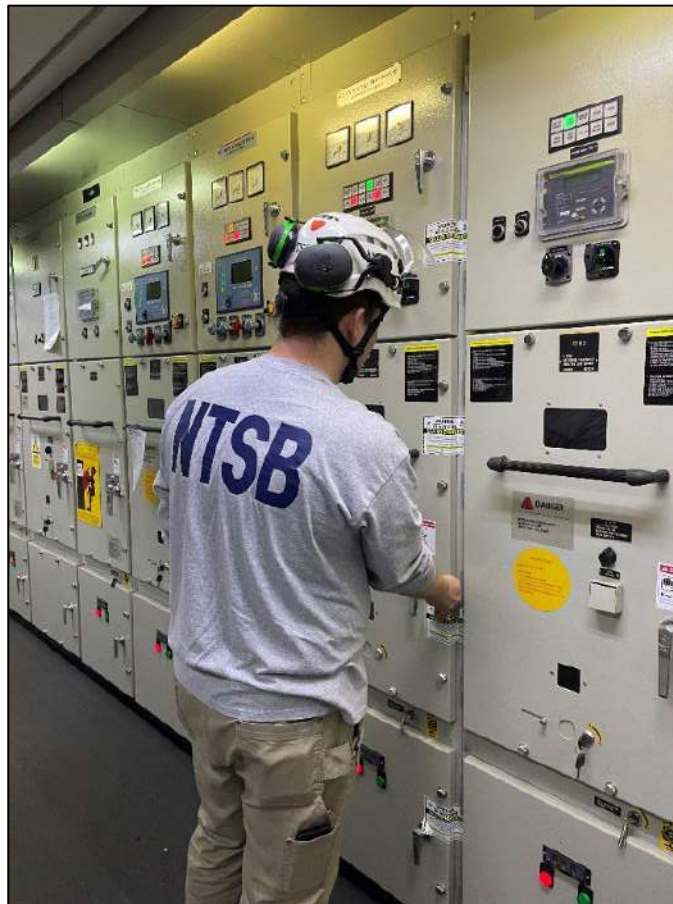
The *Dali* was equipped with an integrated control and monitoring system (ICMS) that retained information related to machinery and system changes and resulting alarms, including vessel engines and the electrical power management system. The NTSB has managed testing of the vessel's HV electrical bus and its components (including the HV and LV breakers) as the investigation parties and the electrical bus manufacturer, HD Hyundai Heavy Industries, Co. Ltd., work to identify the cause(s) of the breakers unexpectedly opening while approaching the Key Bridge and the subsequent blackouts (see figure 8).

Figure 8. An NTSB investigator examining the *Dali*'s HV switchboard (which houses the HV bus) and applying tamper-evident preservation seals.

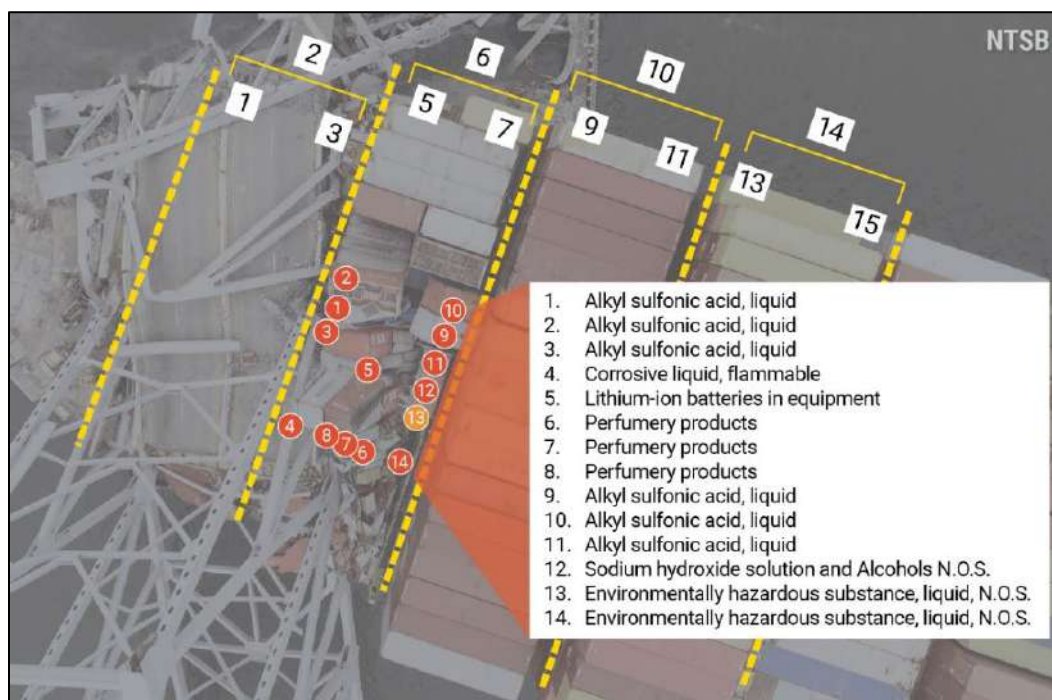
Figure 9. Approximate locations of cargo bays (yellow with numbers in white squares) and the 14 impacted hazardous materials shipping containers (orange circles with white numbers) transposed onto the *Dali* as seen after the accident. Hazardous material container no. 13 was in a portable tank, stored in the hold, below the deck.

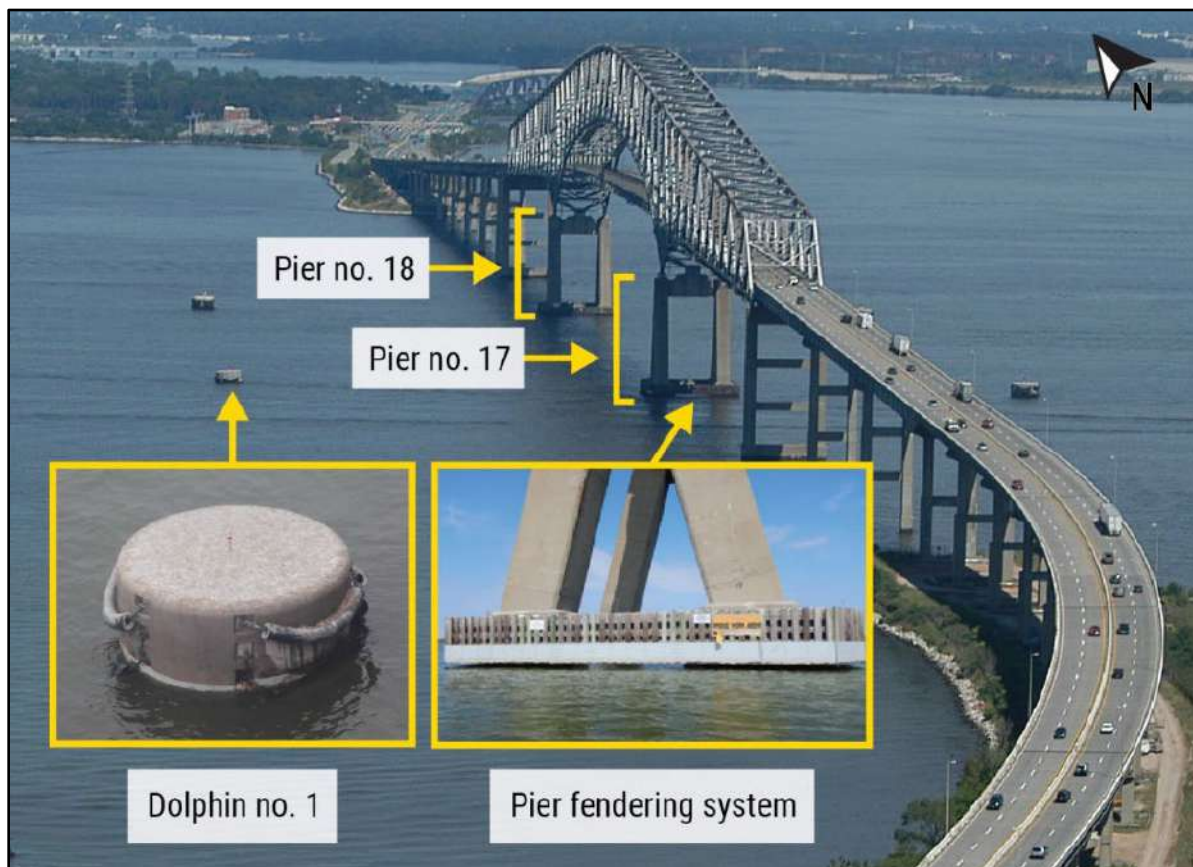
Figure 12. The Key Bridge and the locations of pier nos. 17 and 18. Insets show dolphin no. 1 as well as pier no. 17's fendering-system surrounding. (Background source: MDTA)

In addition to the dolphins, pier nos. 17 and 18 were each surrounded by a 100-foot-by-84.5-foot crushable concrete box and timber fender system, as seen in figure 12. These systems were comprised of hollow, thin-walled, concrete box structures attached to the piers. The timber portions of the fender were attached to the outer face of the concrete box and utilized a combination of vertical and horizontal members. Additionally, steel plates were secured at the base of the vertical timber members.

The *Dali* struck pier no. 17 and the fendering system surrounding the pier but did not contact dolphin no. 1 or its rubber fenders. Both fendering systems surrounding pier nos. 17 and 18 were further damaged during the collapse of the truss spans of the bridge when components of the truss spans impacted portions of the fenders as the components fell into the water.
