Report on the investigation of the  
grounding of the roll-on/roll-off passenger ferry

***Alfred***

at Swona Island, Pentland Firth, Scotland

on 5 July 2022

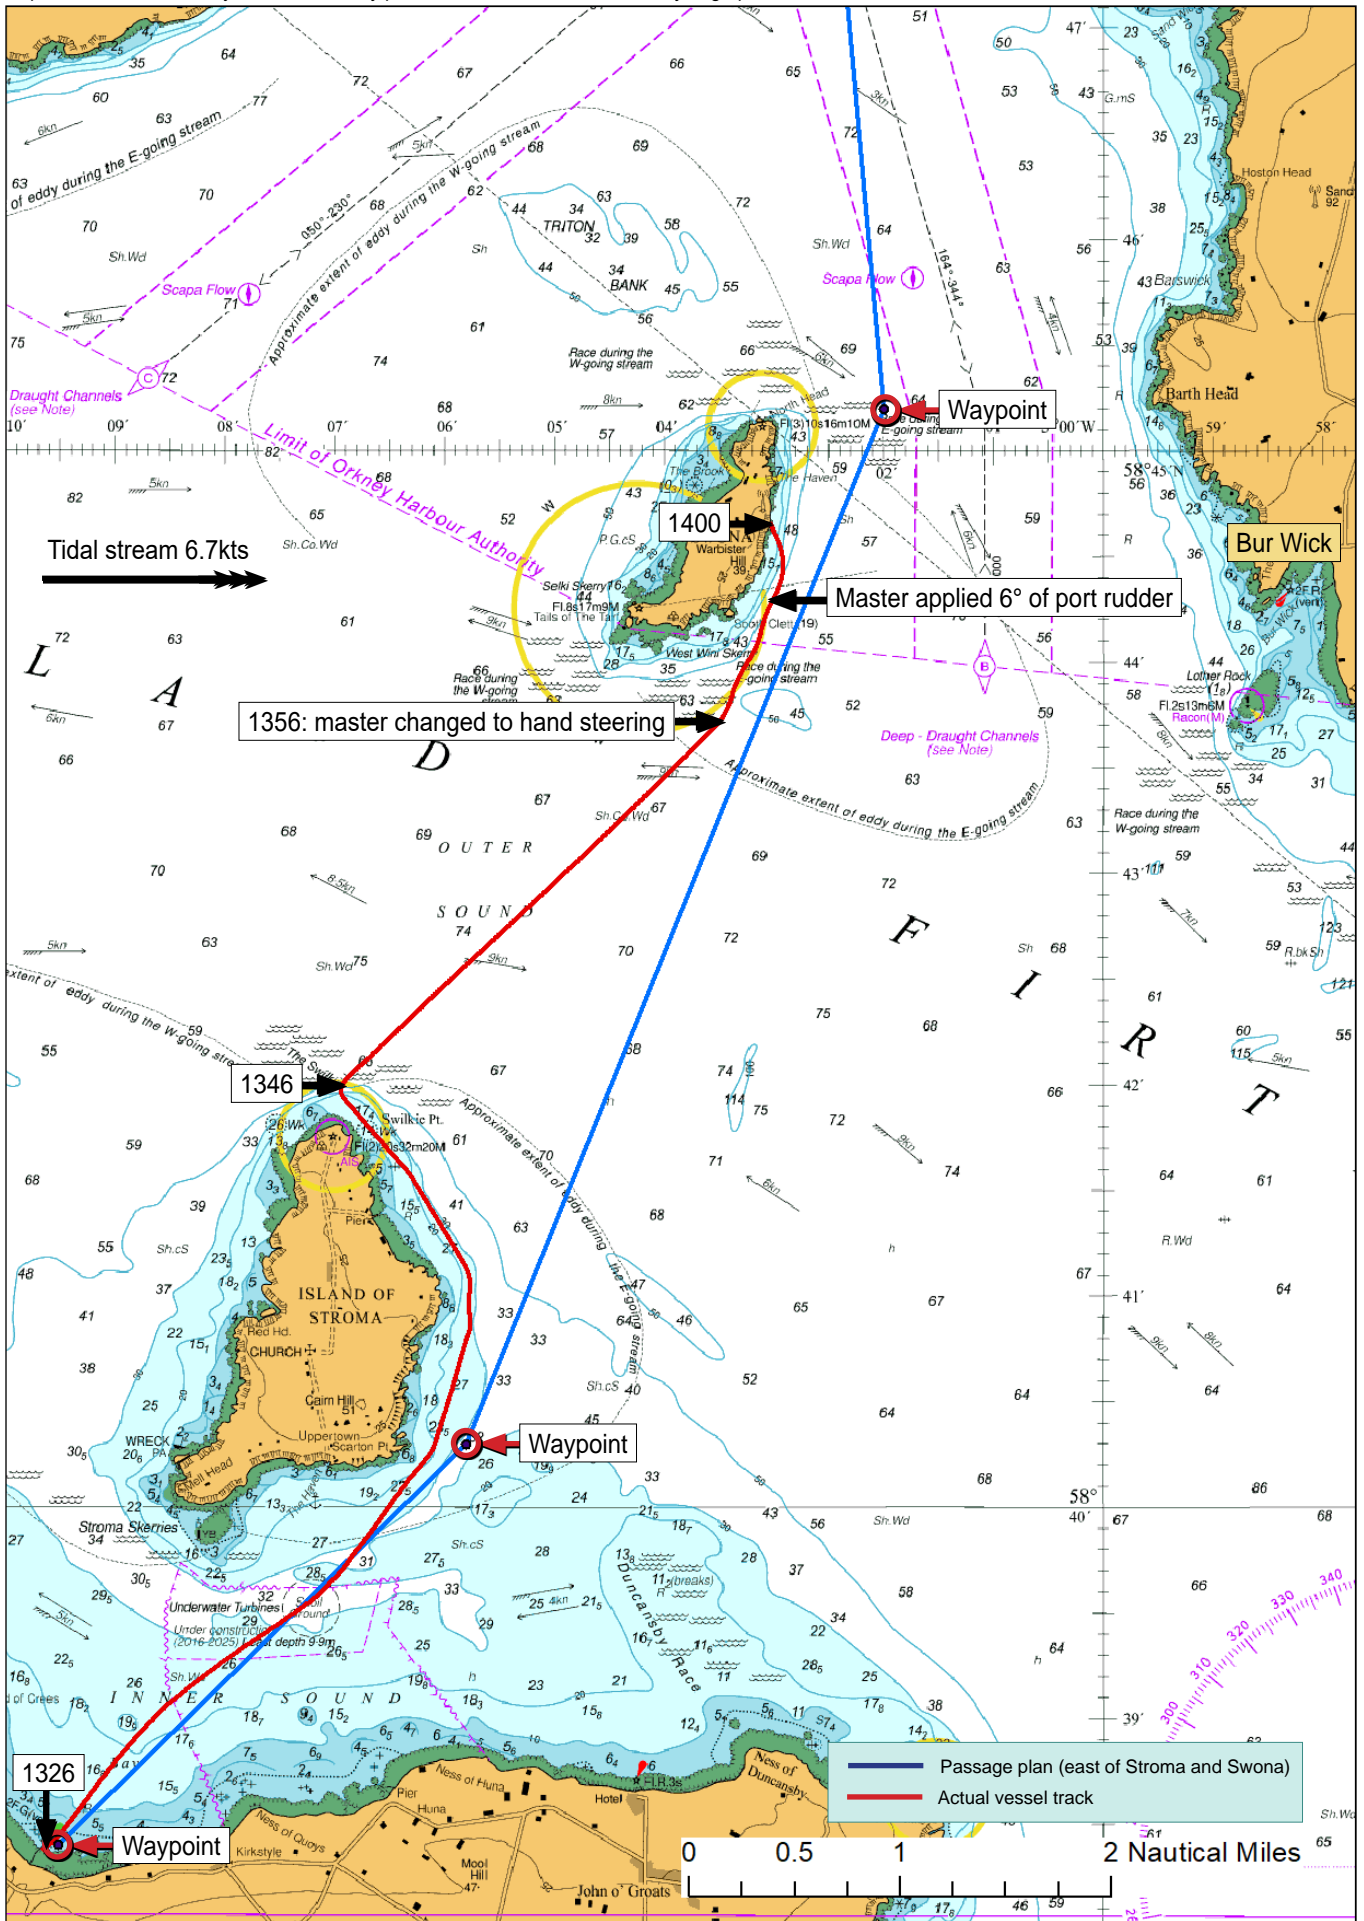
Figure 3: Alfred's navigational track before the grounding

Although *Alfred* started to turn away from the island when the master applied 60° of starboard rudder, his actions were too late and the vessel's port bow struck the rocky coast at a speed of about 13kts. This resulted in significant damage to the vessel's port bulbous bow, almost all of the vehicles on board, and injuries to more than 40% of the crew and passengers.

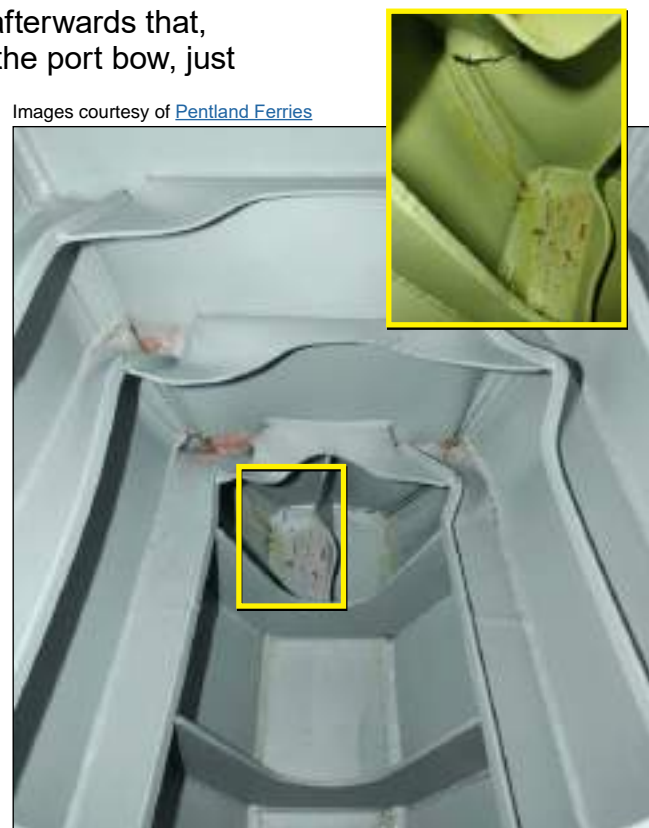
The C/O informed the master shortly afterwards that, other than a small amount of water in the port bow, just behind the collision bulkhead that had taken the impact of the grounding (**Figure 4**), he had found nothing else to indicate that the watertight integrity of the vessel had been breached. The C/E informed the master that the starboard outer engine had shut down and he was unable to restart it. The master informed the Pentland Ferries Designated Person Ashore (DPA) of the grounding. The DPA then cascaded this information to the other members of the Pentland Ferries emergency response team (ERT) ashore.

**Figure 4:** Post-grounding hull damage, showing slight water ingress behind the collision bulkhead

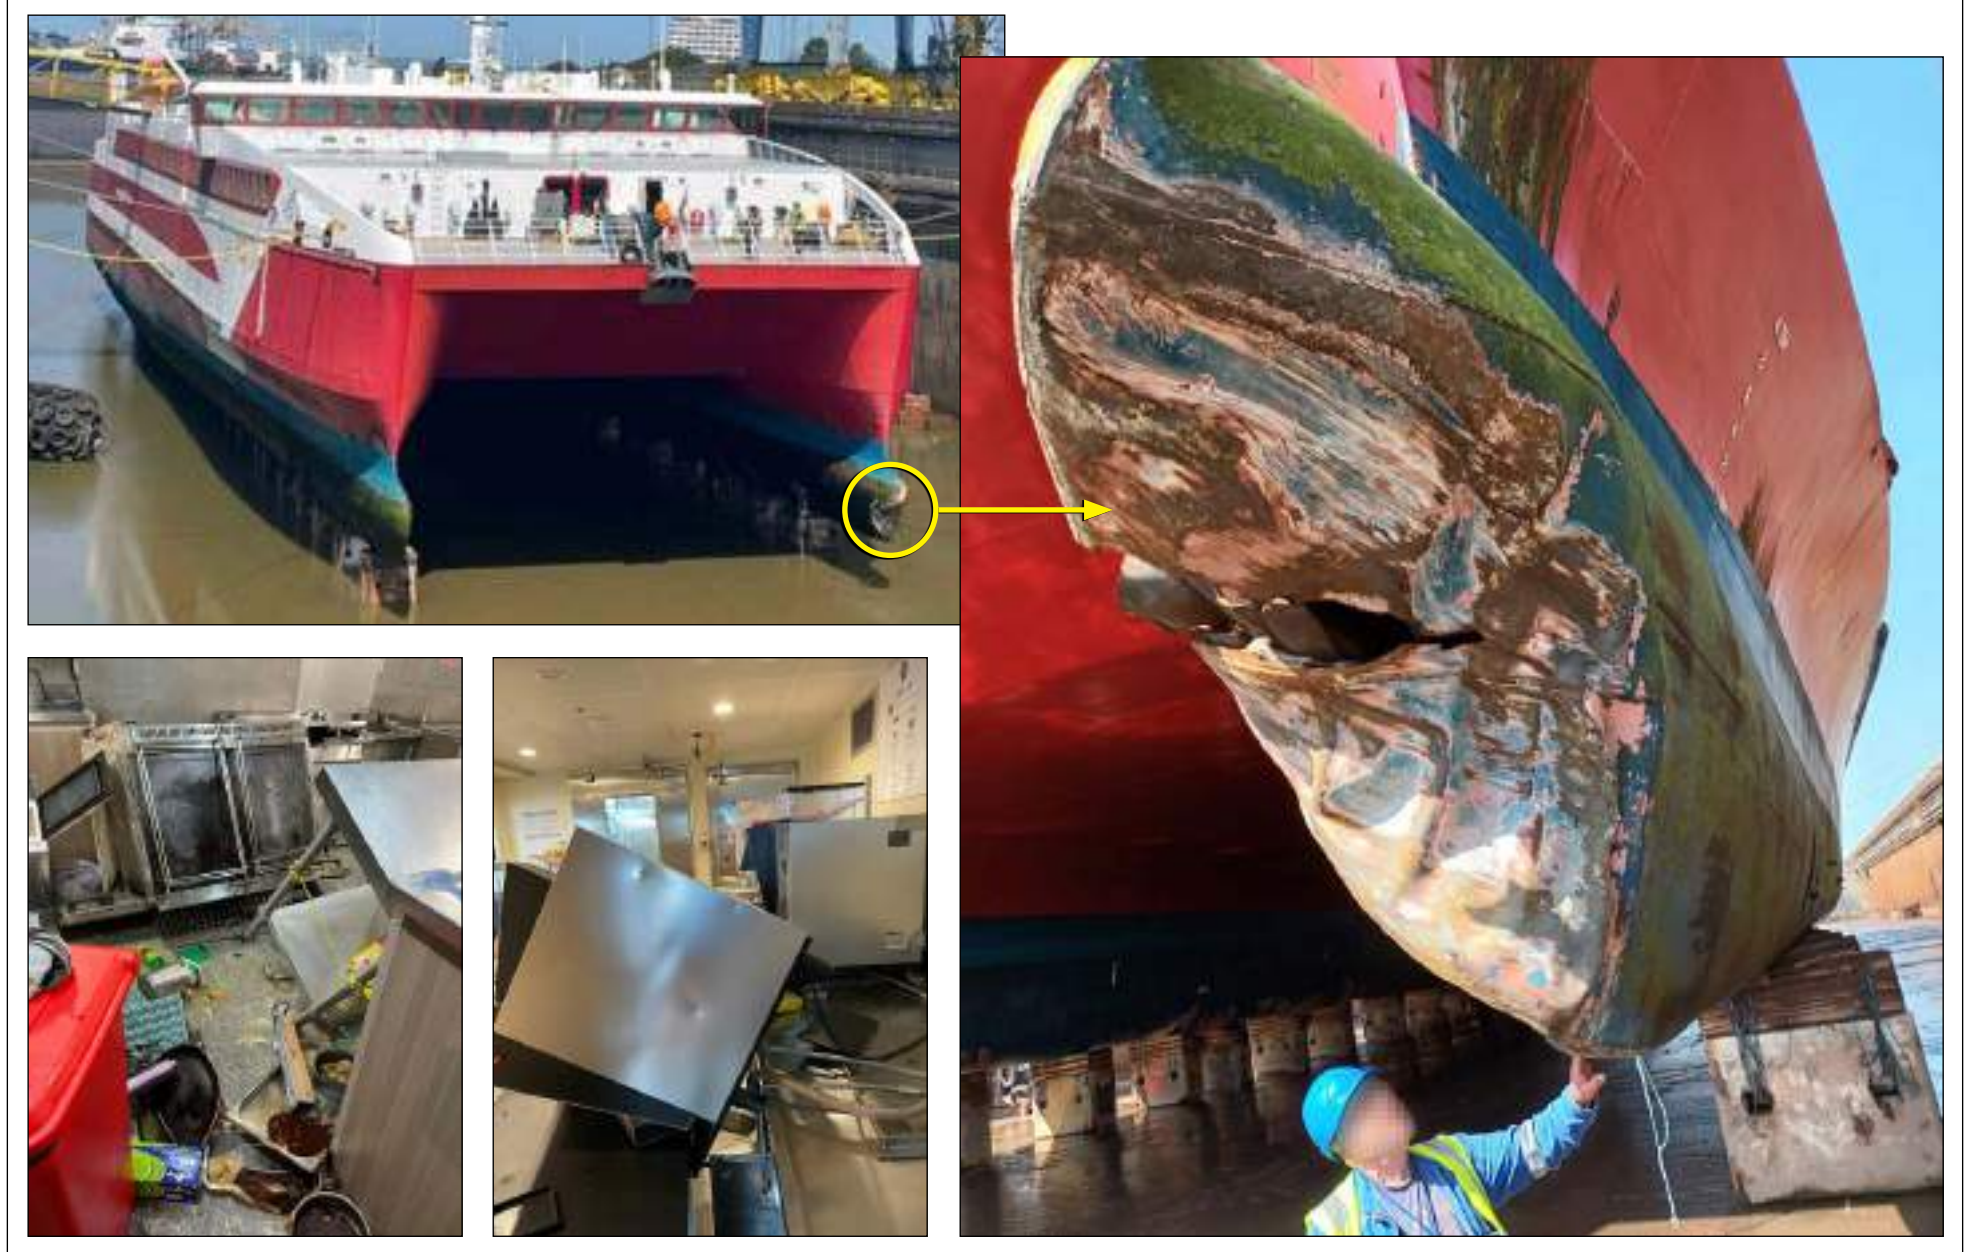
*Alfred* was taken out of service and entered dry-dock for four weeks, during which the port side bulbous bow, including the damage around the collision bulkhead, was cut out and replaced (**Figure 6**). Heavy items such as the galley range, catering equipment and vending machines were resecured to their mountings. A technical inspection of *Alfred's* steering system found no defects.

**Figure 6:** Post-grounding internal and external damage to *Alfred*

The grounding caused extensive external damage to *Alfred's* port bulbous bow. The impact also caused interior items such as part of the galley range, catering equipment and vending machines to break free from their welded mountings, which posed a risk of serious injury to the passengers and crew.

This damage revealed a need for Pentland Ferries to critically survey *Alfred's* internal fixtures, similar to the best practice promulgated by CLIA after the *Pacific Sun* incident, to ensure that heavy items were properly secured for sea.

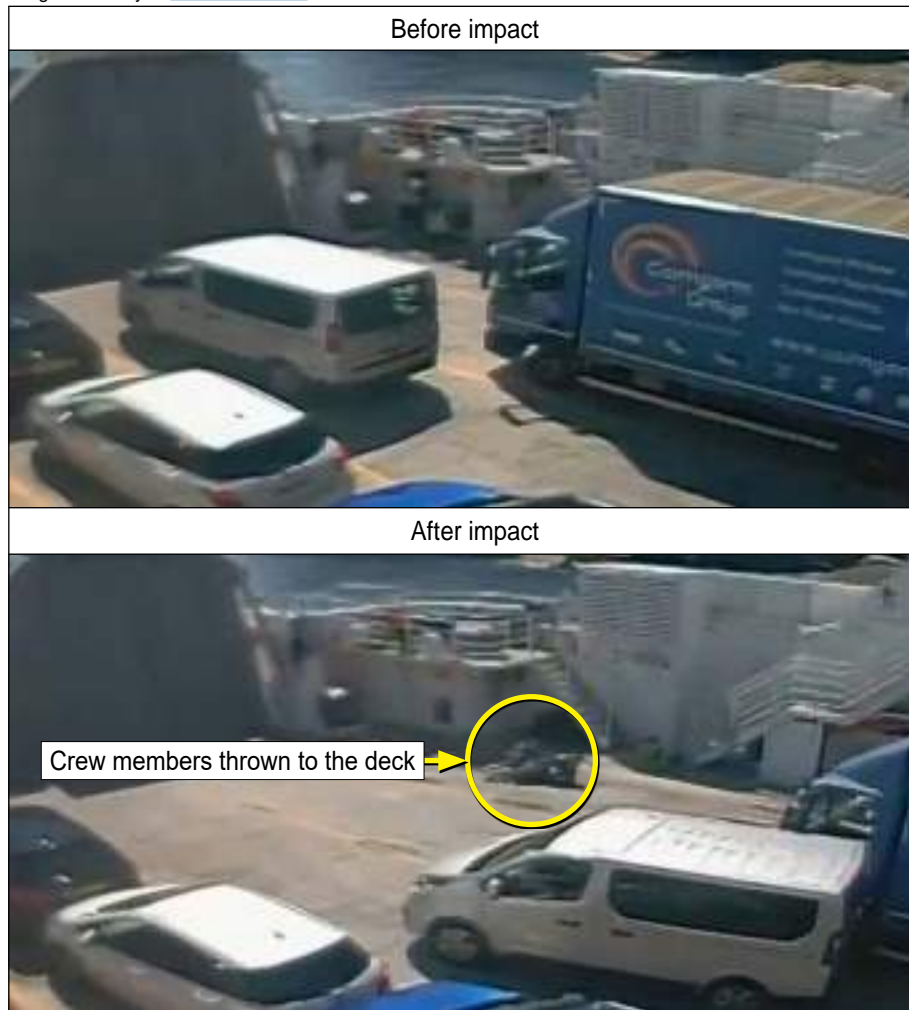
CCTV imagery of *Alfred's* vehicle deck showed cars and lorries rolling forward on impact (**Figure 7**) and 35 of the 37 vehicles on board were damaged due to striking either adjacent vehicles or the ferry's superstructure during the grounding.

**Figure 7:** CCTV images, showing vehicle movement as *Alfred* grounds on Swona Island

*Alfred's* CCTV imagery showed significant vehicle movement when the ferry grounded. This indicated that the crew had not ensured that vehicles were secured in accordance with the CSM, probably because the weather conditions were perceived as benign and little motion was expected. The CSM required crew to ensure that drivers left their vehicles in a high gear with the handbrake on. Further, the CSM also required lorries over 3.5 tonnes, like the one in **Figure 7**, to be secured using two lashings on each side of the vehicle. Additionally, the vehicle

deck signs only directed drivers to apply the handbrake but did not advise them to leave their vehicles in a high gear. Consequently, although the ferry's structure was intact, in a similar manner to the *Stena Voyager* incident, almost all vehicles were damaged.

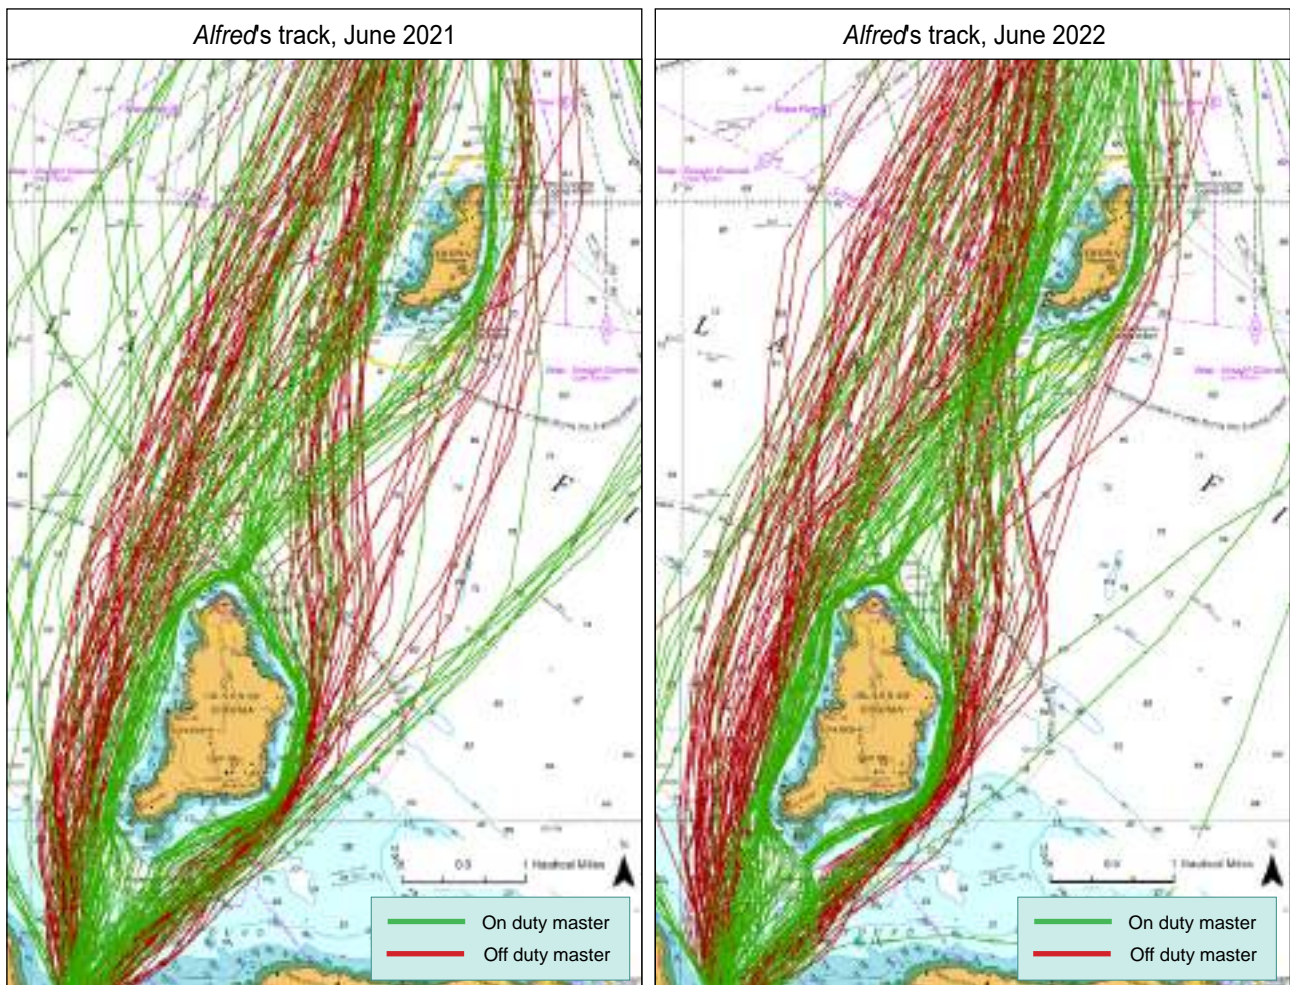
Figure 10: Alfred's June 2021 and June 2022 navigational tracks

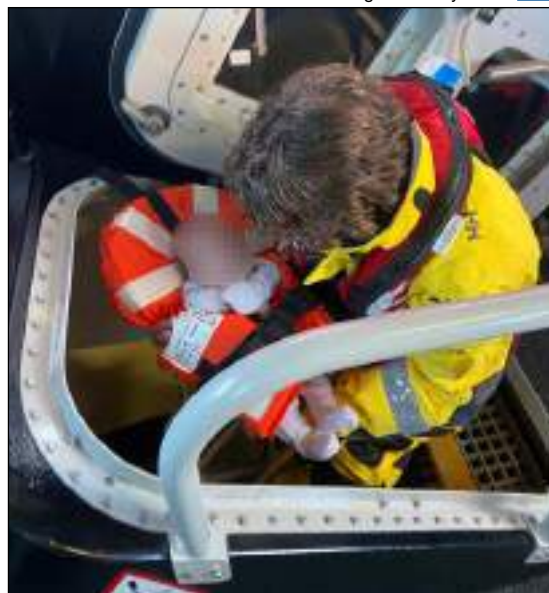
- 55% of the respondents felt the master's announcement was unclear and that the procedures described in the passenger safety video were not followed.
- Over 40% of the respondents reported that they were injured by the grounding and several commented that they were not warned of the impending impact before the vessel struck the island.
- Some passengers with babies reported that the crew were unsure how the infant lifejacket they had provided should be worn (**Figure 11**).

**Figure 11:** Baby on board the Longhope all-weather lifeboat, wearing an incorrectly fitted infant lifejacket

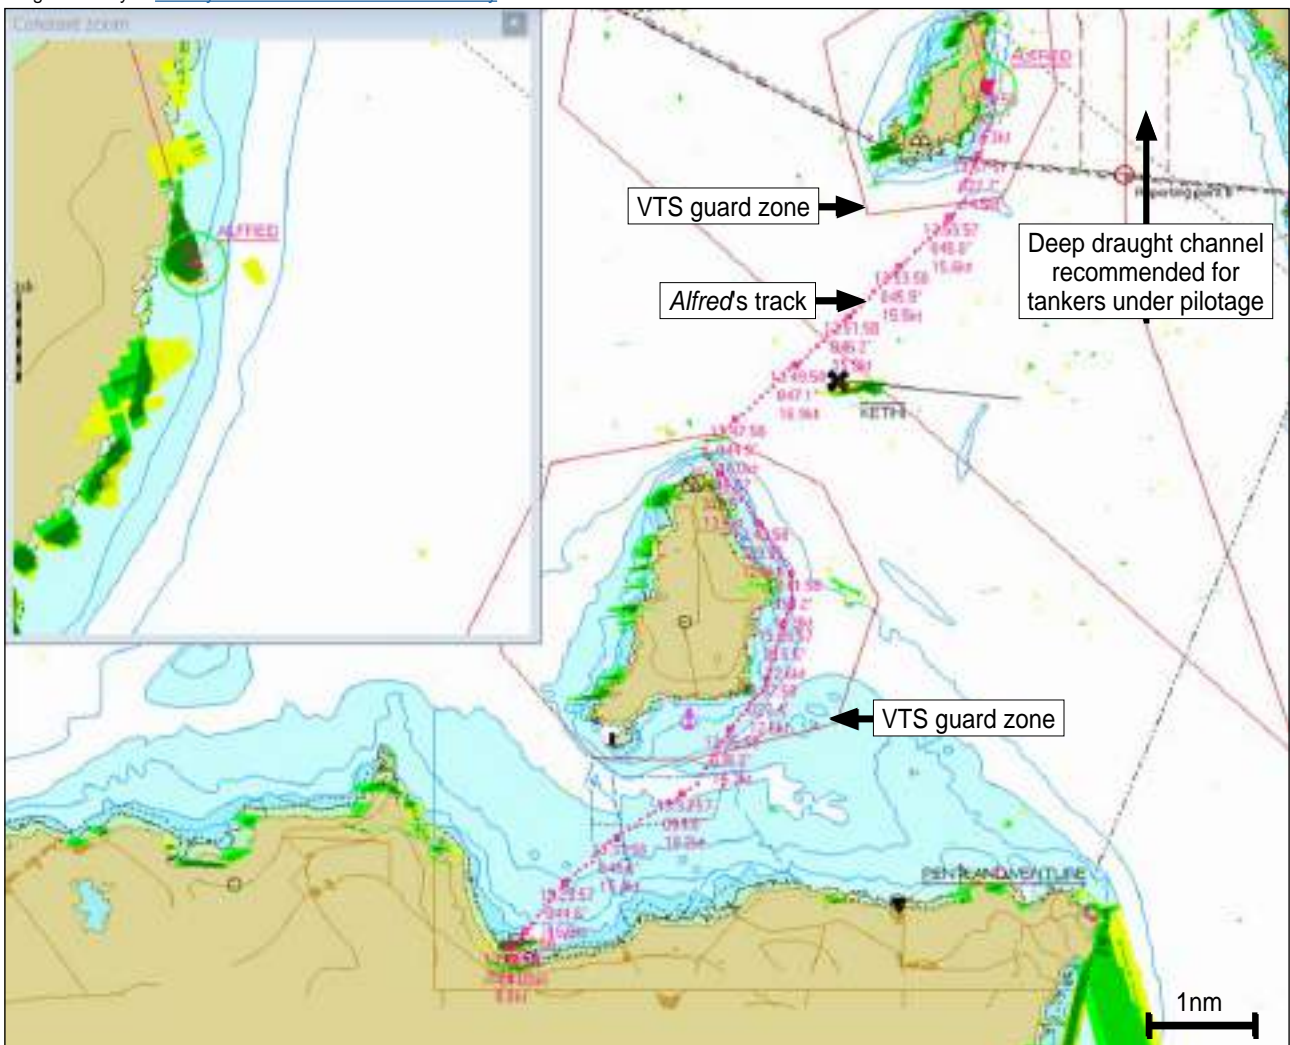
Orkney Islands Council Harbour Authority had created VTS guard zones approximately 1000m from the coast around the islands of Stroma and Swona (**Figure 13**). The VTS system automatically alerted the VTS operator if either a vessel or its heading vector entered the guard zone. This provided the VTS operator with the opportunity to warn the vessel's crew of the *development of unsafe situations*. These guard zones were not marked on navigational charts. *Alfred's* track routinely triggered the VTS guard zones around the islands of Stroma and Swona, as it did on this occasion; the VTS operators did not call the ferry.

Figure 13: VTS replay of Alfred's track, showing the recommended route and the guard zones
