Report on the investigation of  
a fall from height on the bulk carrier

***Equinox Seas***

resulting in one fatality

at ONEX Syros Shipyard, Ermoupoli, Syros, Greece

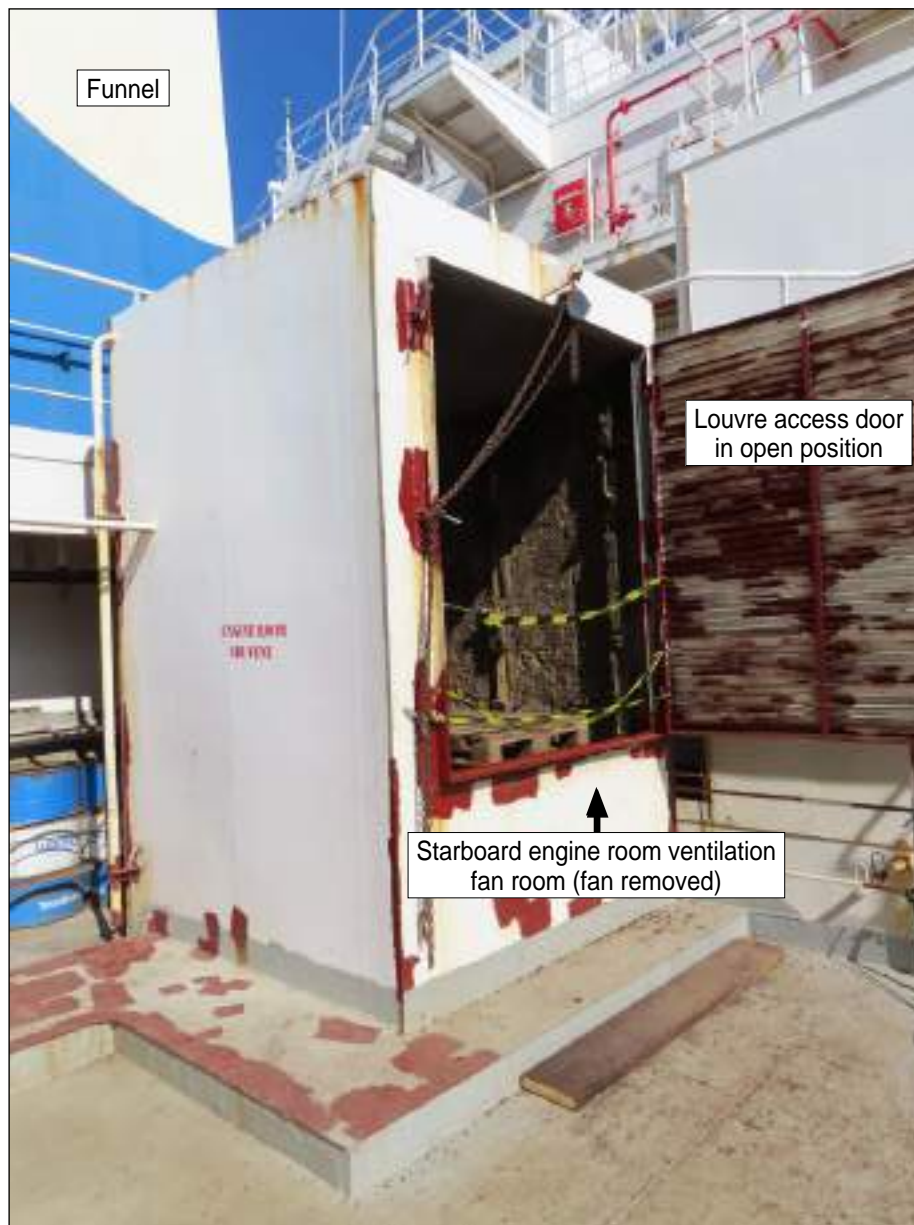
**Figure 1:** Access to the starboard engine room ventilation fan room

When the master and C/E arrived at the fan room no-one was visible, so they made their way down to the engine room. The C/E identified the access to the trunk leading from the fan room inside the entrance to the storeroom on the first platform deck. Listening at the access cover, they could hear the fallen fitter groaning inside. Crew members arrived at the scene in response to the announcement on the public address system and, with the assistance of a technician who was working on board, they started to unbolt the ventilation trunk access cover.

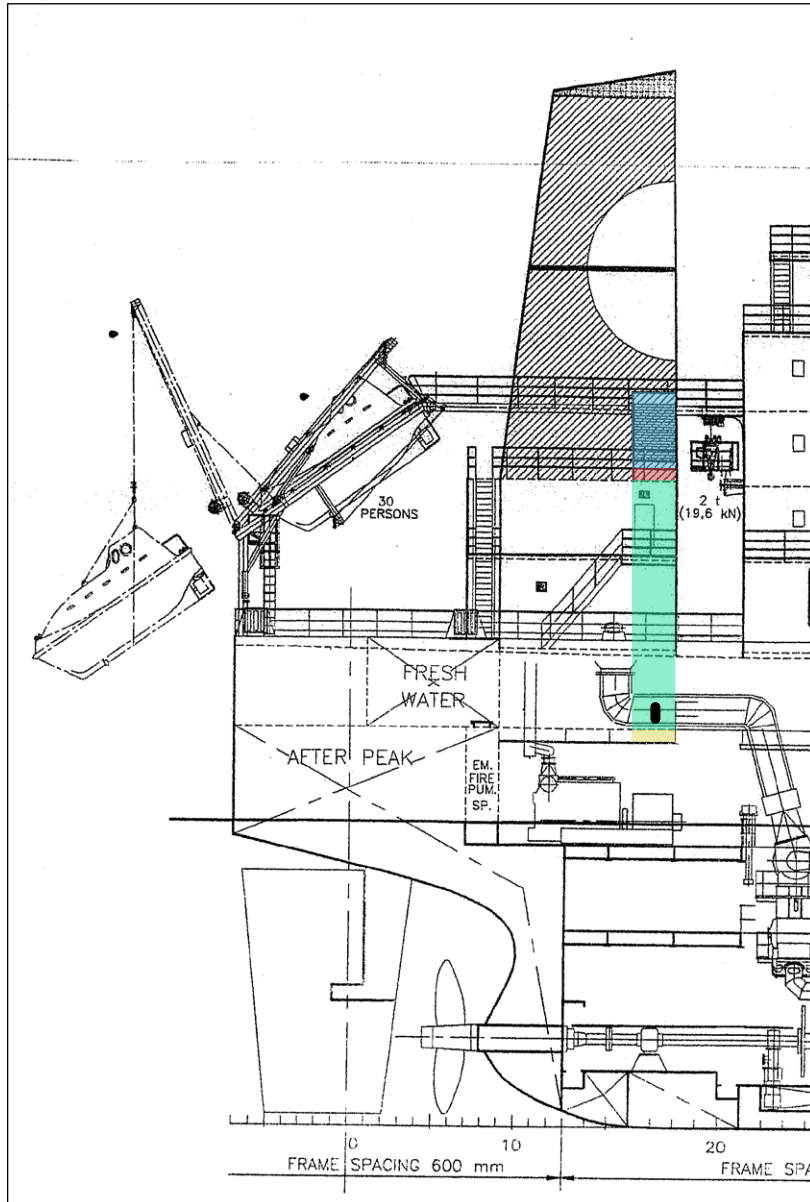
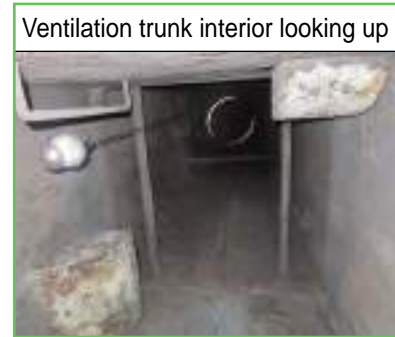
**Figure 3:** Starboard engine room ventilation duct arrangement

The starboard fan pedestal sat at the top of a trunk leading vertically down to the engine room. The trunk was 10m long and was of rectangular cross-section, 1.67m wide and 1.60m deep (**Figure 3**).

The fitter died as a result of the serious injuries sustained during the 10m fall down the ventilation trunk to the plenum chamber at its base. The dimensions of the trunk were sufficient to allow the fitter to rotate during the fall. His orientation at entry to the fan pedestal cannot be determined from the position he was in when found.

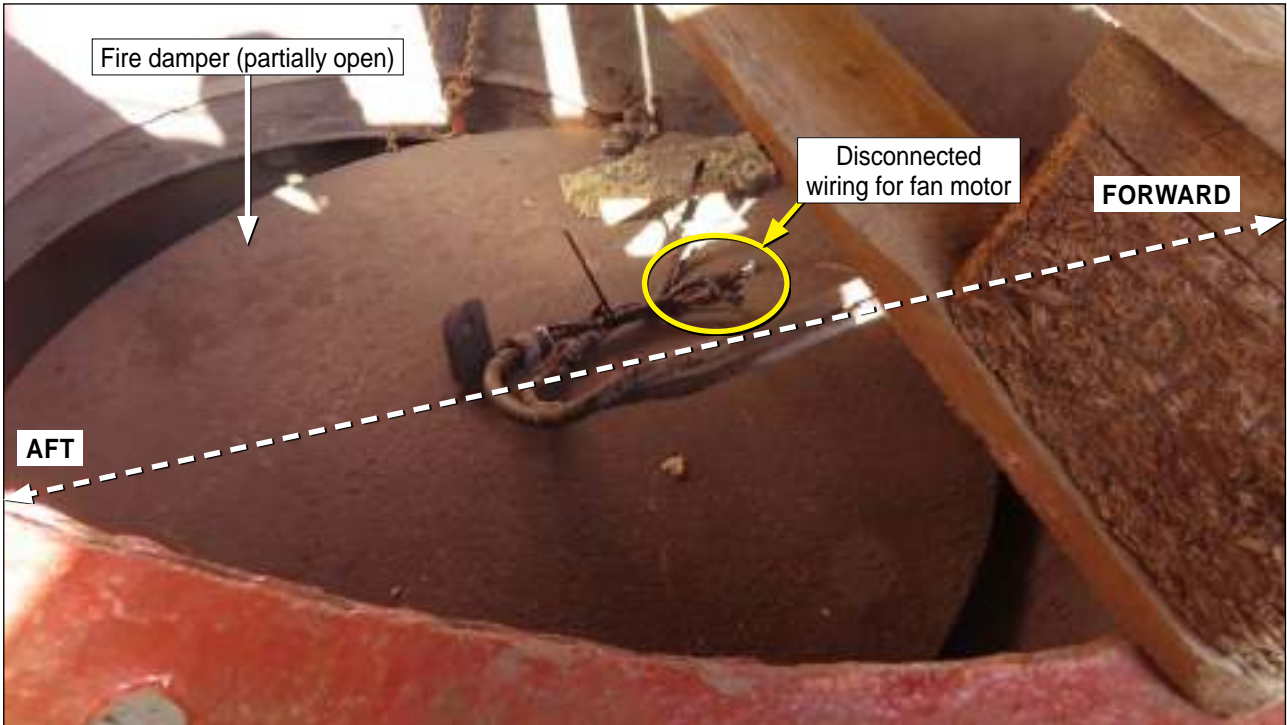
Figure 4: Starboard engine room fan pedestal fire damper

The starboard ventilation trunk fire damper comprised a steel disk pivoted along its central axis, offset by  $45^\circ$  to the centreline of the ship. The damper was designed to rotate by  $90^\circ$  between the open and closed positions. In the closed position, across the airflow, the damper rested against seats set into the pedestal. The aft inboard half of the flap rotated downwards to open the damper (**Figure 4**). An actuator was installed to allow the damper to be operated remotely.

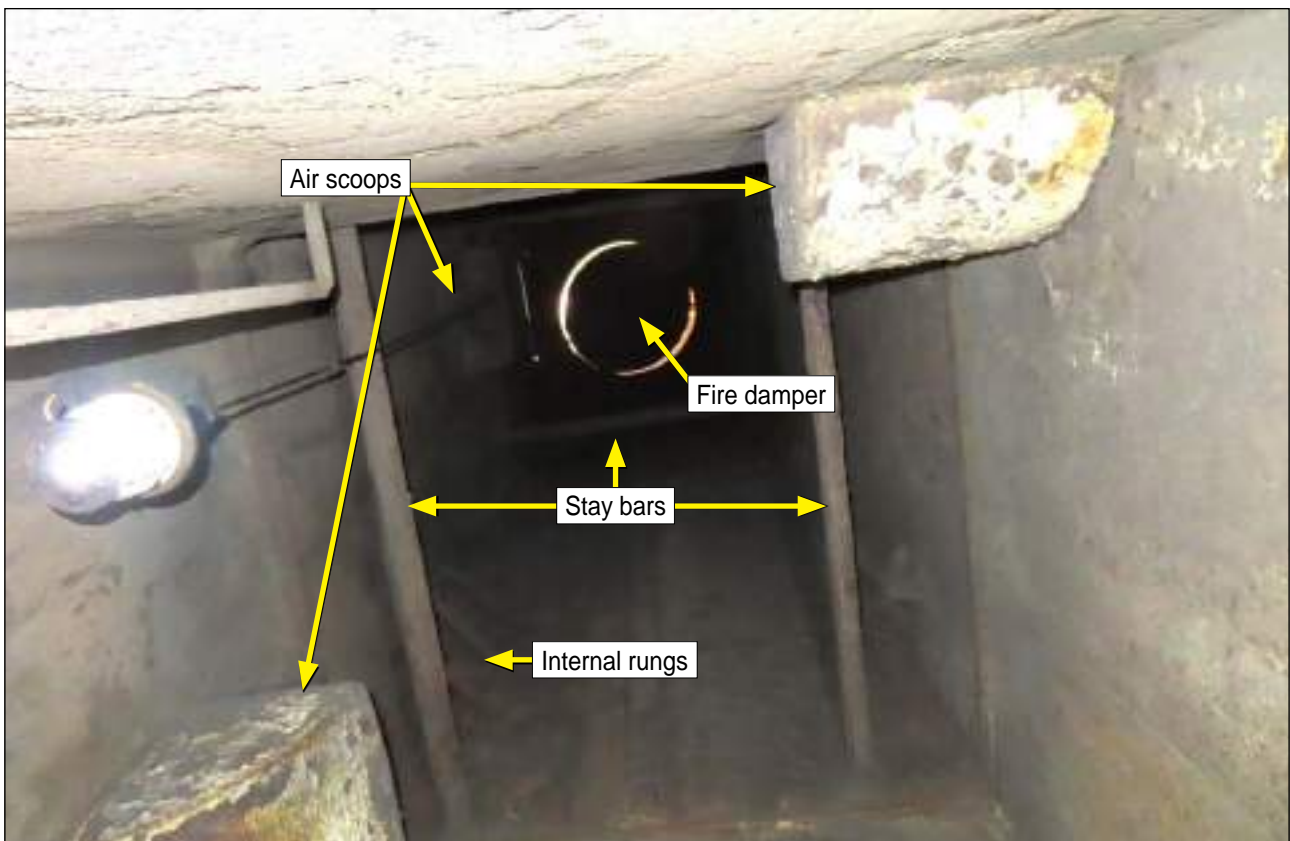
Figure 5: Starboard ventilation trunk internal structure, looking up from the access cover

At the base of the ventilation trunk at deckhead level on the second platform deck, a plenum chamber contained three distribution duct outlets that supplied ventilation to the engine room. Ventilation to the engine casing at main deck level and the first platform deck was provided by a series of scoops set into the vertical trunk leading to distribution ducts on those levels. The trunk was fitted with four stay bars of 50mm angle profile, two each at deck one and main deck levels. Internal rungs providing means to ascend the trunk for maintenance were installed up the forward outboard corner (Figure 5).

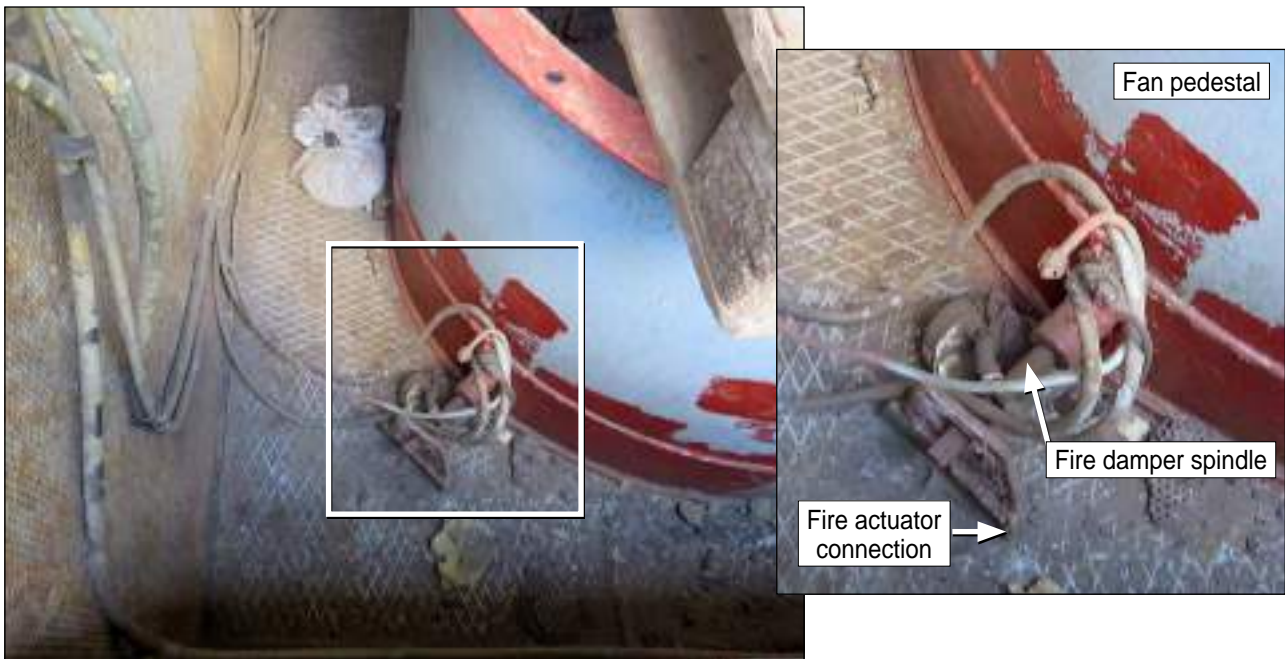
**Figure 6:** Disconnected fire damper actuator

After the removal of the starboard engine room fan, the fire damper actuator at the base of the pedestal was disconnected (**Figure 6**) by *Equinox Seas*' electrician. With the actuator removed, the damper was free to rotate.

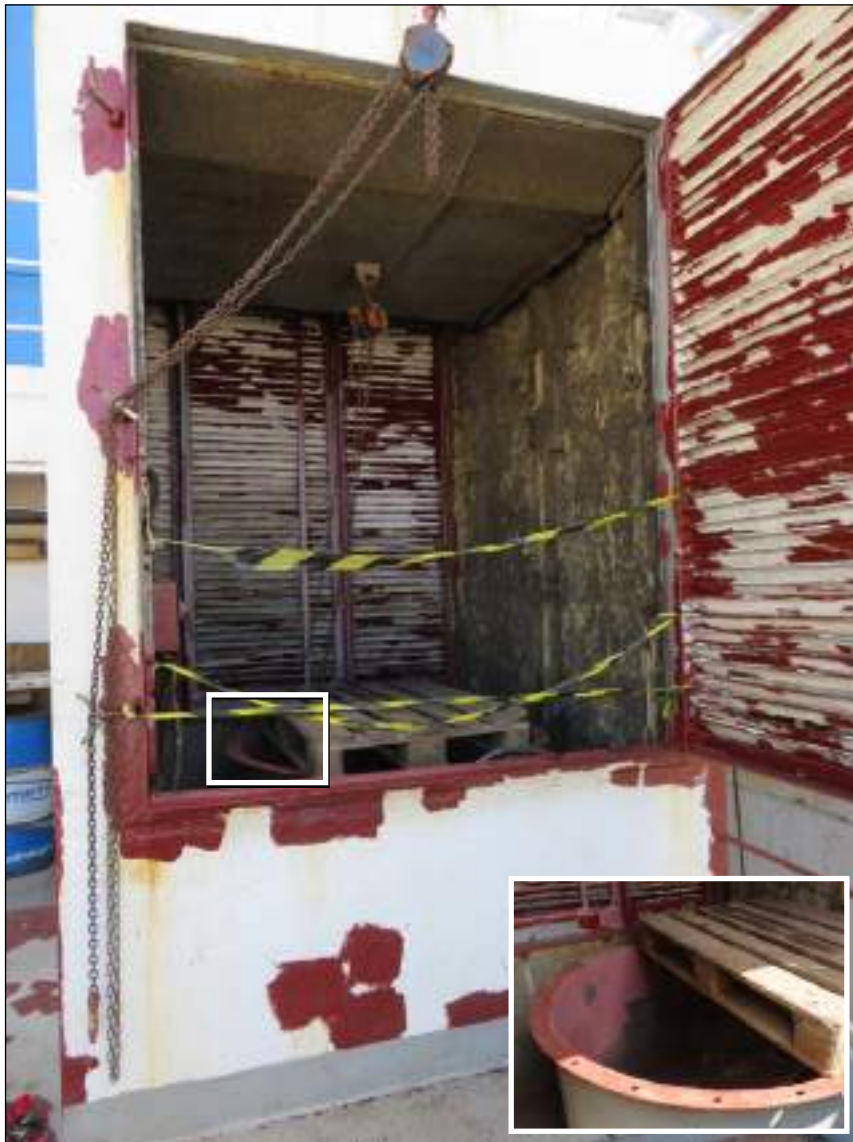
The removal of the fans enabled access to the rear of the fan room and the ship's deck crew were instructed by the C/O, under the direction of the outgoing master, to scale and paint the fan rooms. In the starboard fan room, the louvres of the fan room air inlets and the fan pedestal were scaled back to a good surface where corroded, and primer paint was applied (**Figure 7**). It was intended that the paintwork would be completed after the installation of the fan.

**Figure 7:** Painting work on the starboard fan room, showing the areas of red and pink primer paint applied by the deck crew

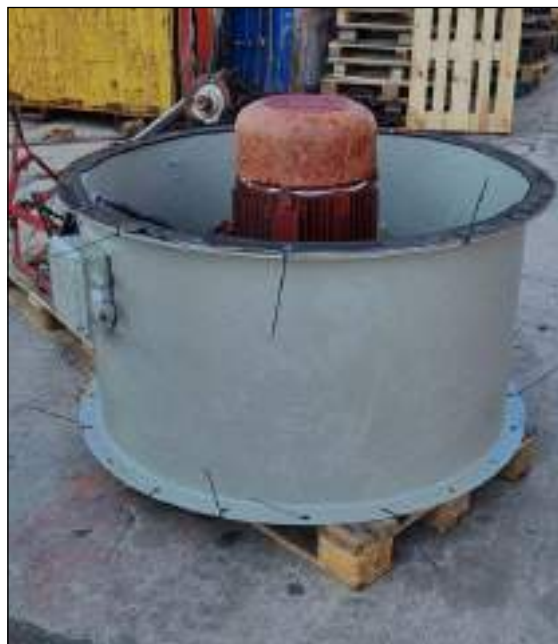
**Figure 8:** Starboard engine room fan unit awaiting replacement on board

The starboard fan overhaul (**Figure 8**) was completed before the shipyard ceased work for the public holiday and its reinstatement was planned for 18 April 2023.

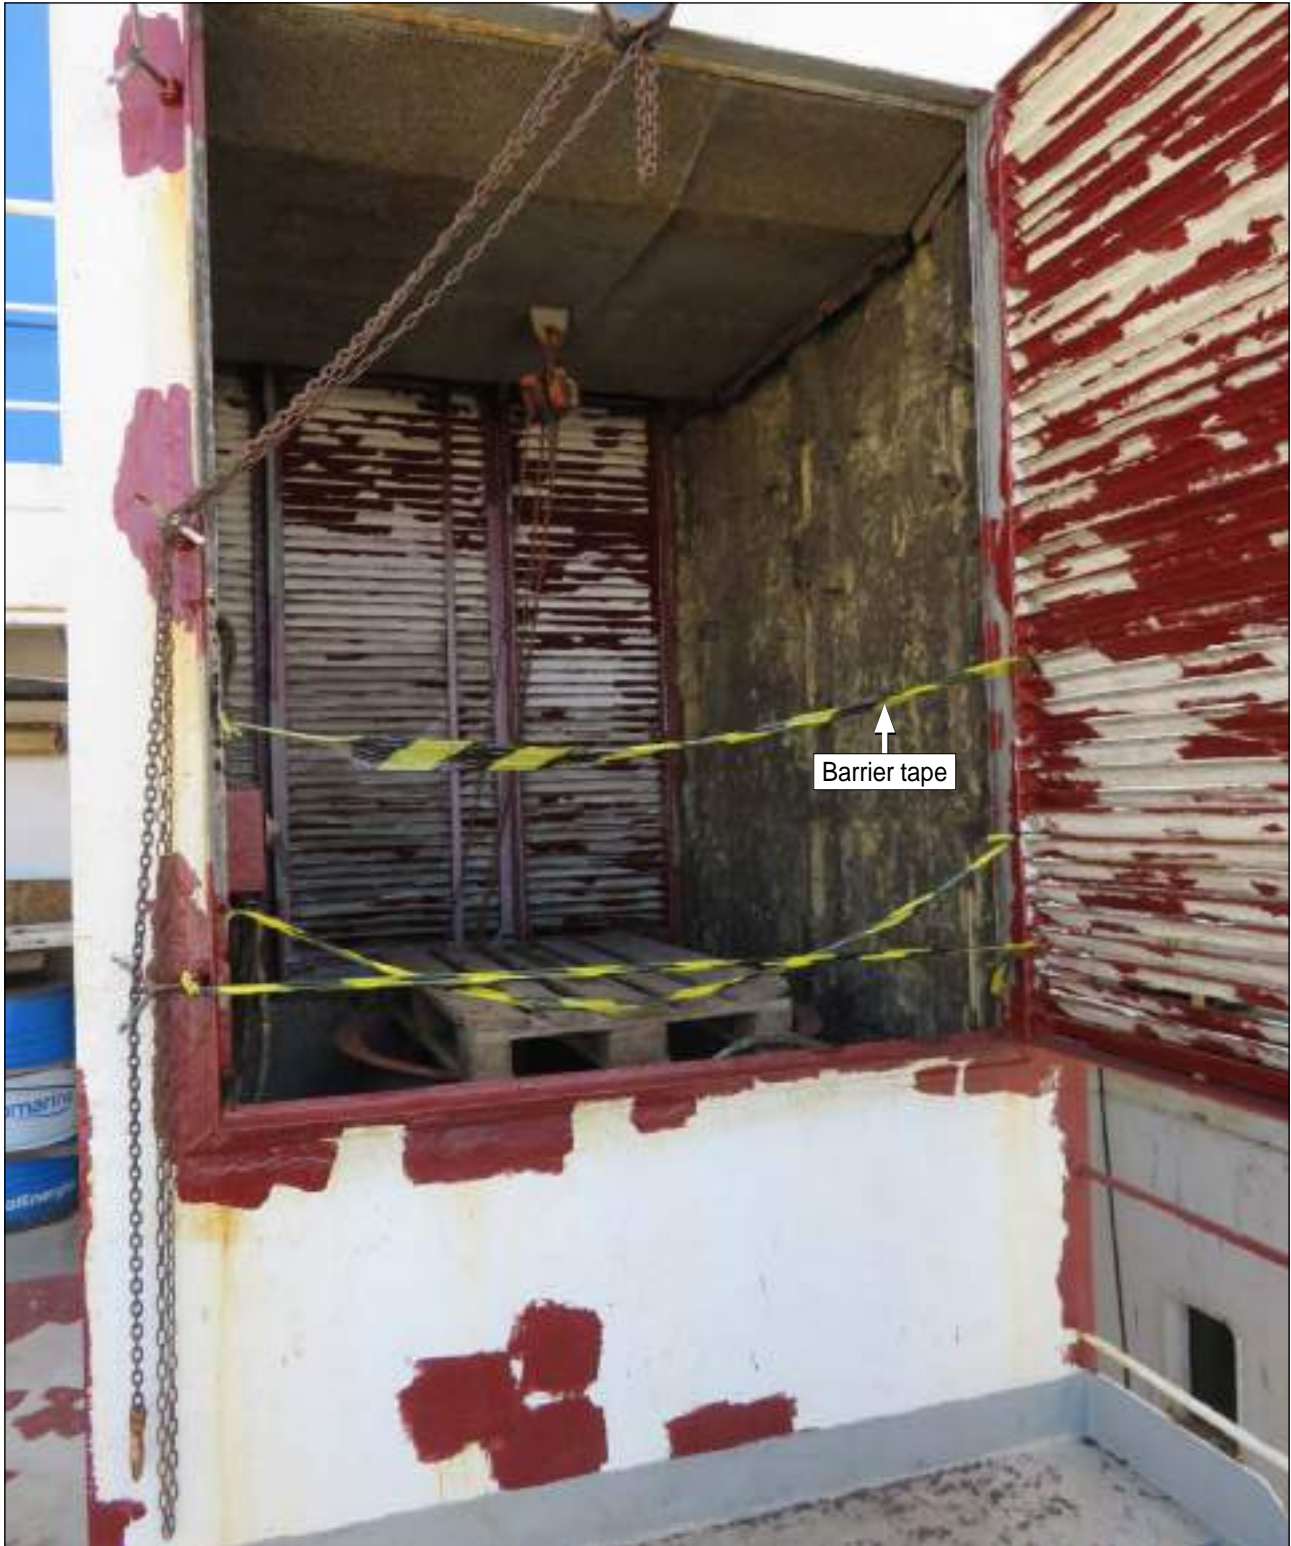
Once the starboard fan was removed, the shipyard placed black and yellow striped tape across the entrance to the fan room to restrict access to the space (**Figure 9**). No steps or staging were provided outside the fan room to provide a means of access. There was no additional signage applied to indicate the nature of any hazards in the space.

**Figure 9:** Barrier tape across the fan room access

The purpose of a barrier is to separate a person from a hazard. The shipyard workers had placed the black and yellow tape across the access to the starboard engine room fan room with the expectation that it would deter access. The use of such tape to warn of a hazard followed the EU directive requirements and national law; however, it did not specify the nature of the hazard it was indicating. By reference to MGN 556 (M+F), the COSWP identified that the use of black and yellow markings could be interpreted as warning of a dangerous location but did not necessarily identify the presence of a fall or electrical hazard. It is possible that the fitter might have taken the tape as denoting only the presence of the wet paint evident in the space.

Without additional signage to indicate the nature of the hazards present in the fan room, the tape alone was insufficient as a control to prevent the space being accessed.

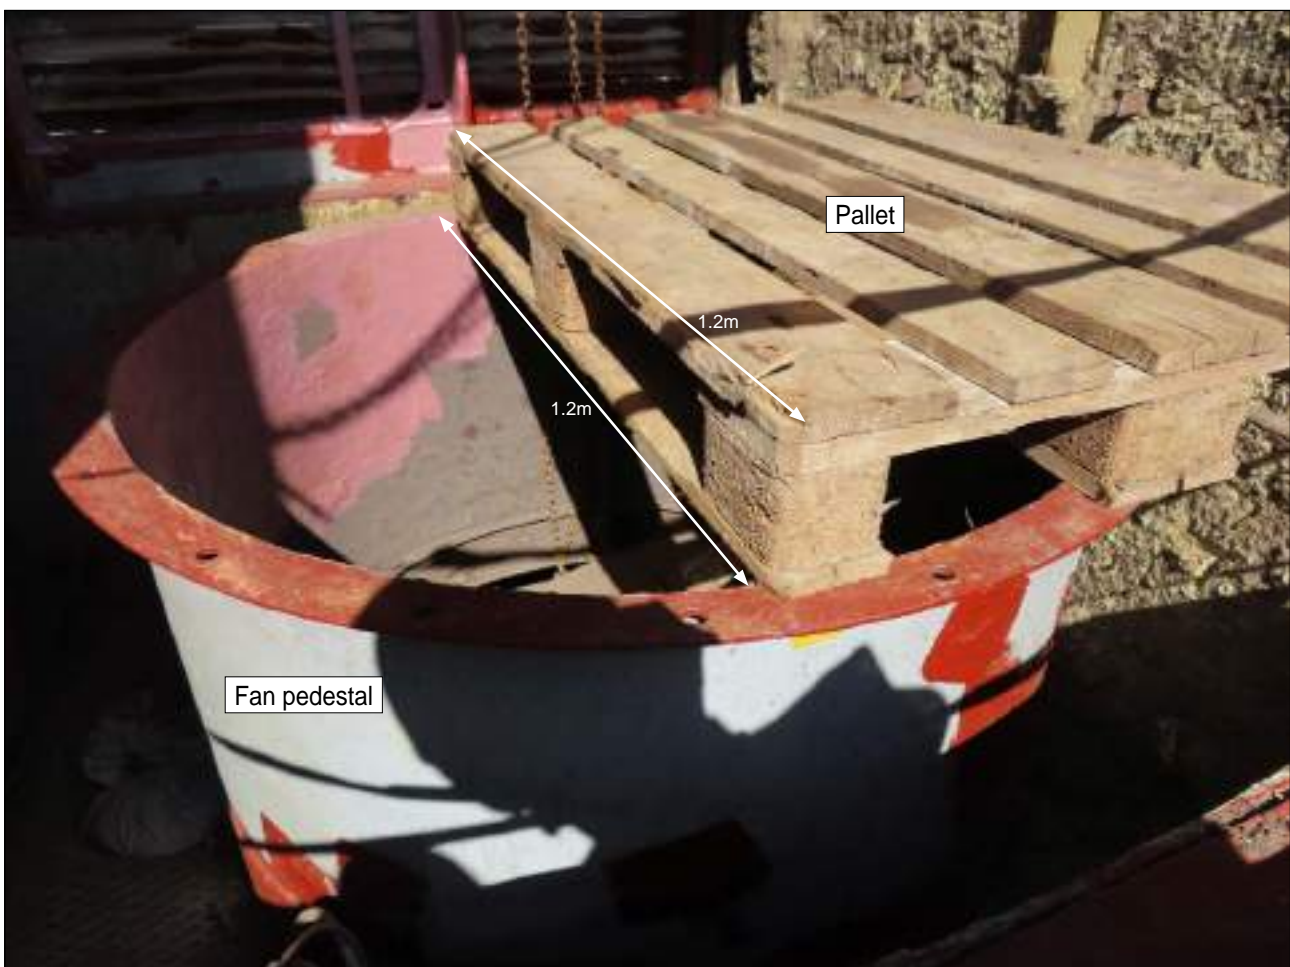
A standard wooden pallet<sup>5</sup> was placed on the top of the pedestal, partially covering the opening. The pallet was not secured and was reported to have been positioned across the forward half of the pedestal opening (**Figure 10**). The length of the pallet was 1.2m, the same as the internal diameter of the pedestal opening.

**Figure 10:** Pallet on the fan pedestal in the position it was reported to have been found
