MARINE SAFETY INVESTIGATION REPORT

Safety investigation into a fatality on board the
Maltese registered oil tanker

SEAPRINCESS

in TK Tuzla Shipyard, Türkiye
on 14 August 2023

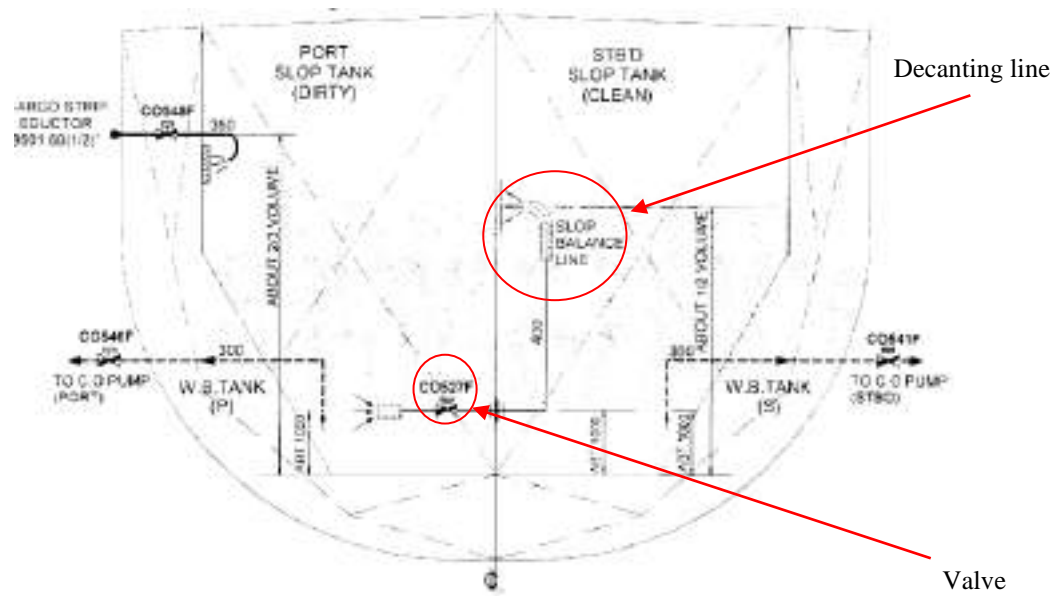
Figure 4: Cross-section through the slop tanks, showing the decanting line

On 07 August, the chief officer and a service technician tested all the valve actuators located in the cargo and slop tanks, to identify any defective valves. Valve 'CO527F' (**Figure 4**) in the port side slop tank was also tested. During the opening and closing testing sequence of the valve, a quantity of oily-water mixture that had remained

entrapped in the decanting line, spilled inside the slop tank, before the valve could be shut. The spillage was reported by the technician to the chief officer, as soon as he came out of the slop tank.

During the testing of the actuator valves inside the slop tank, a quantity of oily-water mixture, which unknowingly had remained inside the decanting line between the two slop tanks, was released inside the port side slop tank. Although the safety

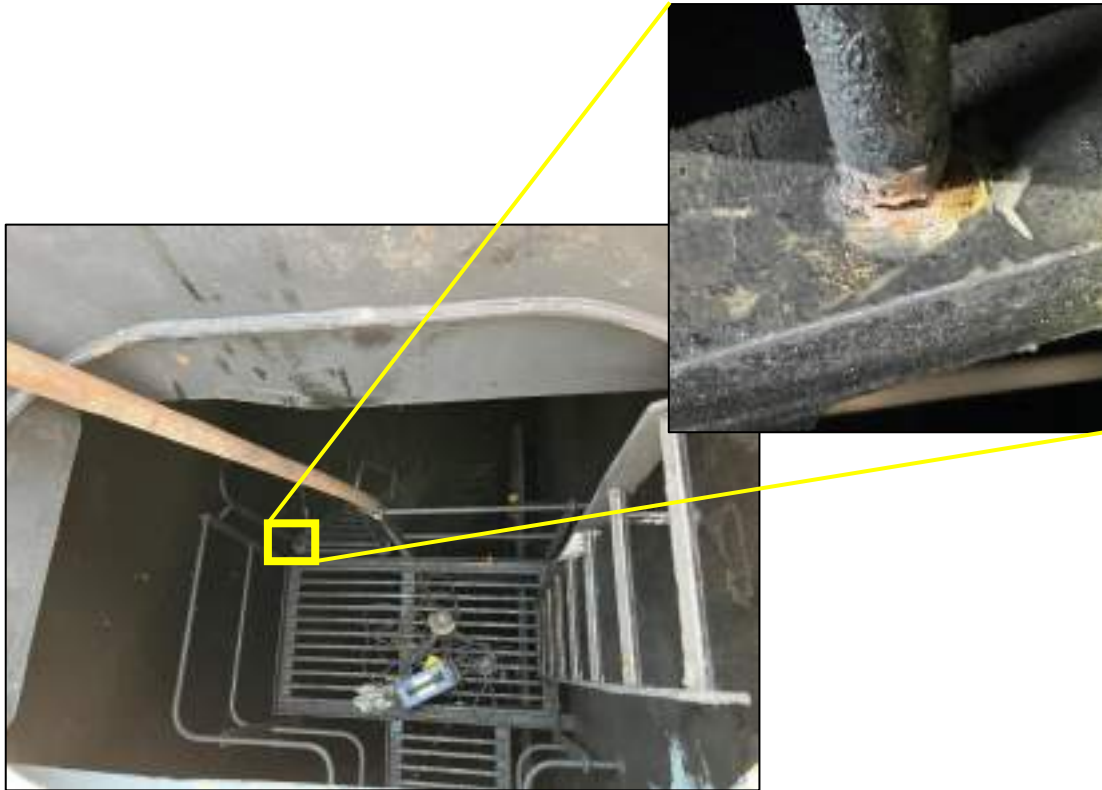
Figure 8: entrance to port side lope tank, showing the first stanchion that required repairs

The first and second stanchions on the sloping ladder were identified as the ones requiring attention (**Figure 8**). Whilst neither an entry permit nor a hot work permit was granted for the entry into the tank, the crew members were not informed that the foreman and welder 2 were entering the tank.

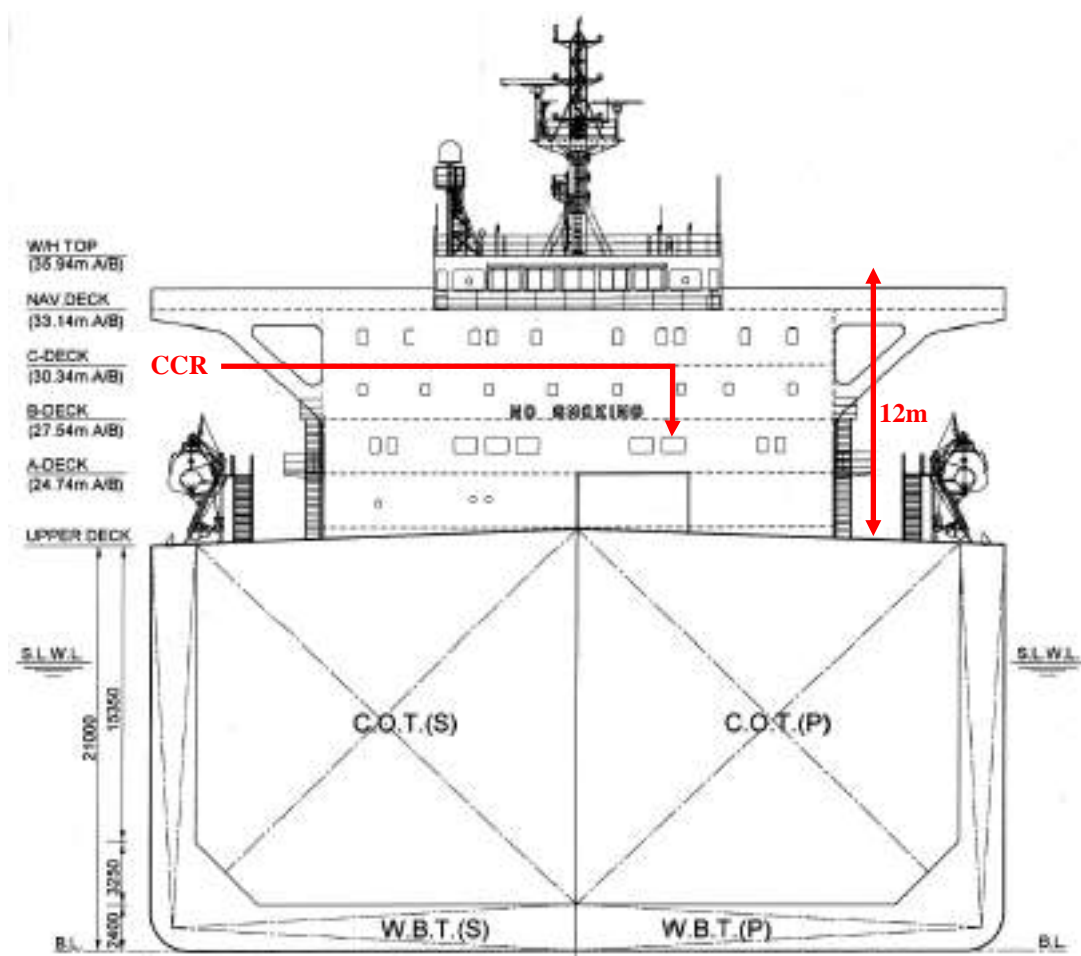
Figure 9: Approximate height from main deck

Persons on board, who witnessed the accident, stated that they saw welder 2 rise to an estimated height of about 12 m from the main deck (Figure 9); the OOW observed welder 2 from the bridge window. Falling back to the main deck, a second explosion³ appeared to cushion his fall, slowing his free fall before landing on the deck.

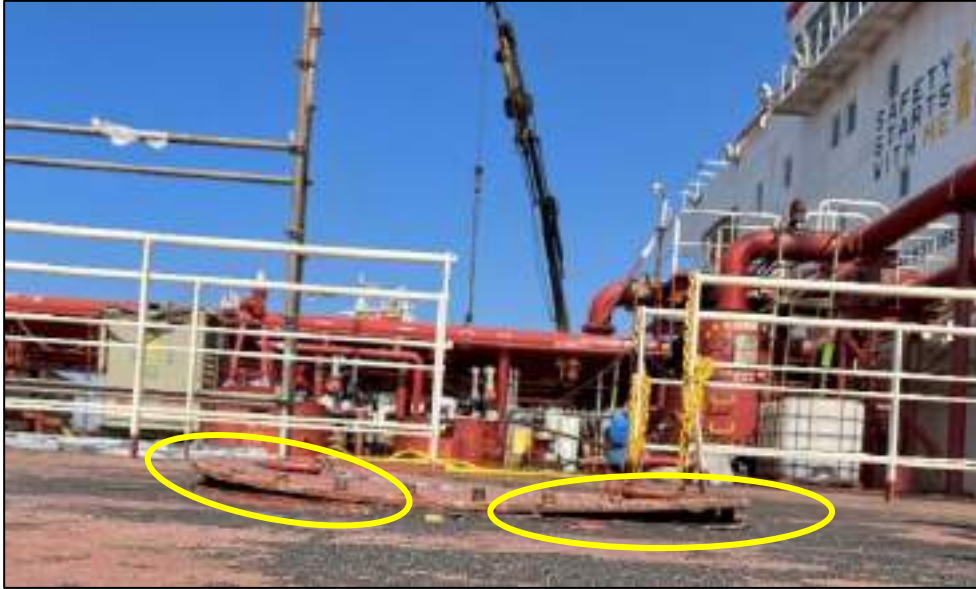
Figure 10: Buckling of the port side slop tank's manhole cover

An inspection of the area only revealed damages to the slop tank's manhole cover, which was found buckled (**Figure 10**) by the pressure wave generated by the explosion inside the tank. No structural damages were observed inside the slop tank. Soot residue from the fire was observed on the bulkheads (**Figure 11**).

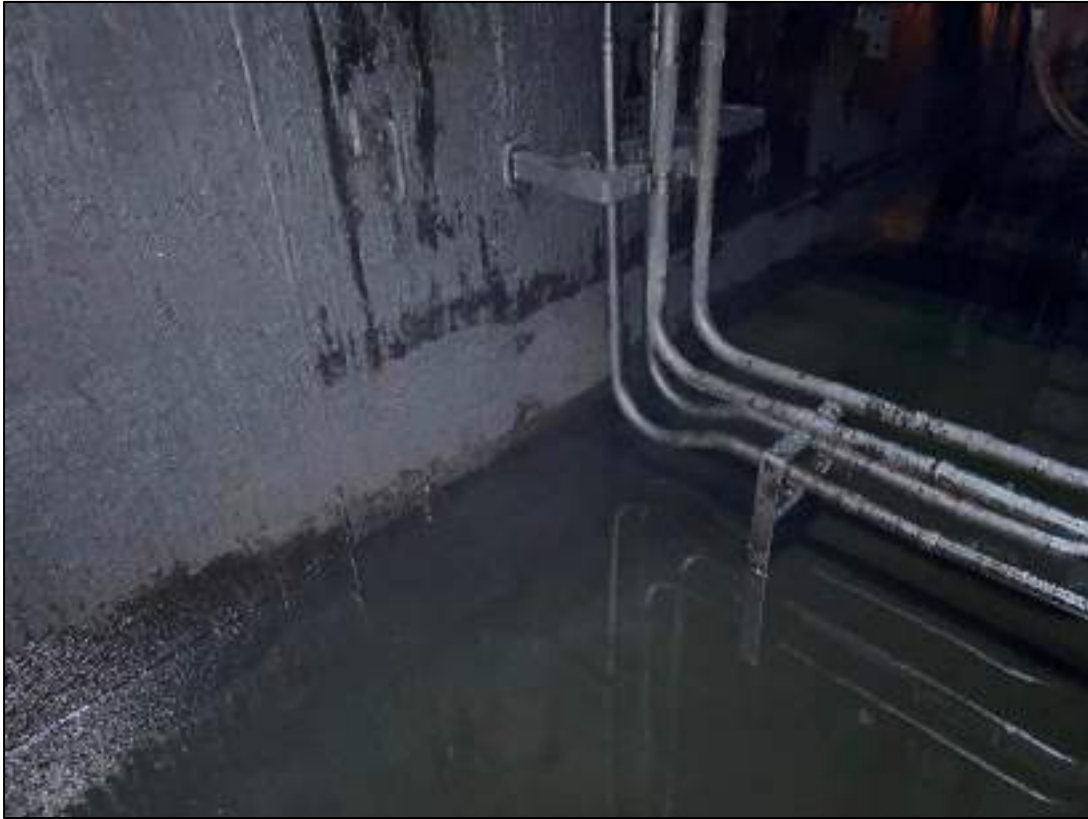
Figure 13: Firefighting water inside the slop tank

investigation could not determine the actual quantity of liquid because of the firefighting water remaining inside the slop tank after the accident (**Figure 13**), it was estimated that between 500 litres and 600 litres of the oily-water mixture may have been accidentally spilled inside the slop tank.

Over the following seven to eight days, the oily-water mixture, which accumulated inside the slop tank at ambient hot temperatures ranging between 29 °C and 33 °C, was very likely to have generated vapour. Being heavier than air, the oil vapour would have remained at the bottom of the tank, with the splatters from the arc welding causing the explosion.

Although the slop tank had been tested at 0800 and was found to be gas free, the safety investigation concluded that the build-up of a small gas pocket at the lower levels of the tank must have escaped detection when the atmosphere was tested by the shipyard that morning. A mixture of hydrocarbon gas and air is heavier than air, if the air content is at least 90% of this volume. It was not excluded that the difference in the densities (between the hydrocarbon vapour and air) may have caused variations in the readings. This issue would have manifested itself more prominently if the
