Marine Safety Investigation Report

VERY SERIOUS MARINE CASUALTY | October 2024

Fri Sea

Man overboard on 28 March 2024

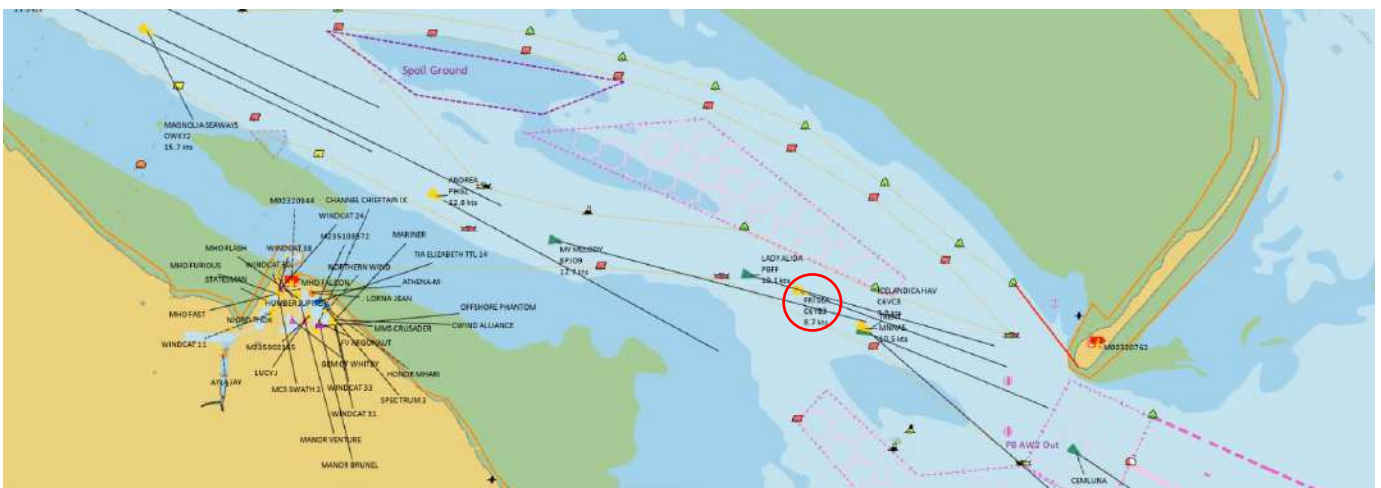
Traffic situation at the time the man overboard was reported. Fri Sea ringed. (Source: Humber VTS)

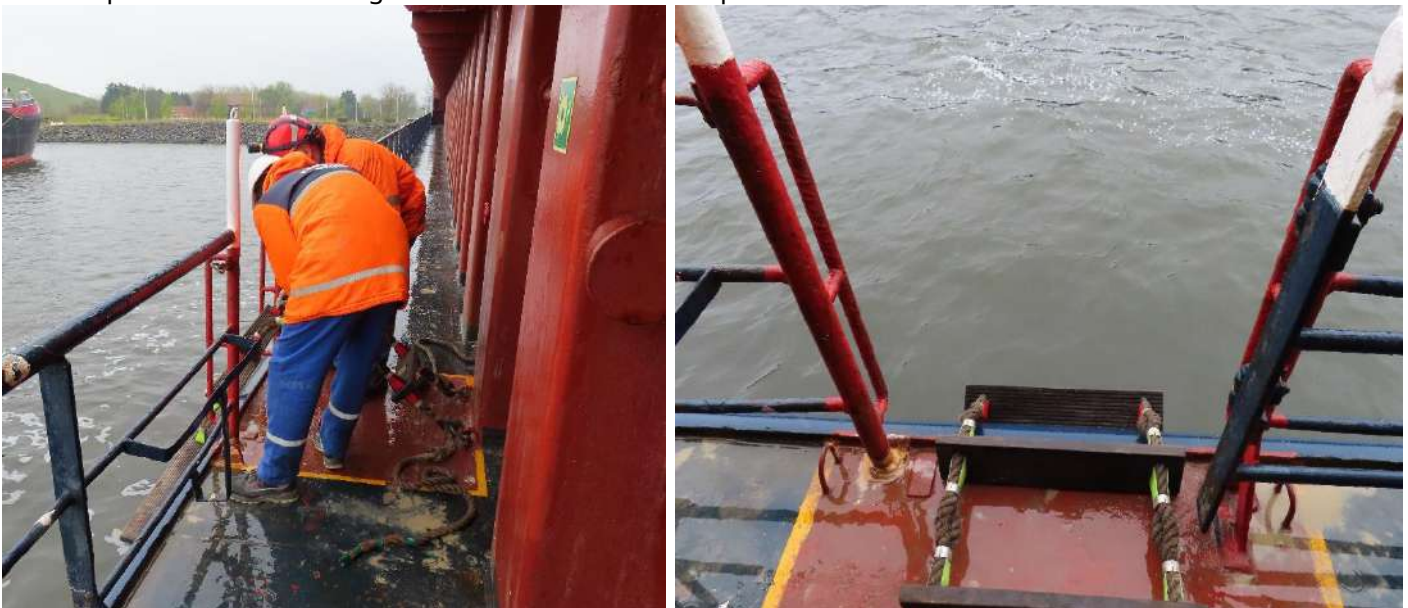
Fri Sea carried two pilot ladders – one of a length suitable for the vessel's loaded condition and one for its ballast condition. When it was required to be rigged 1.5m above the sea, the ladder could be shackled directly onto two purpose fitted lugs on the deck. The pilot ladder then passed through an inward-opening gate in the ship's rail. This task could only be completed with two crew working together. Due to the design of the gate, it was not possible to close the gate once the ladder was in position.

Rigging the ladder, ladder in position (gate opens to the right of picture)

The design of the pilot transfer arrangement meant that when the pilot ladder was rigged, there was a gap in the ship's rails that could not be closed, adjacent to a potential trip hazard (the ladder). As the hazard of falling overboard was not recognised, there were no control measures in place to reduce the risk of falling over the side (such as a temporary barrier/chain) and no appropriate personal protective equipment available to the crew to mitigate the outcome of a fall.

In line with requirements, the gate in the ship’s rails opened inwards but its design meant that it had to remain open when the pilot ladder was in place – increasing exposure to risk.

- Provided vessels in its fleet with inflatable lifejackets.
- Reviewed the design of openings in ship’s rails throughout its fleet. The gate on Fri Sea has been altered to allow it to be closed when the pilot ladder is rigged.
- Added anti-slip coating to the decks between pilot ladder and accommodation.
- Revised its procedure for rigging of the pilot ladder (including mandatory use of inflatable lifejackets) and issued a fleet circular explaining the changes.

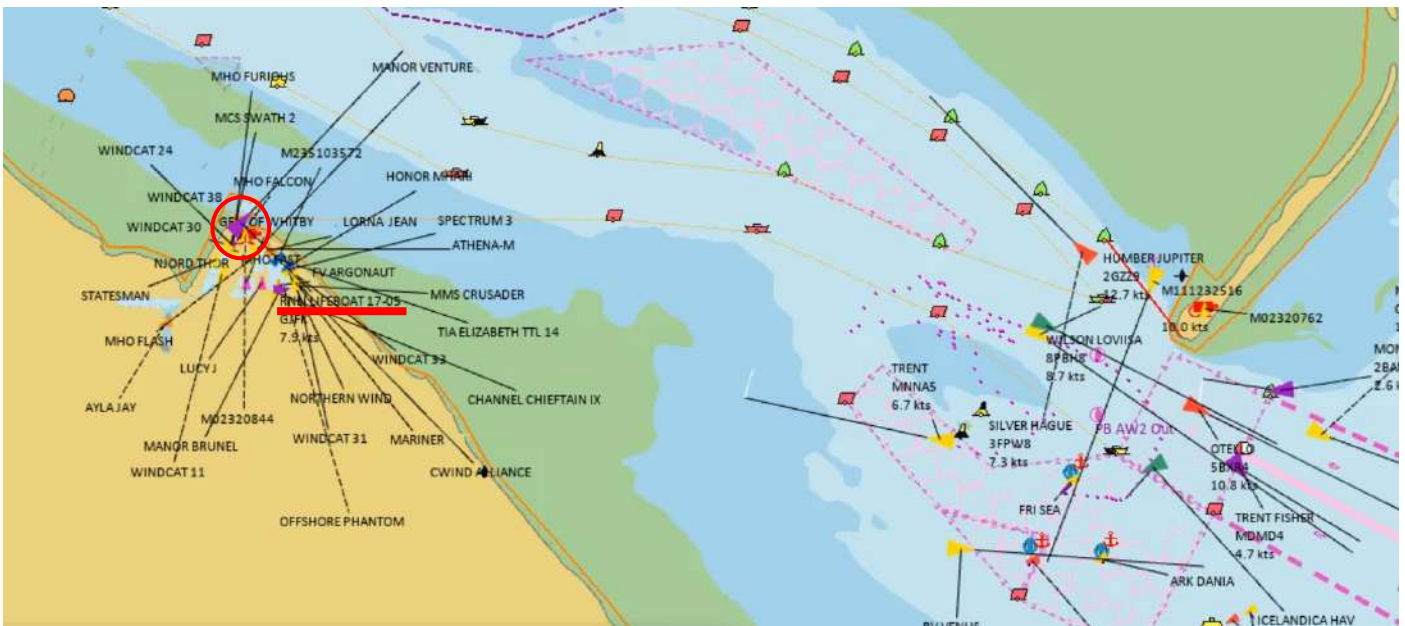
Pride of Humber (RNLi Lifeboat 17-05) leaving Royal Dock lock at 23:57 (Source: Humber VTS)

Whilst it would not have had an impact on the outcome of the casualty, Humber lifeboat was waiting in the lock for over an hour after mobilising due to an issue with the outer sluice gate which reduced ability to remove lock water to match the falling tide outside the gates. Further delay would have resulted in insufficient depth of water for the lifeboat to safely cross the sill.
