Australian Government
Australian Transport Safety Bureau

Steering failure and contact with navigational beacon involving CMA CGM Puccini, Port of Melbourne, Victoria, on 25 May 2023

Investigation number	Report release date	Report status
MO-2023-002	12/02/2025	Final
Investigation level	Investigation type	
Short	Occurrence Investigation

Final report

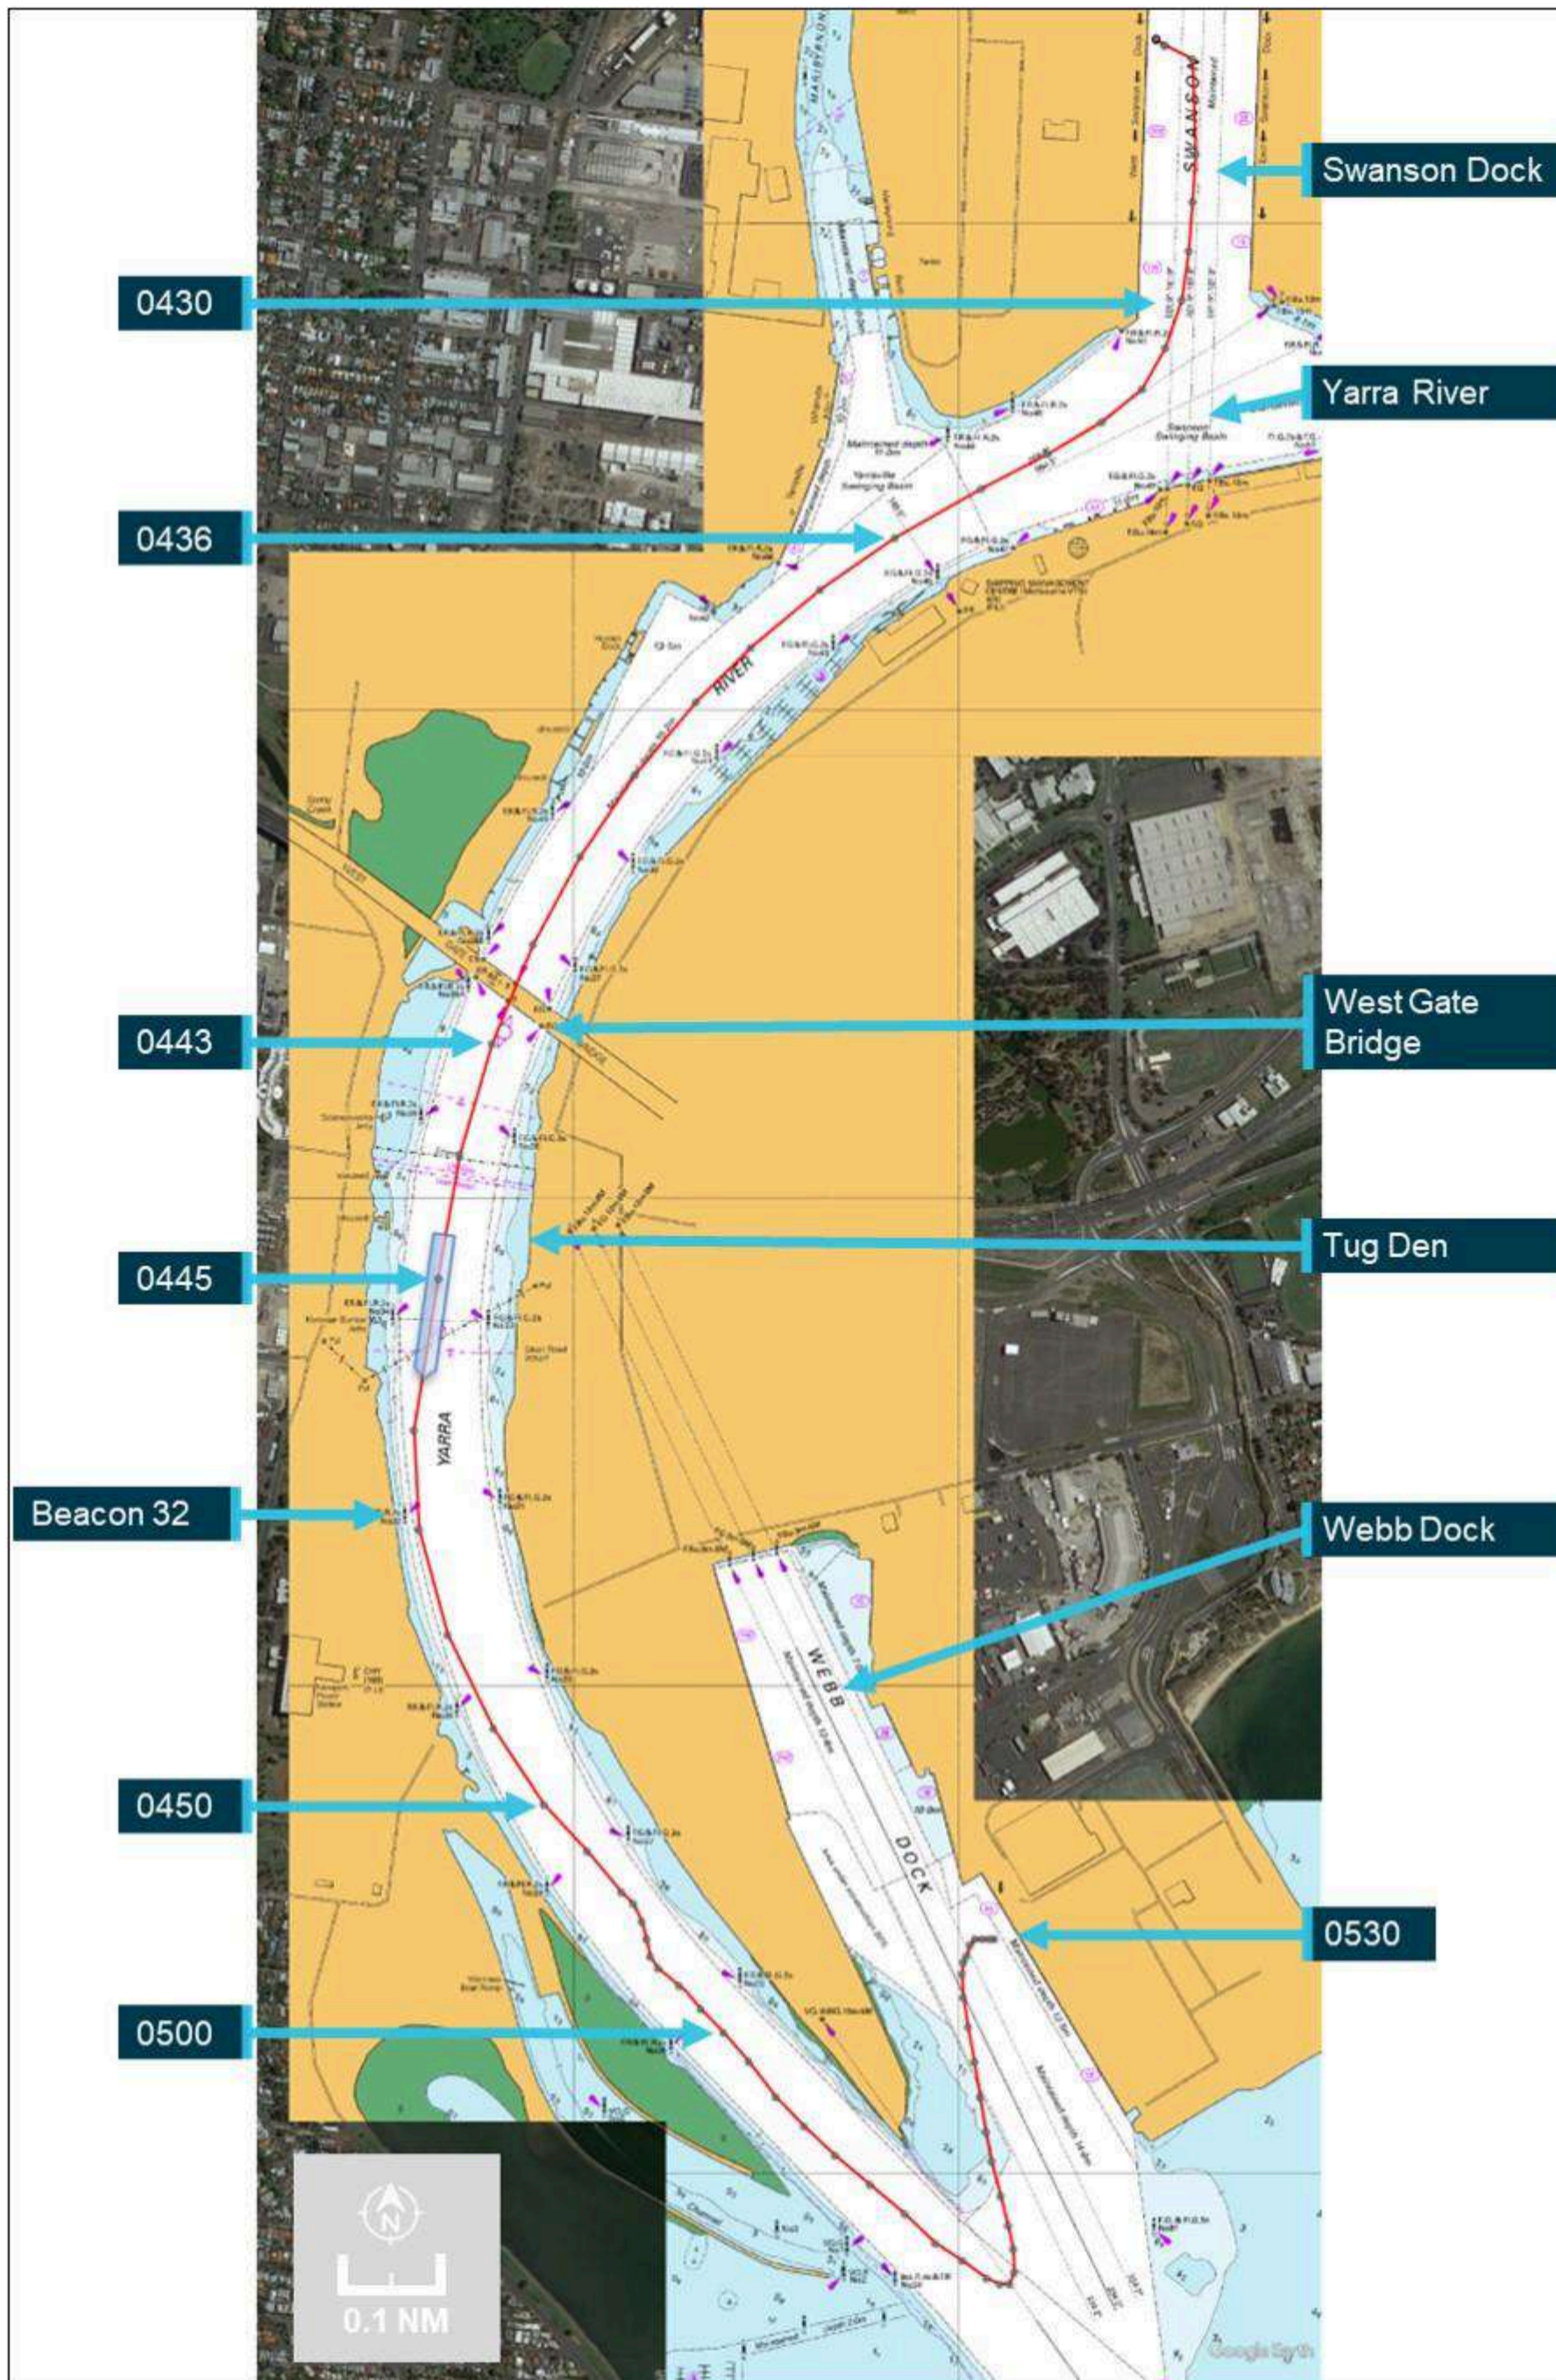
Figure 2: *CMA CGM Puccini*'s track from Swanson Dock to Webb dock

Soon thereafter (0444:03), the pilot noticed that the rudder angle indicator was showing that the rudder was midships and repeated the earlier port 10 order. The able seafarer steering the ship by hand (helmsman) advised that the helm (steering wheel) was at port 10. This exchange drew the attention of the master and chief mate, who both verified that the helmsman had correctly followed the order.

The helmsman informed them that the rudder was not responding to the wheel. By that time, the chief mate had moved to the steering console to investigate and observed that the rudder moved to port 5 and then slowly to starboard 5. The ship, with its speed increasing and rate of turn diminishing, tracked toward the western edge of the channel and beacon 32. At the time, the ship's speed was 7.7 knots, it was turning to port at 3° per minute and was 7 m to starboard of its planned track.^[8]

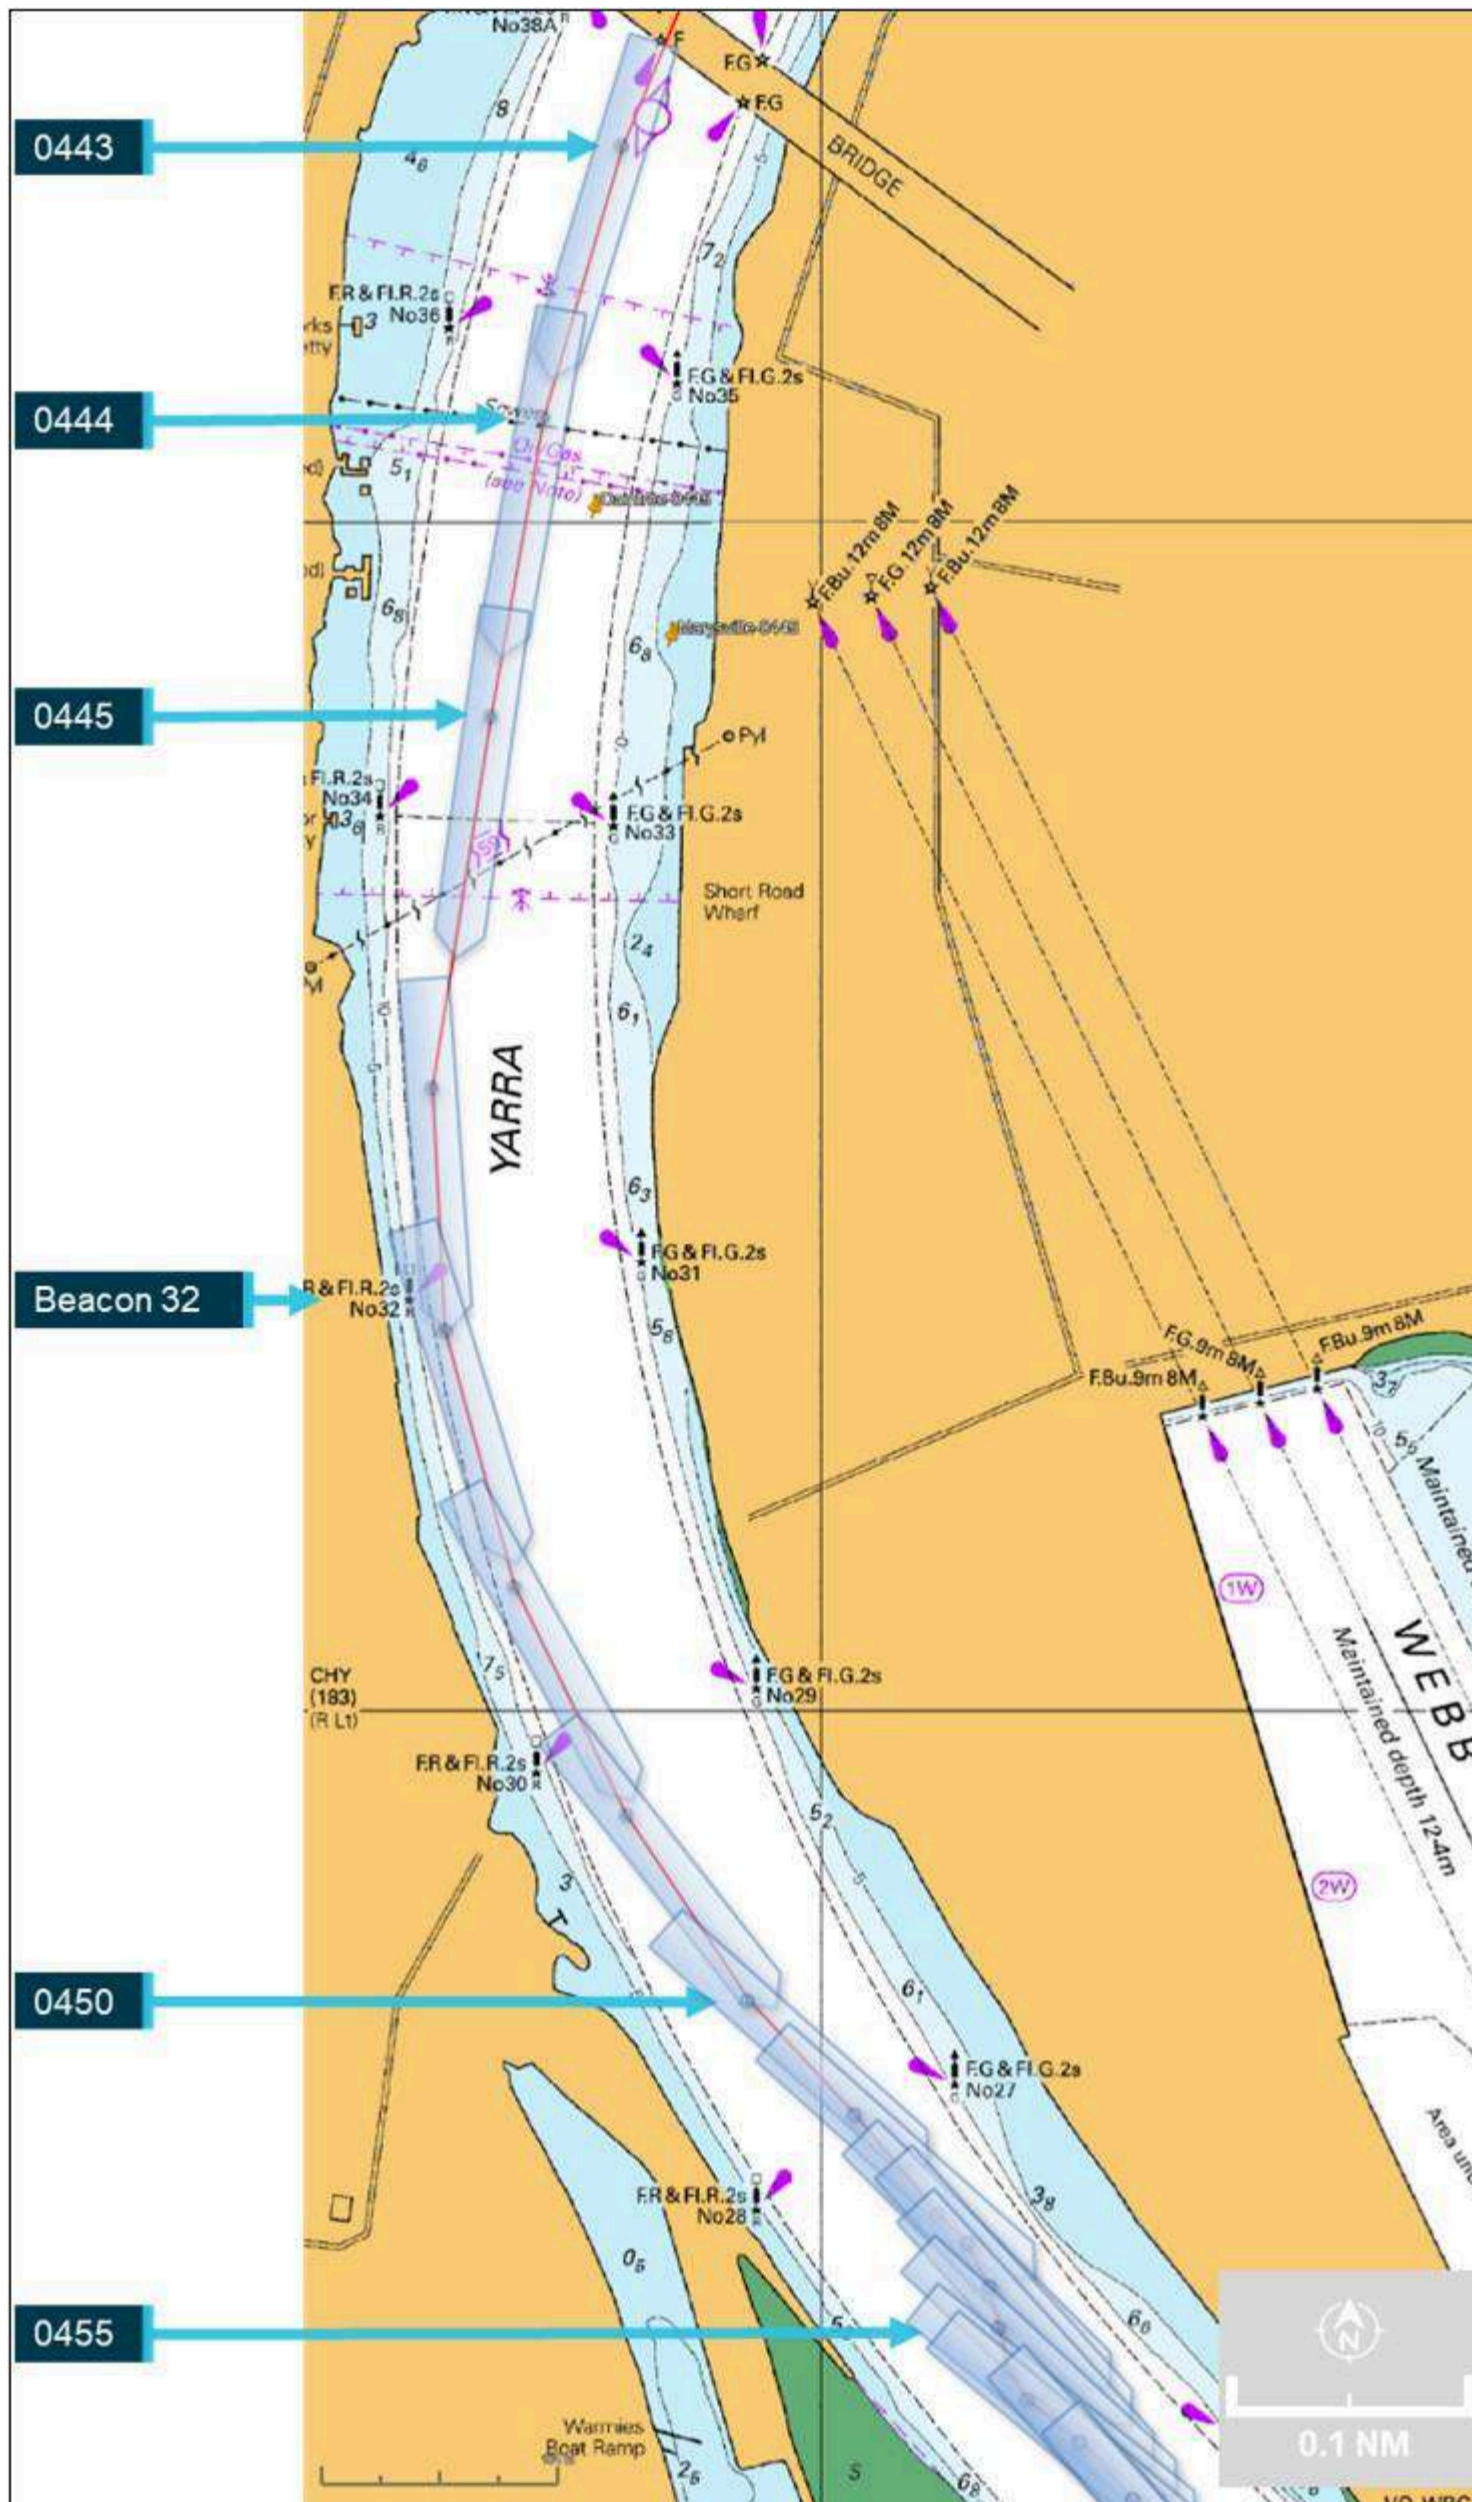
Figure 3: *CMA CGM Puccini's* track showing contact with Beacon 32

Shortly thereafter, the rudder was observed to move to 35° to port (wheel was hard to port). The main engine was restarted, and the bow thruster set full to port. At 0445:30, the ship's rate of turn to port suddenly increased as its bow closed with the side of the channel. By 0445:44, the ship's speed had reduced marginally (to 7.9 knots) and its swing to port had increased to 13° per minute, with the bow now less than 20 m from channel's edge. The pilot ordered the rudder midships and immediately after to starboard 20 to reduce the increasing swing to port with the aim of avoiding the ship's stern closing and contacting the western bank or shoals (Figure 3).

At 0446:12, the ship was 58 m to starboard of the planned track with significant headway (7.7 knots) and turning rapidly to port (20° per minute) with the bow only about 12 m from the 10 m depth contour and shoal water. Hard starboard rudder and bow thruster full starboard were ordered and the rudder observed to move to about 20° to starboard. However, as *CMA CGM Puccini* was swinging to port, its stern was swinging in the opposite direction (to starboard) and contacted beacon 32. The impact resulted in damage to the beacon, which canted over about 20° from the vertical (cover photo). The ship's side paintwork was scratched due to scraping against the beacon.

Following the contact, the helmsman advised that the wheel was hard starboard (as ordered) but the rudder angle was only 5° to starboard. At 0447, the ship's speed had decreased to 7.2 knots and its swing to port had reduced (now 13° per minute). The ship was 67 m to starboard of track as the curve of its stern passed across the 10 m depth contour.

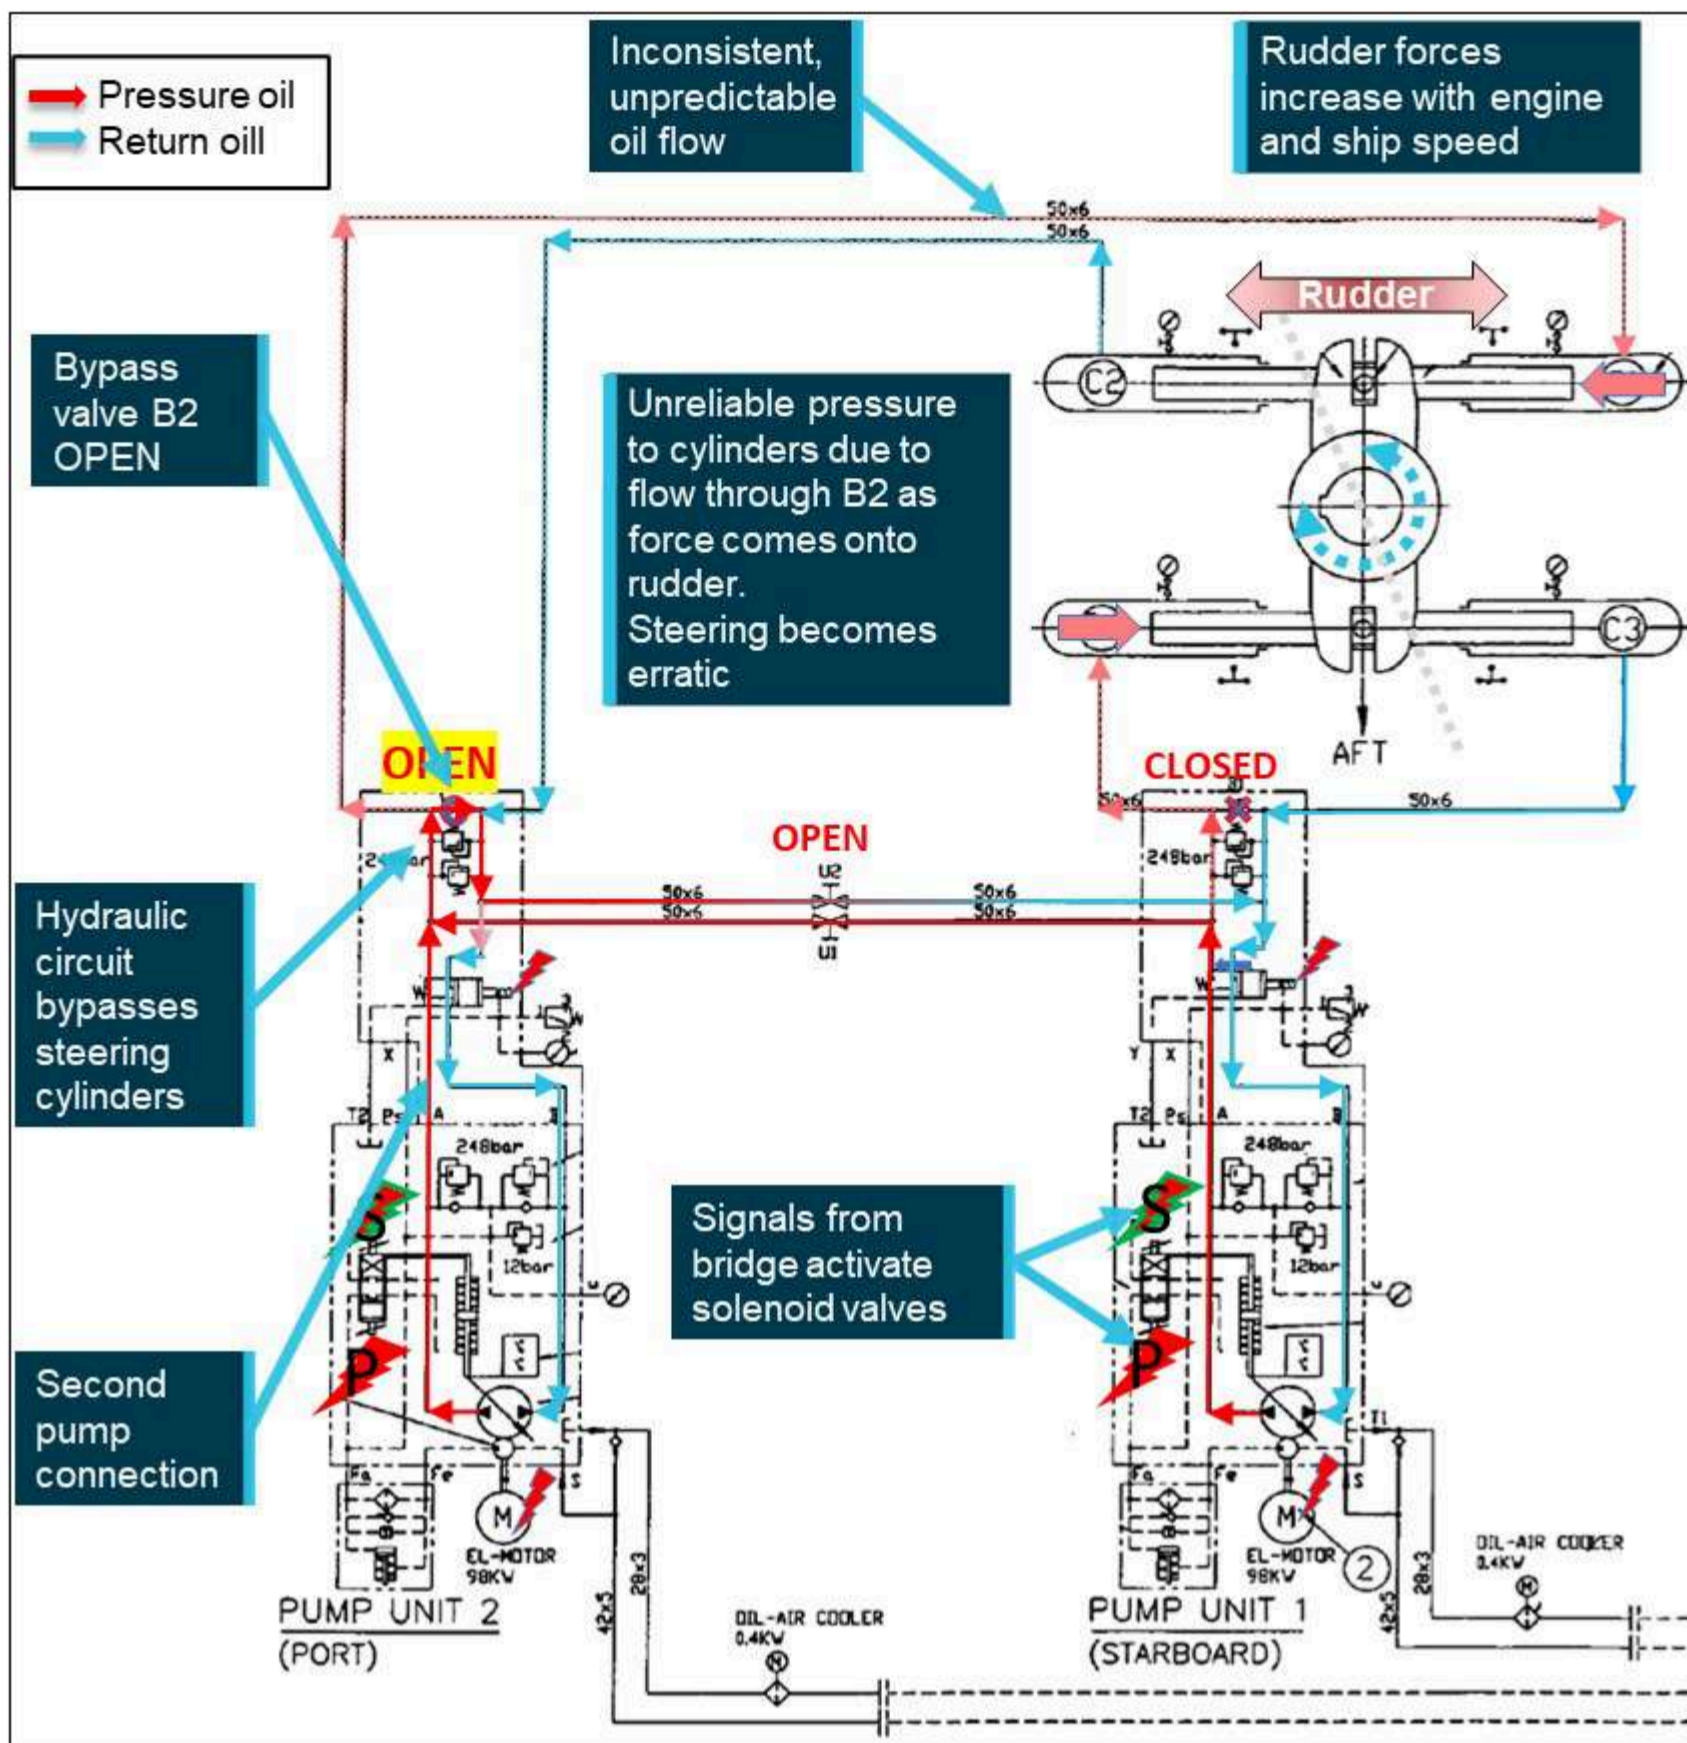
Figure 8: Steering gear hydraulics with both pumps running and one pump bypass valve open

Following steering tests conducted for port State control inspections on the day before the incident, one of the hydraulic pump bypass valves was left open. This resulted in the steering system hydraulics being incorrectly configured for normal operation.

The open bypass valve would have slowed the speed of response but the system, with either, or both pumps running, was still capable of moving the rudder. This was probably the case during the PSC inspection, as well as during pre-departure steering checks.

However, when the ship was underway and the main engine speed was increased, as the rudder was moved and a larger surface area was exposed to the water flow, the load on the rudder increased. At low speeds, the hydraulic system pressure and flow were sufficient to overcome the rudder loads. However, as the main engine was increased to half ahead, and the ship's speed exceeded about 8 knots, the hydraulics were then adversely affected by the flow through the open bypass valve, leading to inconsistent, erratic response of the machinery. Control of the steering was subsequently lost, with the ship turning wide in the channel and making contact with the navigational beacon.

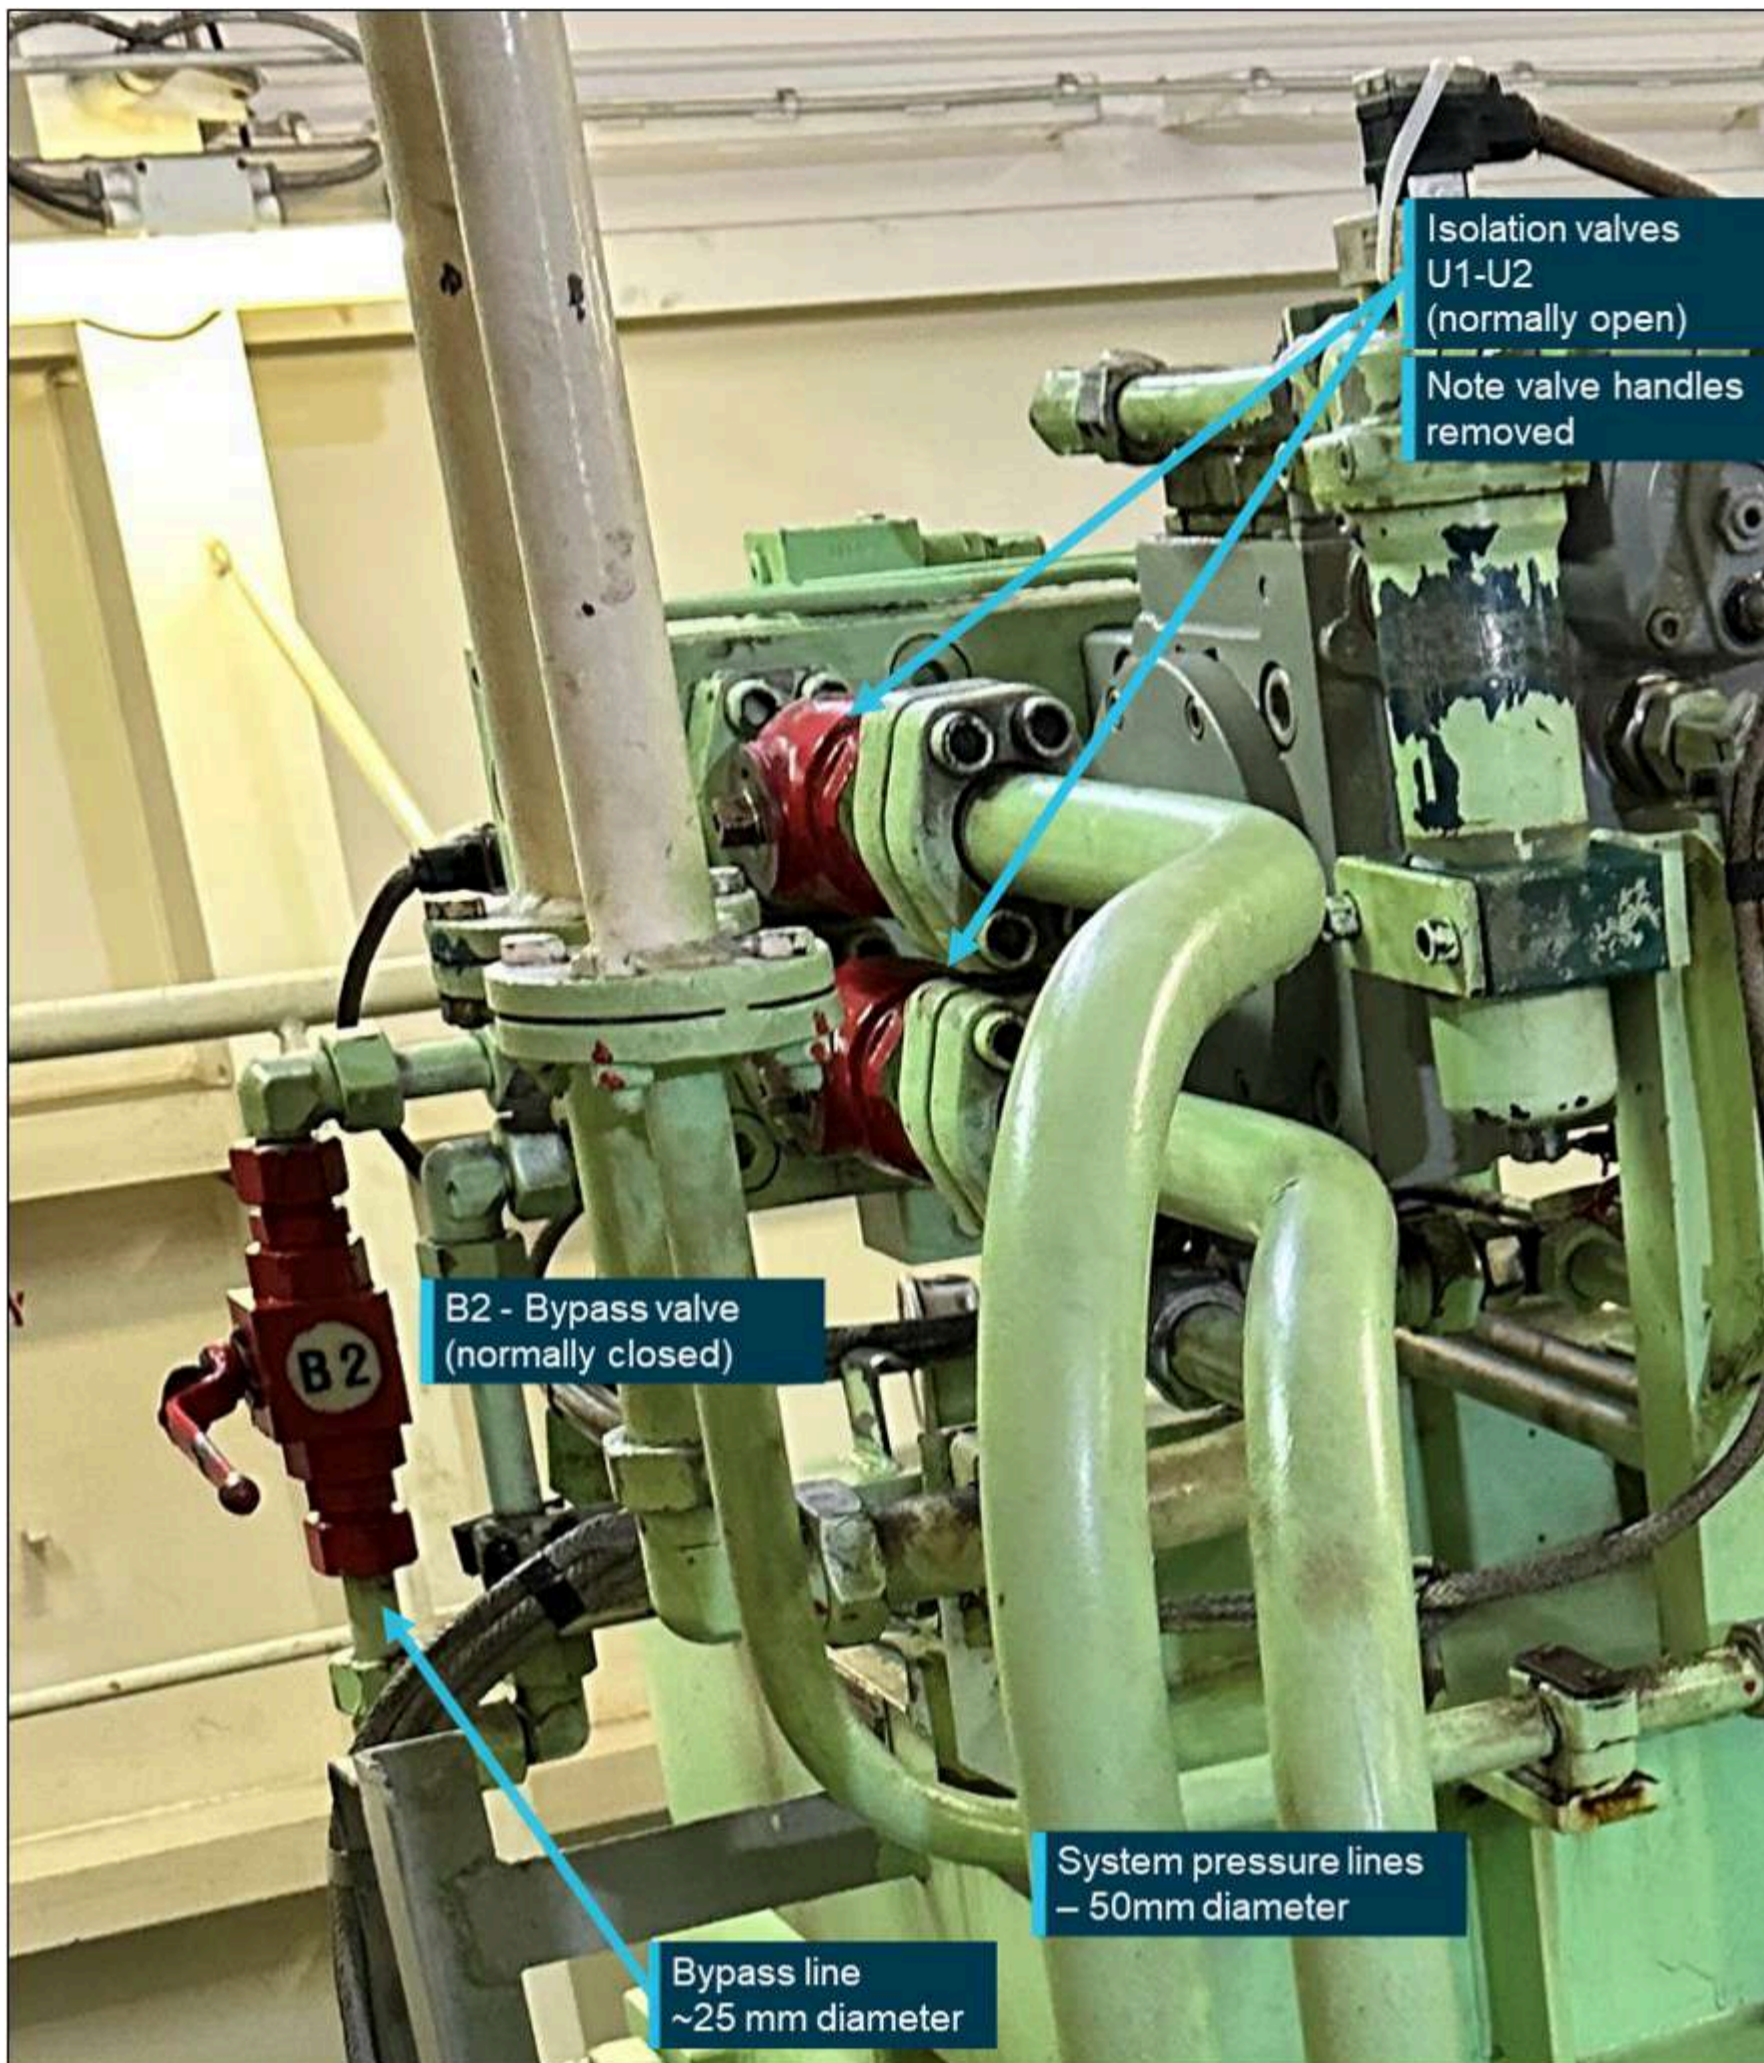
Figure 9: Steering pump #2 bypass valve and system isolation valve arrangement

The steering pump bypass lines were about half the diameter of the system flow lines (Figure 9). The difference in pipe diameter allowed the majority of oil flow to pass to the hydraulic cylinders, with leakage through the open valve around the pump. With the ship alongside and with no water flow over the rudder, the load on the rudder was minimal and the hydraulics moved the rudder as expected and sufficiently well to pass the visual observations.
