**REPUBLIC OF CYPRUS
MARINE ACCIDENT AND INCIDENT
INVESTIGATION COMMITTEE**

Investigation Report No: 50A/2022

Very Serious Marine Casualty

Collision of the RO-RO/PAX “KATTEGAT” with Pilot Boat on the 01st of April 2022 at “Tanger Med” whilst underway from Tanger Med (Morocco) to Algeciras (Spain)

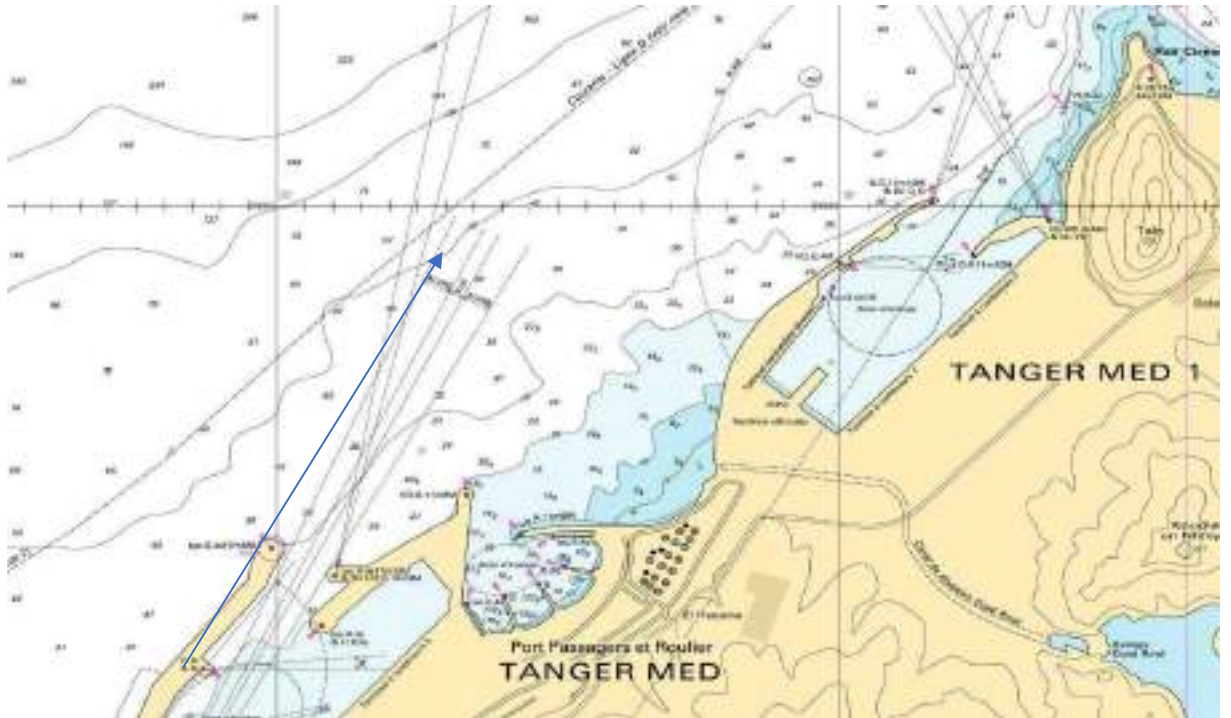
12. At 04:49:24 Hrs LT, the “KATTEGAT” collided with the pilot boat, at approx. 0.3NM north of the Tanger Med port’s breakwater. At the time of the collision the “KATTEGAT’ was on course 002° at a speed of 11 knots. The “SVITZER OUED MARTIL” was on a course 241.6° at a speed of 13.9 knots.
The position of the collision was: Latitude: 35-53.38 North Longitude: 005-31.09 West. The wind was from 309 at 15m/s, Sea -Swell North-West Direction, Waves 2m height.

Position of the collision – 0,3NM from Green Light Breakwater

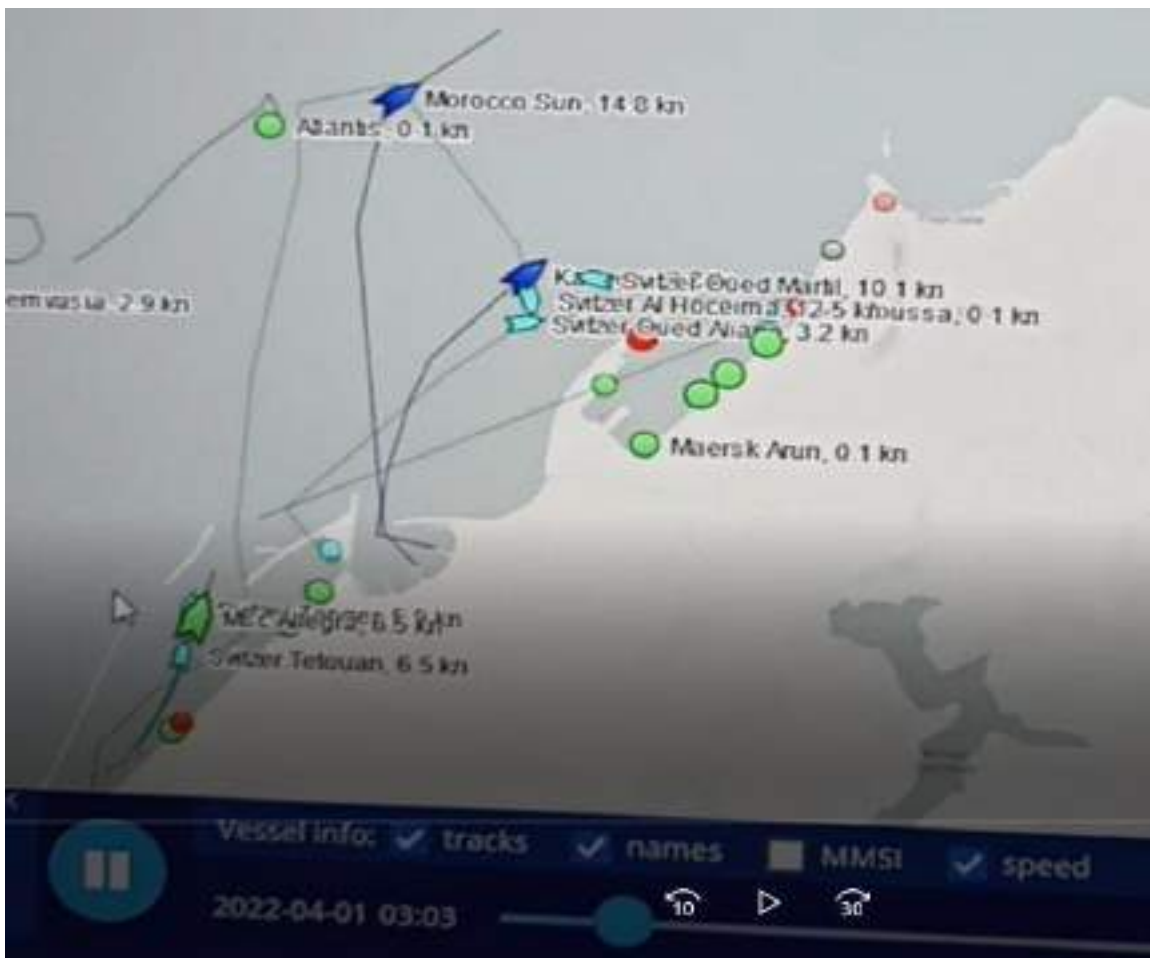
20. After about 10 minutes, the tugboat “SVITZER ALHOCEIMA” and the pilot boat “MOUSSA”, reached the area of the collision position and started searching together for the damaged pilot boat “SVITZER OUED MARTIL”. From the “KATTEGAT’s” nav bridge, the search light was used to help the assisting vessels to locate the pilot boat.

From Marine Traffic Website: Appr. 10 min after the collision (assistance on the scene)
