Interim report on the investigation of the collision between the container ship *Solong* and the oil/chemical tanker *Stena Immaculate*, resulting in one fatality, 14 nautical miles north-east of Spurn Head at the entrance to the Humber Estuary, England, on 10 March 2025

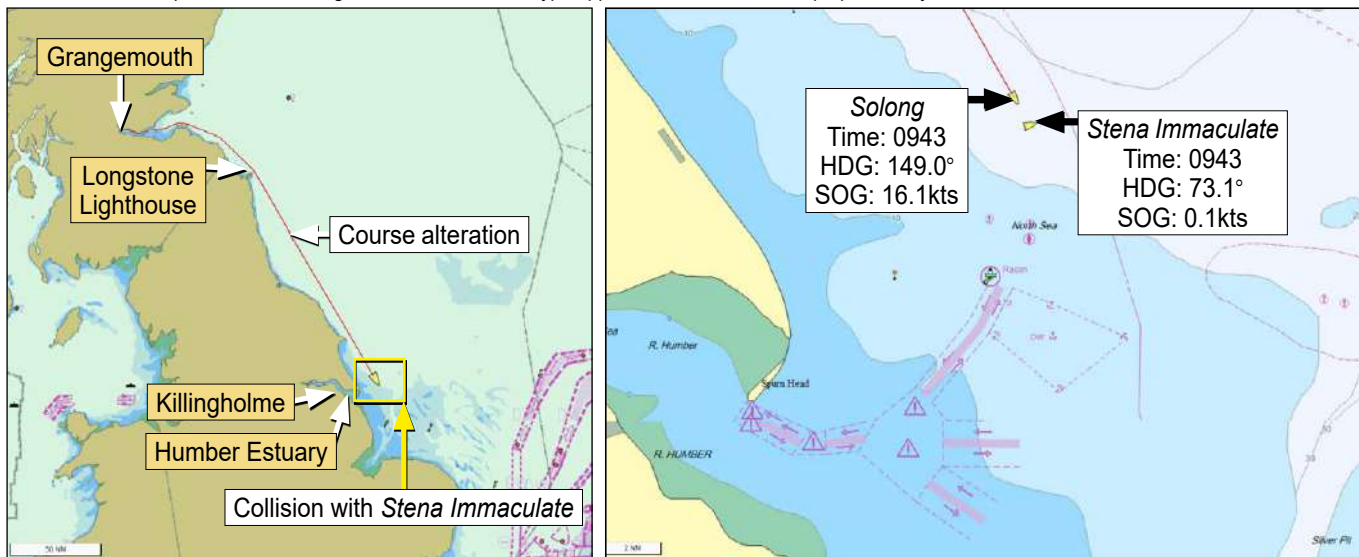
Figure 3: Passage of *Solong* and collision area

At 0947, *Solong* collided with the anchored *Stena Immaculate's* port side on a heading (HDG) of 150° and speed over the ground (SOG) of about 16 knots (kts) (**Figure 3**). Able seaman Mark Pernia, one of *Solong's* crew, was reported to be in the forecastle area at the time of the collision.

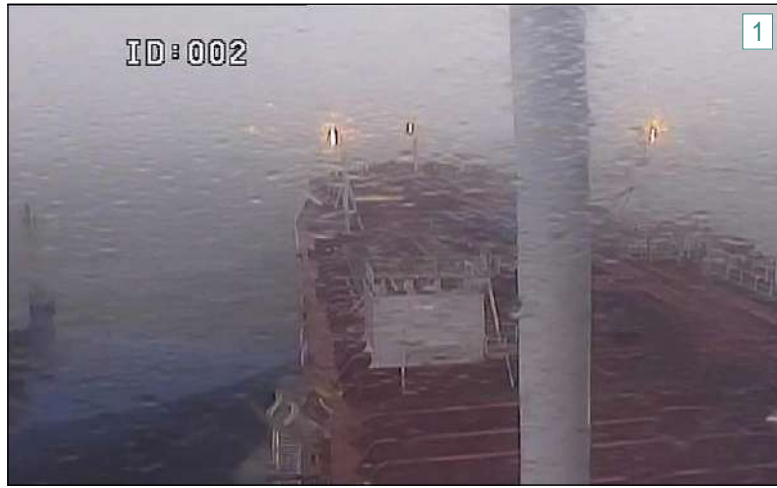
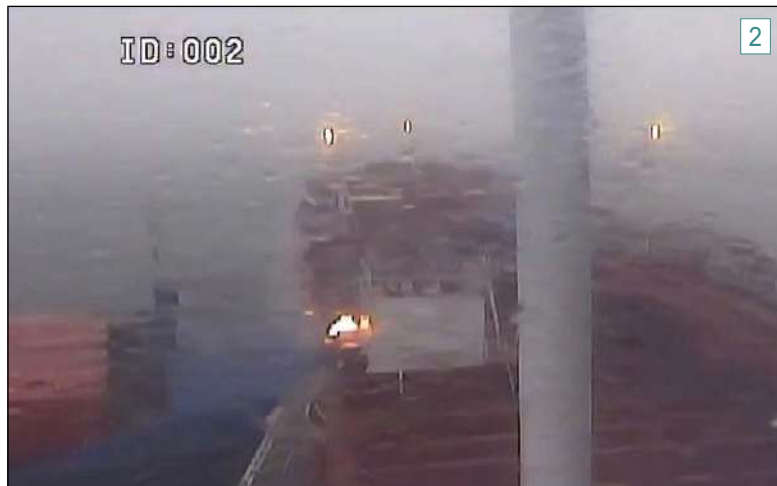
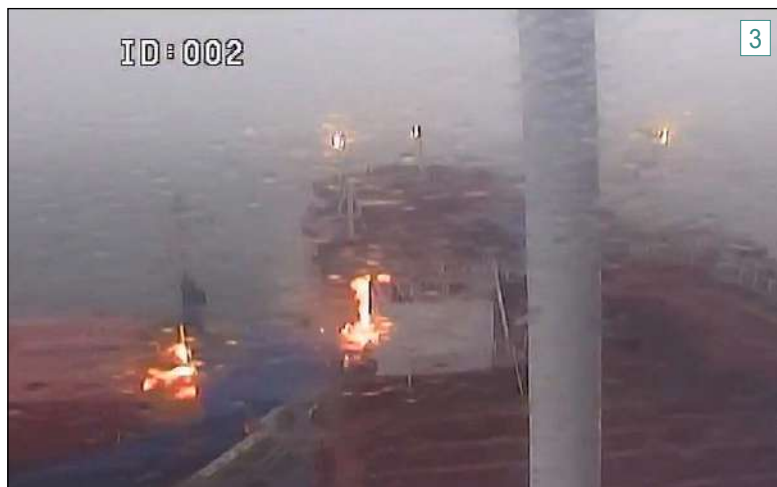
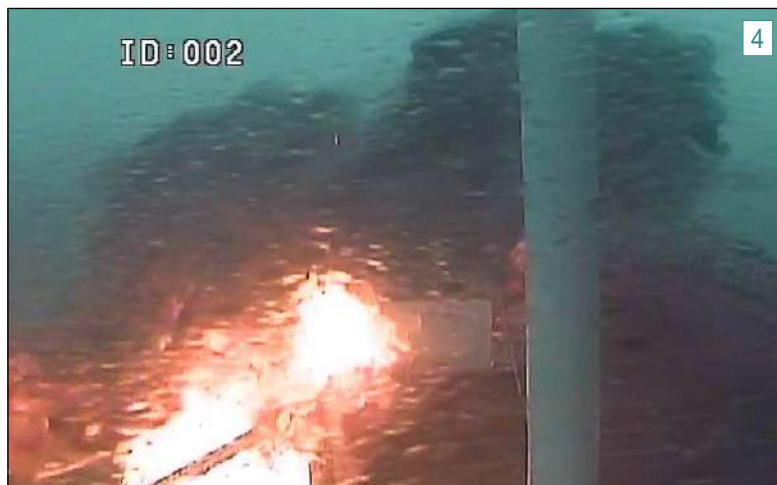
Figure 4: Initial collision

The collision breached *Stena Immaculate's* No.7 port cargo tank, releasing aviation fuel into the sea and onto the bow of *Solong*. The aviation fuel was ignited by the heat generated by the force of the collision (**Figure 4**) and the resulting fire ignited the contents of containers carried on board *Solong*.
