**MARINE ACCIDENT
INVESTIGATION REPORT**

Vessel Type and Name: Bulk Carrier EVER FELICITY

Accident Type: Injury and Fatality of Stevedores

Date and Time: May 20, 2024, at around 07:35

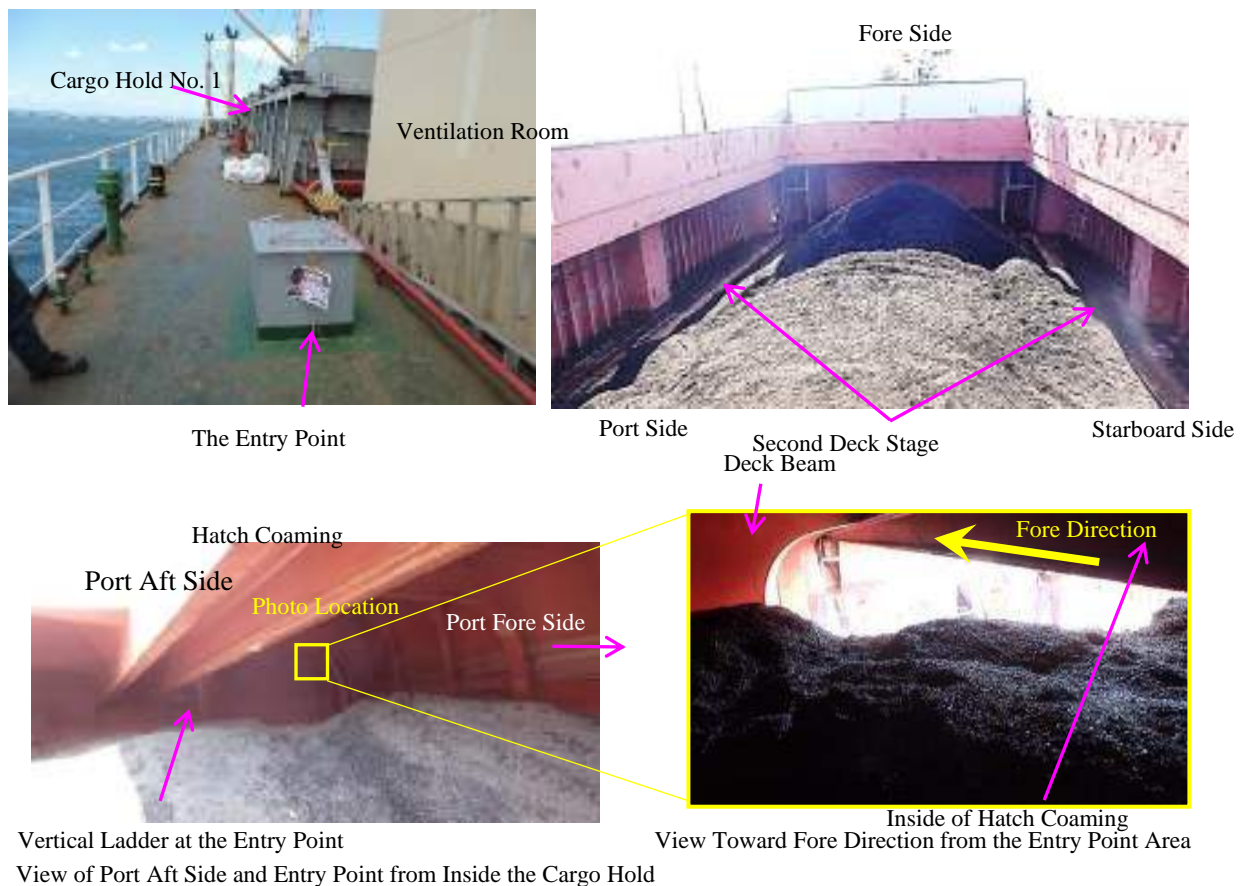
Figure 3 – Condition Inside No.1 CH and at the Entry Point

The entrance to No.1 CH, located at the center of the port side of the upper deck (hereinafter referred to as “the Entry Point”), was positioned at the aft-most section of No.1 CH. At the area beneath this Entry Point, Palm Kernel Shells (hereinafter referred to as “the PKS”) had been loaded to approximately halfway between the upper deck and the second deck—approximately 10.3 meters above the tank top deck, about 3.2 meters below the Entry Point hatch opening, and approximately 2.6 meters below the upper deck. In addition, from approximately the midsection of No.1 CH toward the fore end, the Subject PKS had been loaded to a height at where the stage of the second deck remained visible—about 7.7 meters above the tank top. (See Figure 3.)

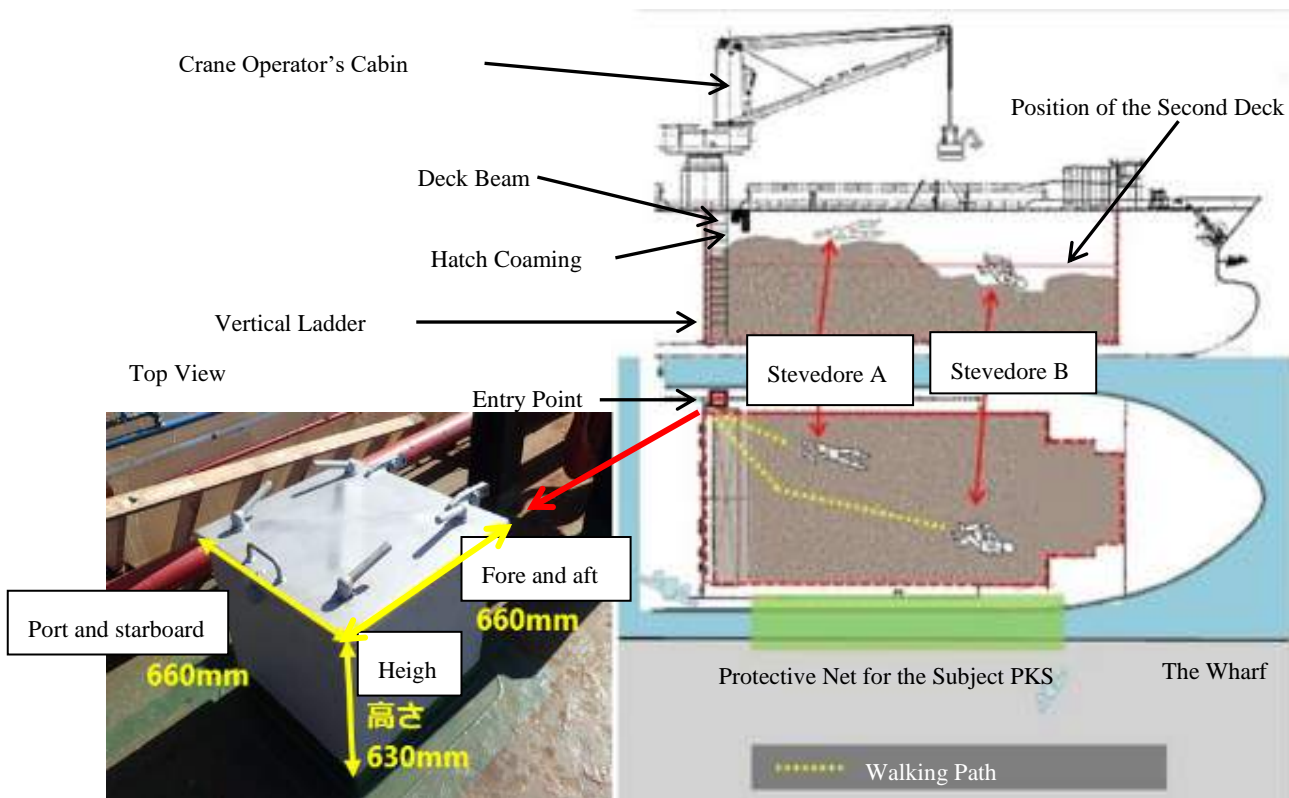
Figure 4 – Injury Locations of the Stevedores Inside No.1 CH

Stevedore B found it difficult to enter from the Entry Point, as the Subject PKS was visibly piled directly beneath the hatch, making access appear obstructed. He attempted to find an alternative entry point, however, unable to locate one, began descending the vertical ladder at the Entry Point. Stevedore A followed behind him.

Note: The walking paths of Stevedore A and Stevedore B are according to information collected by A1 B. Office.

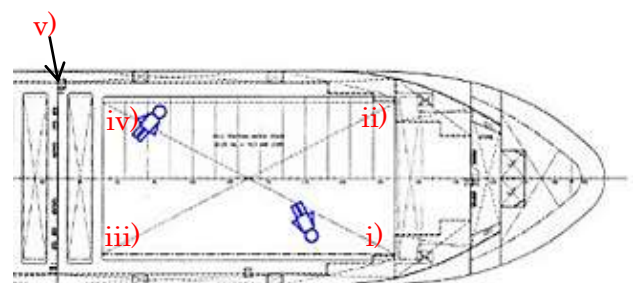
At around 08:15, prior to entering No.1 CH to carry out rescue operations, the rescuers measured the oxygen concentration directly above the PKS at five locations inside the hold: the four corners of the hatch opening and the area near the Entry Point. The measurement results were as follows (Note: The oxygen concentration in standard atmosphere is approximately 21%.):

Location in Cargo Hold	Oxygen Concentration (%)
i) Starboard Fore Side	17.6
ii) Port Fore Side	17.9
iii) Starboard Aft Side	19.9
iv) Port Aft Side	20.6
v) Entry Point	19.1

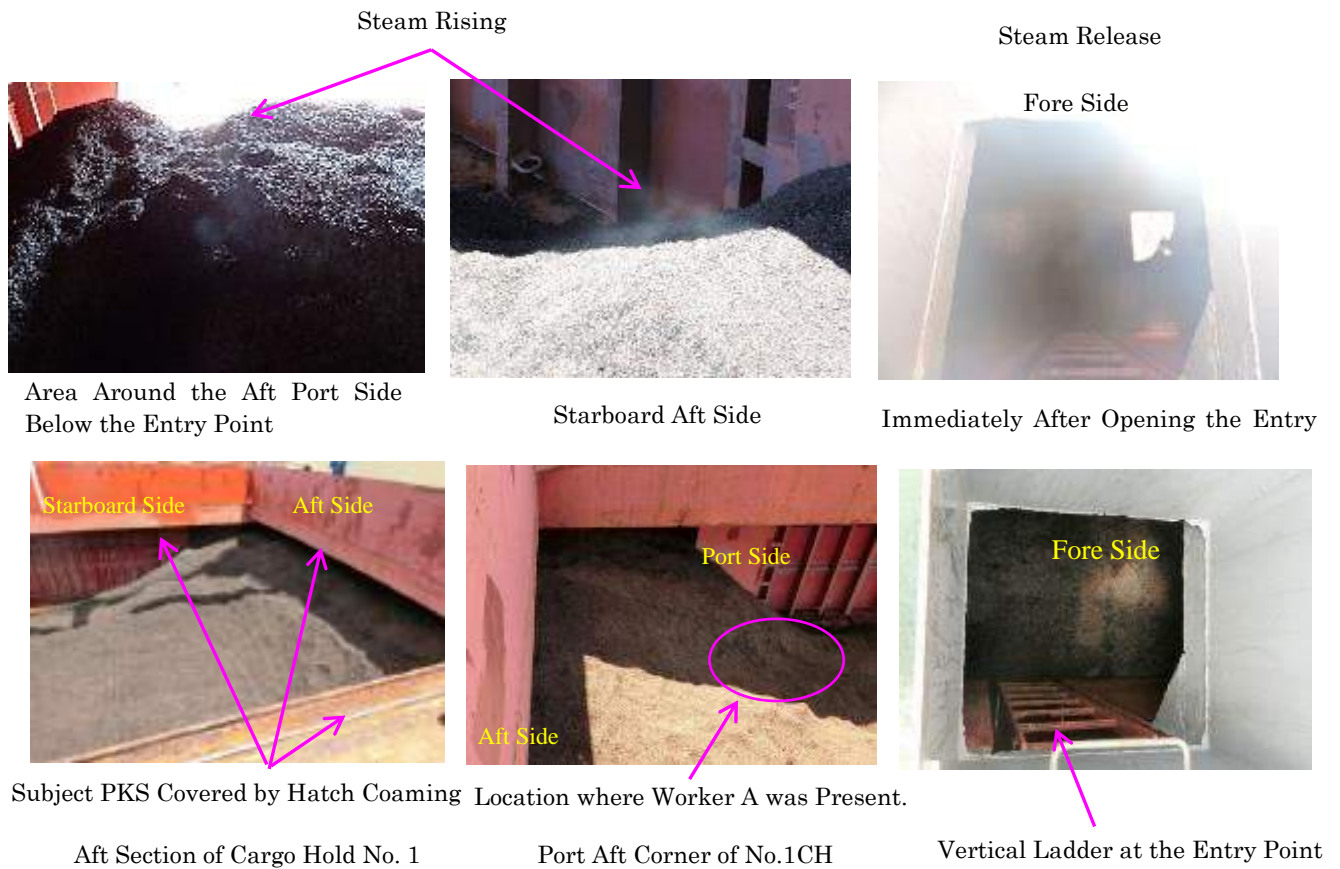
Figure 6 – Condition Inside No.1 CH (May 25)

The port aft side of No.1 CH, where Stevedore A collapsed, had a relatively high accumulation of the Subject PKS. This area was located in a corner near the hold's inner wall and was enclosed above by the overhanging hatch coaming from the upper deck, resulting in poor ventilation even when the hatch cover was open. During the investigation conducted on May 25, steam was observed rising from the surface of the Subject PKS.

open compared to other areas of the hold. The Subject PKS was not loaded as high as in the aft side, and no steam was observed rising from its surface.
