REPUBLIC OF LIBERIA
Liberia Maritime Authority

**Very Serious Marine Casualty Investigation Report
into the death of the Ordinary Seaman
on board M/V TOI CHALLENGER (IMO
9151515) on August 4, 2024**

**PUBLISHED BY THE LIBERIA MARITIME AUTHORITY
March 2, 2026
Dulles, Virginia
USA**

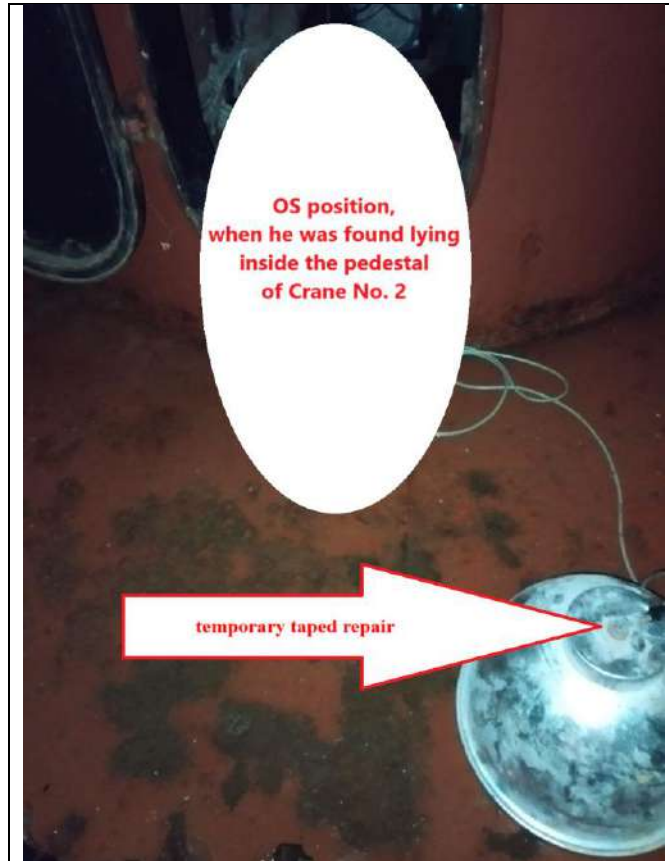
0010 LT, the OS was found lying inside the pedestal of Crane No. 2, facing inward, with the same light projector still energized and connected to the 220 V socket. The projector cable showed a taped repair.

Figure 1: Location of the OS within the Crane No. 2 pedestal at the time of discovery, with the portable light projector still connected by its tape repaired electrical cable.

The casualty likely resulted from the OS entering the pedestal of Crane No. 2 and contacting energized and shorted 220-V electrical equipment, most likely while attempting to disconnect the portable projector used to illuminate Hold No. 2. The projector remained energized and its cable had a temporary taped repair. The task occurred at night, in high humidity, with wet gloves, and the OS had limited experience. No task-specific risk assessment or toolbox talk was conducted prior to entry into this restricted space. Combined with insufficient supervision and communication, these conditions exposed the OS to live electrical hazards, resulting in fatal electrocution.

The probable cause of the casualty was the OS coming into contact with energized and shorted 220-V electrical equipment inside the pedestal of Crane No. 2 while attempting to disconnect a portable light projector, under conditions of high humidity, inadequate equipment condition, lack of electrical isolation, and absence of proper supervision.

- Introduce a formal inspection, testing, and maintenance program for portable lights, cables, and connectors.
- Prohibit the use of taped repairs; any damaged equipment must be removed from service and replaced.
- Provide ELV or RCD-protected lighting for hold illumination where feasible.

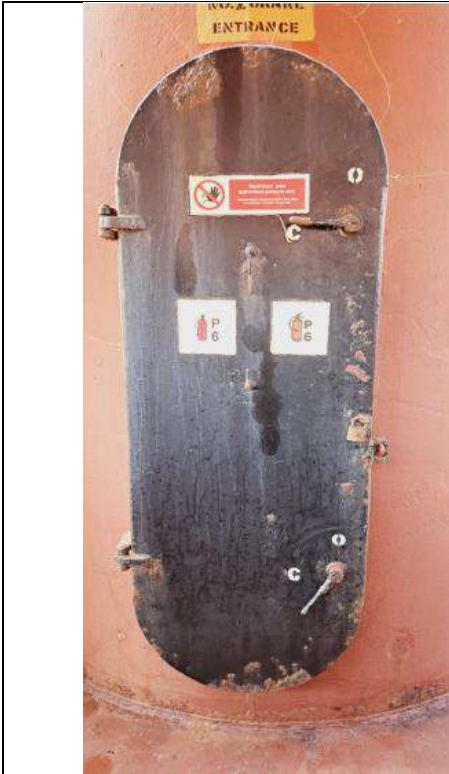
- c. Although no hazardous work, such as aloft or overside operations, was scheduled, the task assigned to the OS required entering a restricted space, the pedestal of Crane No. 2, where 220-V and 440-V electrical components were present. The work was undertaken at night in high-humidity conditions and involved handling energized equipment.

Figure 2: Entrance to the Crane No. 2 pedestal with posted signage reading “Restricted Area. Authorized Persons Only.”

- Clearly designate crane pedestals as restricted electrical spaces requiring authorization and permit work.

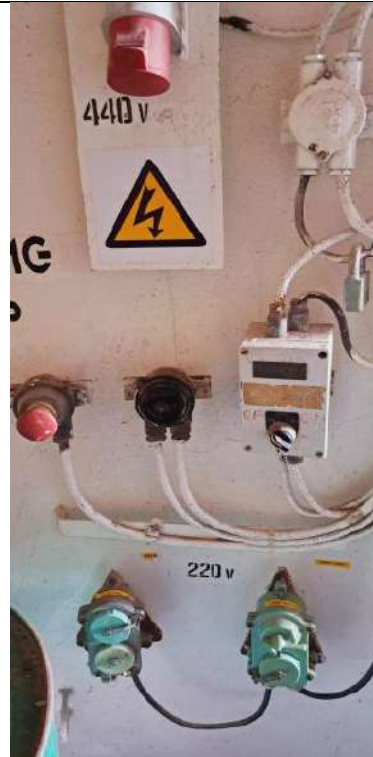
Figure 3: 220-V and 440-V sockets and the emergency stop for the crane located inside the pedestal of Crane No. 2.
