UK P&I CLUB

# RISK FOCUS: ENGINE ROOM FIRES

*The majority of onboard fires originate in the engine room*

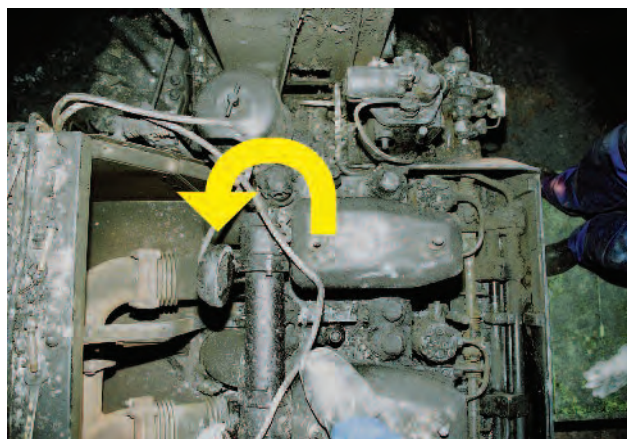
**Potential route for hot oil vapour to spread from the hot box enclosure to the exhaust enclosure (cladding/covers removed for inspection)**

The maintenance of leak detection/alarm equipment is especially important where oil vapour from a leak of hot oil at a temperature above its flashpoint can, for example, migrate from the hot box of a generator, across the engine entablature to exhaust system enclosures where the vapour can auto-ignite

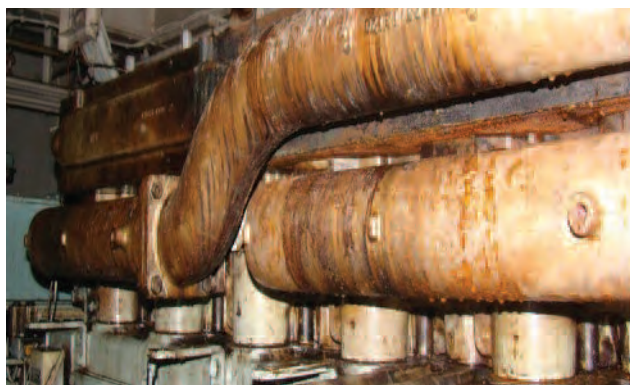
**Exhausts completely uninsulated**

It is a SOLAS requirement that surfaces, with temperatures above 220°C that might come into contact with oil as a result of a system failure are properly insulated. Ship's crew should, therefore, appreciate that even a small exposed area of non-insulated hot surface, such as part of a flange joint or an instrument pipe, can be potentially dangerous. The photographs below illustrate examples of defective protection of hot surfaces ranging from a complete failure to clad generator exhausts to the exposure of parts of exhaust systems.

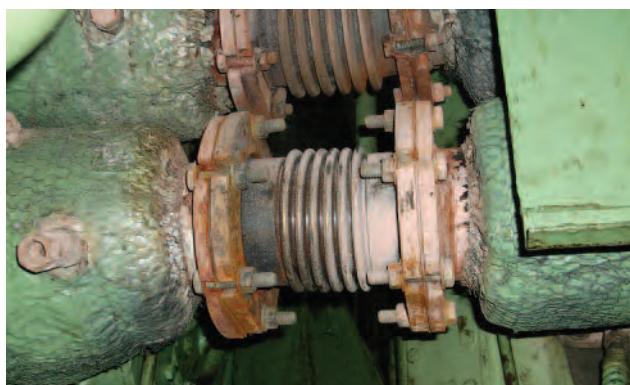
**Exhaust bellows exposed**

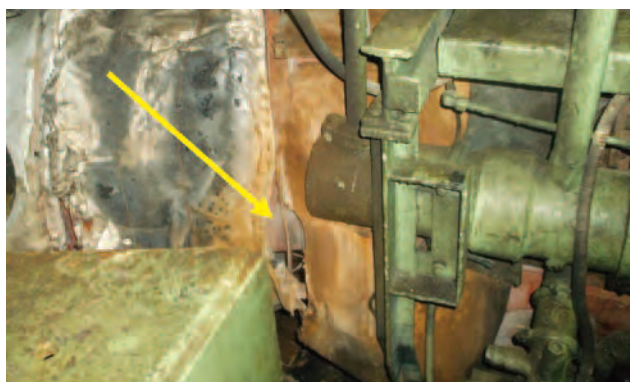
**Small portion of exhaust surface exposed (as arrowed)**

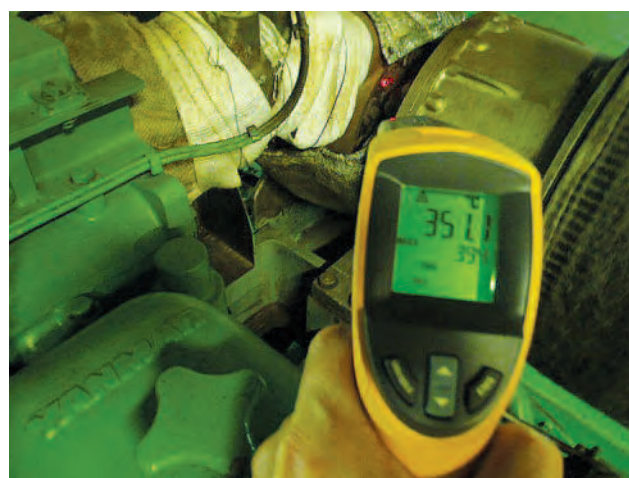
**"Hot spot" due to missing insulation**

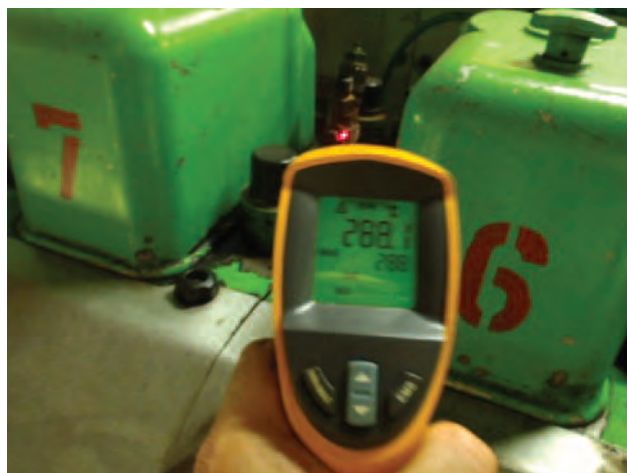
Uncovered indicator cock with exposed temperature above SOLAS limit

Indicator cocks are another potential source of ignition. IMO MSC.1/Circ. 1321 Para 1.1.5 recommends that "Exposed indicator cocks should be insulated in order to cover the high temperature surface."

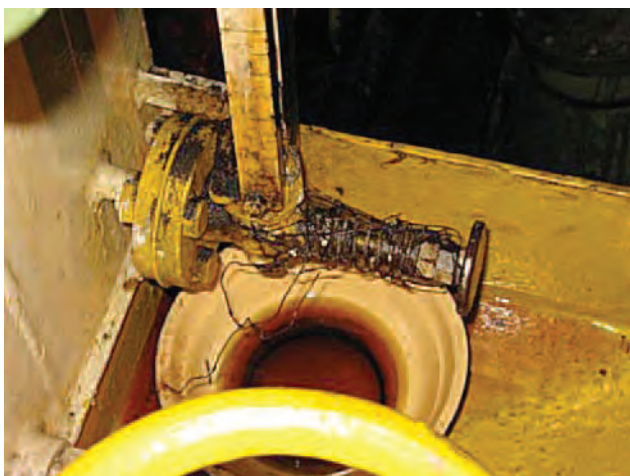
The UK Club's ship inspectors regularly find that various methods are used to keep these valves permanently in the open position. Chocks of wood, pieces of wire and purpose made clamps are often seen to be used to for this purpose. This is dangerous practice. If a gauge glass breaks in a fire the entire contents of the tank will leak into the burning area, escalating the fire.

**Self-closing gauge glass valve gagged with wire**

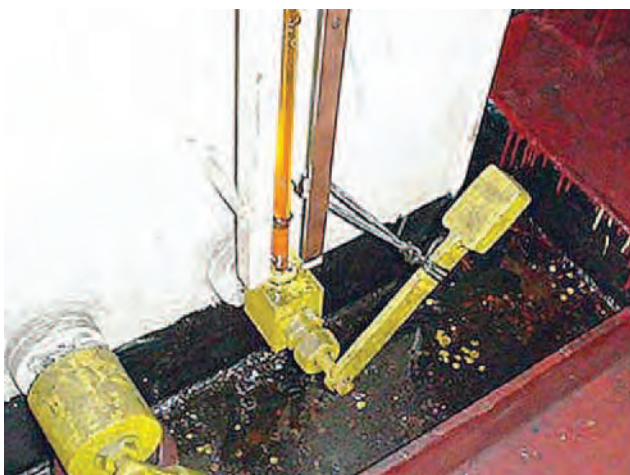
**Self-closing gauge glass held open with string**

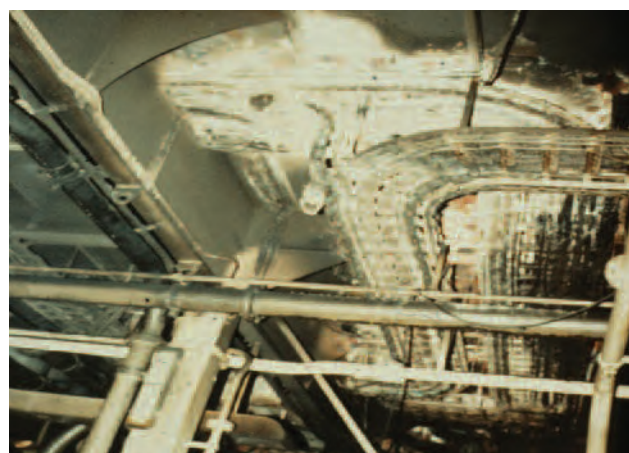
**Damage caused by the spread of fire along cable trays after being exposed to a fire at a lower level of the engine room.**

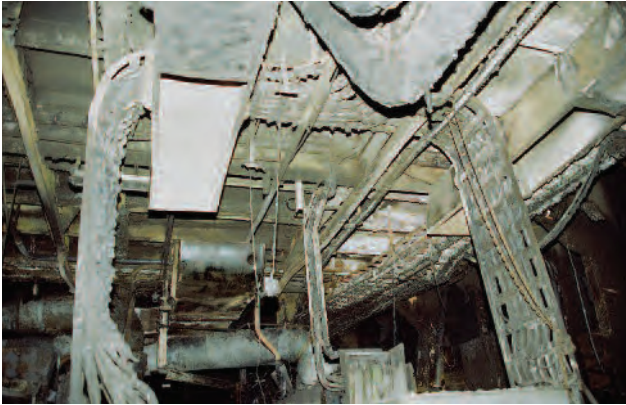
**Fire spread along cable trays away from an auxiliary generator where the fire originated**

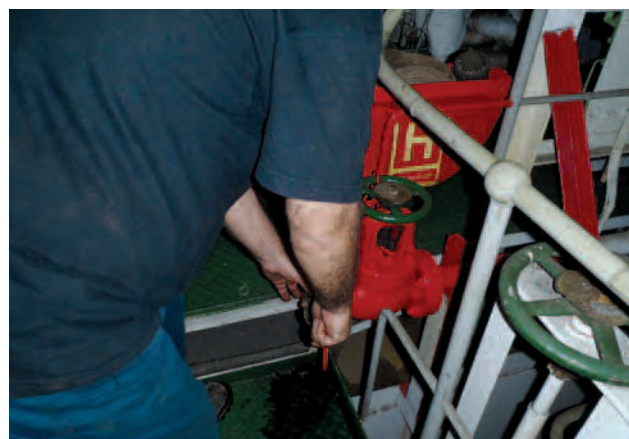
The UK Club's Risk Assessors also frequently note defects in this area. Fire hydrant caps are often found to be difficult to remove by hand (requiring the use of a spanner) and hydrant valves are found to be leaking. Leaking hydrants in an engine room may be tightened with a wheel key and this may render them inoperable by hand in the event of a fire. It is recommended that the high risk threat of engine room fires is recognised and that ship's crew pay particular attention to training and the care, maintenance and correct operation of all fire fighting equipment.

Hydrant cap difficult to remove, and valve leaking

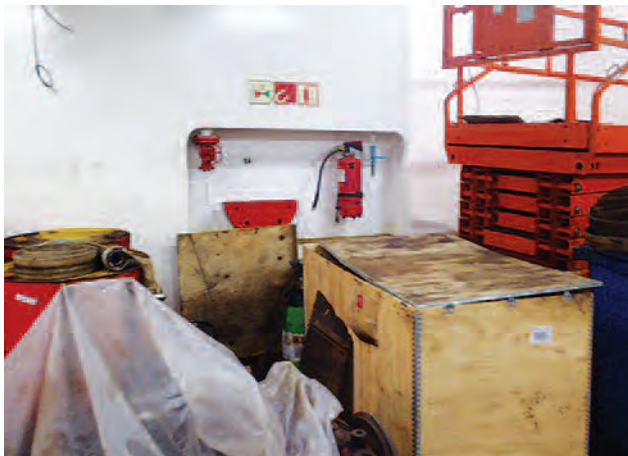
**Obstructed FFE**

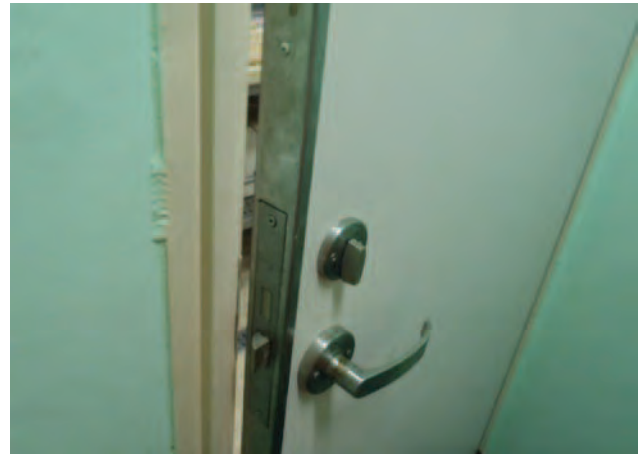
Fire door failing to close

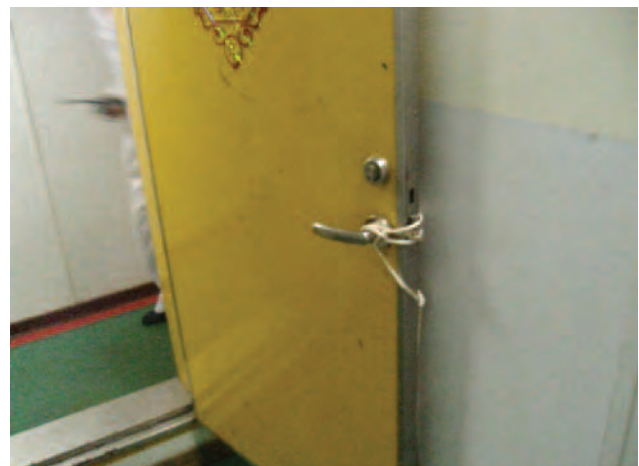
Fire door tied open

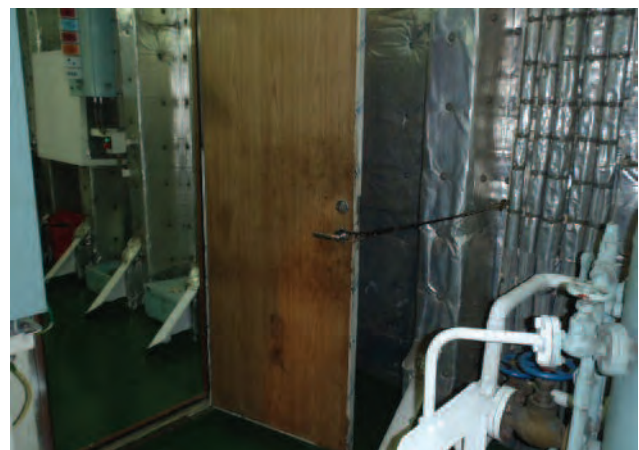
This creates an unnecessary hazard because it provides a route by means of which smoke and fire can spread to adjacent compartments and accommodation areas can quickly fill with smoke preventing safe egress, resulting in fatalities. Moreover, this may also prevent fire parties from preparing and taking up the most favourable strategic positions or accessing fire lockers etc. It may be necessary to evacuate an engine room before there is sufficient time to close engine room access doors that are held open. This is likely to render the CO<sub>2</sub> system as ineffective.

Fire door tied open

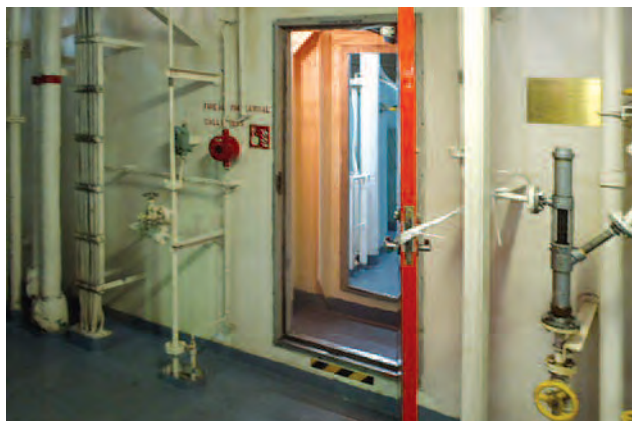
The particular importance of the fire doors between the Engine Room and Steering Gear Compartment should also be emphasised. These are very frequently found to be tied in the open position.

**Steering gear fire doors tied open**

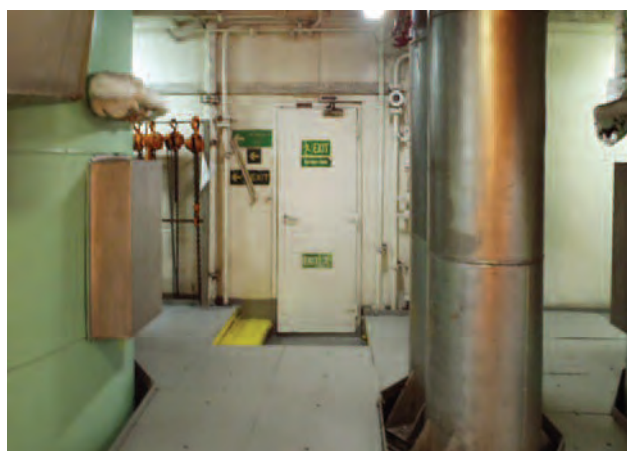
**Poorly marked escape route and door**

Technical Bulletin No. 39/2007 also recommends that the exit doors are clearly highlighted. In both the above photographs, it can be seen that white painted doors do not stand out well against white painted bulkheads. Doors painted with “tiger stripes” or marked with retro reflective tape are far more obvious.

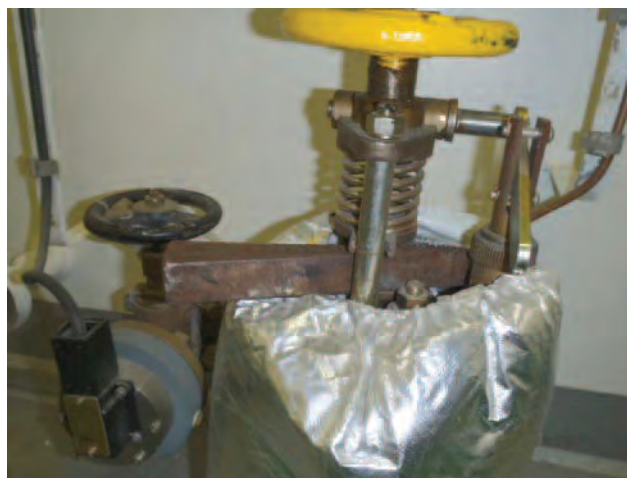
Quick closing valves will not shut if, as sometimes noted, they are tied or wedged in the open position. This is an unnecessary and highly dangerous practice.

**Quick closing valve held open with a steel wedge**

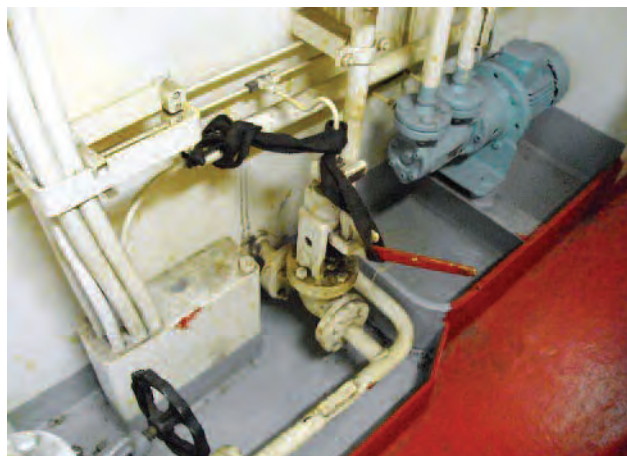
**Quick closing valve held open with a strop**
