Report on the investigation of
the structural failure of
MSC Napoli
English Channel
on 18 January 2007

Marine Accident Investigation Branch
Carlton House
Carlton Place
Southampton
United Kingdom
SO15 2DZ

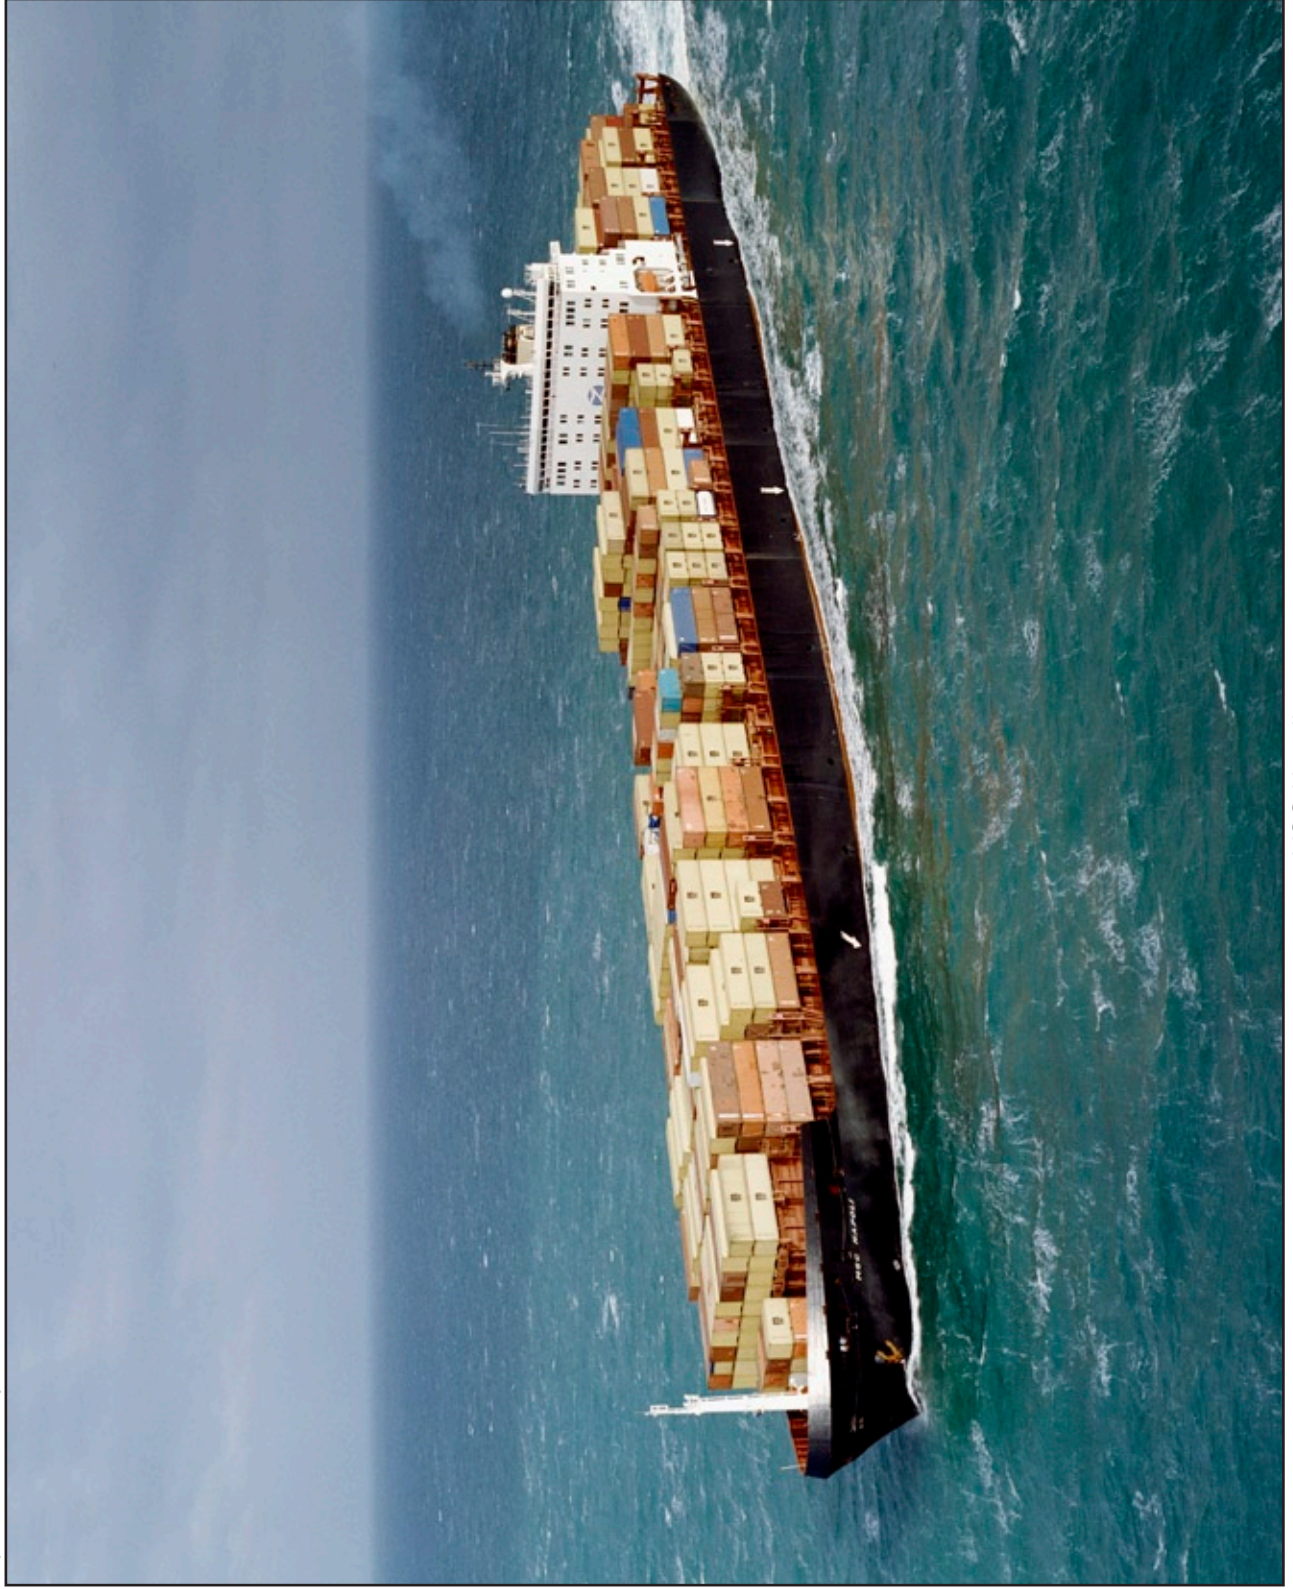
Recommendations have been made to the International Association of Classification Societies, which are intended to increase the requirements for container ship design, consolidate current research into whipping effect, and to initiate research into the development and use of technological aids for measuring hull stresses on container ships. Recommendations have also been made to the International Chamber of Shipping with the aim of promoting best practice within the container ship industry, and to Zodiac Maritime Agencies, with reference to its safety management system.

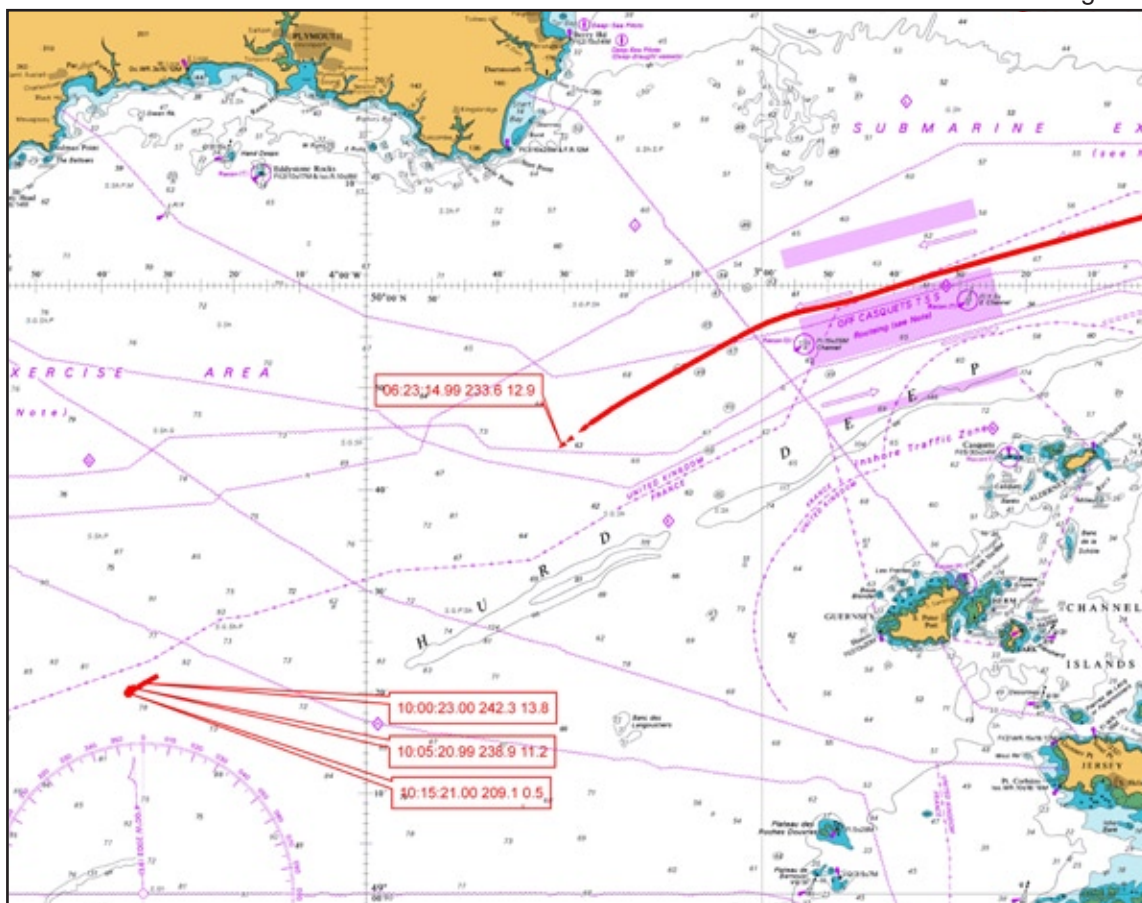
Ship's track as recorded by AIS (UTC)

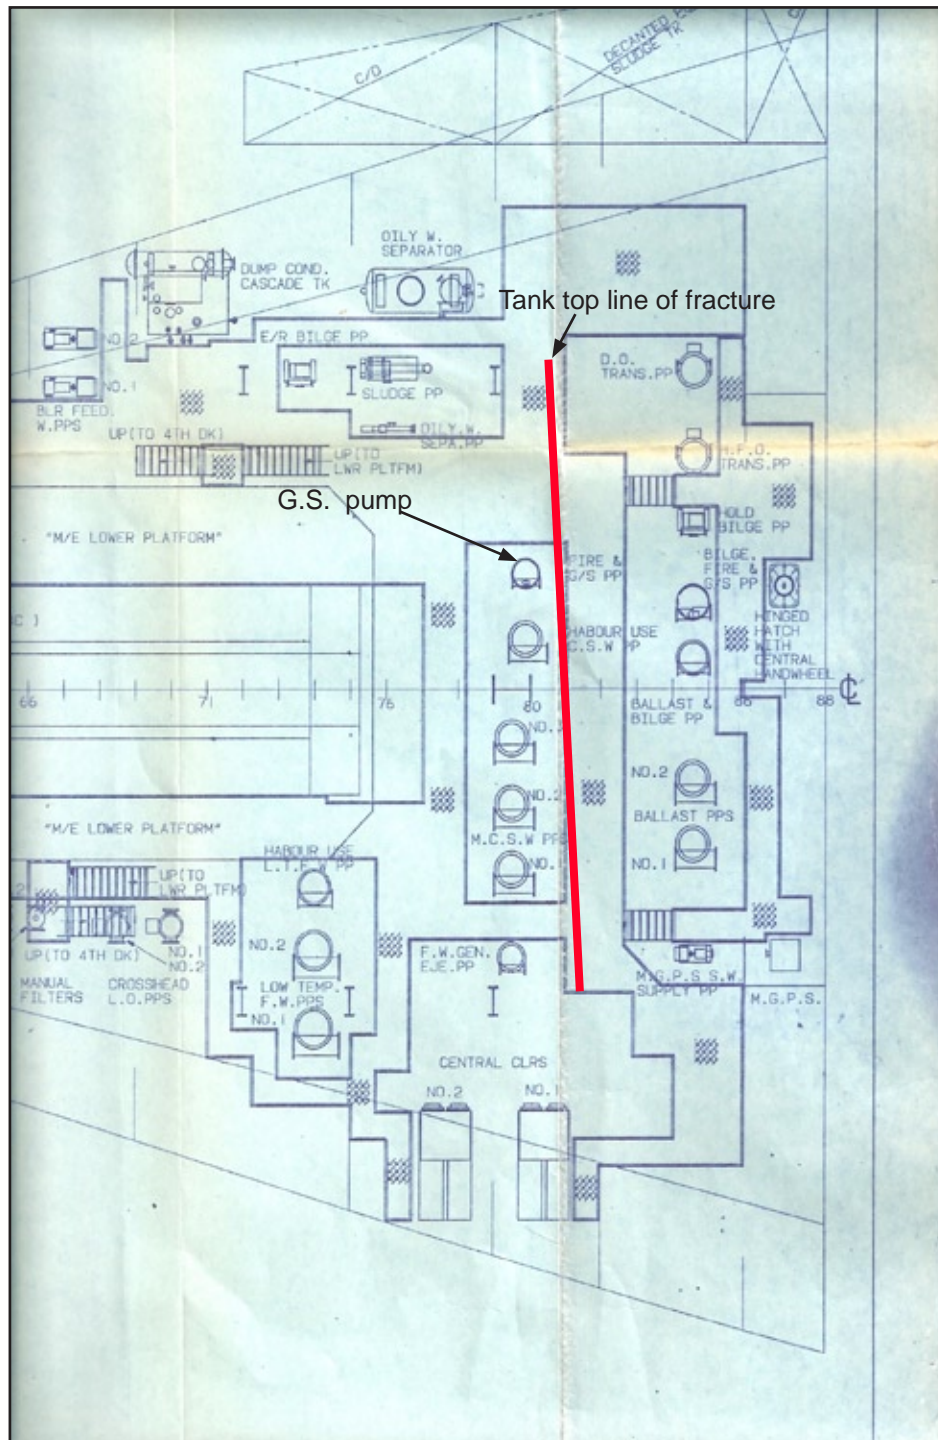
Forward engine room arrangement showing fracture line

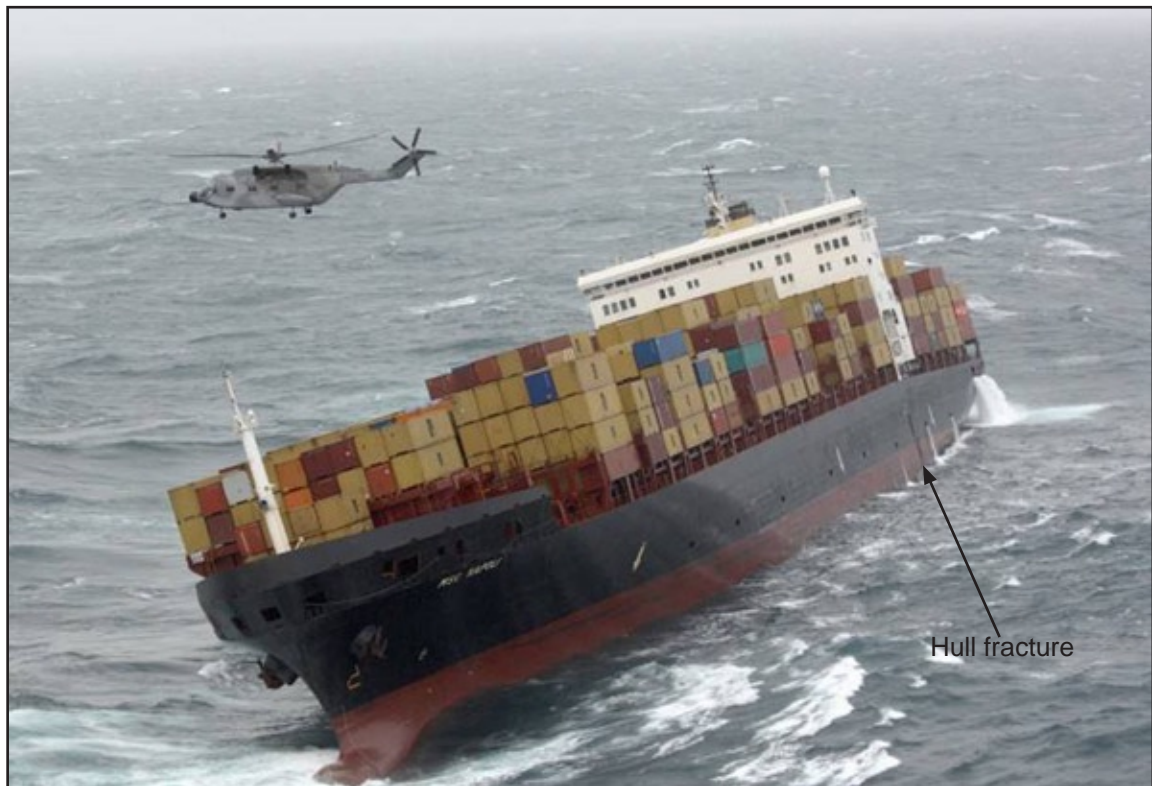
MSC Napoli following the structural failure

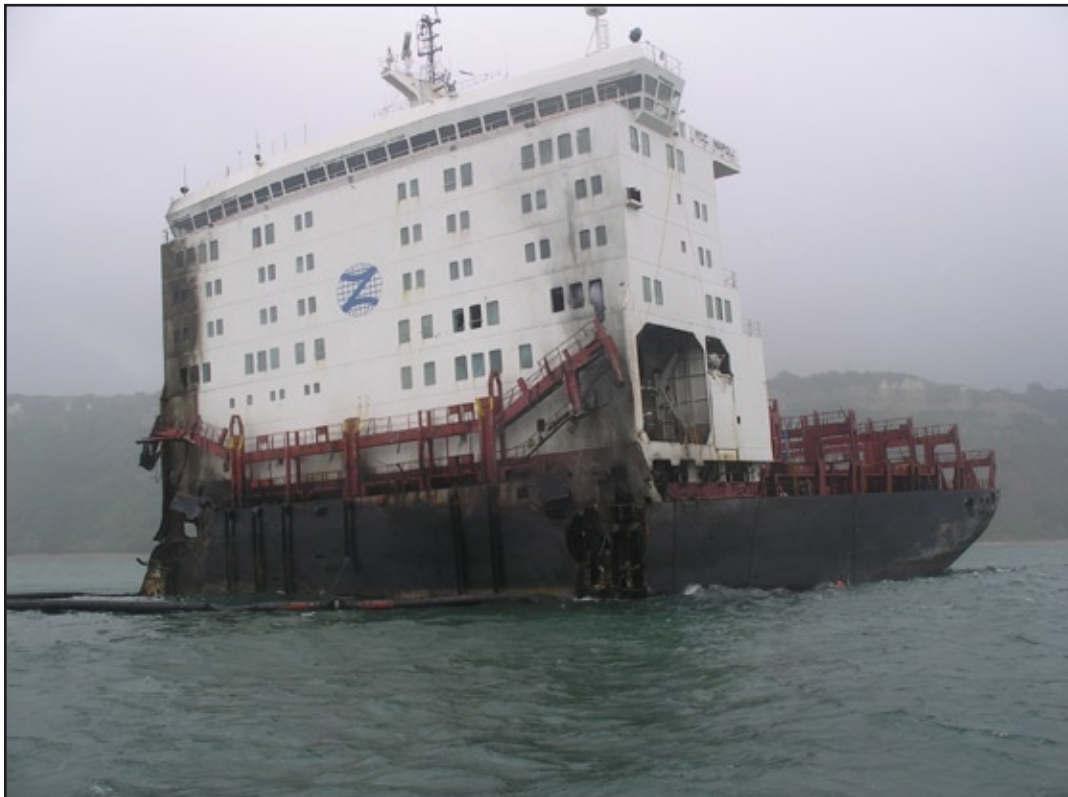
MSC Napoli - aft section

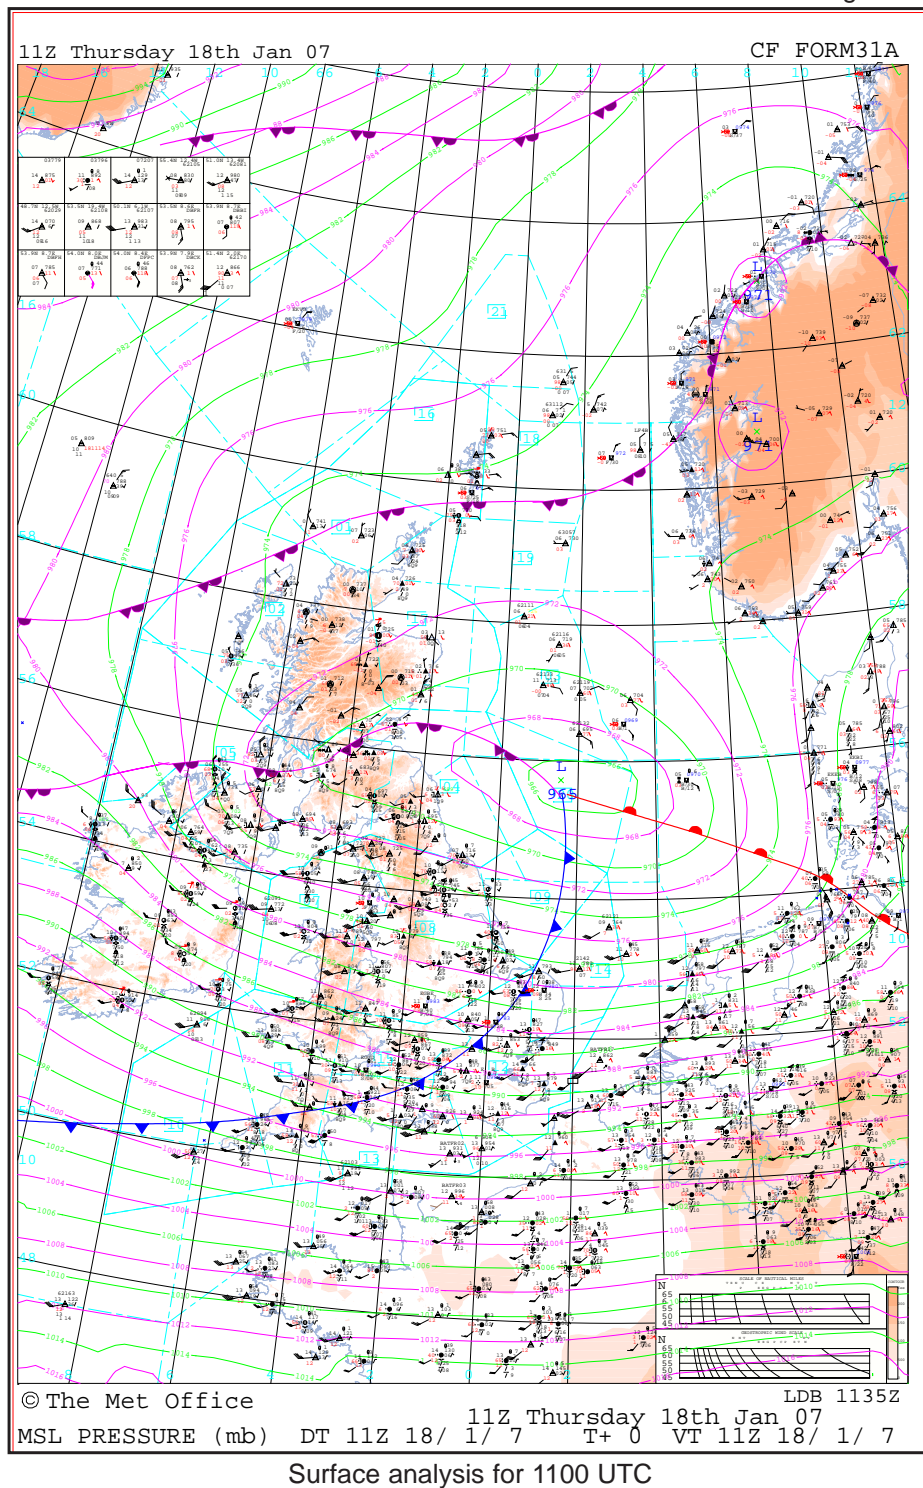
1.5 LOADED CONDITION

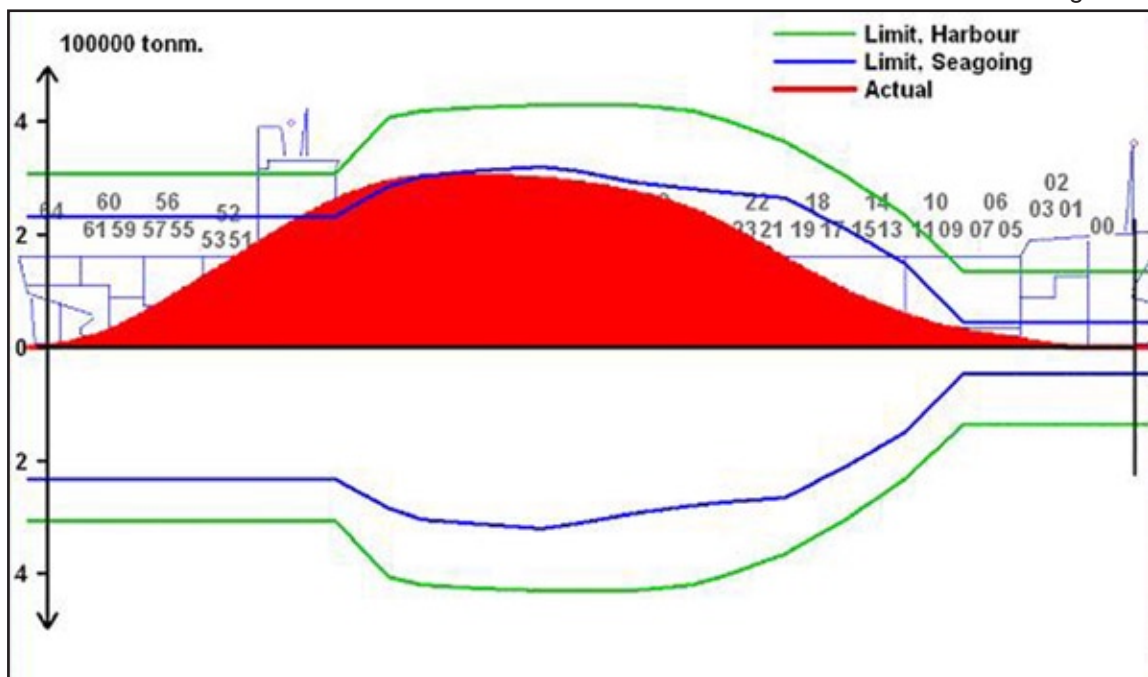
Departure condition on leaving the berth in Antwerp

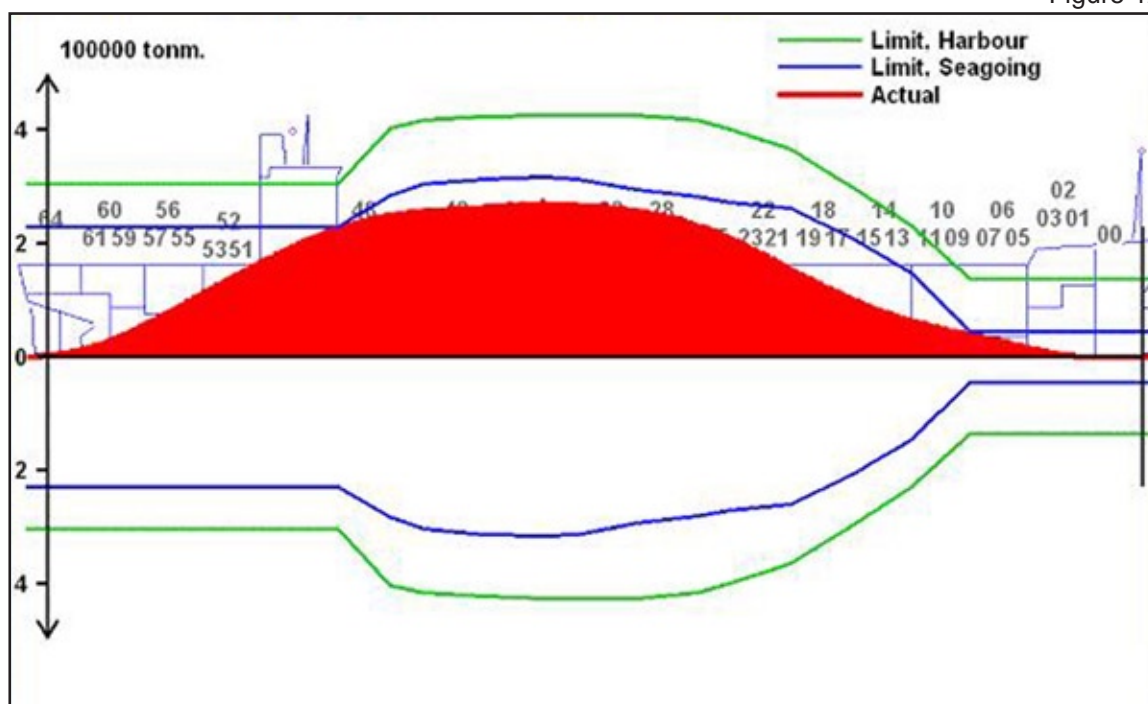
Condition on leaving the River Schelde

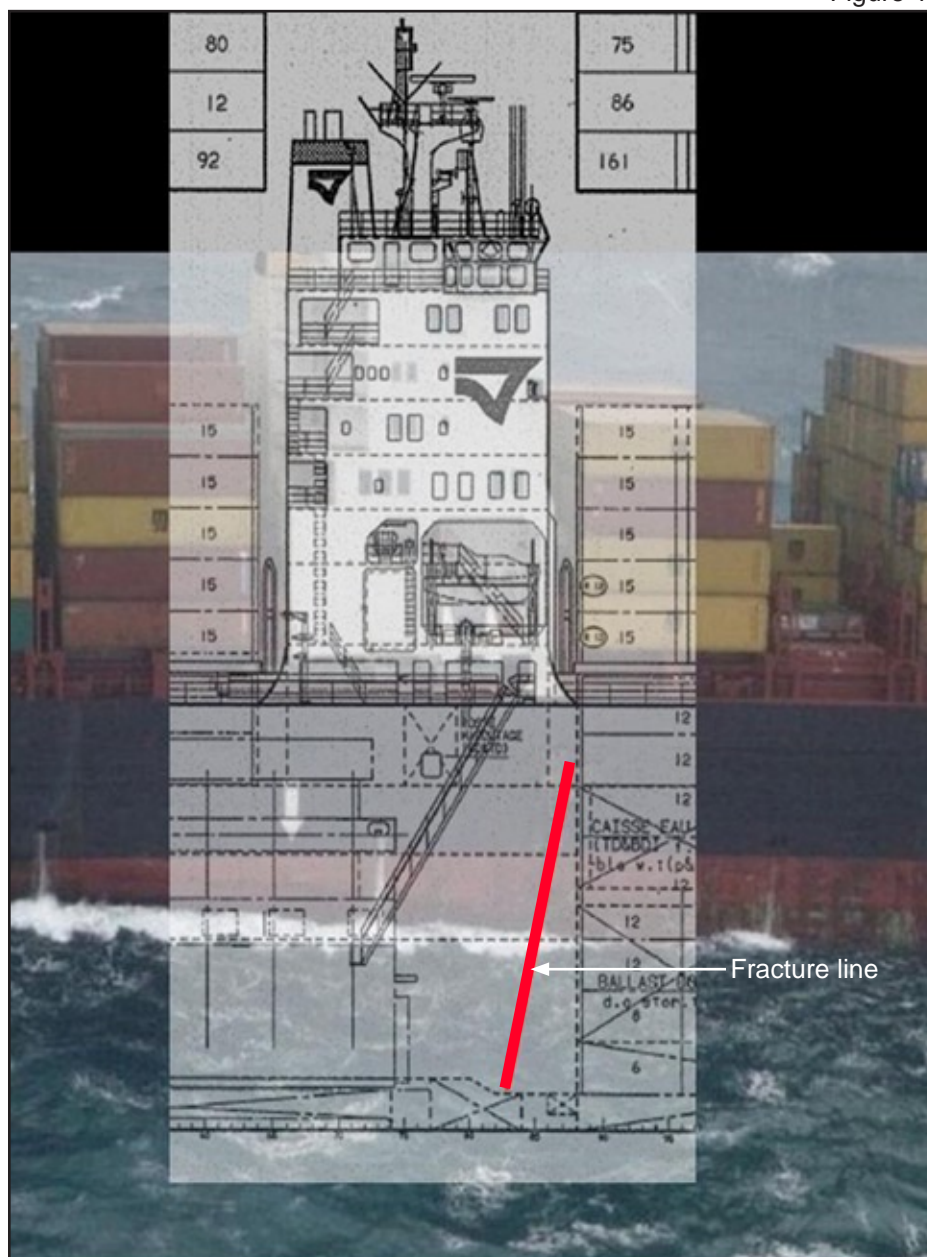
Path of fracture line established during dive surveys

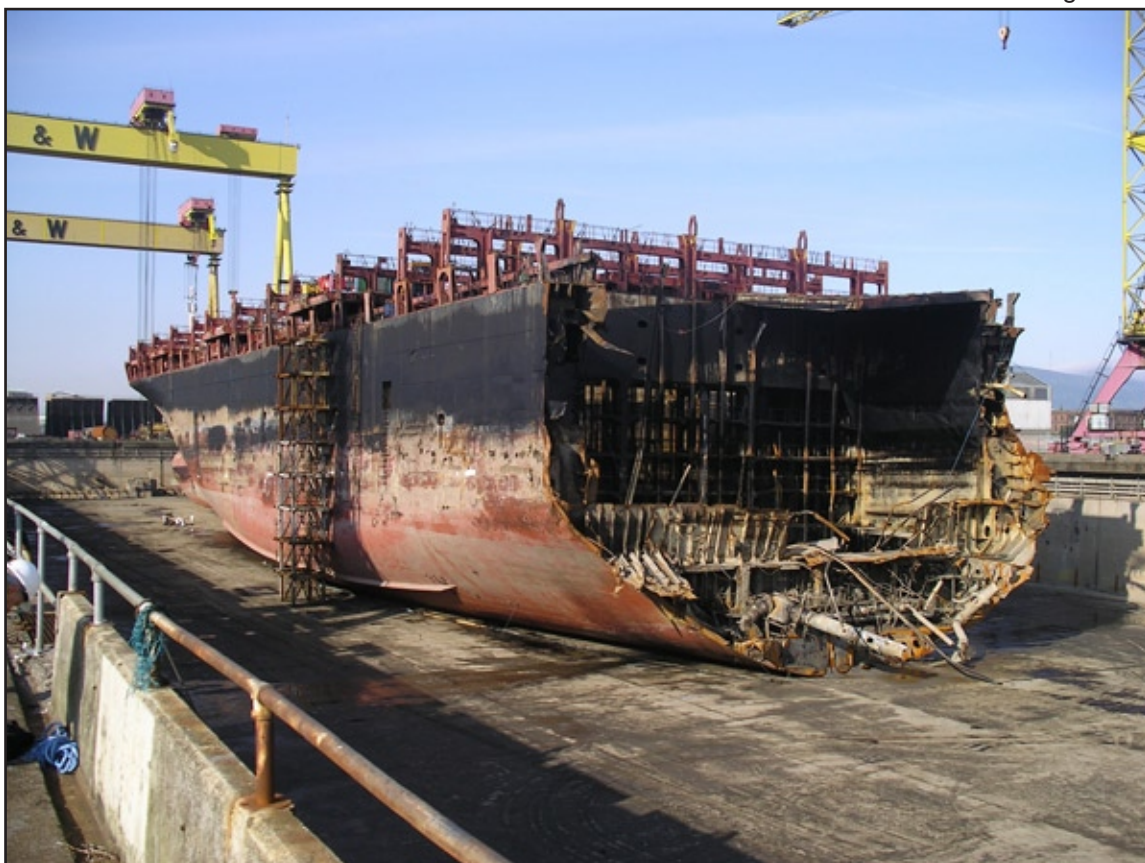
Forward section of hull in Belfast dock

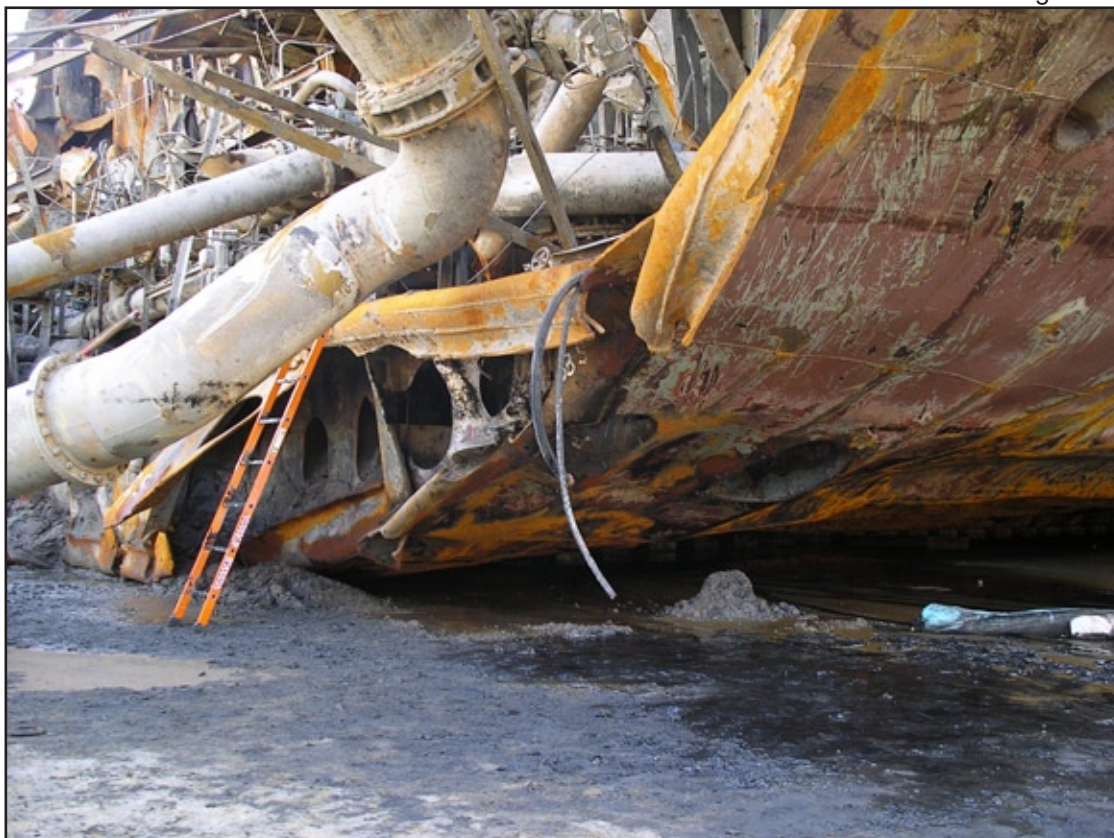
Starboard side hull collapse near lower sea chests

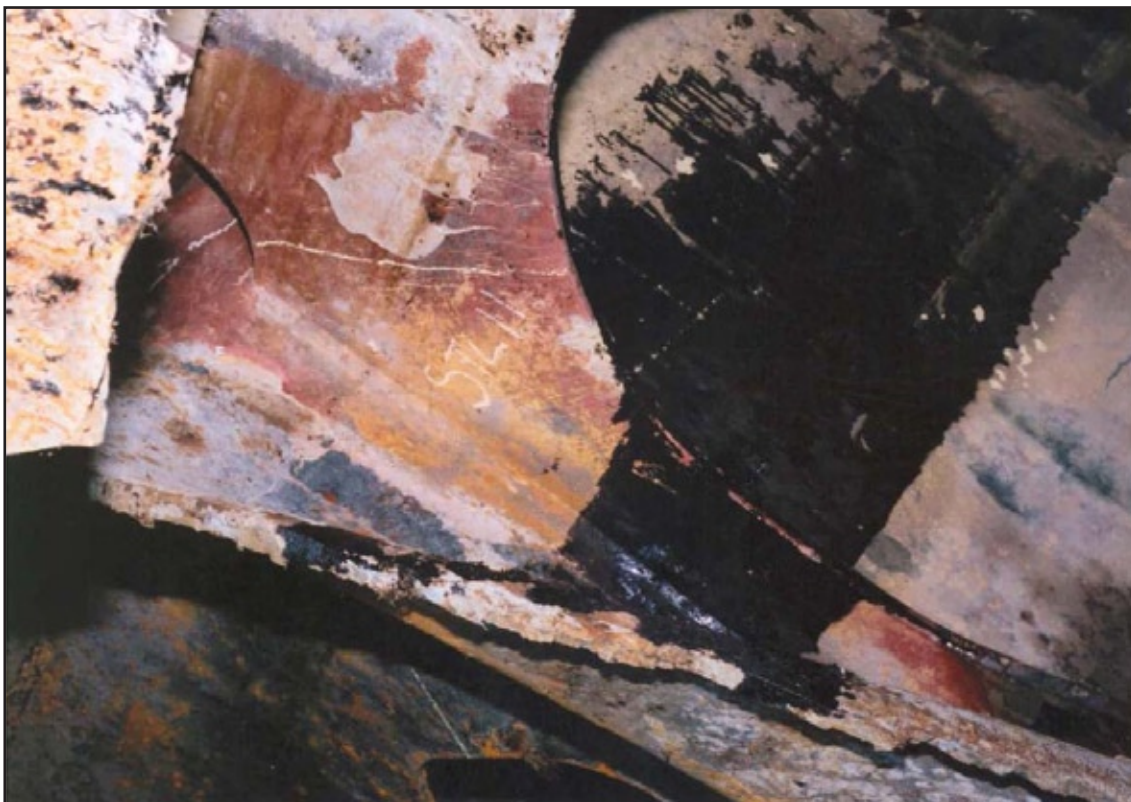
Transverse floor and longitudinal girder number 3 at 6050mm off centre line (including fillet weld connection) inside sea chest, frame number 84 starboard side prior to removal from the vessel

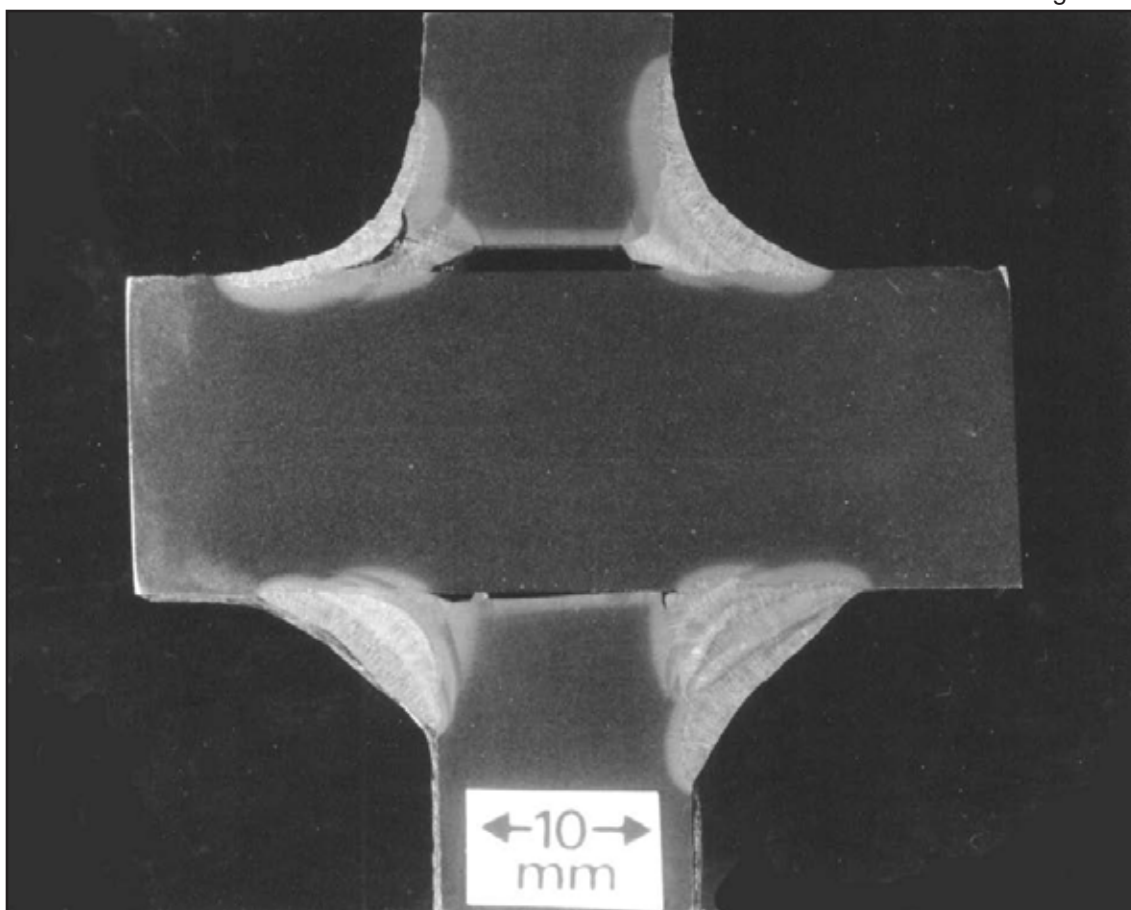
Macrophoto of specimen taken from sample removed from the sea chest showing weld repair

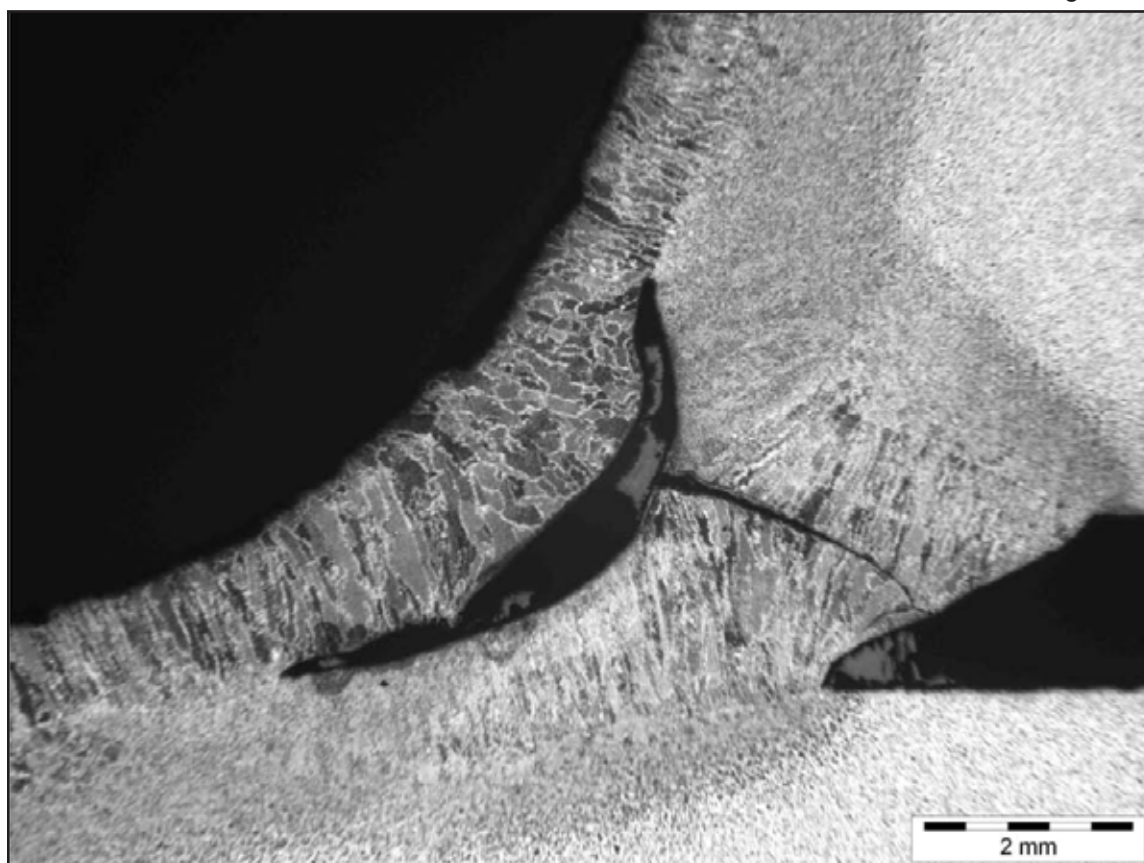
Macrograph of specimen taken from sample removed from the starboard sea chest showing detail of fatigue crack and repair

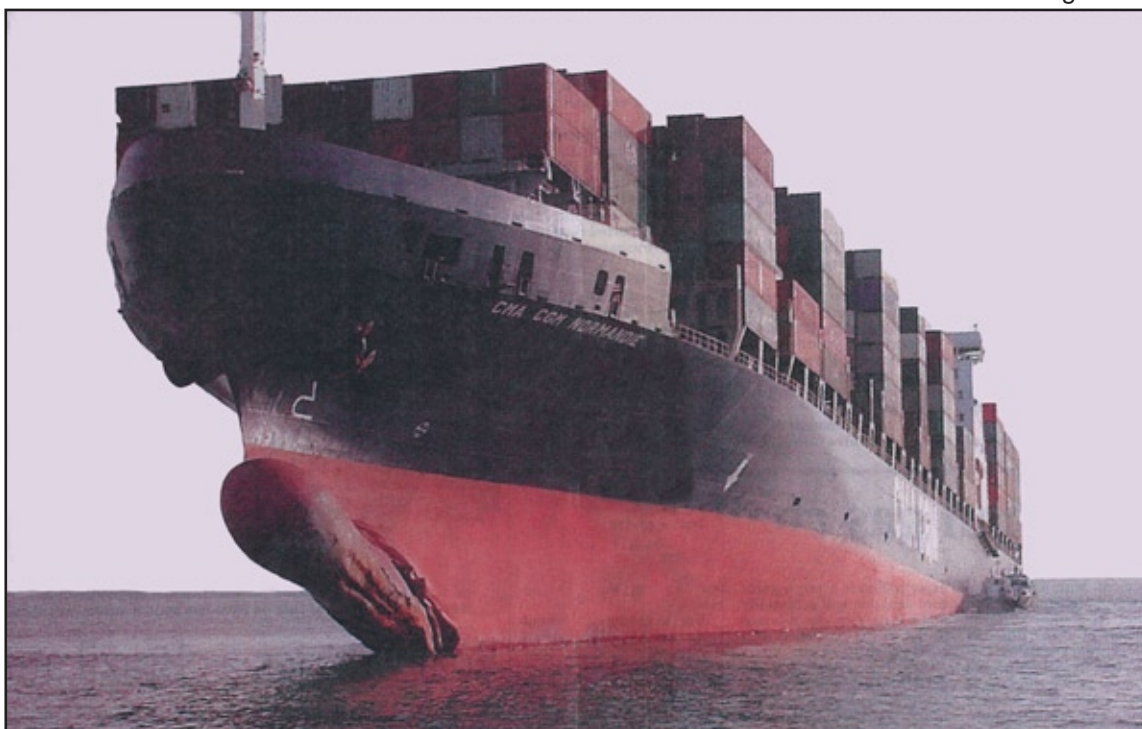
MSC Napoli (formerly CMA CGM Normandie) aground in 2001

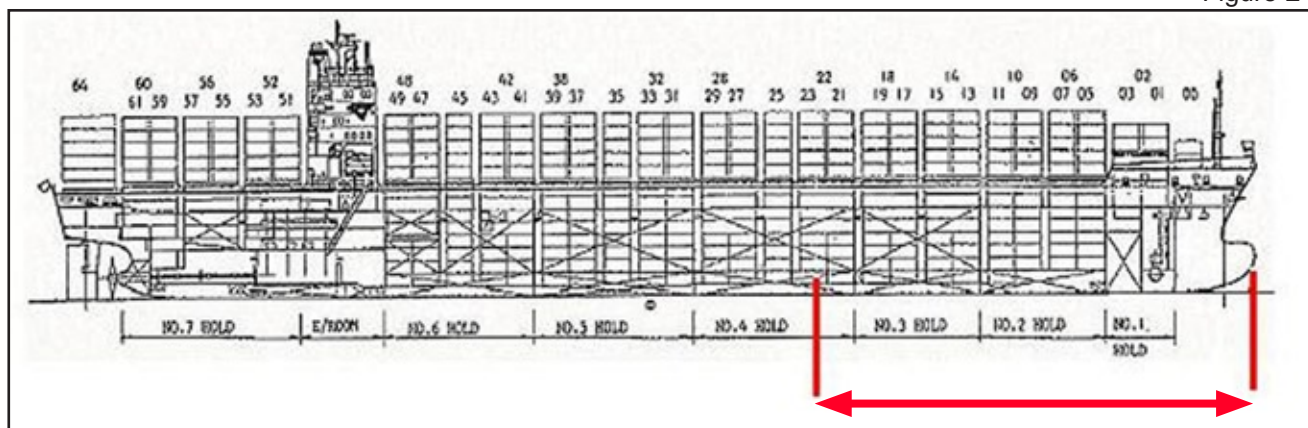
Extent of bottom damage

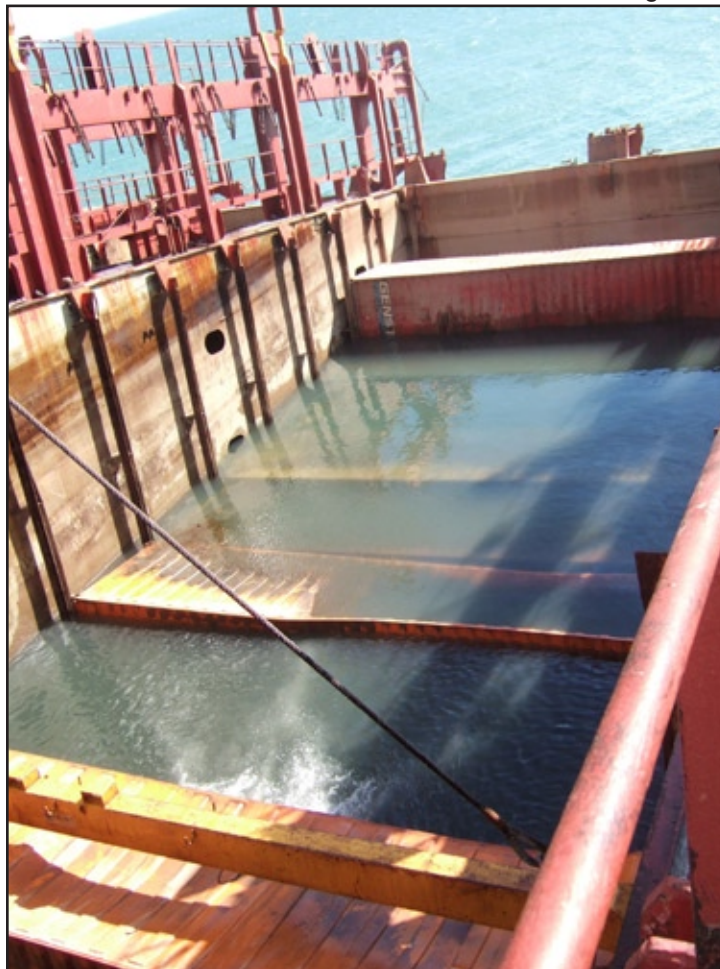
Waterlogged containers in hold

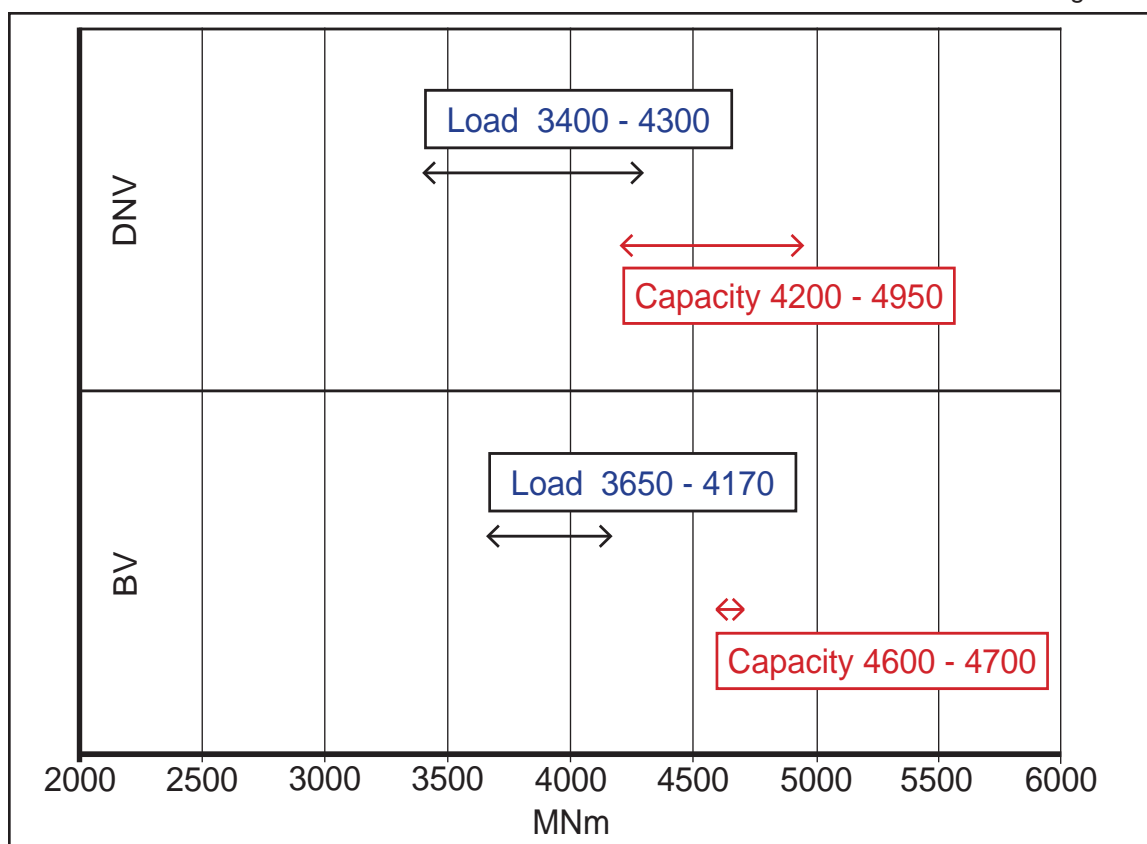
Comparison of DNV and BV load and capacity assessments

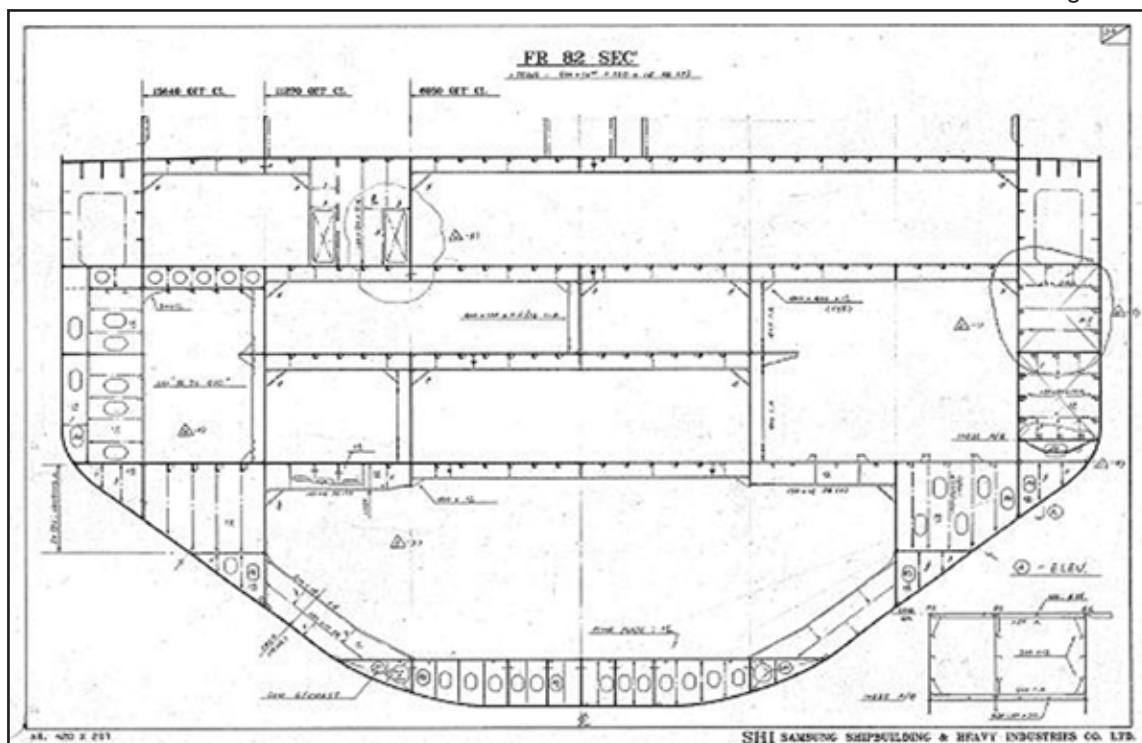
Similar results were obtained for the two sets of rules. A number of panels in the tank top, bottom and lower side structure in the region of frame 82 were found to be deficient (**Figure 29**). Other panels, although passing the buckling checks, were close to the buckling criteria. Consequently, it is likely that when the vessel's hull girder strength was reduced due to the buckling of the weaker panels, the remaining structure had insufficient margin to withstand the increased load. This failure mechanism is consistent with the failure mechanism identified in the FE analyses.
